Expertise

Protocol number: 45898795  
Order No. / Reference: 26361393  
Inspection date: 11 Jun 2026

Manufacturer: Mercedes-Benz  
VIN: W1N4N1CB5PJ501338

Model: GLA 200 d 8G-DCT AMG Line

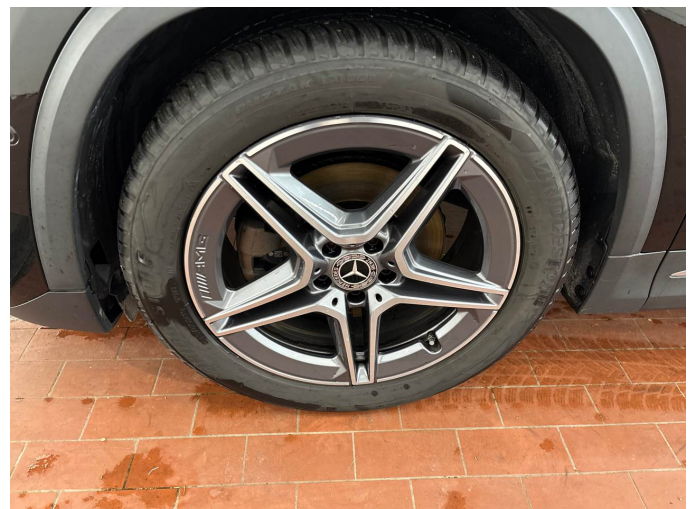
| # | Tyre size | Type of tyre | Manufacturer | Tread depth |
|---|---|---|---|---|
| 1) | 235/50 R19 99H | Winter tyres on Light alloy | Bridgestone | 5mm / 5mm |
| 2) | 235/50 R19 99H | Winter tyres on Light alloy | Bridgestone | 5mm / 5mm |

**Figure 12: Mounted tyres**

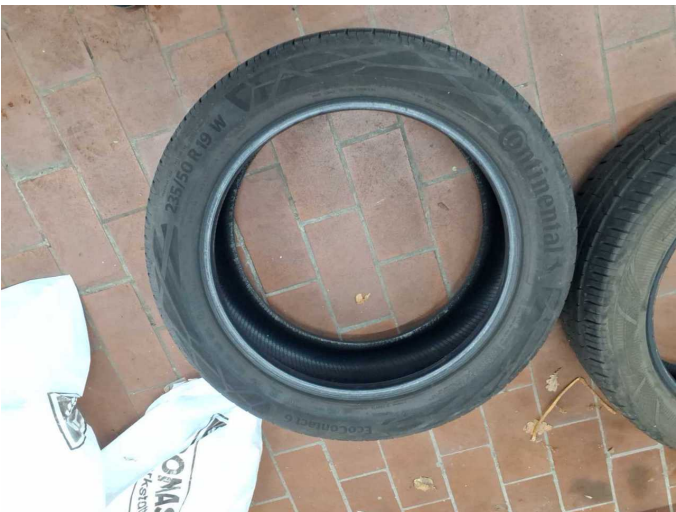
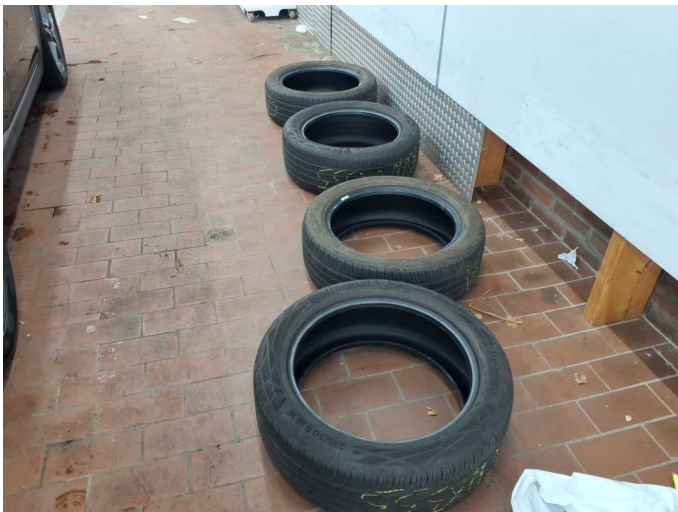
| # | Tyre size | Type of tyre | Manufacturer | Tread depth |
|---|---|---|---|---|
| 1) | 235/50 R19 99W | Summer tyres (Without wheel rim) | Continental | 4mm / 4mm |
| 2) | 235/50 R19 99W | Summer tyres (Without wheel rim) | Continental | 4mm / 4mm |

Figure 17: Additional tyres

Figure 18: Additional tyres

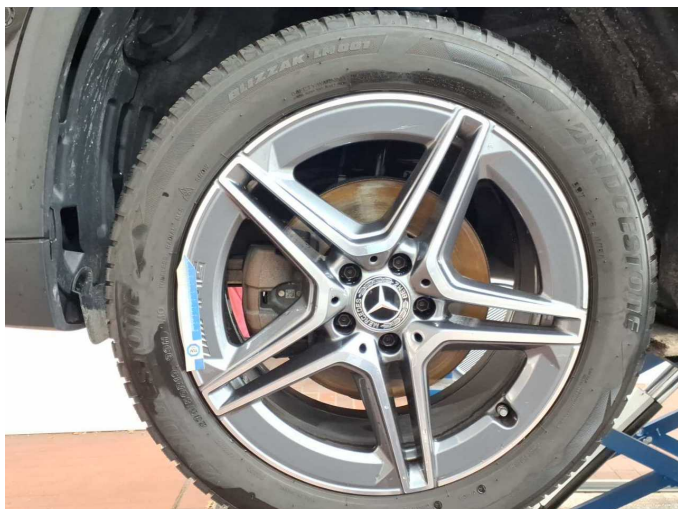
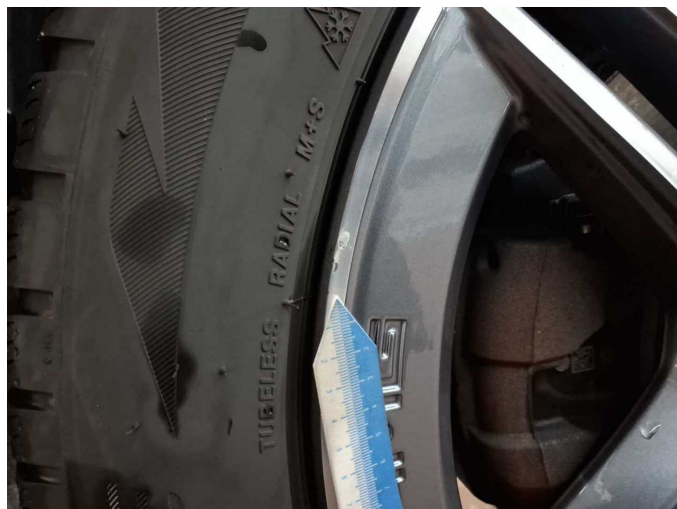
| No. | Component group | Description |
|---|---|---|
| 1 | Wheel / tyres | Alloy rim - front left side - Scratch(es) - Loss in value |

**Damage 1:** Wheel / tyres: Alloy rim - front left side - Scratch(es) - Loss in value

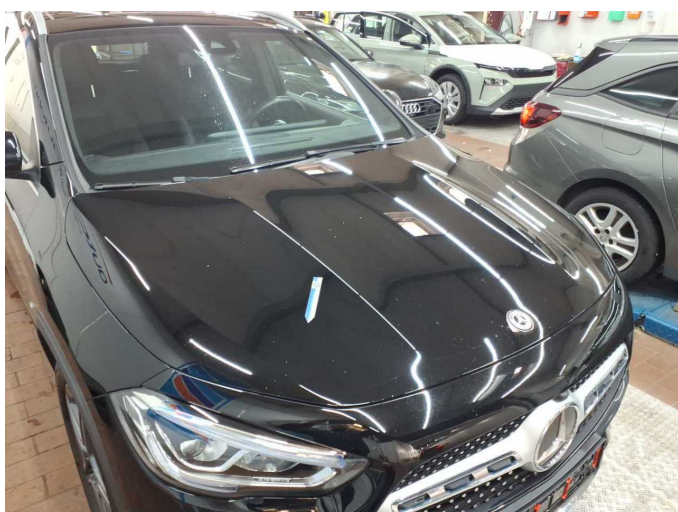
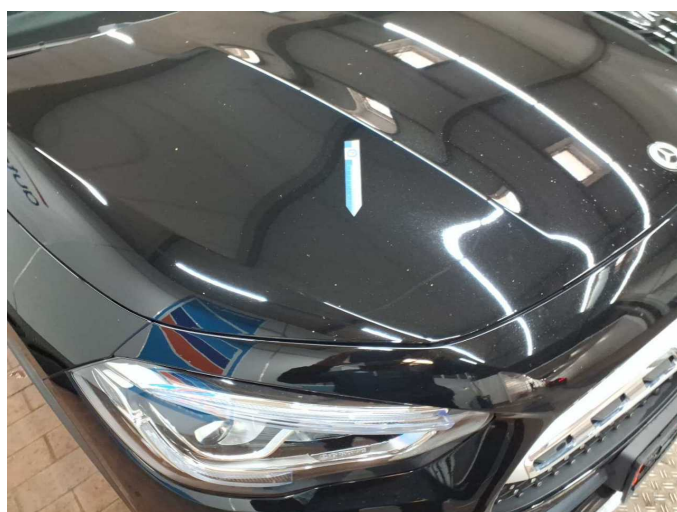
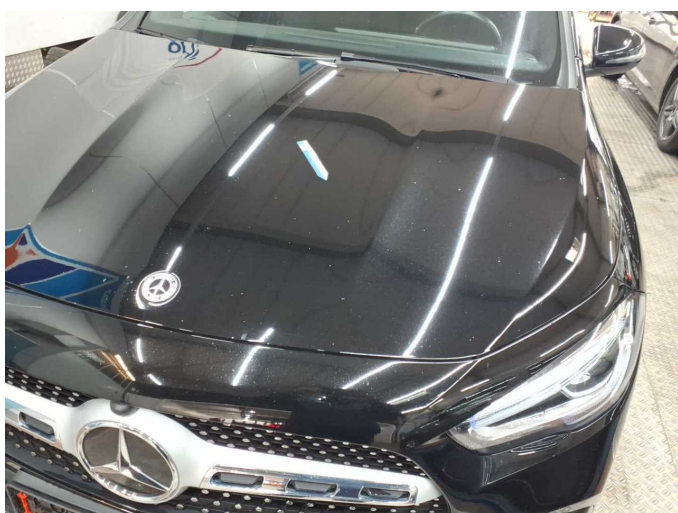
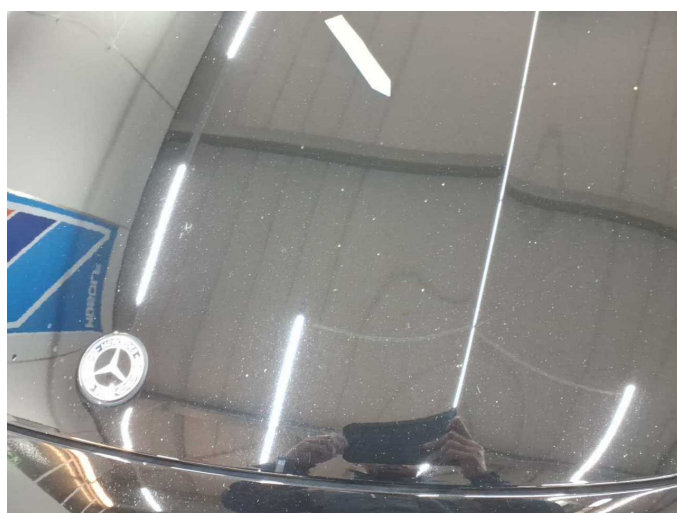
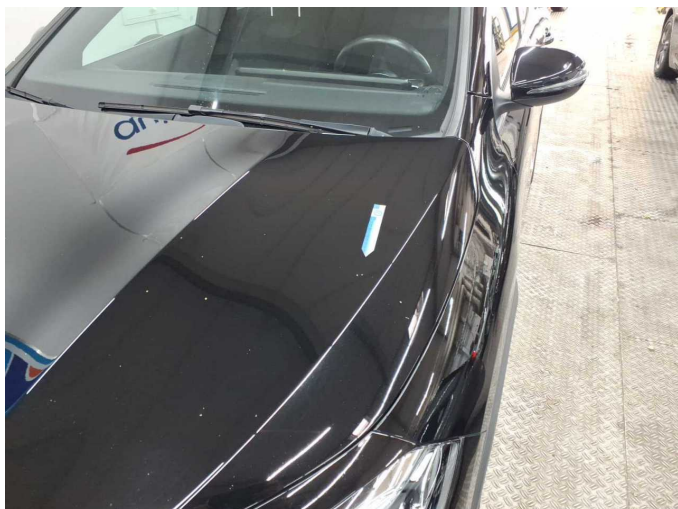
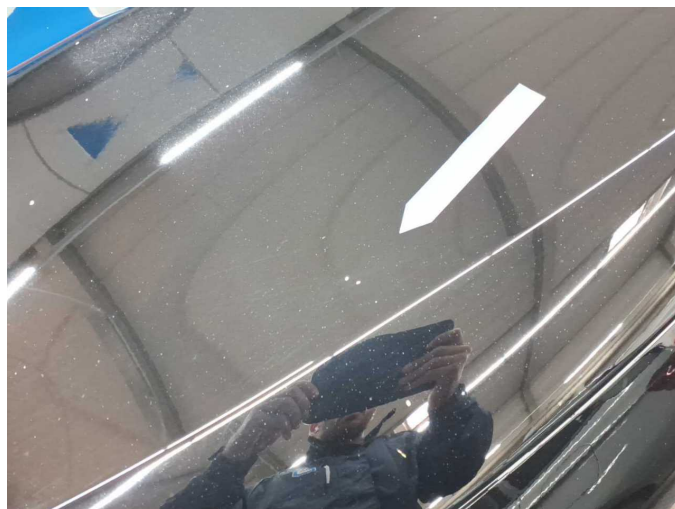
| No. | Component group | Description |
|---|---|---|
| 2 | Bonnet | Bonnet - Stone chips - Paint |

**Damage 2:** Bonnet: Bonnet - Stone chips - Paint
