Expertise

Protocol number: 46537672  
Order No. / Reference: 26723544  
Inspection date: 13 Jul 2026

Manufacturer: Mercedes-Benz

Model: C 200 d T 9G-TRONIC Avantgarde

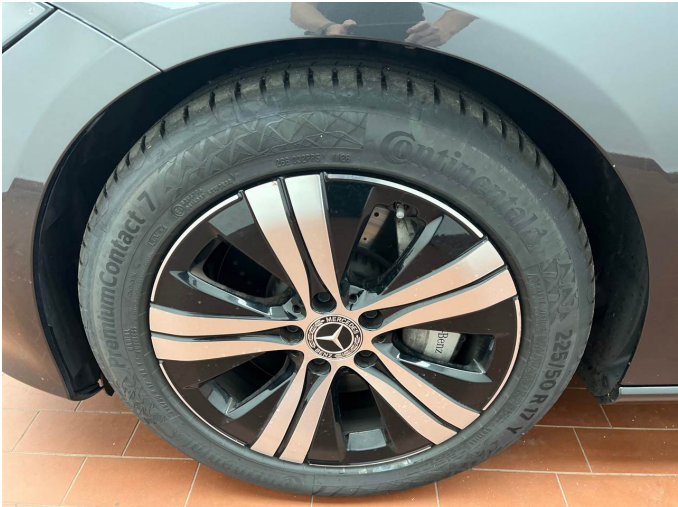
Figure 12: Mounted tyres

| # | Tyre size | Type of tyre | Manufacturer | Tread depth |
|---|---|---|---|---|
| 1) | 225/50 R17 94Y | Summer tyres on Light alloy | Continental | 7mm / 7mm |
| 2) | 225/50 R17 94Y | Summer tyres on Light alloy | Continental | 7mm / 7mm |

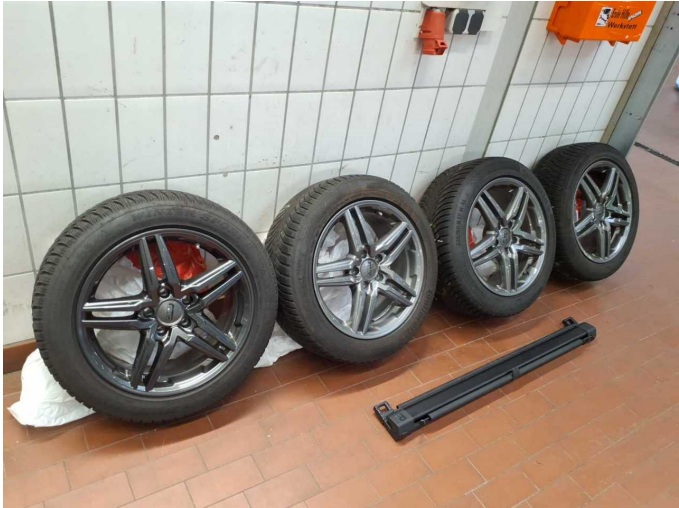
Figure 16: Additional tyres

| # | Tyre size | Type of tyre | Manufacturer | Tread depth |
|---|---|---|---|---|
| 1) | 225/50 R17 94H | Winter tyres on Light alloy | Dunlop | 6mm / 6mm |
| 2) | 225/50 R17 94H | Winter tyres on Light alloy | Continental | 6mm / 6mm |

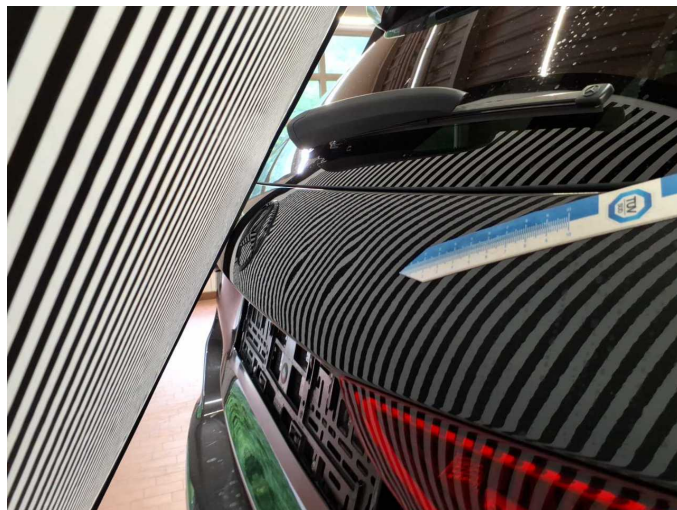
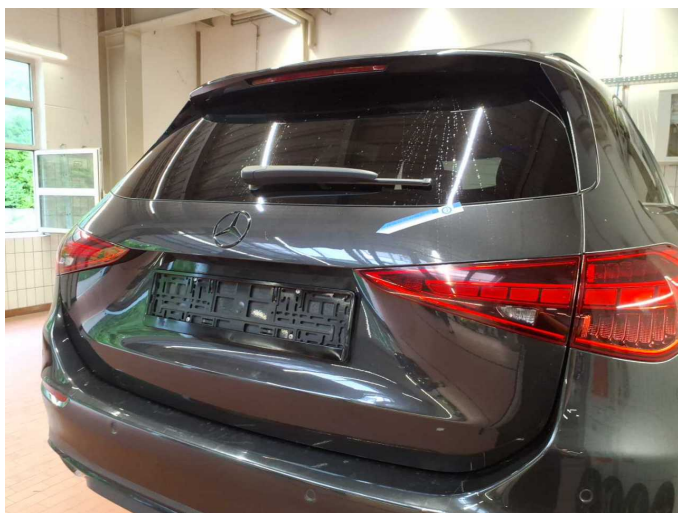
| No. | Component group | Description |
|---|---|---|
| 1 | Boot lid / rear door | Boot lid - dent(s) - Smooth repair work |

**Damage 1:** Boot lid / rear door: Boot lid - dent(s) - Smooth repair work

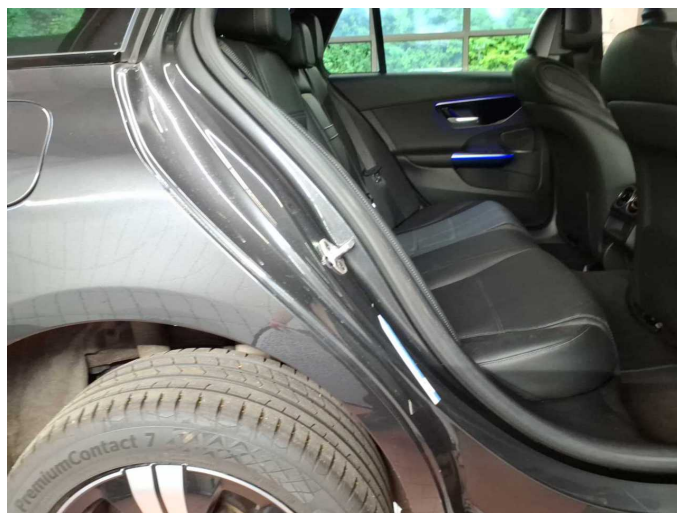
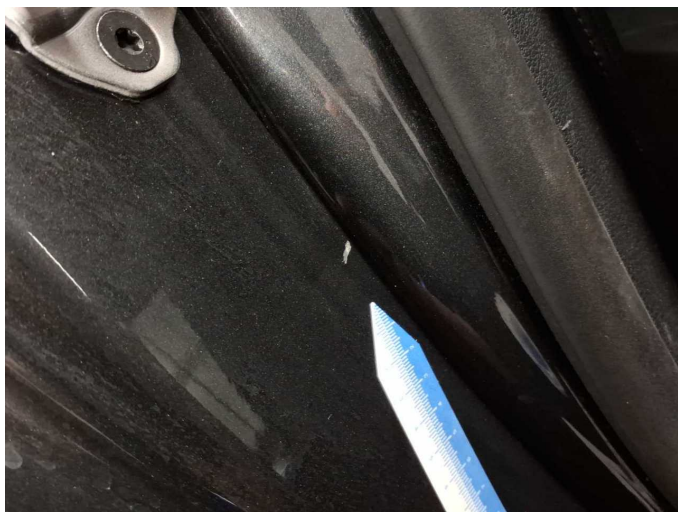
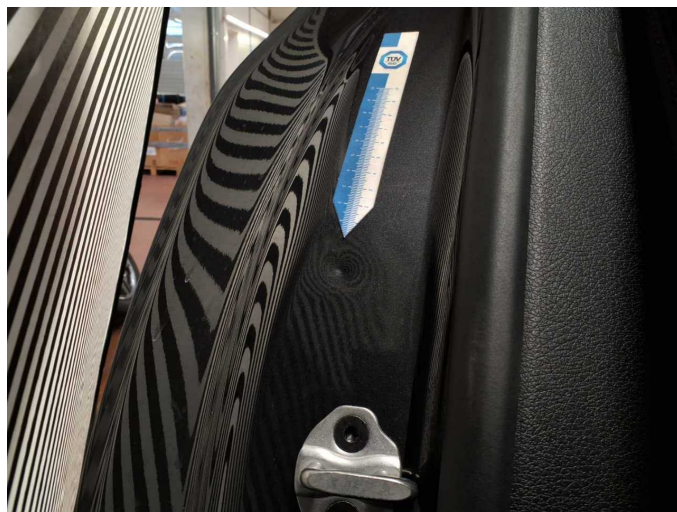
| No. | Component group | Description |
|---|---|---|
| 2 | Side panel - rear right side | Sill - Dent / paintcoat damage - Smart repair |

**Damage 2:** Side panel - rear right side: Sill - Dent / paintcoat damage - Smart repair

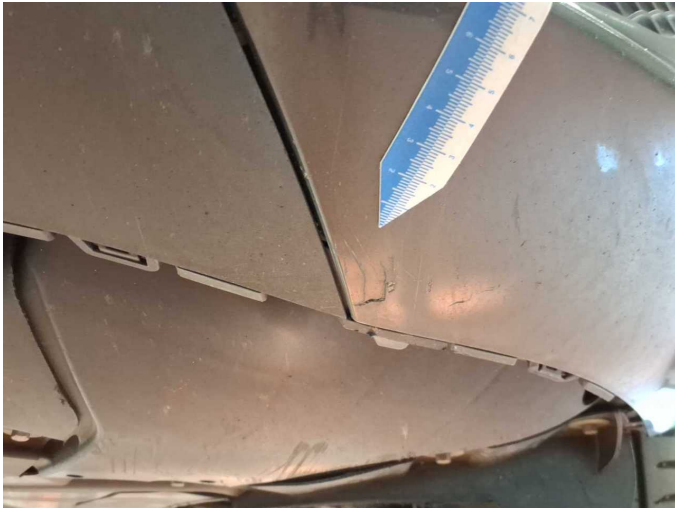
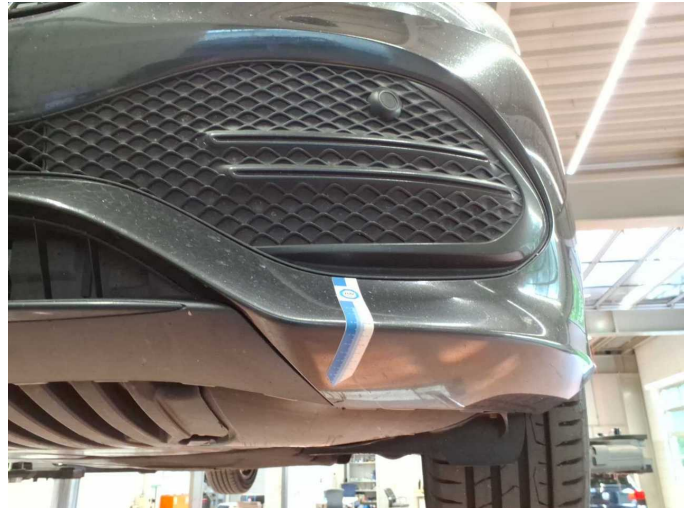
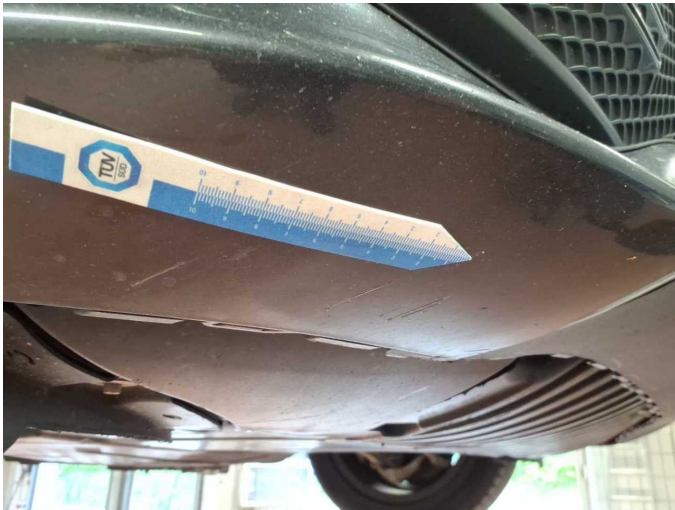
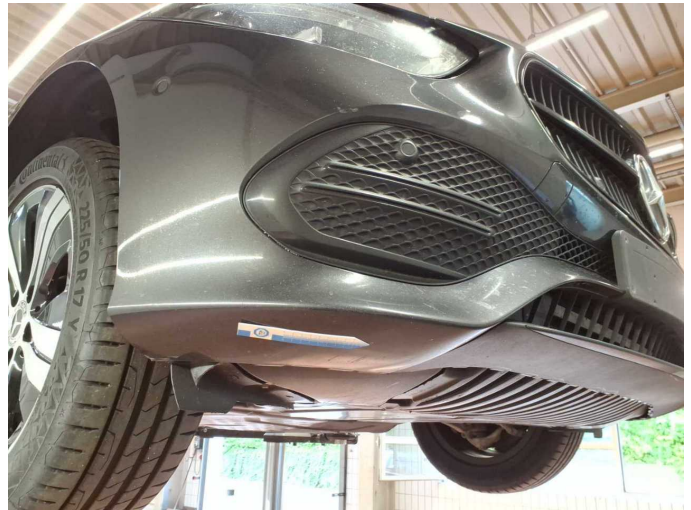
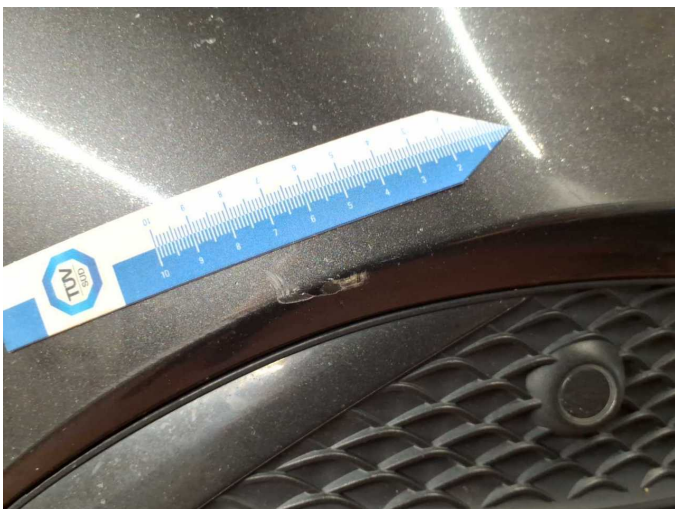
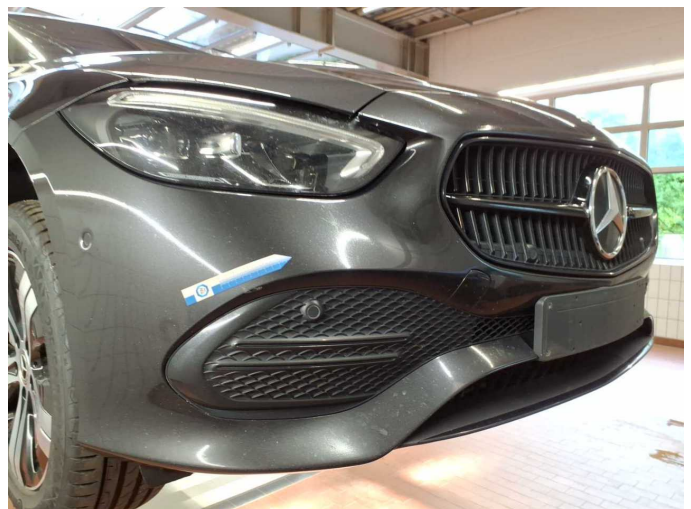
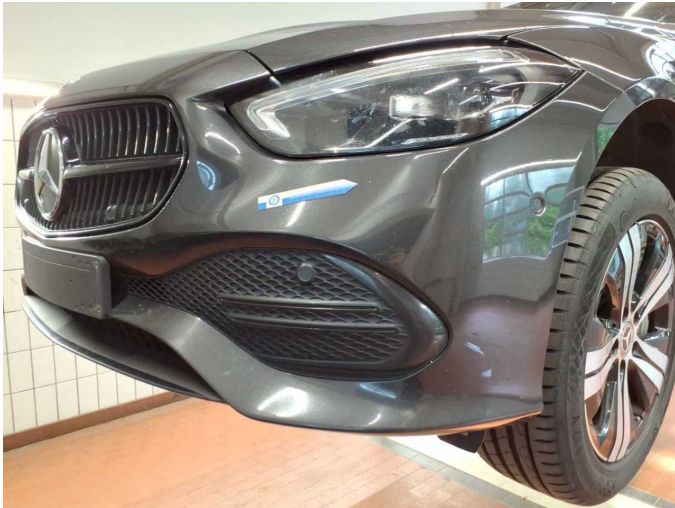
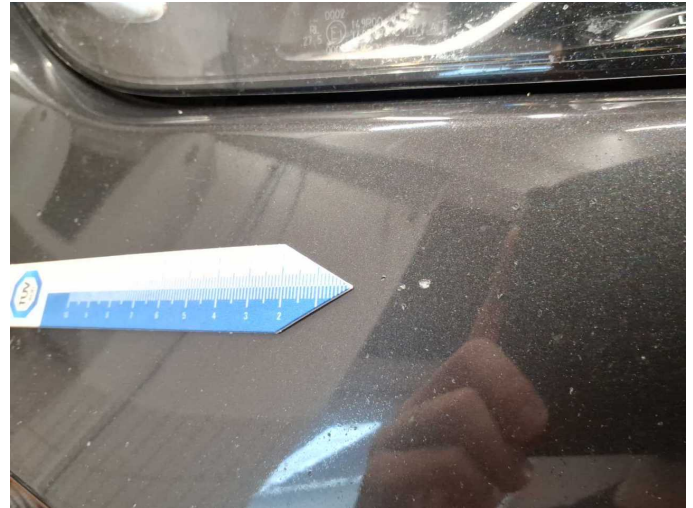
| No. | Component group | Description |
|---|---|---|
| 3 | Front bumper | Front bumper - Scratch(es) - Paint |

**Damage 3:** Front bumper: Front bumper - Scratch(es) - Paint

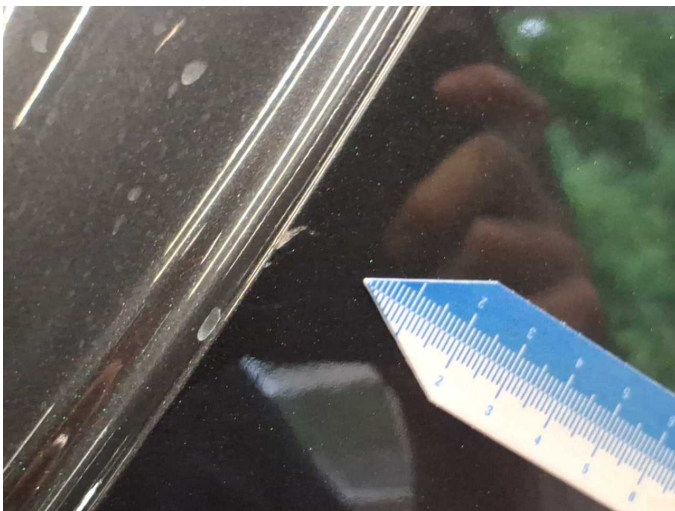
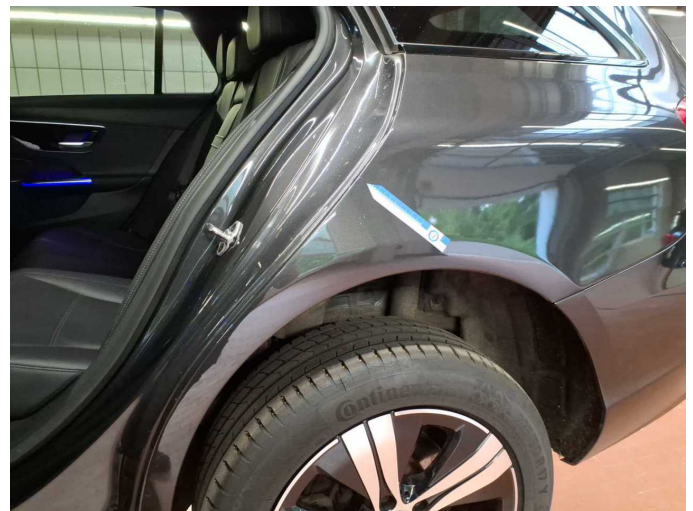
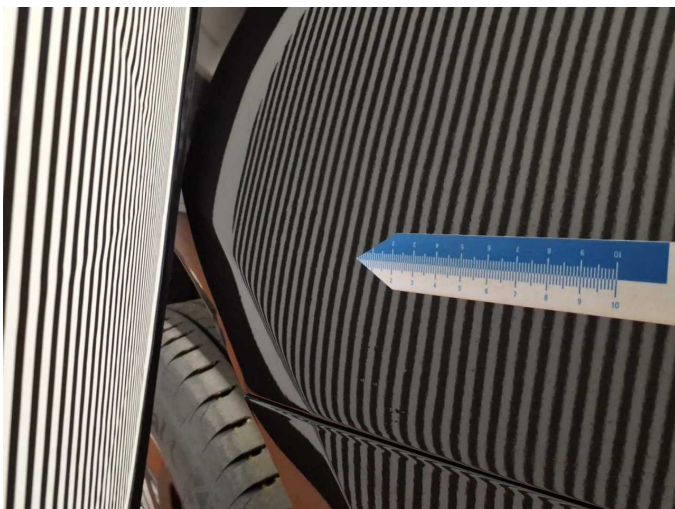
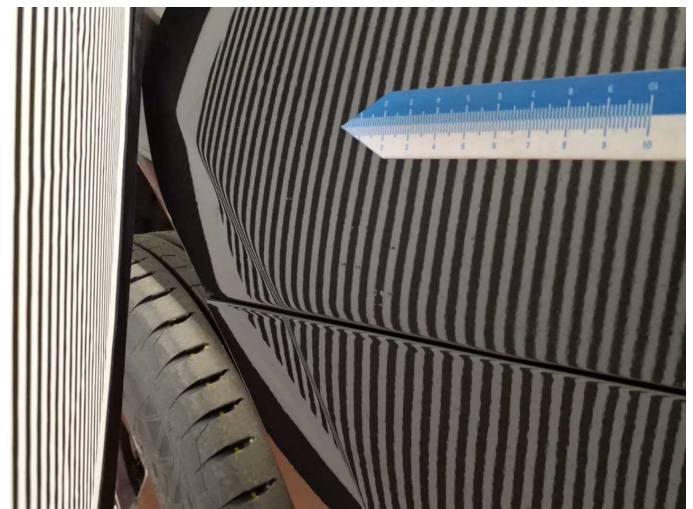
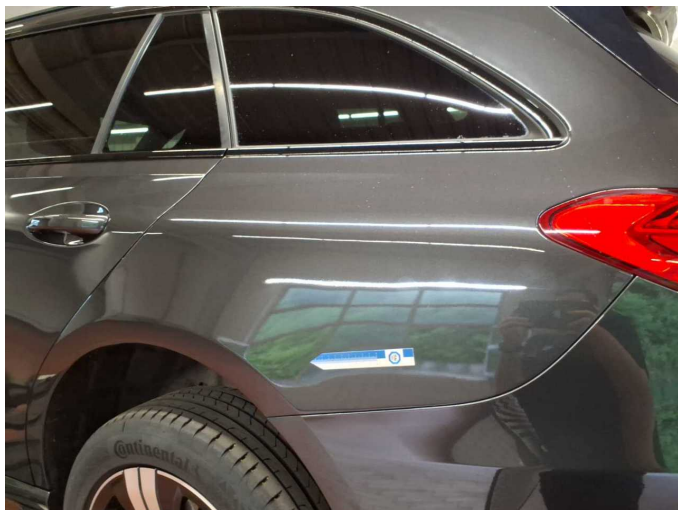
| No. | Component group | Description |
|---|---|---|
| 4 | Side panel - rear left side | Side panel (Lackblasen) - Unprofessionally repaired - Repair and paint |

| No. | Repainting |
|---|---|
| 7 | Side panel - rear left side, Unprofessionally carried out, Invoice of repair done Non-existent |

| Side panel - rear left side | 2,220 µm | Side panel - rear right side | 195 µm |

**Damage 4:** Side panel - rear left side: Side panel (Lackblasen) - Unprofessionally repaired - Repair and paint

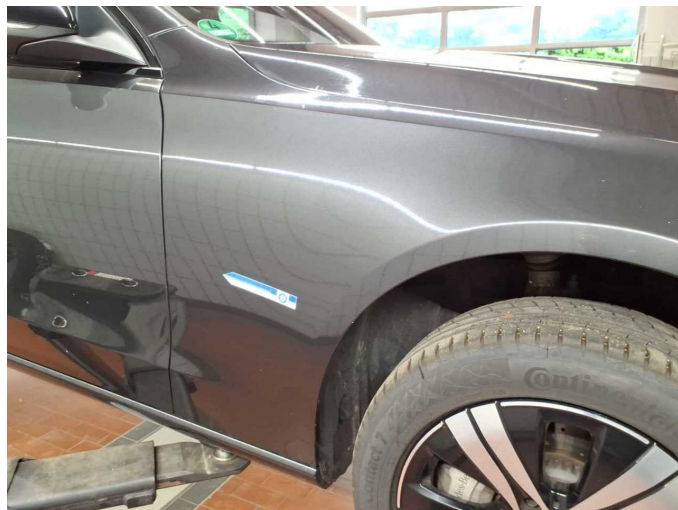
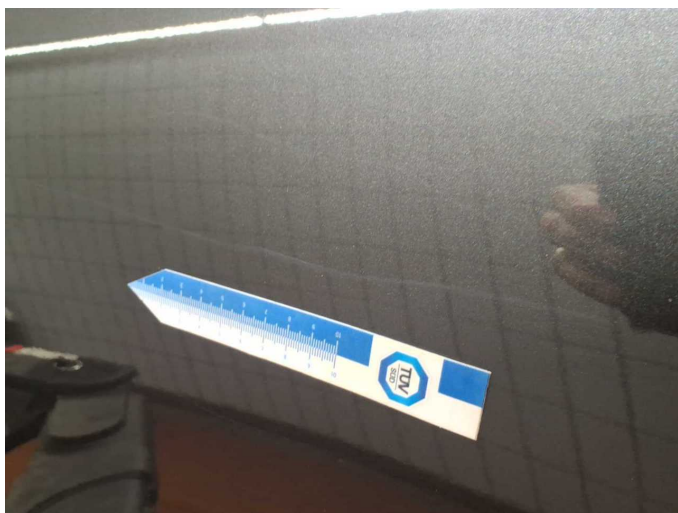
| No. | Component group | Description |
|---|---|---|
| 1 | Mudguard - right side | Mudguard - right side - Scratch(es) - No deduction |

**Wear and tear 1:** Mudguard - right side: Mudguard - right side - Scratch(es) - No deduction

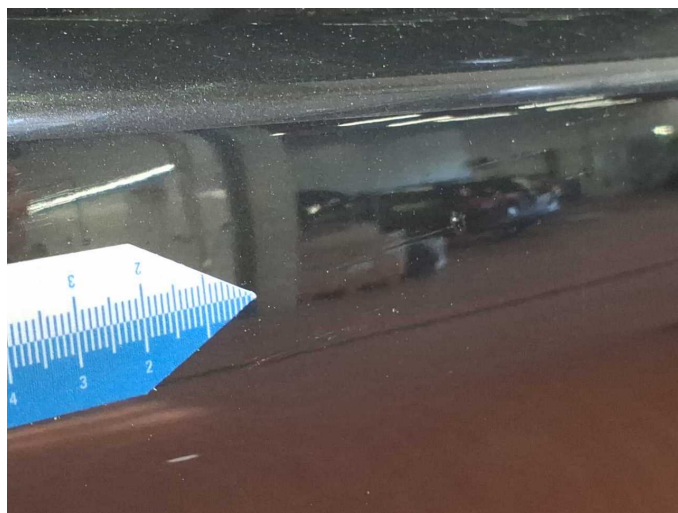
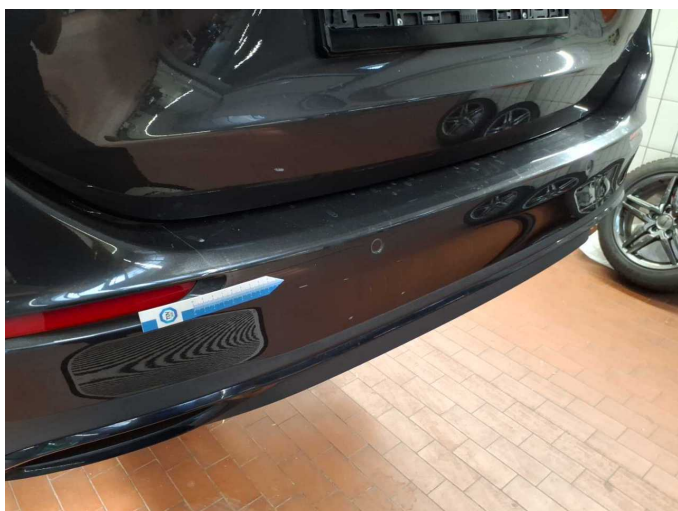
| No. | Component group | Description |
|---|---|---|
| 2 | Rear bumper | Rear bumper - Scratch(es) - No deduction |

**Wear and tear 2:** Rear bumper: Rear bumper - Scratch(es) - No deduction

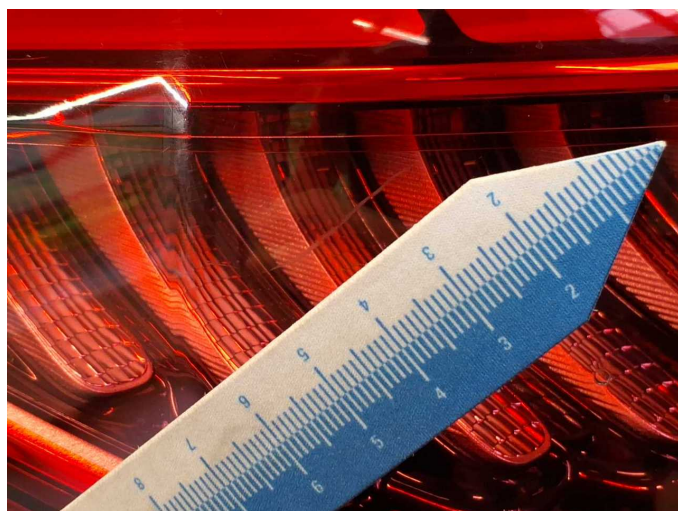
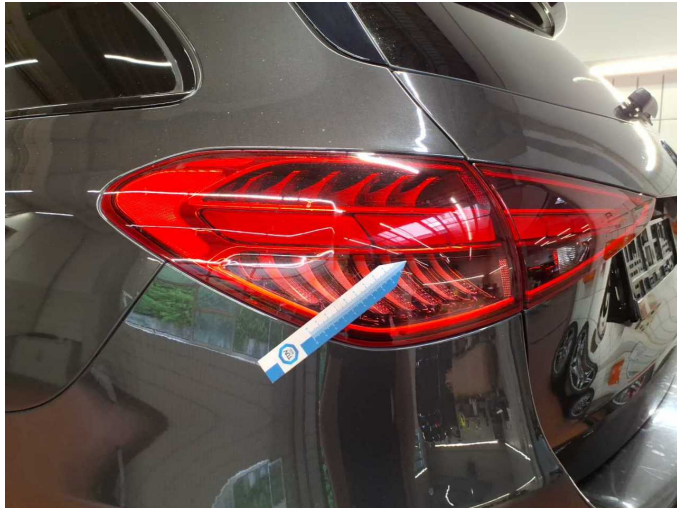
| No. | Component group | Description |
|---|---|---|
| 3 | Tail light | Tail lamp - left side - Scratch(es) - No deduction |

**Wear and tear 3:** Tail light: Tail lamp - left side - Scratch(es) - No deduction

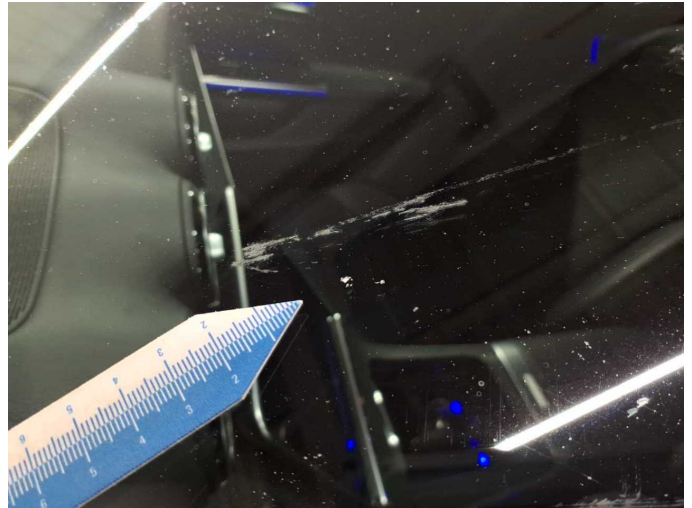
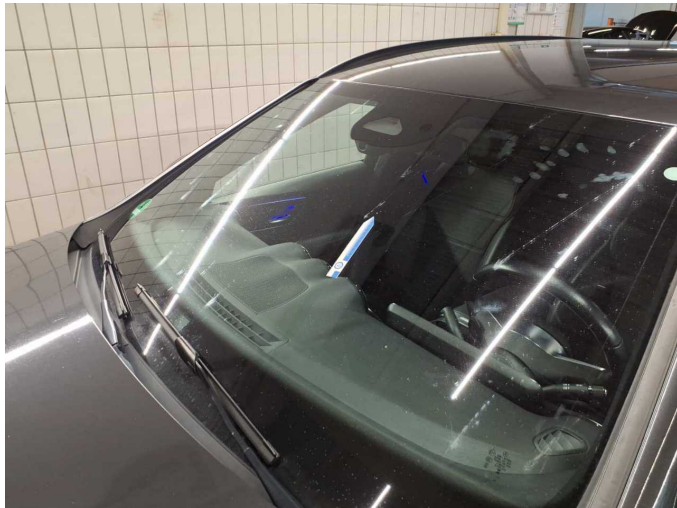
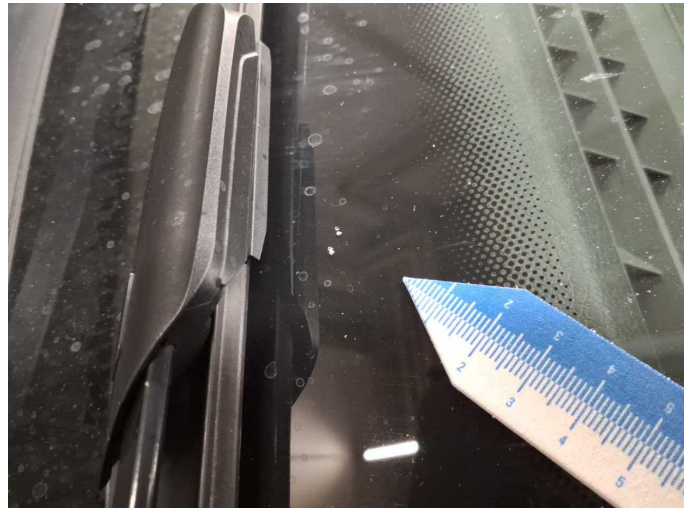
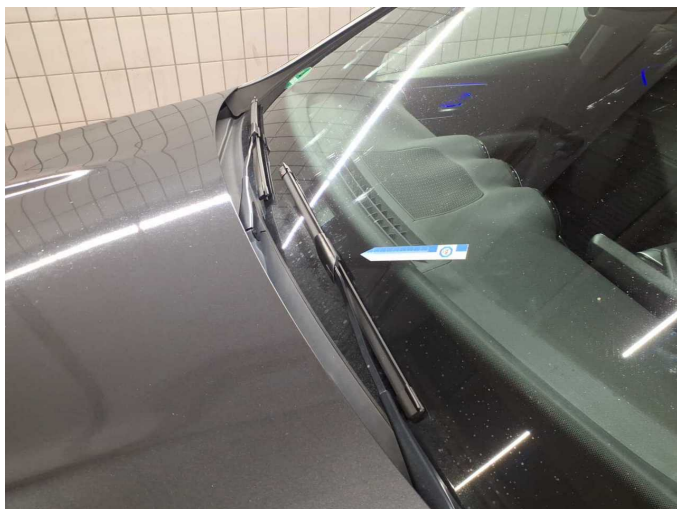
| No. | Component group | Description |
|---|---|---|
| 4 | Vehicle glazing | Windscreen - Stone chips - No deduction |

**Wear and tear 4:** Vehicle glazing: Windscreen - Stone chips - No deduction

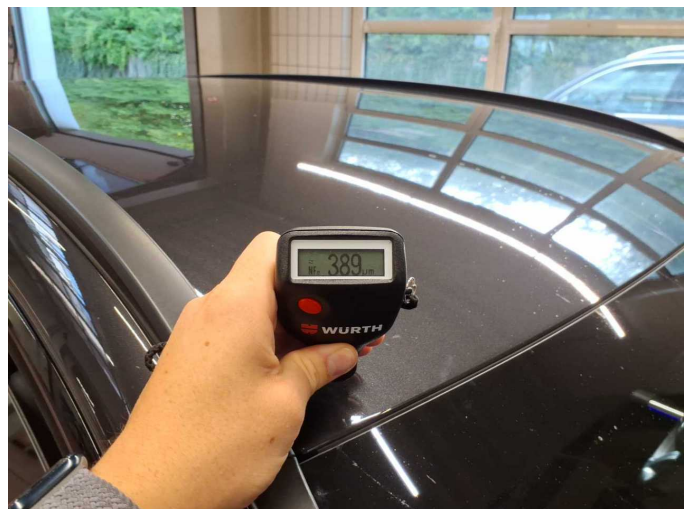
**Repainting 1:** Roof

| No. | Repainting |
|---|---|
| 1 | Roof, Professionally carried out, Invoice of repair done Non-existent |

| Roof | 389 µm | Roof rail - left side | 188 µm |

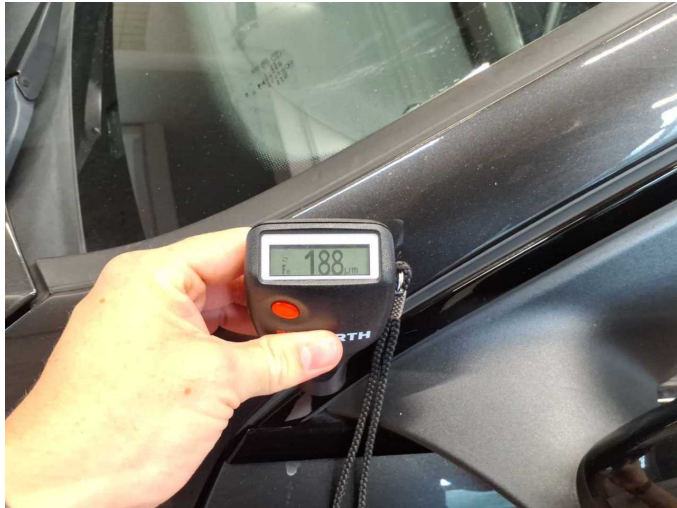
**Repainting 2:** Roof rail - left side

| No. | Repainting |
|---|---|
| 2 | Roof rail - left side, Professionally carried out, Invoice of repair done Non-existent |

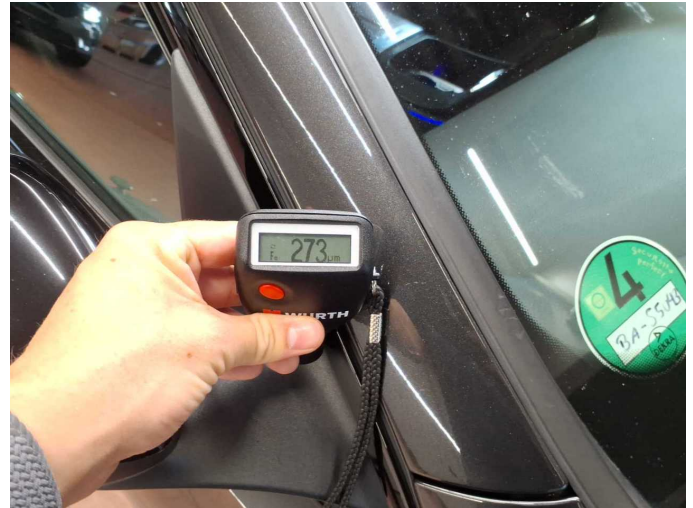
**Repainting 3:** Roof rail - right side

| No. | Repainting |
|---|---|
| 3 | Roof rail - right side, Professionally carried out, Invoice of repair done Non-existent |

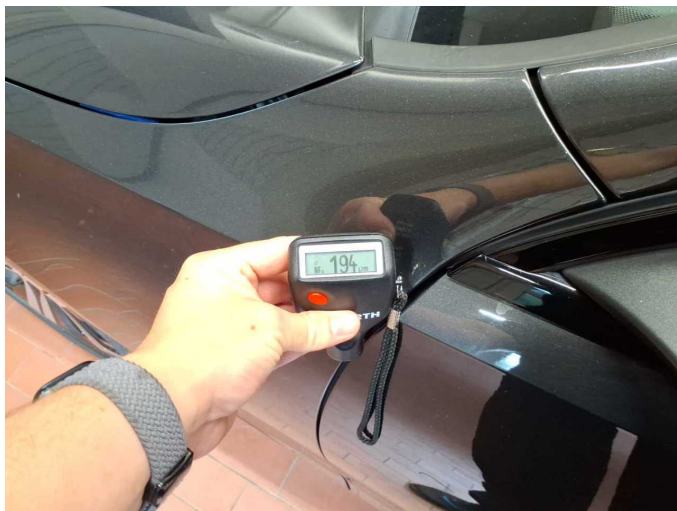
**Repainting 4:** Mudguard - left side

| No. | Repainting |
|---|---|
| 4 | Mudguard - left side, Professionally carried out, Invoice of repair done Non-existent |

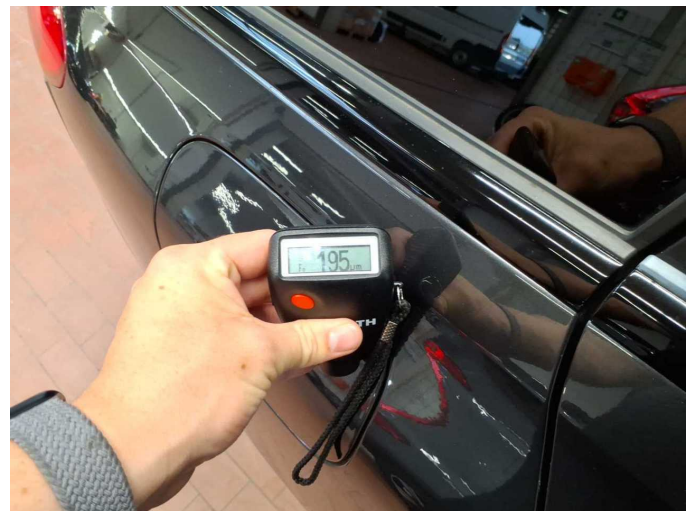
**Repainting 5:** Side panel - rear right side

| No. | Repainting |
|---|---|
| 5 | Side panel - rear right side, Professionally carried out, Invoice of repair done Non-existent |

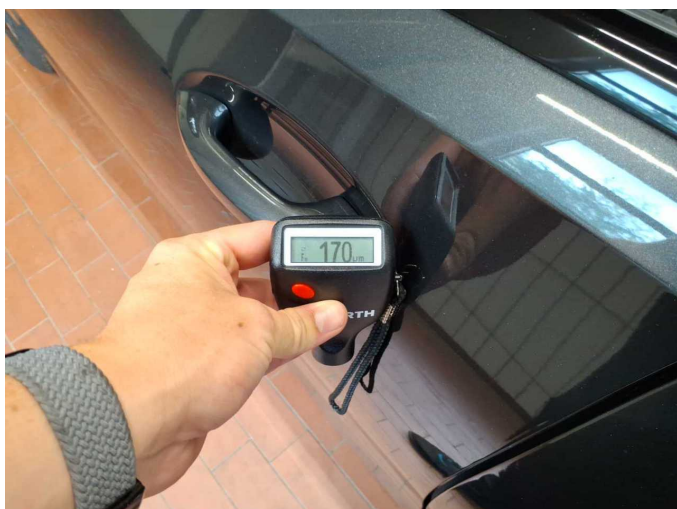
**Repainting 6:** Door - front left side

| No. | Repainting |
|---|---|
| 6 | Door - front left side, Professionally carried out, Invoice of repair done Non-existent |
