Expertise

Manufacturer: Toyota

Model: Aygo X S-CVT Play

VIN: JTDAGNAC000112481

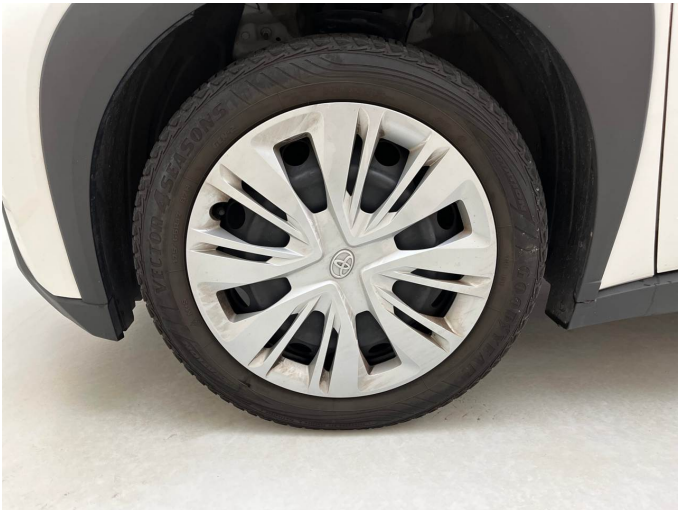
Figure 12: Mounted tyres

| Tyres | | | | |
|---|---|---|---|---|
| 1) | 175/65 R17 87H | All-season tyres on Steel rim with wheel cover | Goodyear | 4mm / 4mm |
| 2) | 175/65 R17 87H | All-season tyres on Steel rim with wheel cover | Goodyear | 6mm / 6mm |

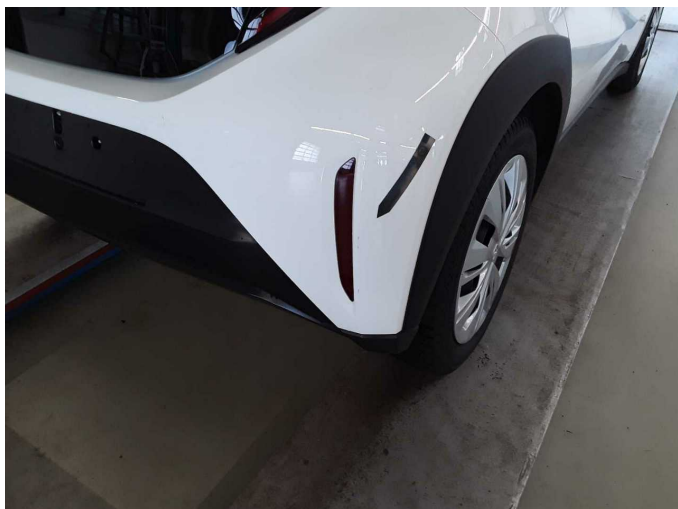
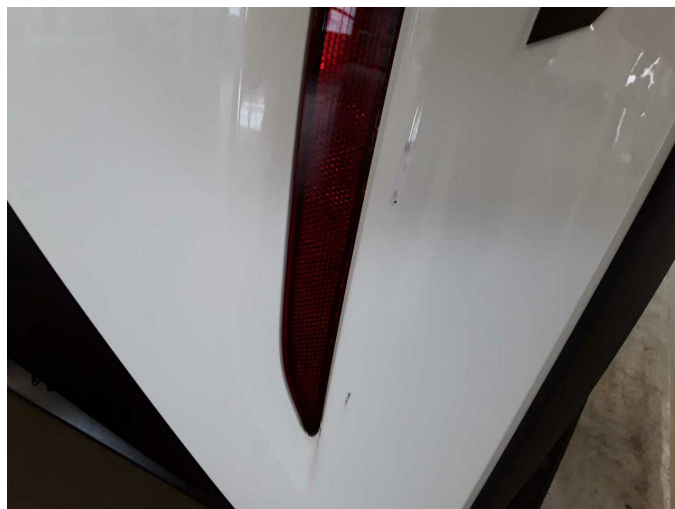
**Damage 1:** Rear bumper: Rear bumper - Scratch(es) - Smart repair

| No. | Component group | Description |
|---|---|---|
| 1 | Rear bumper | Rear bumper - Scratch(es) - Smart repair |

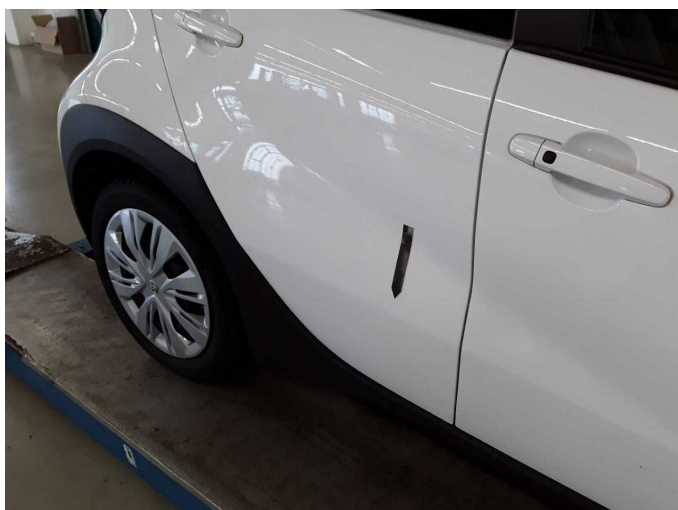
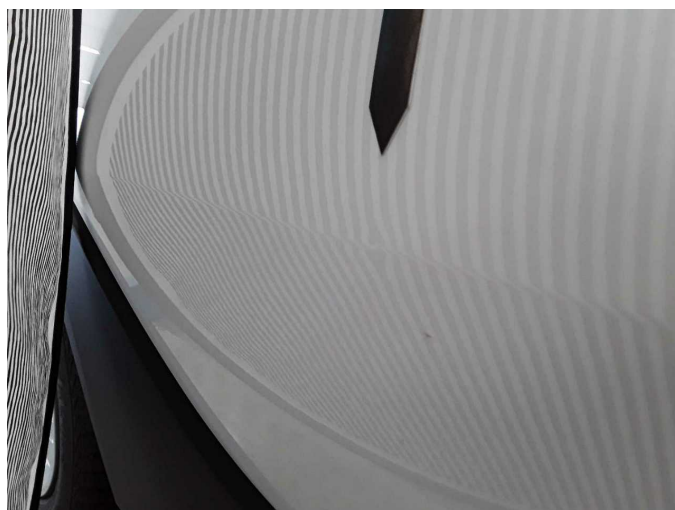
**Damage 2:** Door - rear right side: Door - dent(s) - Smart repair

| No. | Component group | Description |
|---|---|---|
| 2 | Door - rear right side | Door - dent(s) - Smart repair |

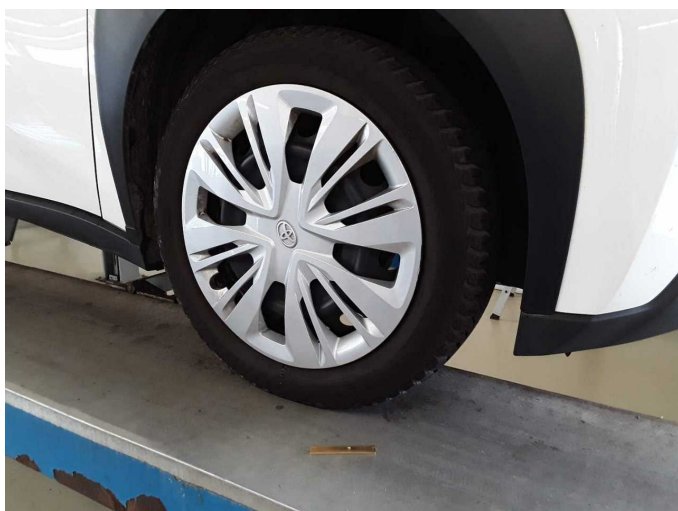
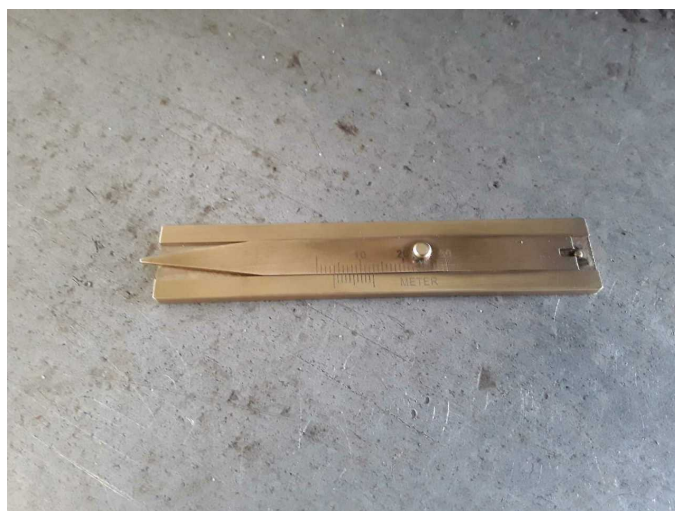
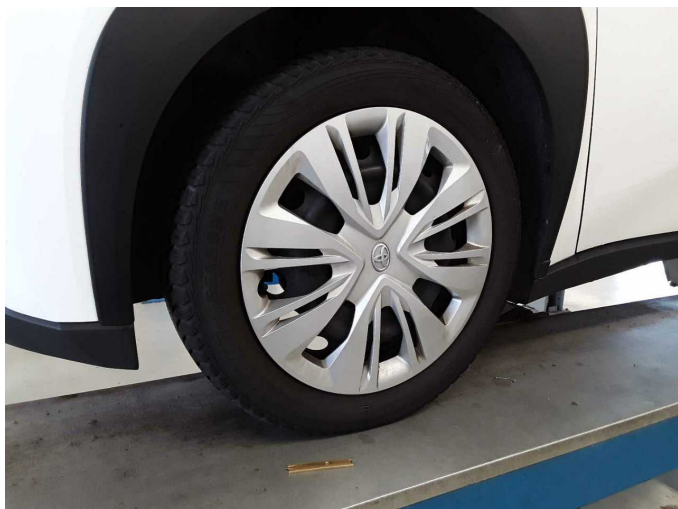
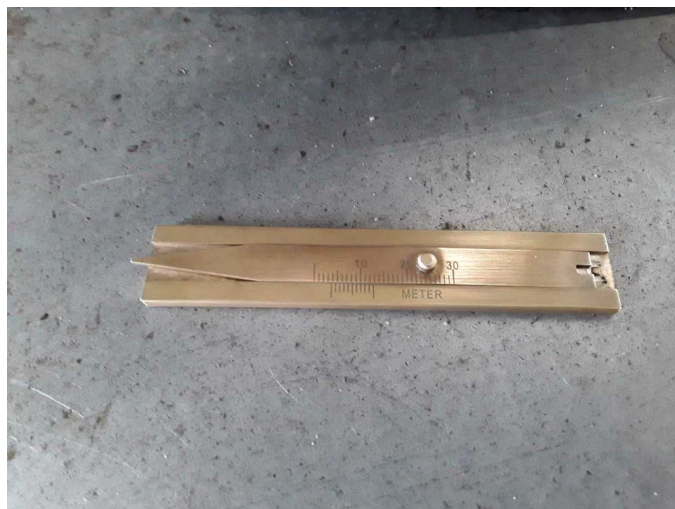
**Damage 3:** Wheel / tyres: Tyre - front - does not meet manufacturer specifications - Replace

| No. | Component group | Description |
|---|---|---|
| 3 | Wheel / tyres | Tyre - front - does not meet manufacturer specifications - Replace |

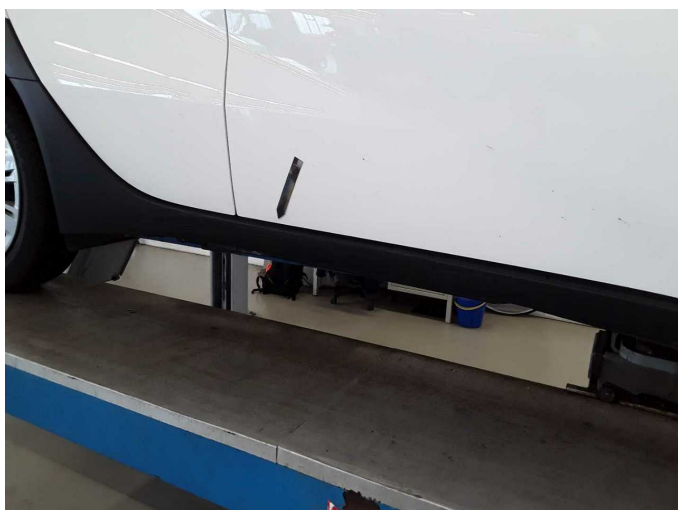
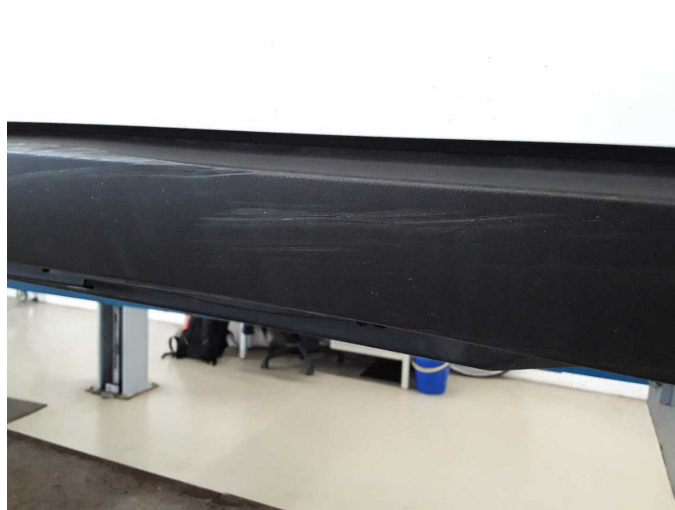
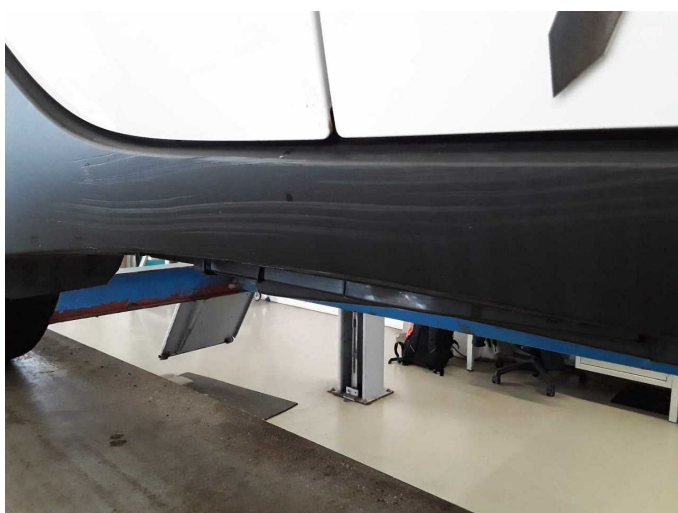
**Damage 4:** Sill - right side: Trim - Scratched - Replace

| No. | Component group | Description |
|---|---|---|
| 4 | Sill - right side | Trim - Scratched - Replace |
