Expertise

Manufacturer: Audi

Model: A4 Avant 40 TDI S tronic advanced

VIN: WAUZZZF47RA024716

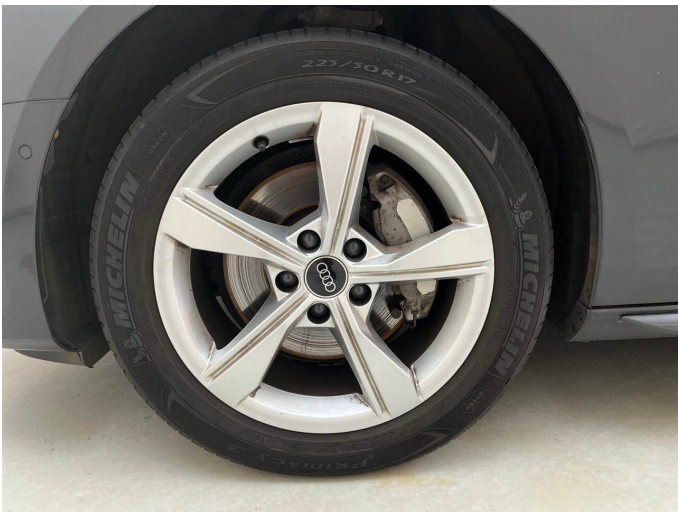
Figure 12: Mounted tyres

| # | Tyre size | Type of tyre | Manufacturer | Tread depth |
|---|---|---|---|---|
| 1) | 225/50 R17 94H | Summer tyres on Light alloy | Michelin | 4mm / 4mm |
| 2) | 225/50 R17 94H | Summer tyres on Light alloy | Michelin | 5mm / 5mm |

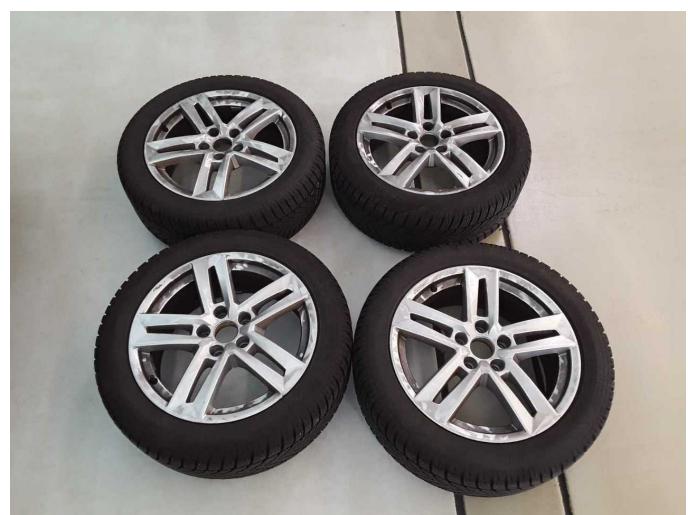
Figure 16: Additional tyres

| # | Tyre size | Type of tyre | Manufacturer | Tread depth |
|---|---|---|---|---|
| 1) | 225/50 R17 98H | Winter tyres on Light alloy | Dunlop | 4mm / 4mm |
| 2) | 225/50 R17 98H | Winter tyres on Light alloy | Dunlop | 6mm / 6mm |

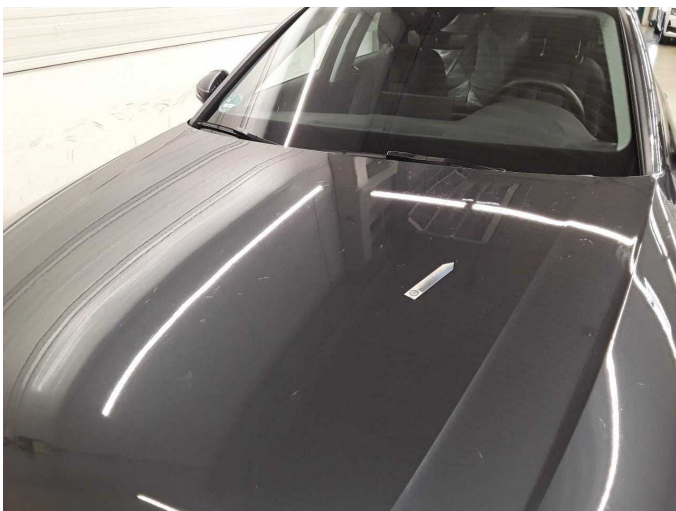
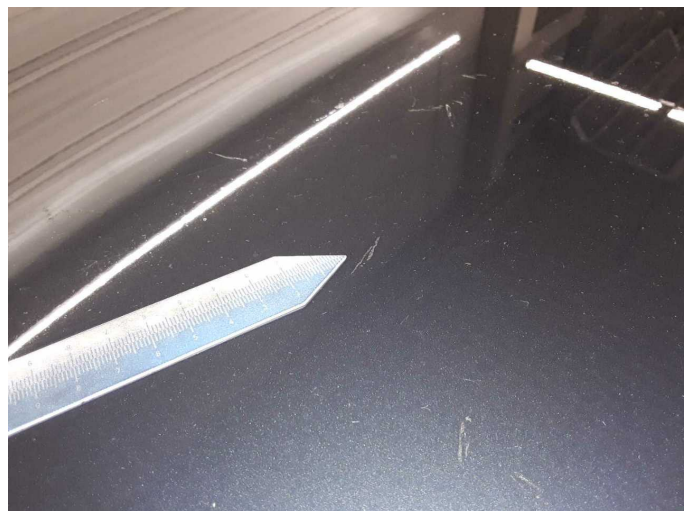
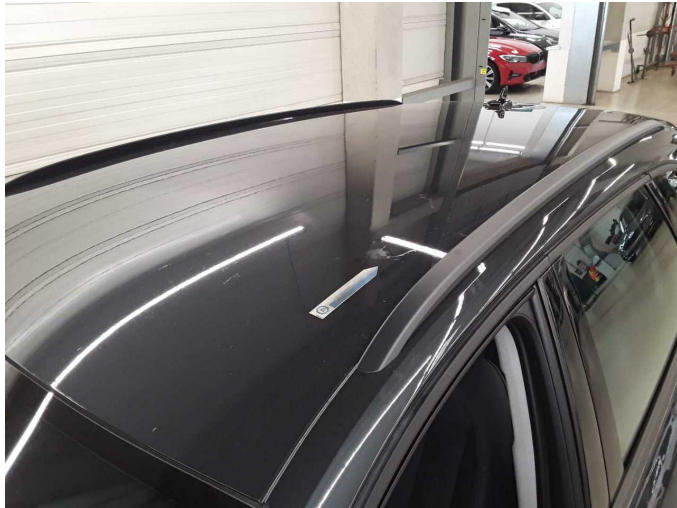
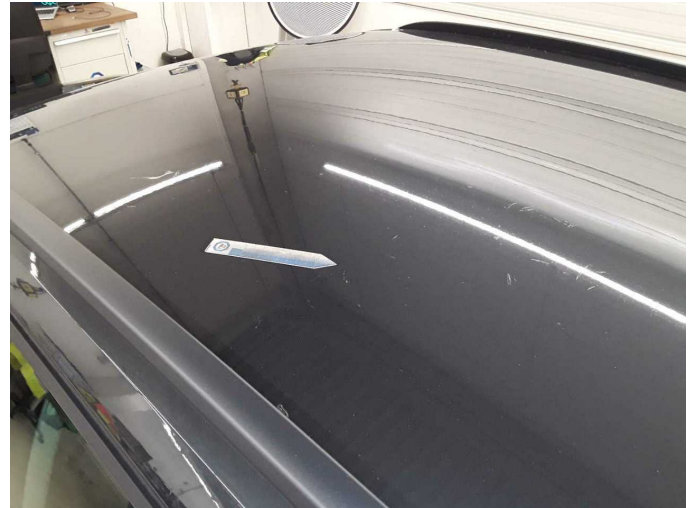
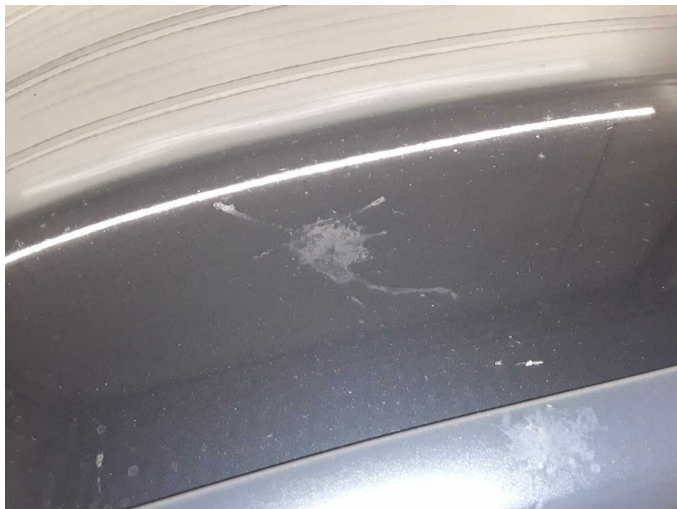
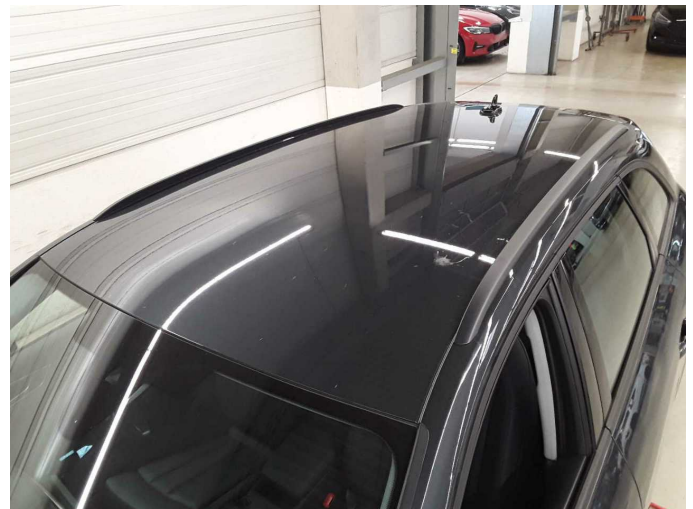
Damage 1: Body: Body (Lackaufbereitung) - Soiled - Clean

**Damage 1:** Body: Body (Lackaufbereitung) - Soiled - Clean

| No. | Component group | Description |
|---|---|---|
| 1 | Body | Body (Lackaufbereitung) - Soiled - Clean |

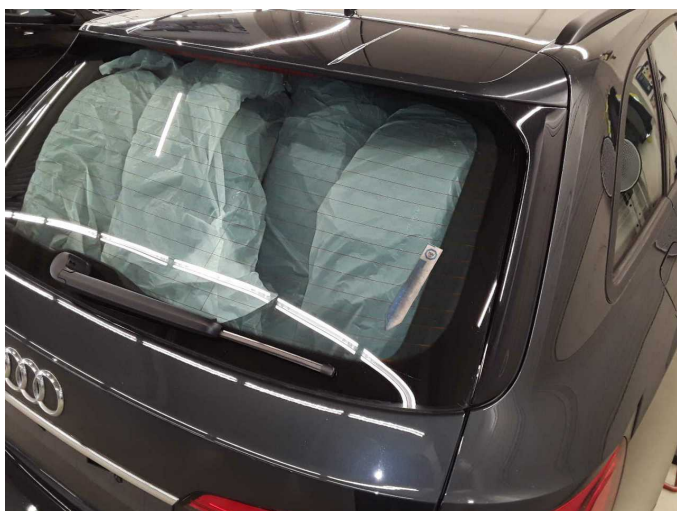
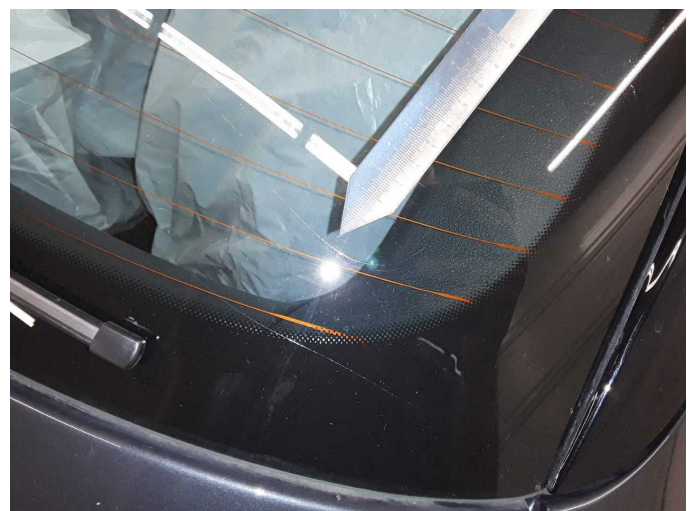
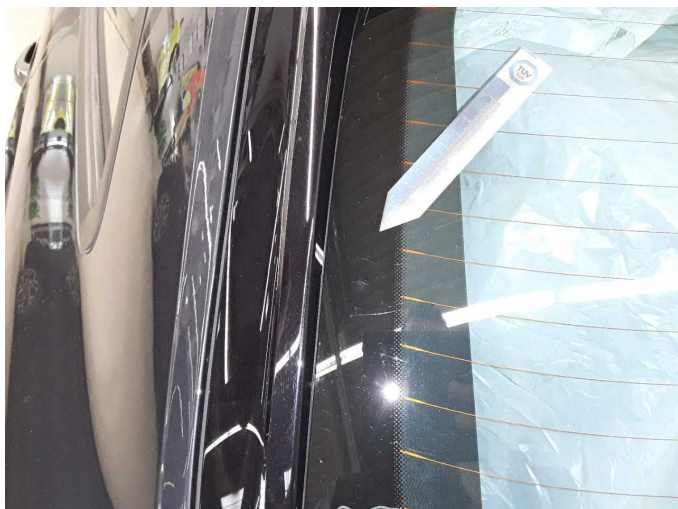
**Damage 2:** Vehicle glazing: Rear window - Scratch(es) - Loss in value

| No. | Component group | Description |
|---|---|---|
| 2 | Vehicle glazing | Rear window - Scratch(es) - Loss in value |

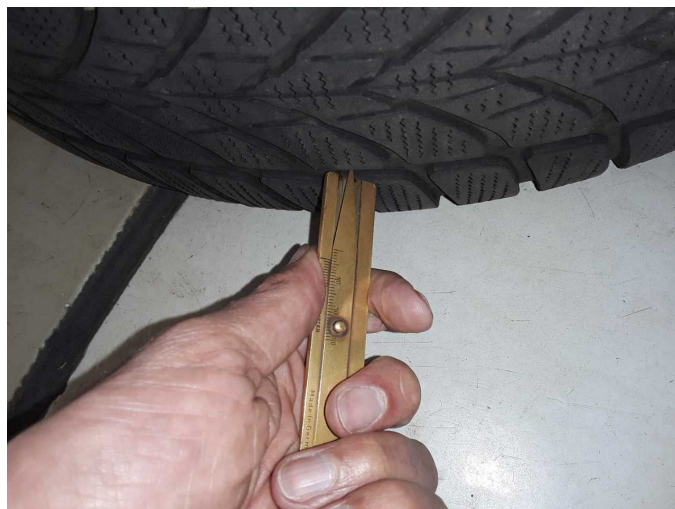
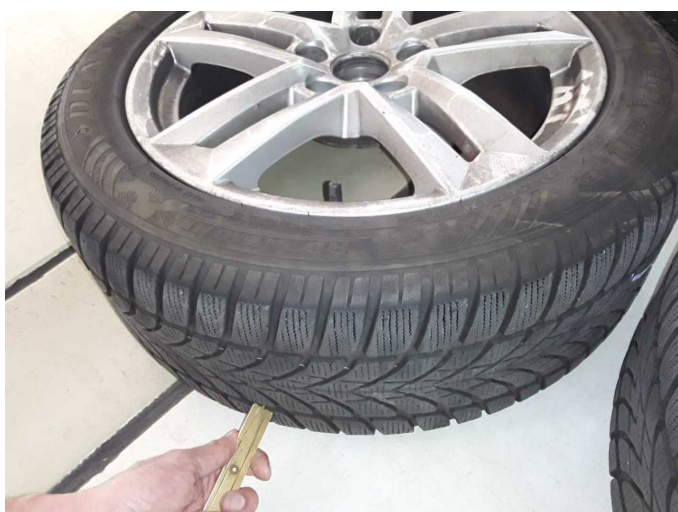
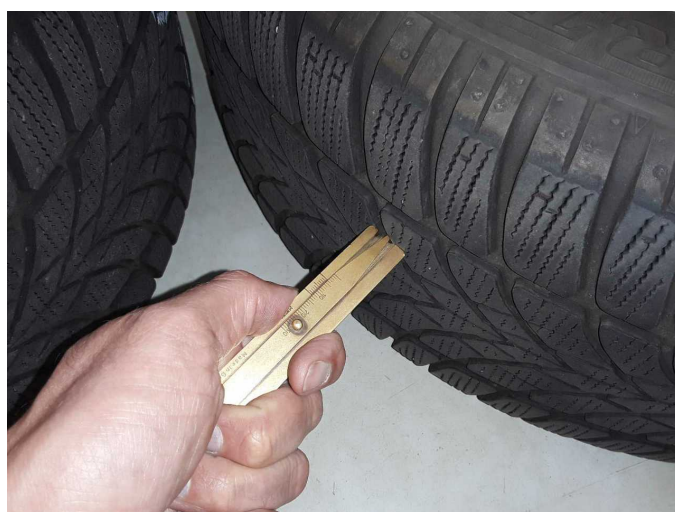
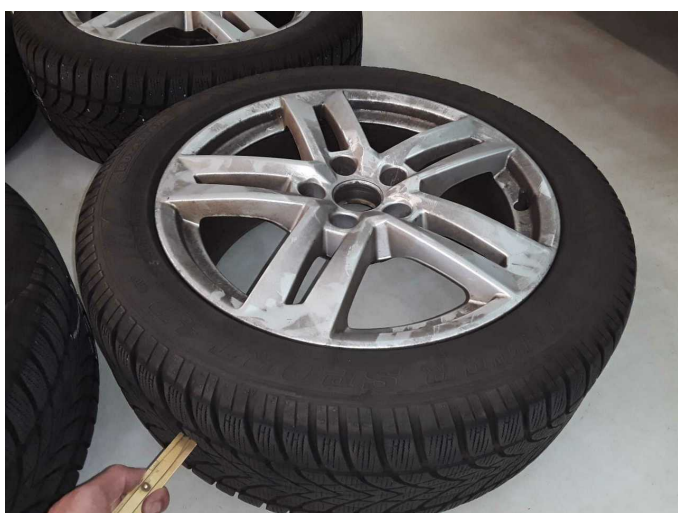
**Damage 3:** 2nd wheel set: 2 tyres - Does not meet the leasing specifications - Replace

| No. | Component group | Description |
|---|---|---|
| 3 | 2nd wheel set | 2 tyres - Does not meet the leasing specifications - Replace |

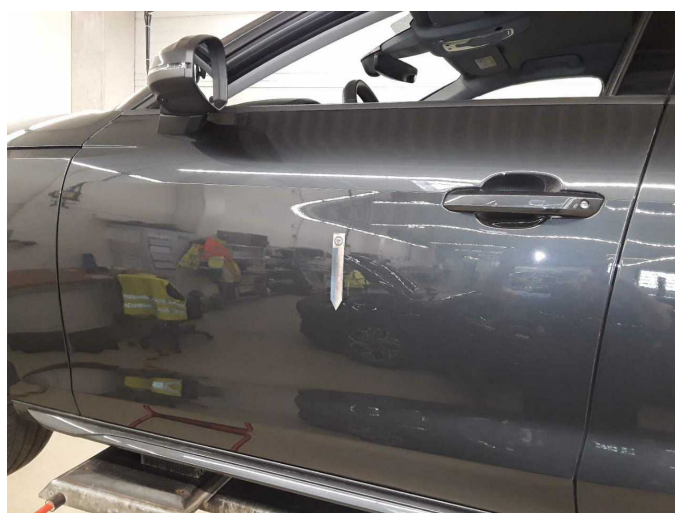
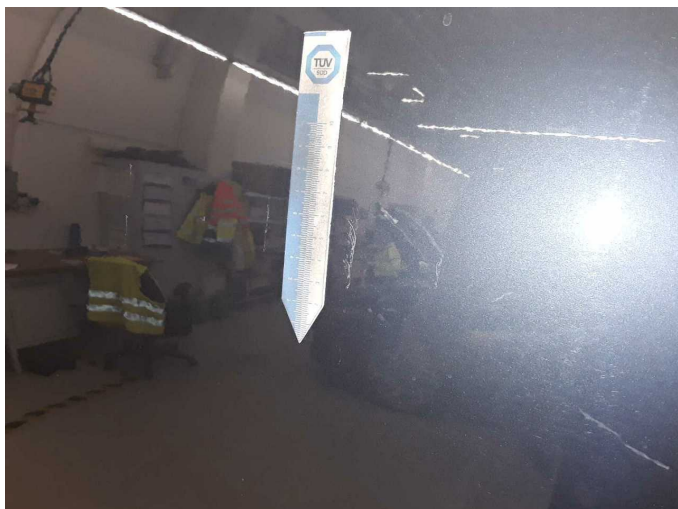
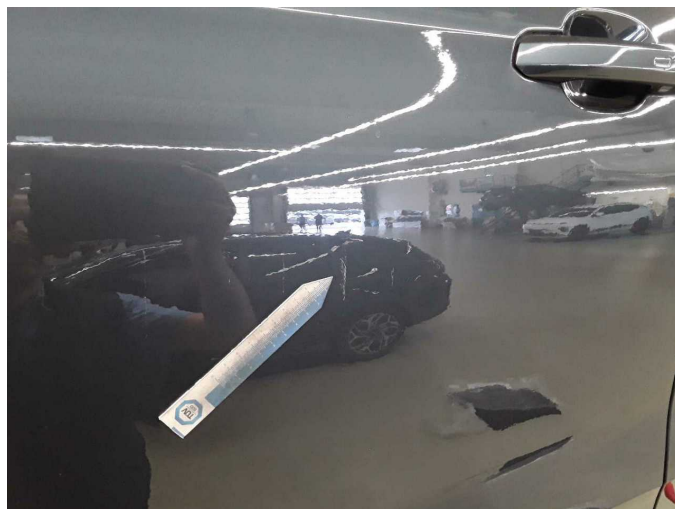
**Damage 4:** Door - front left side: Door - Scratch(es) - Repair and paint

| No. | Component group | Description |
|---|---|---|
| 4 | Door - front left side | Door - Scratch(es) - Repair and paint |

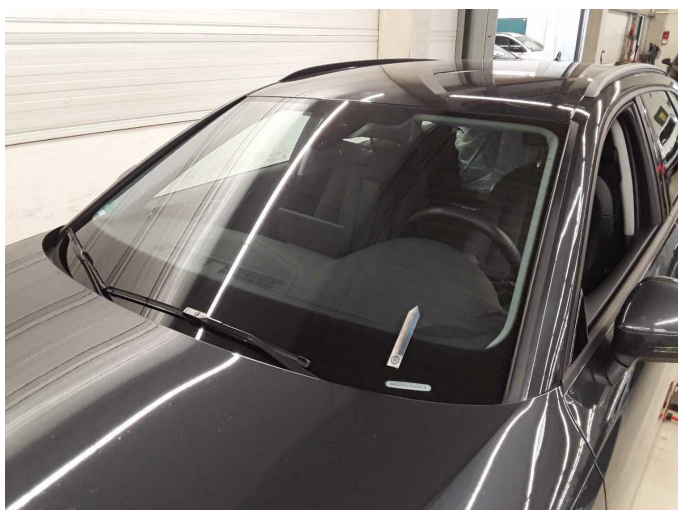
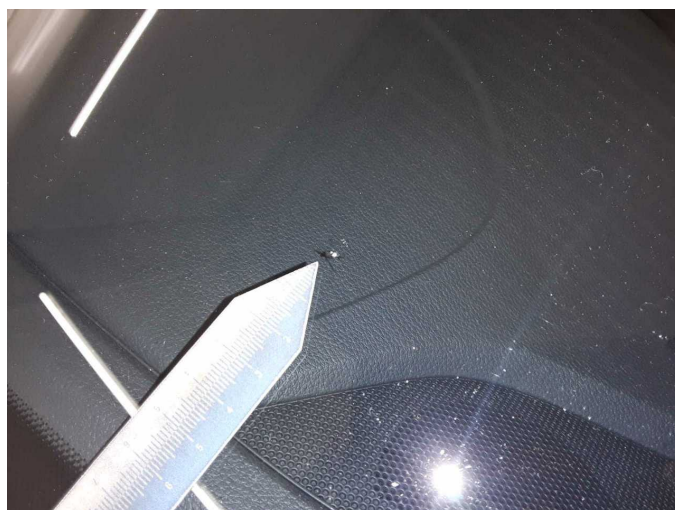
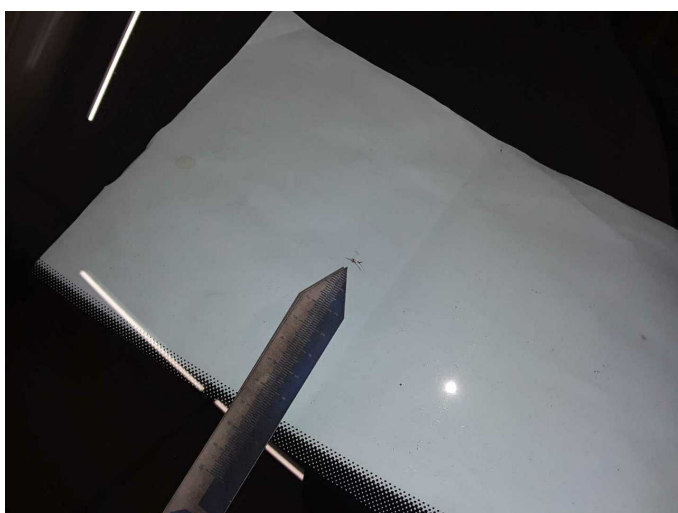
**Damage 5:** Vehicle glazing: Windscreen - Stone chips - Replace

| No. | Component group | Description |
|---|---|---|
| 5 | Vehicle glazing | Windscreen - Stone chips - Replace |

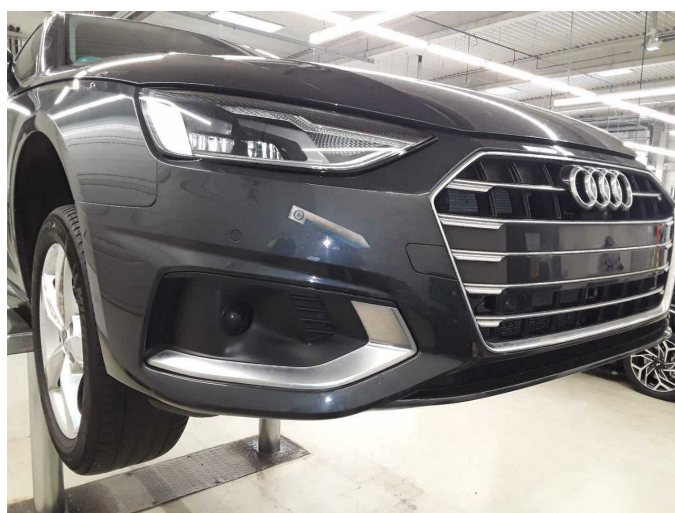
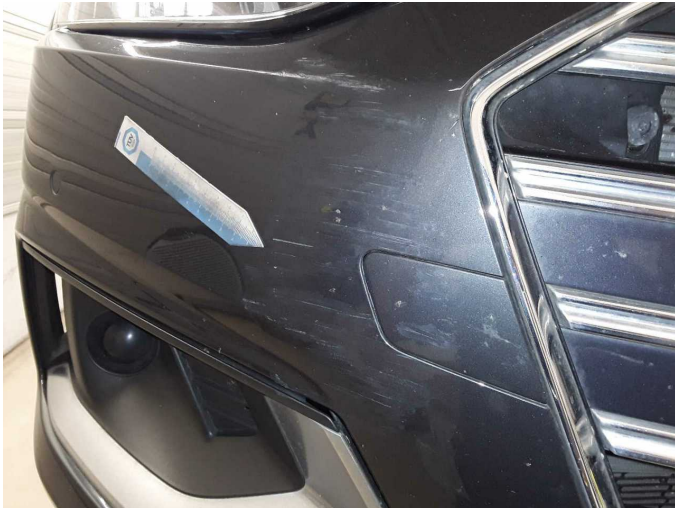
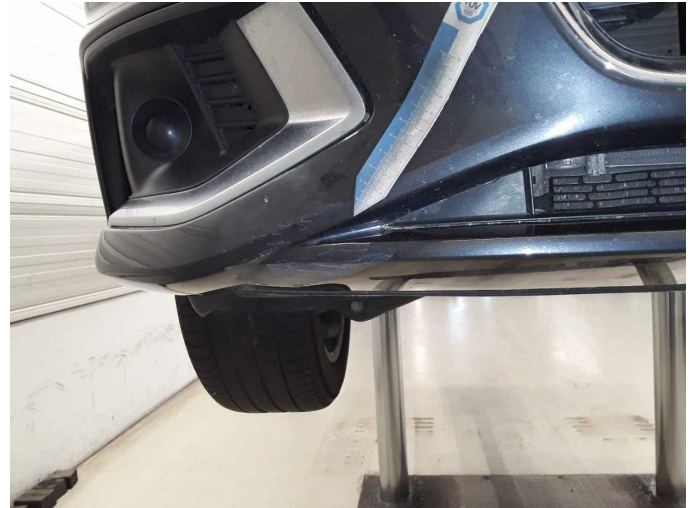
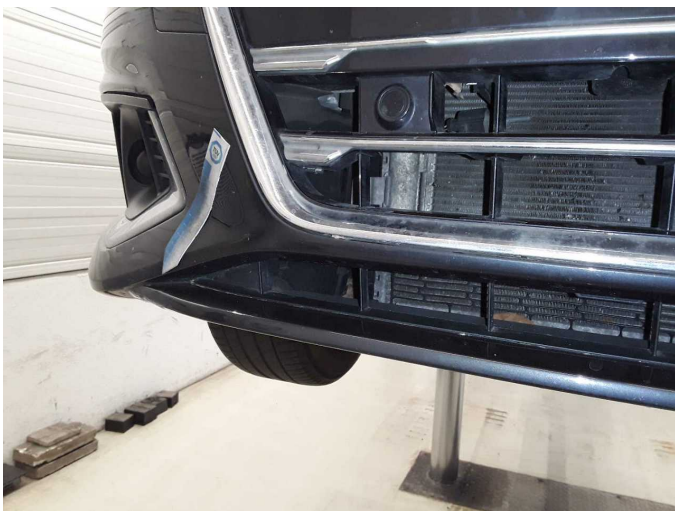
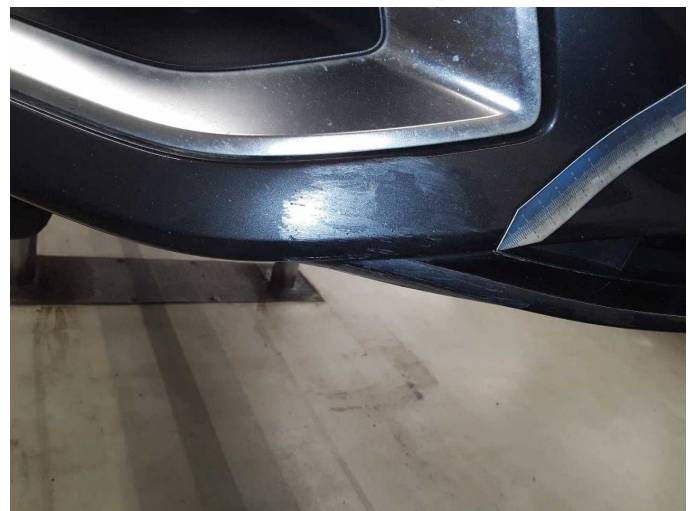
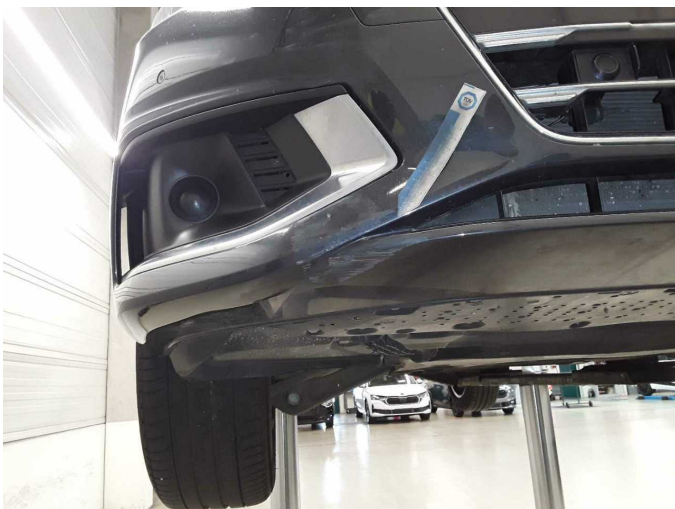
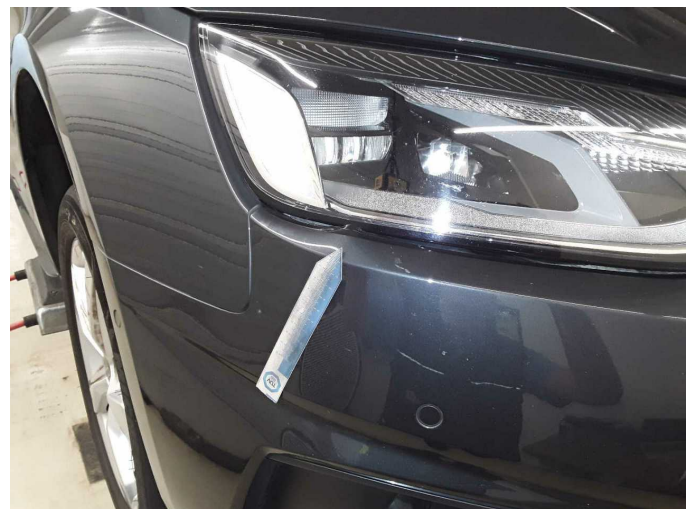
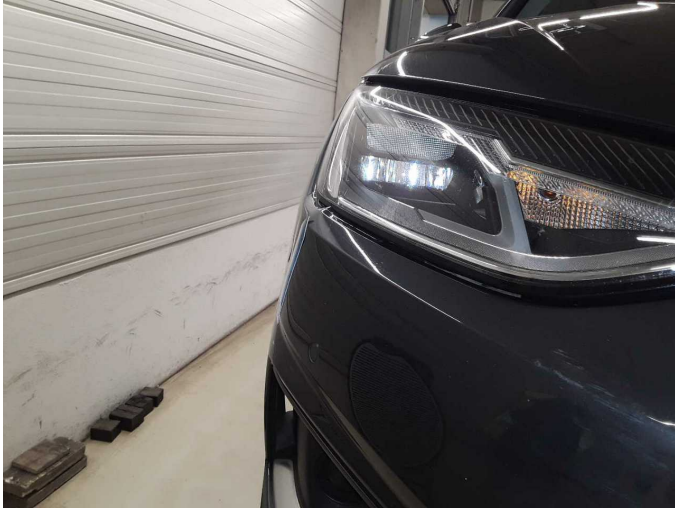
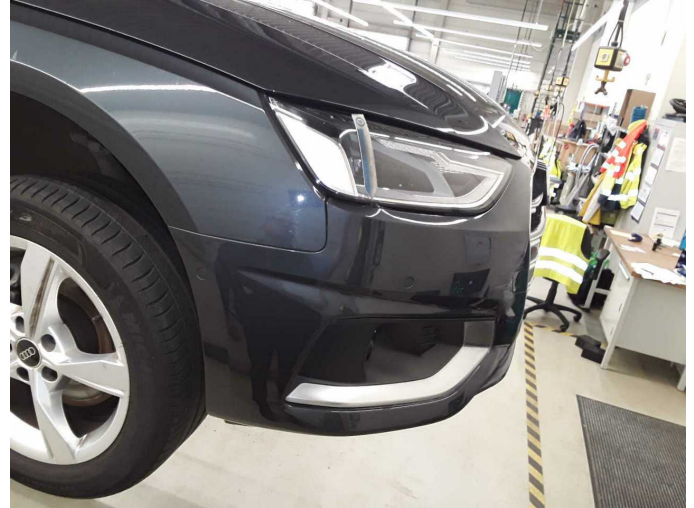
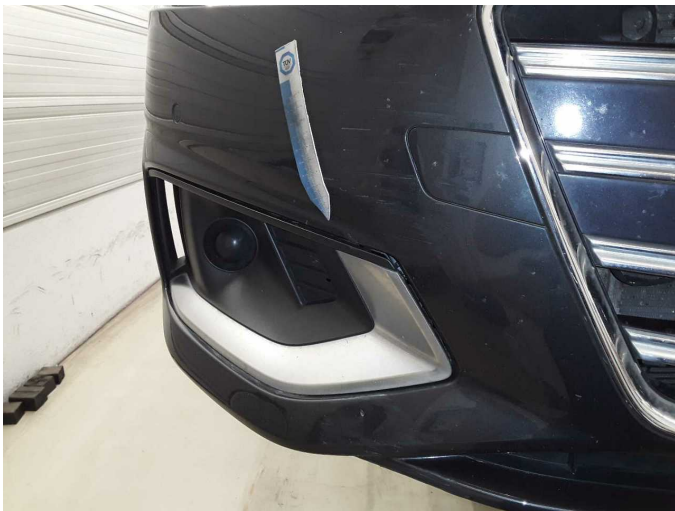
**Damage 6:** Front bumper: Front bumper - Deformed - Replace

| No. | Component group | Description |
|---|---|---|
| 6 | Front bumper | Front bumper - Deformed - Replace |
