Expertise

Protocol number: 45624623  
Order No. / Reference: 26484856  
Inspection date: 27 May 2026

| Manufacturer: Audi | Model: A6 40 TDI quattro S tronic sport |

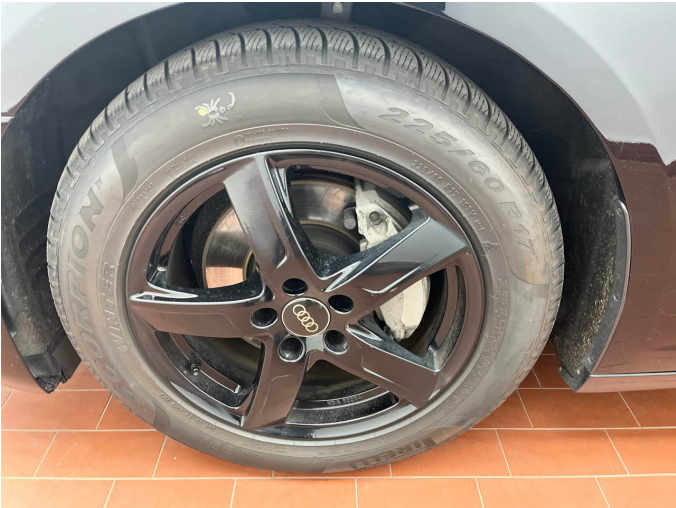
| # | Tyre size | Type of tyre | Manufacturer | Tread depth |
|---|---|---|---|---|
| 1) | 225/60 R17 103V | Winter tyres on Light alloy | Pirelli | 4mm / 4mm |
| 2) | 225/60 R17 103V | Winter tyres on Light alloy | Pirelli | 3mm / 3mm |

| No. | Component group | Description |
|---|---|---|
| 1 | Wheel / tyres | Tyres - complete set (4mm) - Does not meet the leasing specifications - No deduction |

Figure 13: Mounted tyres

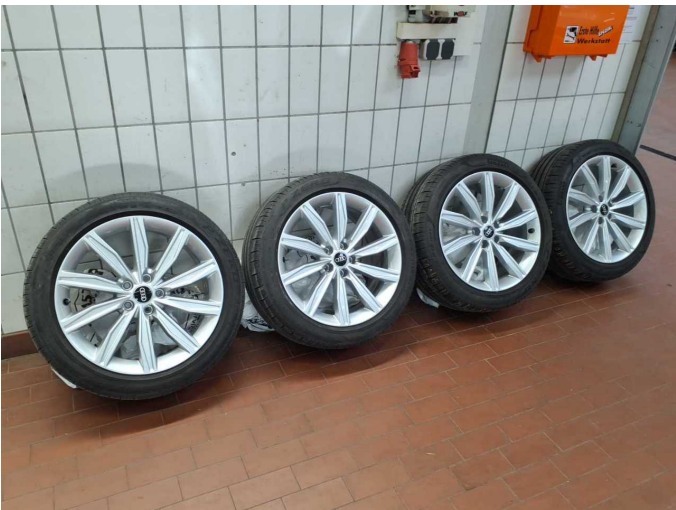
| # | Tyre size | Type of tyre | Manufacturer | Tread depth |
|---|---|---|---|---|
| 1) | 245/45 R19 102Y | Summer tyres on Light alloy | Pirelli | 5mm / 5mm |
| 2) | 245/45 R19 102Y | Summer tyres on Light alloy | Pirelli | 5mm / 5mm |

Figure 17: Additional tyres

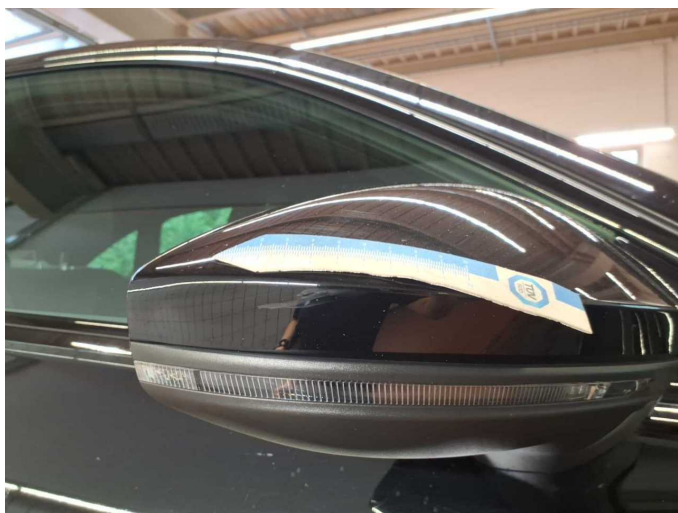
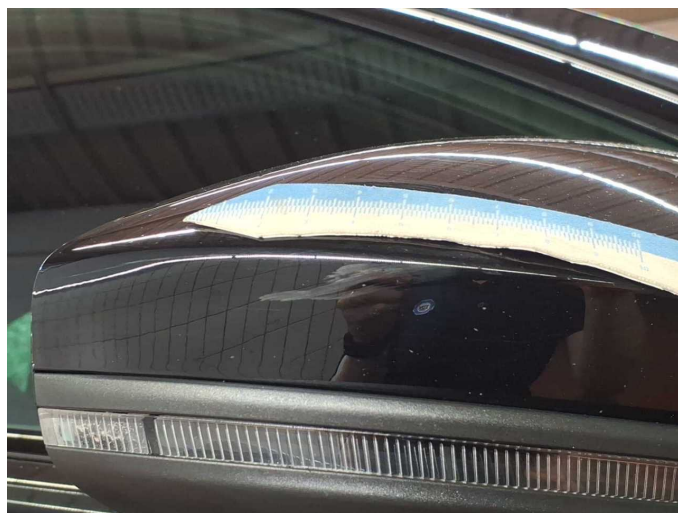
| No. | Component group | Description |
|---|---|---|
| 1 | Wing mirror - right side | Cap - Scratch(es) - Smart repair |

Damage 1: Wing mirror - right side: Cap - Scratch(es) - Smart repair

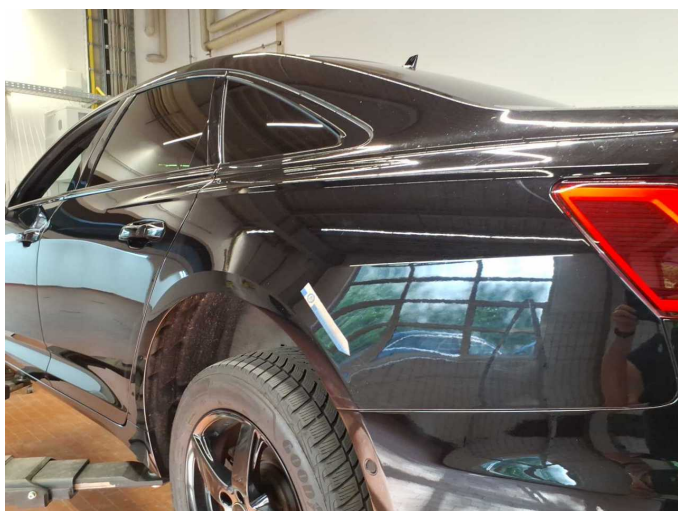
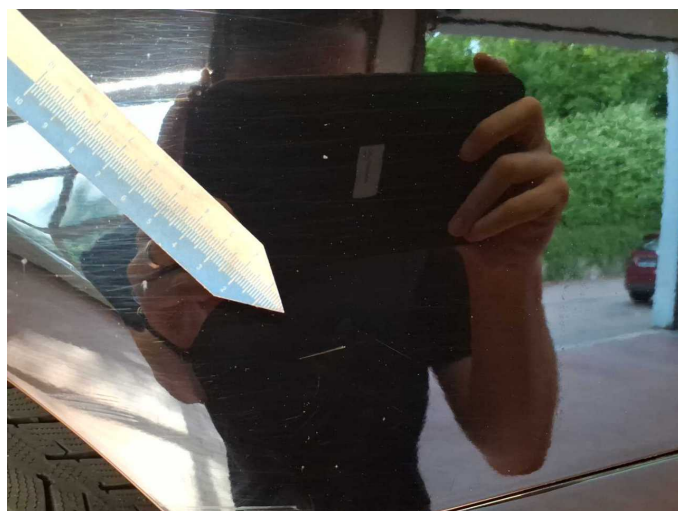
| No. | Component group | Description |
|---|---|---|
| 2 | Side panel - rear left side | Side panel - Scratch(es) - Smart repair |

Damage 2: Side panel - rear left side: Side panel - Scratch(es) - Smart repair

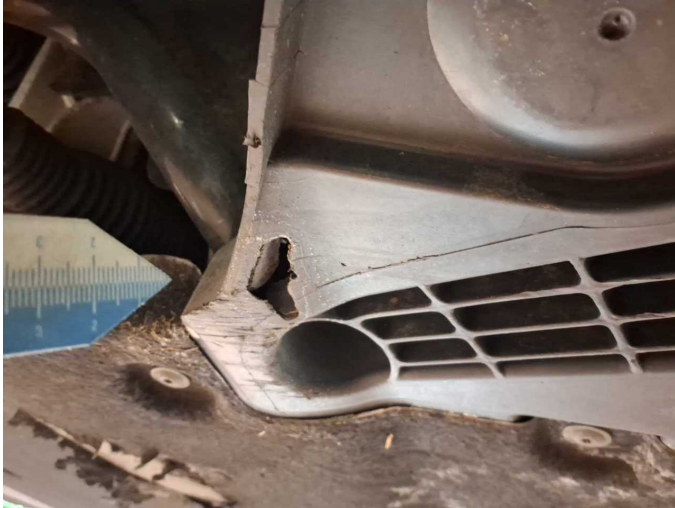
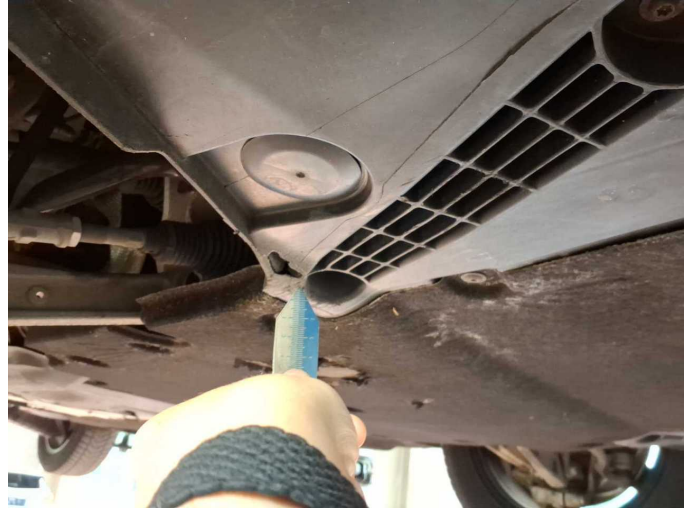
| No. | Component group | Description |
|---|---|---|
| 3 | Body | Underbody panelling - Broken / torn - Replace |

**Damage 3:** Body: Underbody panelling - Broken / torn - Replace

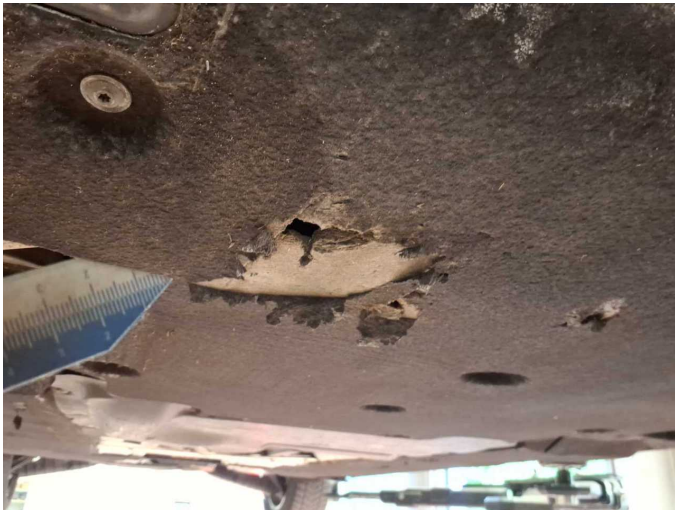
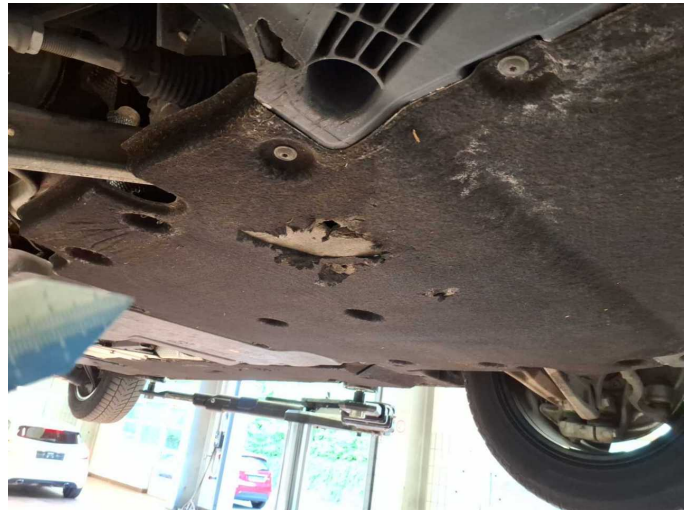
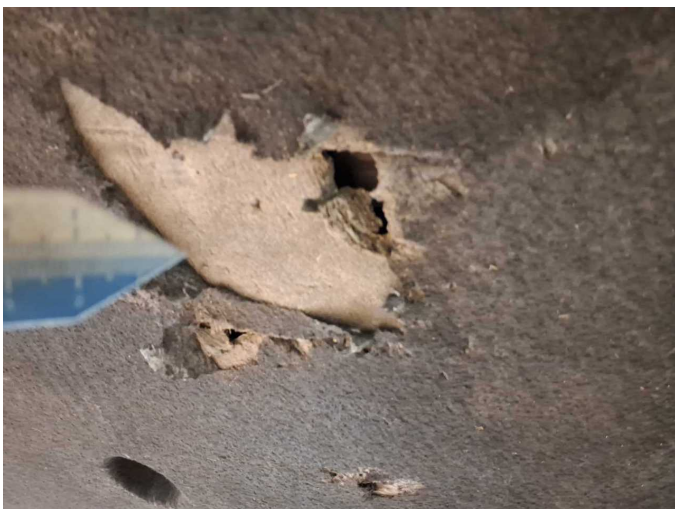
| No. | Component group | Description |
|---|---|---|
| 4 | Body | Underbody panelling - Broken / torn - Replace |

**Damage 4:** Body: Underbody panelling - Broken / torn - Replace

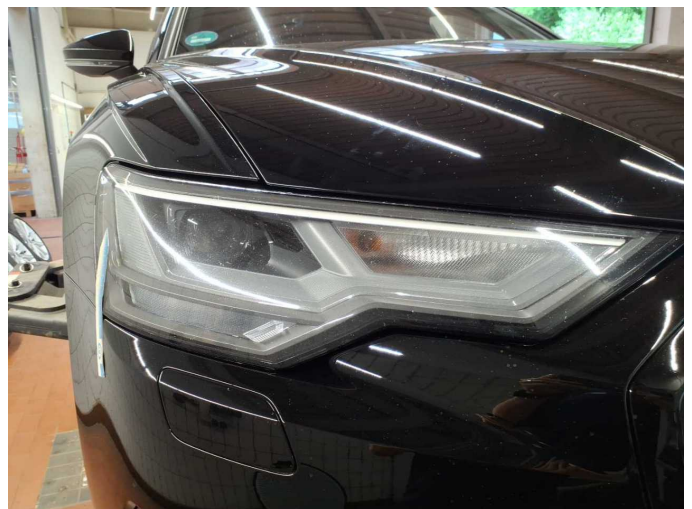
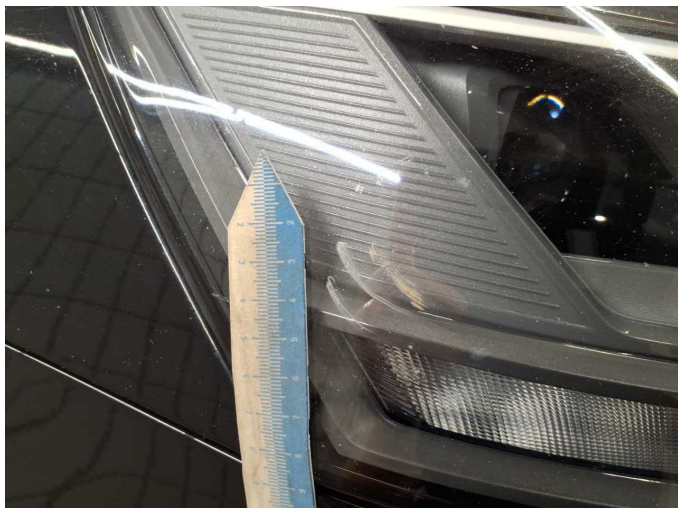
| No. | Component group | Description |
|---|---|---|
| 5 | Headlight | Headlight - left side - Scratch(es) - Loss in value |

**Damage 5:** Headlight: Headlight - left side - Scratch(es) - Loss in value

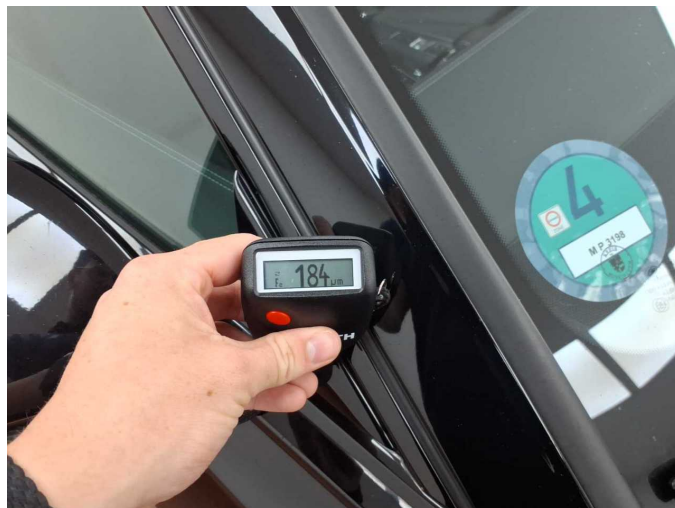
| No. | Repainting |
|---|---|
| 1 | Roof rail - right side, Professionally carried out, Invoice of repair done Non-existent |

| Roof rail - right side | 184 µm | Boot lid / rear door | 392 µm |

**Repainting 1:** Roof rail - right side

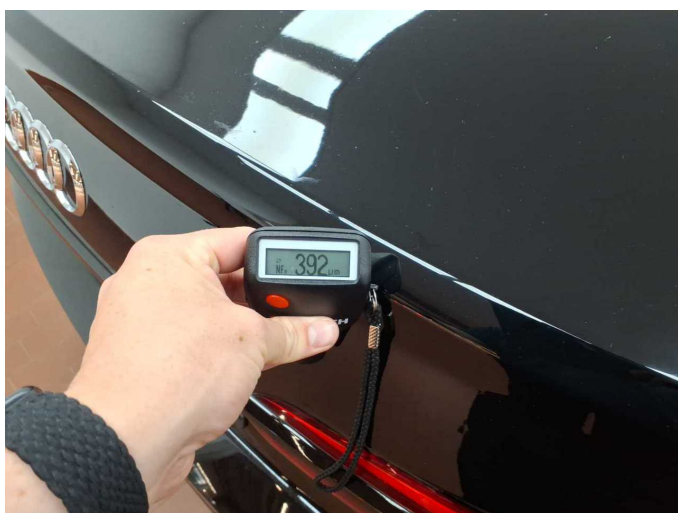
| No. | Repainting |
|---|---|
| 2 | Boot lid / rear door, Professionally carried out, Invoice of repair done Non-existent |

**Repainting 2:** Boot lid / rear door

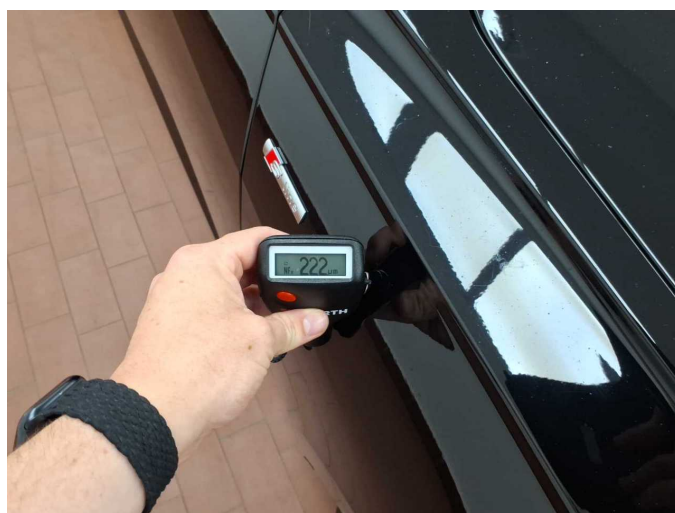
| No. | Repainting |
|---|---|
| 3 | Mudguard - right side, Professionally carried out, Invoice of repair done Non-existent |

| Mudguard - right side | 222 µm | Bonnet | 210 µm |

**Repainting 3:** Mudguard - right side

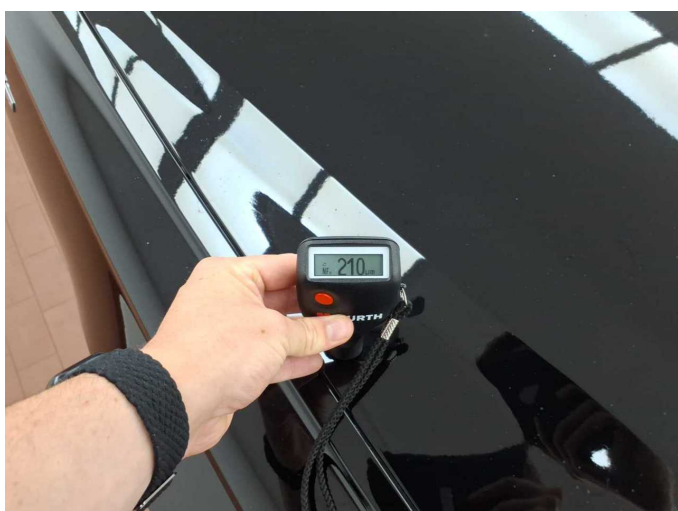
| No. | Repainting |
|---|---|
| 4 | Bonnet, Professionally carried out, Invoice of repair done Non-existent |

**Repainting 4:** Bonnet

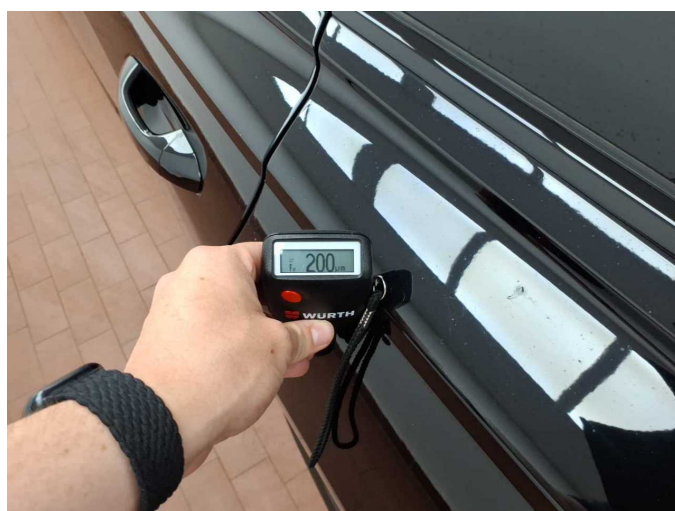
| No. | Repainting |
|---|---|
| 5 | Side panel - rear left side, Professionally carried out, Invoice of repair done Non-existent |

| Side panel - rear left side | 200 µm | Door - front left side | 199 µm |

**Repainting 5:** Side panel - rear left side

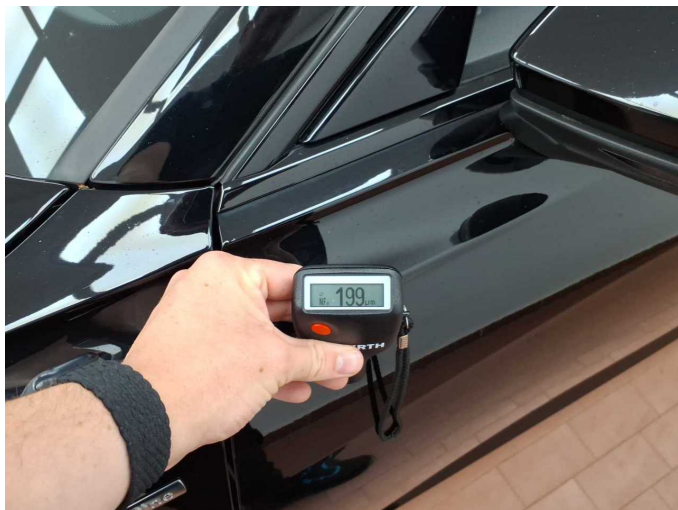
| No. | Repainting |
|---|---|
| 6 | Door - front left side, Professionally carried out, Invoice of repair done Non-existent |

**Repainting 6:** Door - front left side

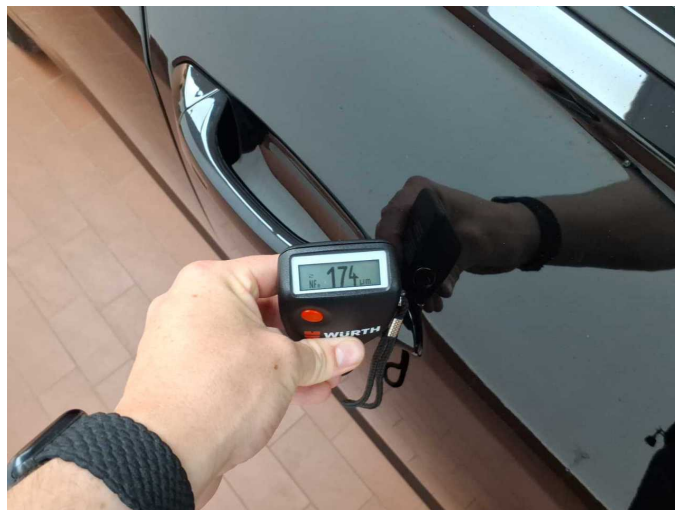
| No. | Repainting |
|---|---|
| 7 | Door - front right side, Professionally carried out, Invoice of repair done Non-existent |

| Door - front right side | 174 µm | | |

**Repainting 7:** Door - front right side
