Expertise

Protocol number: 46299111  
Order No. / Reference: 26562482  
Inspection date: 3 Jul 2026

| Manufacturer: Ford | Model: Tourneo Custom 320 L1H1 VA Aut. Titanium |
| VIN: WF03XXTTG3MK26582 | |

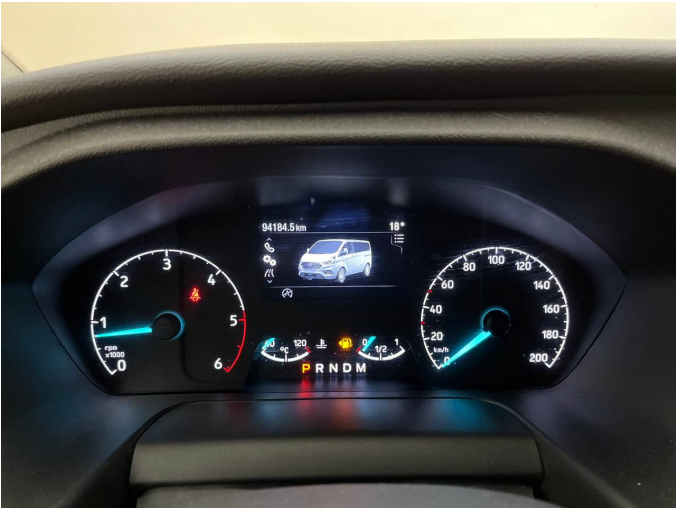
| Vehicle details | |
|---|---|
| Mileage (Read) | 94,184 km |

Figure 7: Instrument cluster

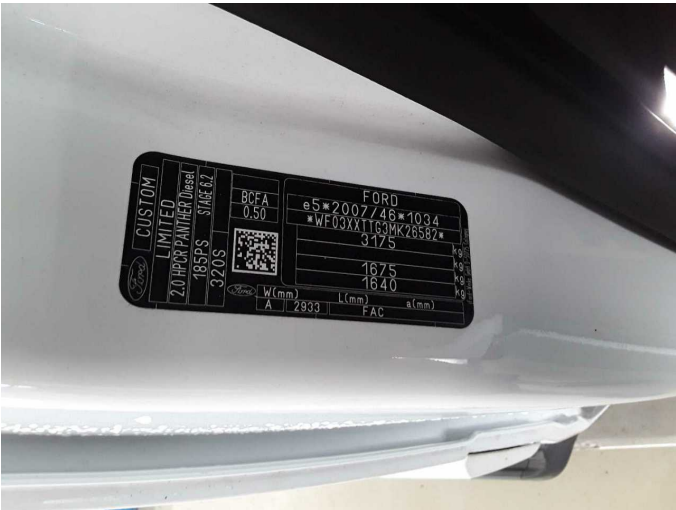
| VIN comparison | The vehicle identification number (VIN) was read from the vehicle and its conformity with the submitted documents was confirmed by the undersigned during the inspection. |

Figure 11: VIN

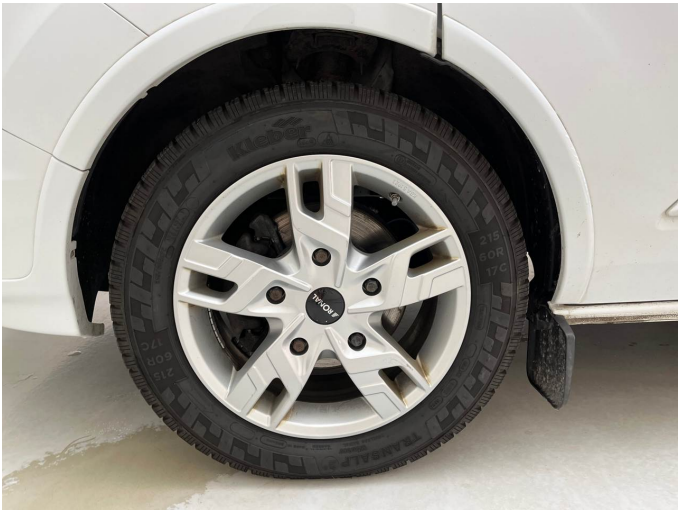
| # | Tyre size | Type of tyre | Manufacturer | Tread depth |
|---|---|---|---|---|
| 1) | 215/60 R17 109T | Winter tyres on Light alloy | Kleber | 8mm / 8mm |
| 2) | 215/60 R17 109T | Winter tyres on Light alloy | Hankook | 8mm / 8mm |

Figure 12: Mounted tyres

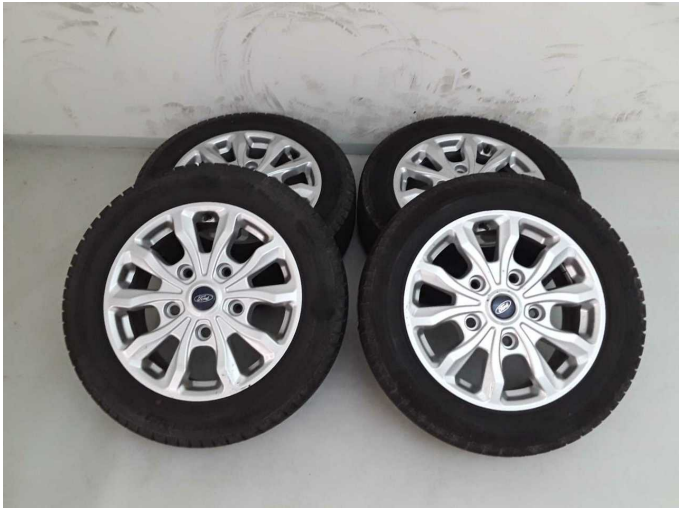
| # | Tyre size | Type of tyre | Manufacturer | Tread depth |
|---|---|---|---|---|
| 1) | 215/60 R17 109T | Summer tyres on Light alloy | Michelin | 7mm / 7mm |
| 2) | 215/60 R17 109T | Summer tyres on Light alloy | Michelin | 9mm / 9mm |

Figure 16: Additional tyres

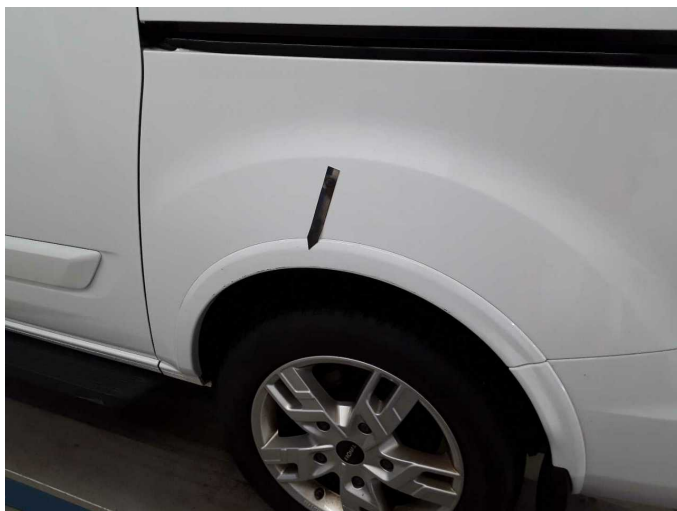
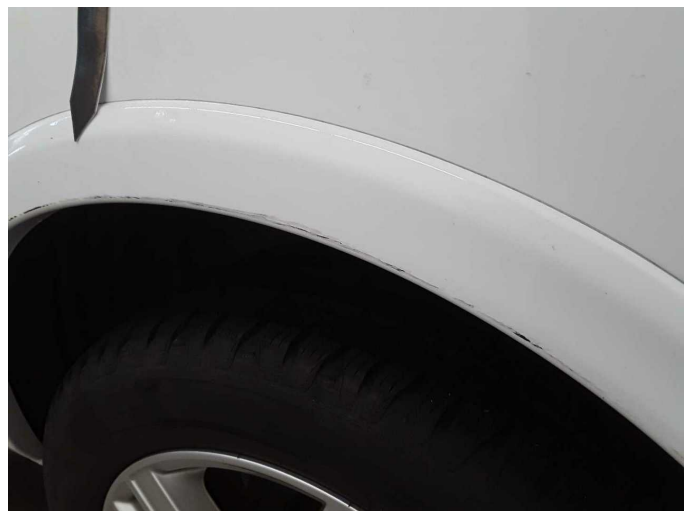
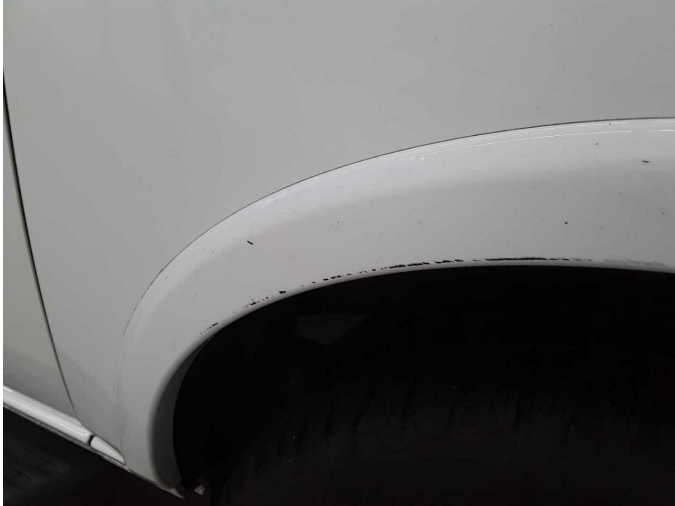
| No. | Component group | Description |
|---|---|---|
| 1 | Side panel - rear left side | Wheel arch - Scratch(es) - Smart repair |

**Damage 1:** Side panel - rear left side: Wheel arch - Scratch(es) - Smart repair

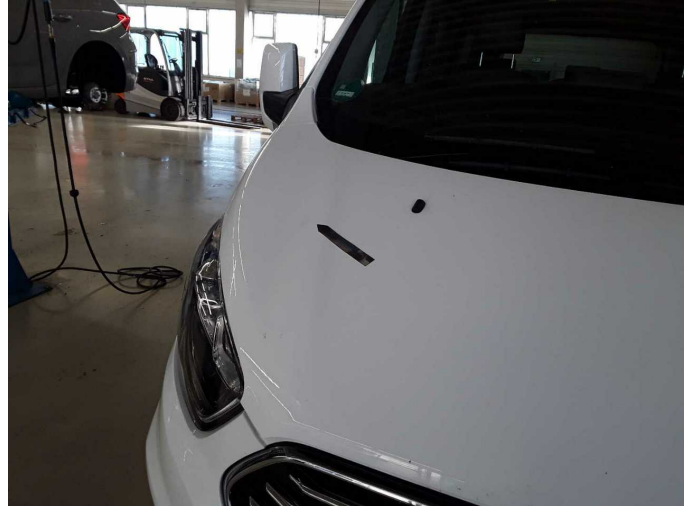
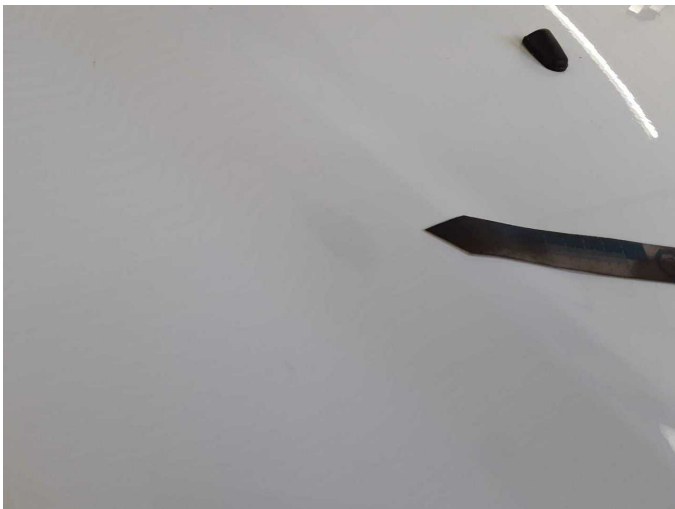
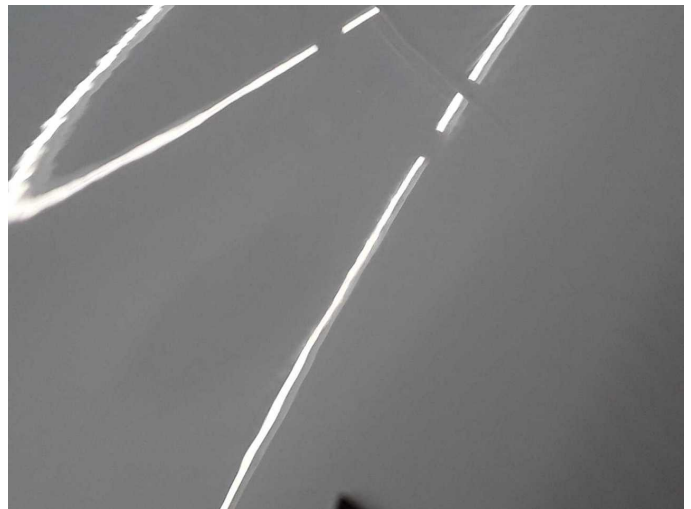
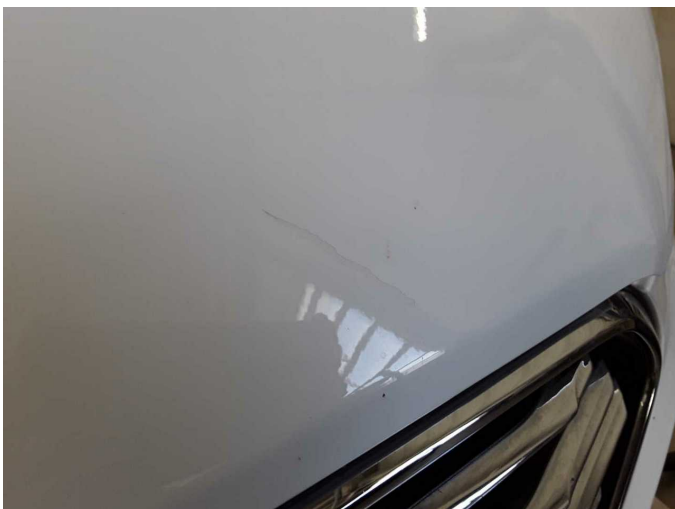
| No. | Component group | Description |
|---|---|---|
| 2 | Bonnet | Bonnet - Paint defect - Paint |

**Damage 2:** Bonnet: Bonnet - Paint defect - Paint
