Expertise

Protocol number: 46229860
Order No. / Reference: 26561989
Inspection date: 24 Jun 2026

Model: Focus Turnier 1.5 EcoBlue Start-Stopp-System Aut. TITANIUM X

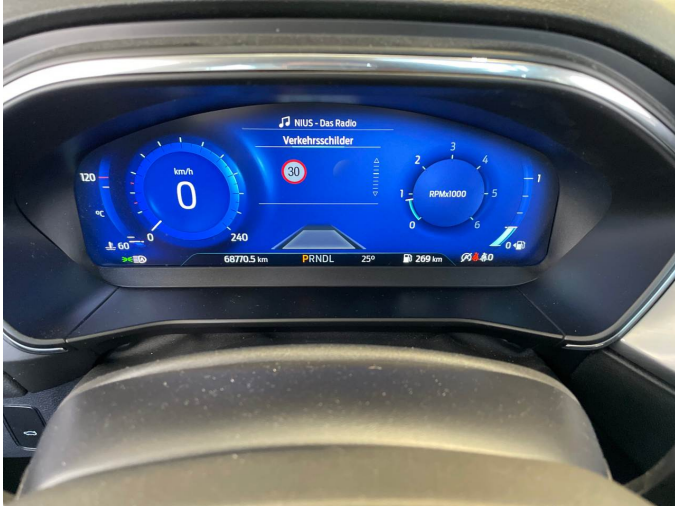
Figure 7: Instrument cluster

Mileage (Read) 68,770 km

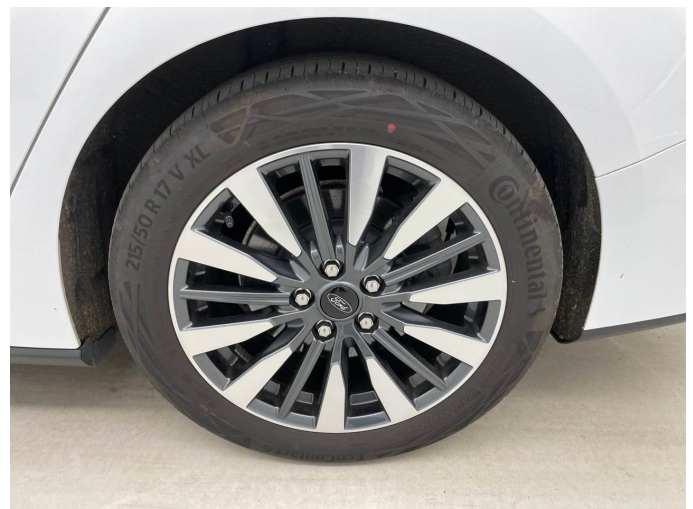
Figure 12: Mounted tyres

Mounted tyres				
#	Tyre size	Type of tyre	Manufacturer	Tread depth
1)	215/50 R17 95V	Summer tyres on Light alloy	Continental	5mm / 5mm
2)	215/50 R17 95V	Summer tyres on Light alloy	Continental	5mm / 5mm
Additional tyres				
#	Tyre size	Type of tyre	Manufacturer	Tread depth
1)	205/60 R16 92H	Winter tyres on Light alloy	Goodyear	6mm / 6mm
2)	205/60 R16 92H	Winter tyres on Light alloy	Goodyear	7mm / 7mm
Replacement				
Typ	Tyre size	Type of tyre	Manufacturer	Tread depth
N	125/70 R16 96M	Summer tyres on Steel	Hankook	4 mm

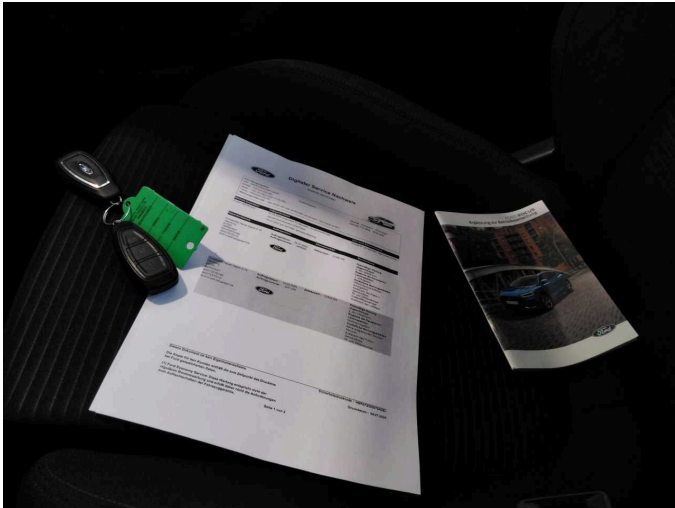
Figure 13: Documents

Documents submitted	At the time of the inspection, the vehicle registration certificate Part 2 (title) was available, but the vehicle registration certificate Part 1 (document) was not. (Copy)
VIN comparison	The vehicle identification number (VIN) was read from the vehicle and its conformity with the submitted documents was confirmed by the undersigned during the inspection.
Inspection	The inspection conditions were sufficient for the assessment of the vehicle. No lifting equipment or pit was available for inspecting the vehicle. Therefore, inspection of the vehicle's underside was only possible to a limited extent.
Test drive	No test drive/shunting maneuver was carried out during the inspection of the vehicle.
Engine function test	An engine test run was performed.
readiness to drive	The vehicle was roadworthy at the time of inspection.

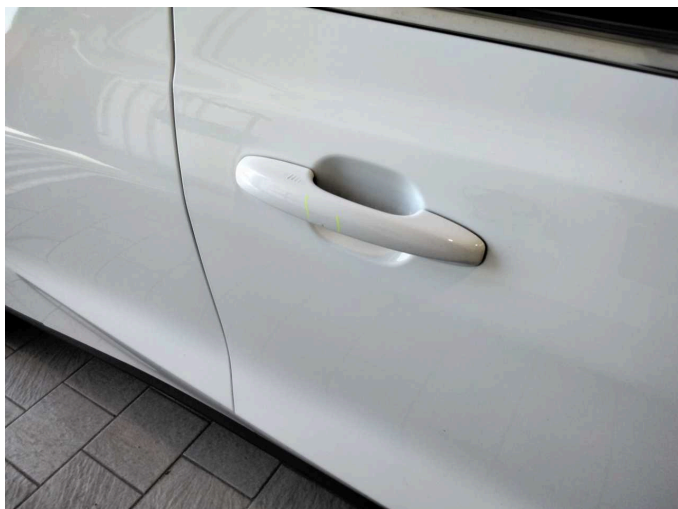
Damage 1: Door - front right side: Door handle - outside - Scratch(es) - Smart repair

No.	Component group	Description
1	Door - front right side	Door handle - outside - Scratch(es) - Smart repair

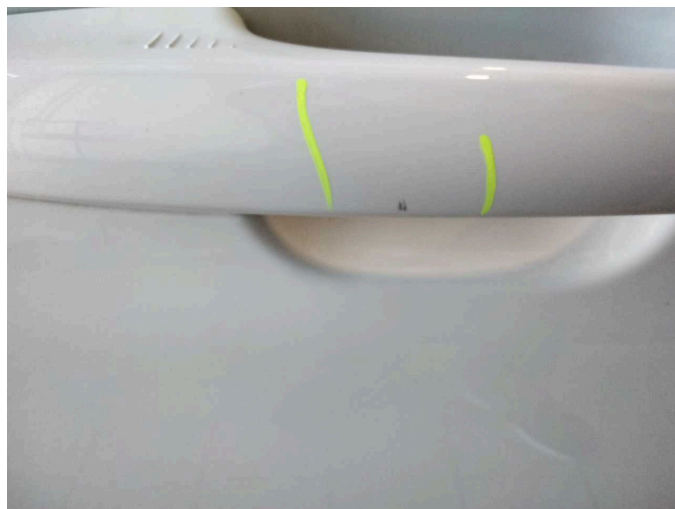
Damage 1: Door - front right side: Door handle - outside - Scratch(es) - Smart repair
