Expertise

Protocol number: 46553016  
Order No. / Reference: 26663252  
Inspection date: 15 Jul 2026

Manufacturer: Opel

Model: Mokka-e Ultimate

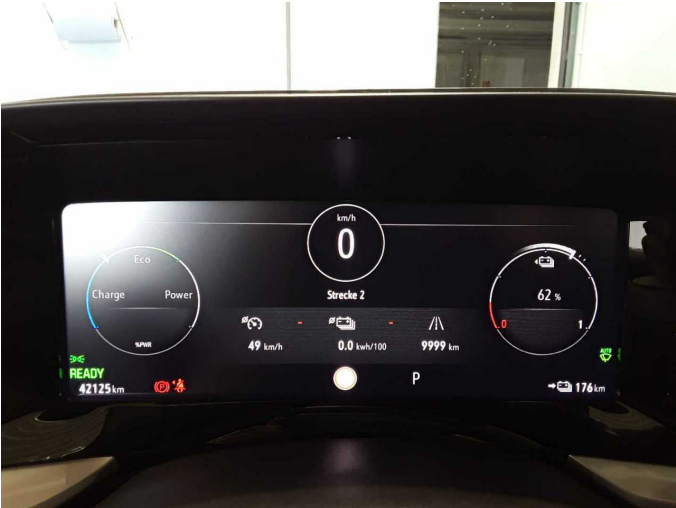
Figure 7: Instrument cluster

Mileage (Read) 42,125 km

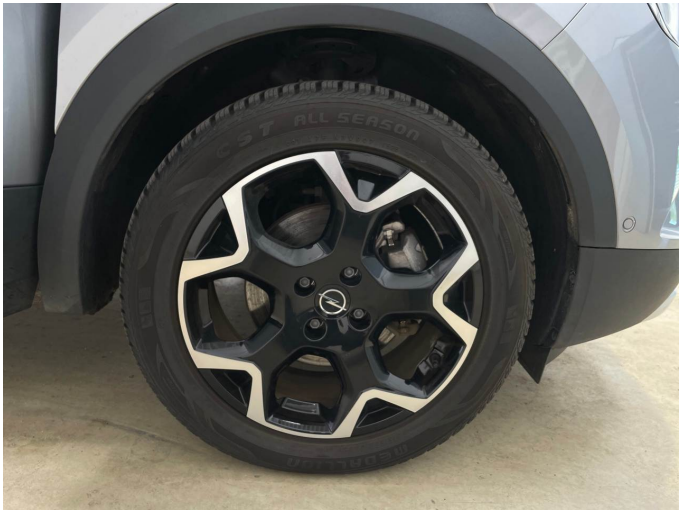
Figure 12: Mounted tyres

| Tyres | | | | |
|---|---|---|---|---|
| 1) | 215/55 R18 99V | All-season tyres on Light alloy | Sonstige | 7mm / 7mm |
| 2) | 215/55 R18 99V | All-season tyres on Light alloy | Falken | 6mm / 6mm |

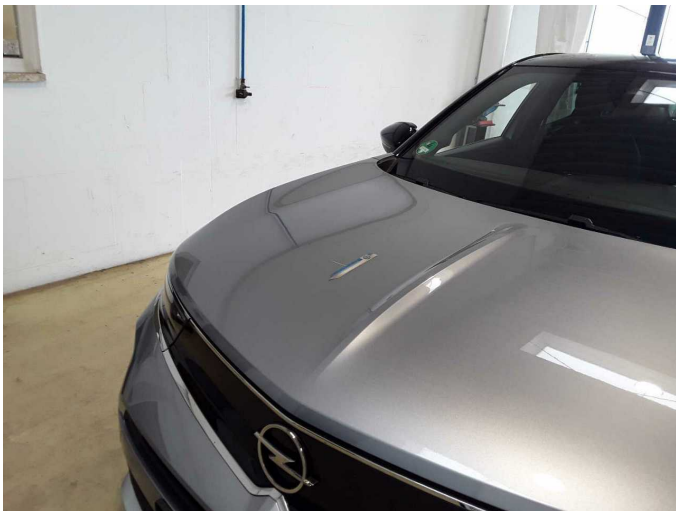
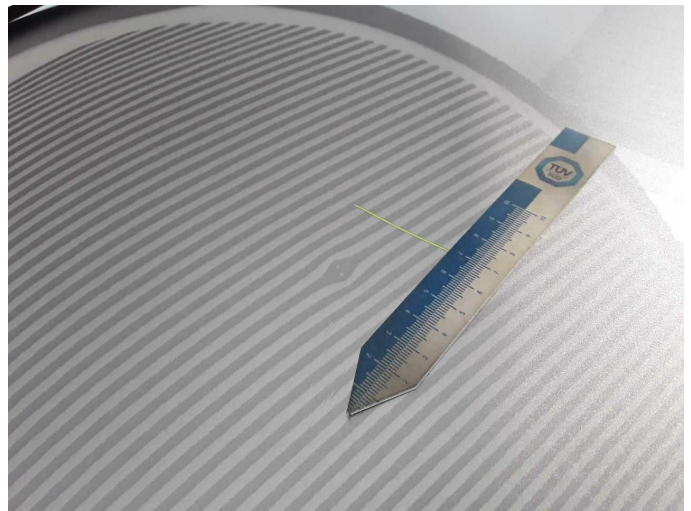
Damage 1: Bonnet: Bonnet - dent(s) - Smooth repair work

| No. | Component group | Description |
|---|---|---|
| 1 | Bonnet | Bonnet - dent(s) - Smooth repair work |

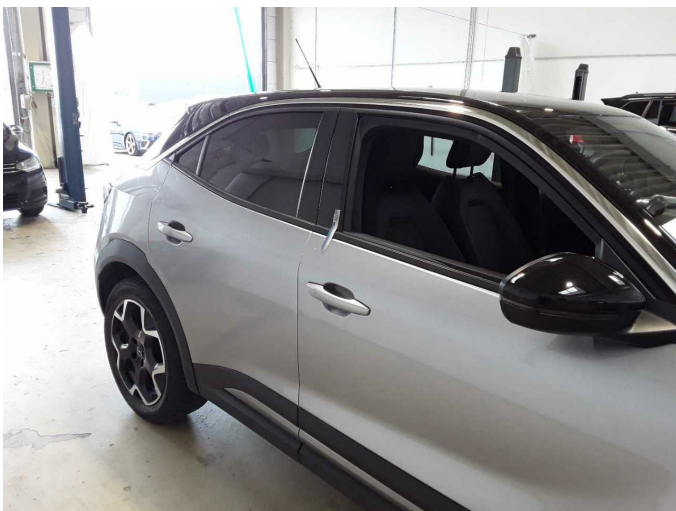
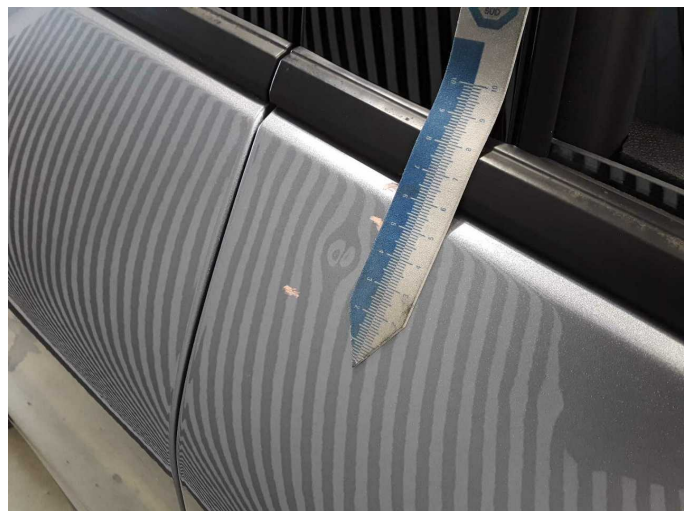
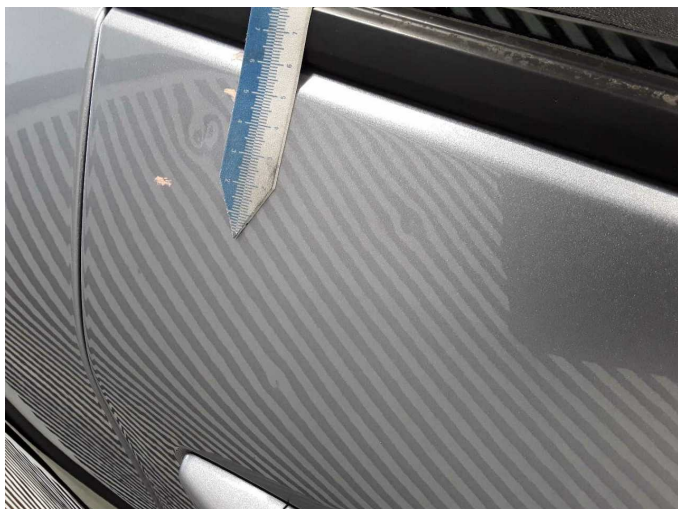
Damage 2: Door - front right side: Door - dent(s) - Smooth repair work

**Damage 2:** Door - front right side: Door - dent(s) - Smooth repair work

| No. | Component group | Description |
|---|---|---|
| 2 | Door - front right side | Door - dent(s) - Smooth repair work |

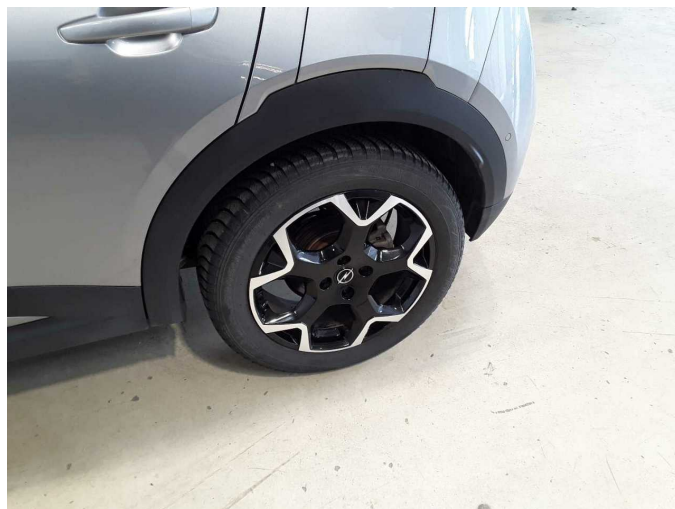
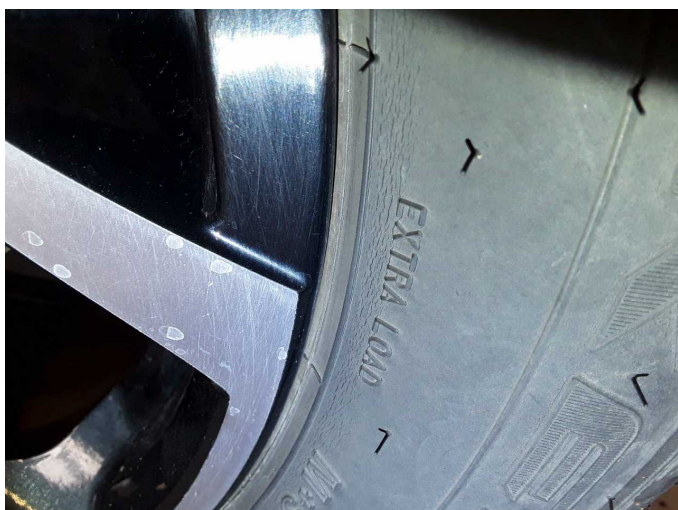
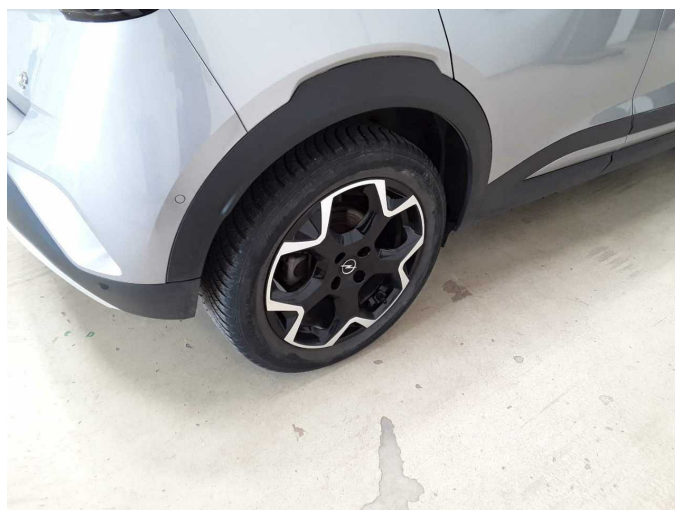
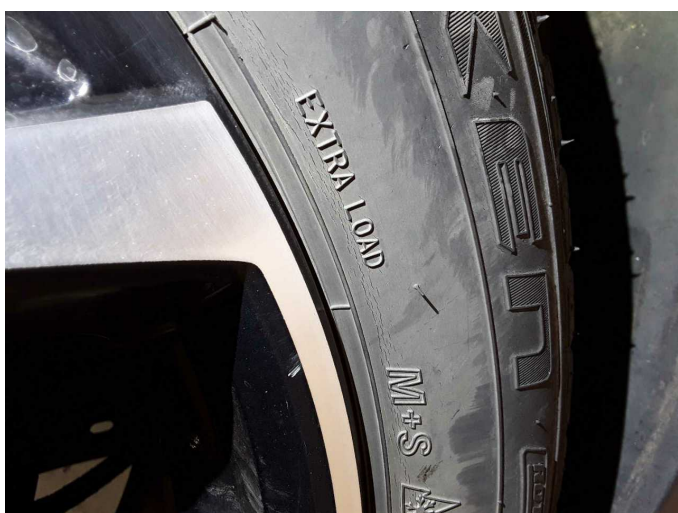
**Damage 3:** Wheel / tyres: Tyre - right - Porous / cracked - Replace

| No. | Component group | Description |
|---|---|---|
| 3 | Wheel / tyres | Tyre - right - Porous / cracked - Replace |

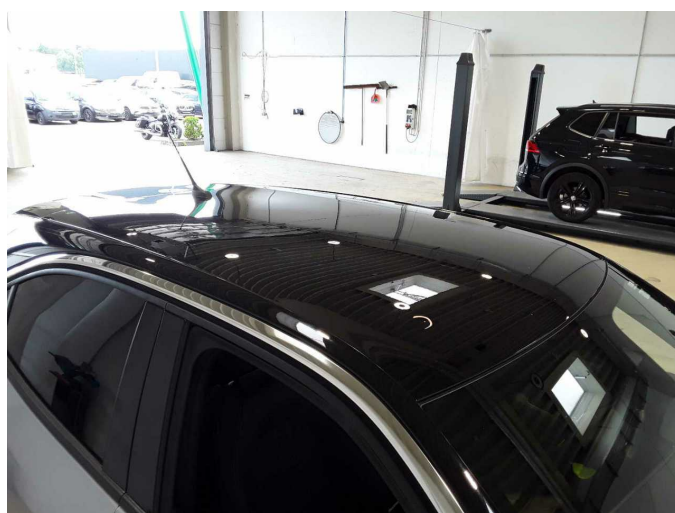
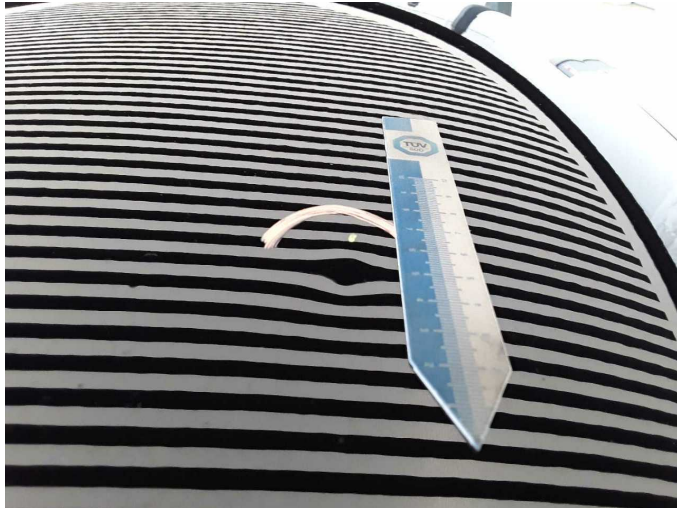
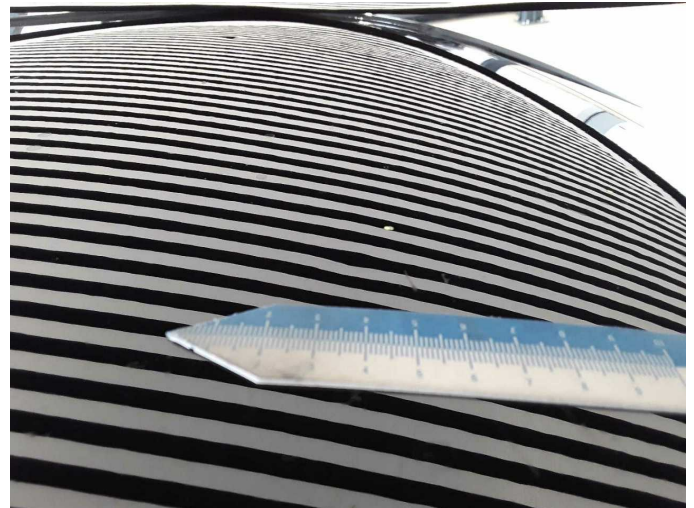
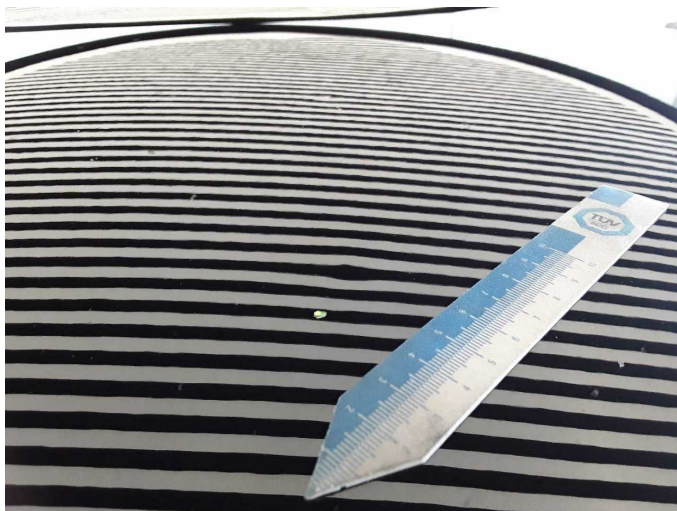
**Damage 4:** Roof: Roof - Damage by hail - Repair

| No. | Component group | Description |
|---|---|---|
| 4 | Roof | Roof - Damage by hail - Repair |
