Expertise

Protocol number: 46907286  
Order No. / Reference: 26837458  
Inspection date: 4 Aug 2026

Manufacturer: Renault

Model: Megane EV40 130hp boost charge Equilibre

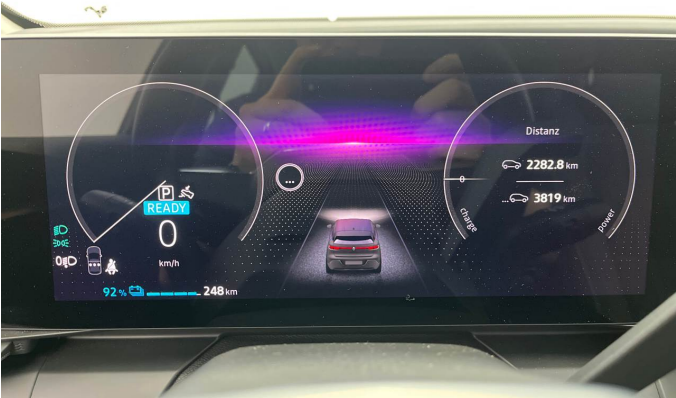
Figure 7: Instrument cluster

| Vehicle details | |
|---|---|
| Mileage (Read) | 3,819 km |

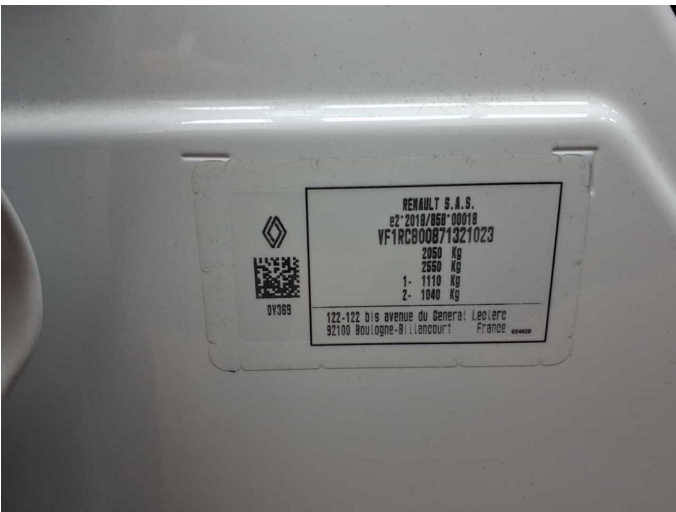
Figure 11: VIN

| VIN comparison | The vehicle identification number (VIN) was read from the vehicle and its conformity with the submitted documents was confirmed by the undersigned during the inspection. |

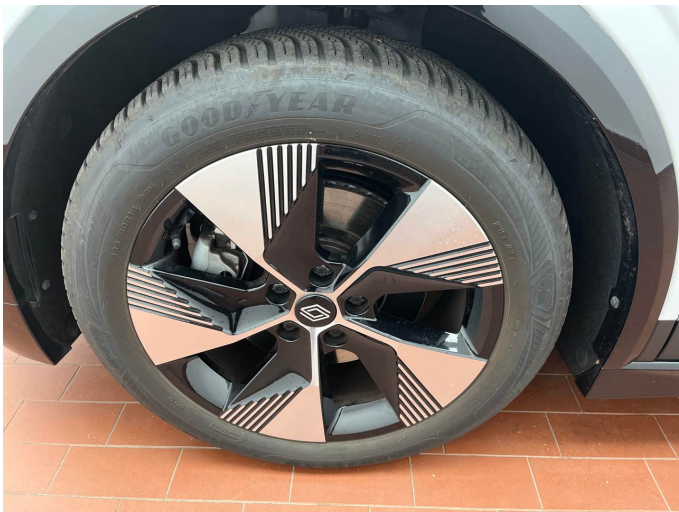
Figure 12: Mounted tyres

| # | Tyre size | Type of tyre | Manufacturer | Tread depth |
|---|---|---|---|---|
| 1) | 195/60 R18 96H | All-season tyres on Light alloy | Goodyear | 6mm / 6mm |
| 2) | 195/60 R18 96H | All-season tyres on Light alloy | Goodyear | 7mm / 7mm |

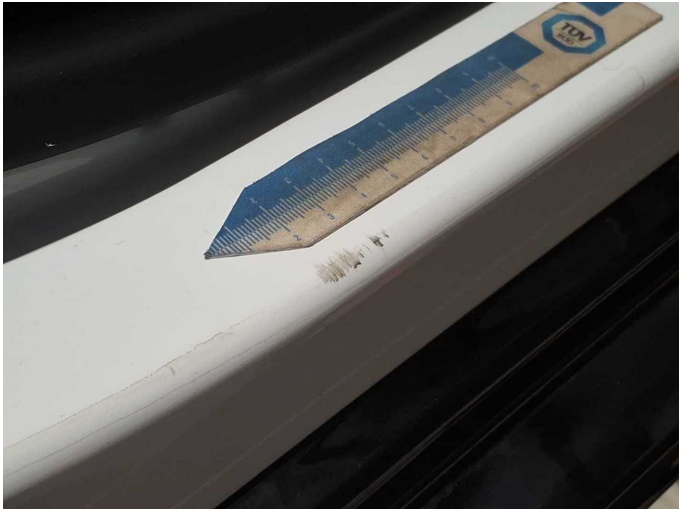
| No. | Component group | Description |
|---|---|---|
| 1 | Side panel - rear right side | Sill - Scratch(es) - Smart repair |

Damage 1: Side panel - rear right side: Sill - Scratch(es) - Smart repair

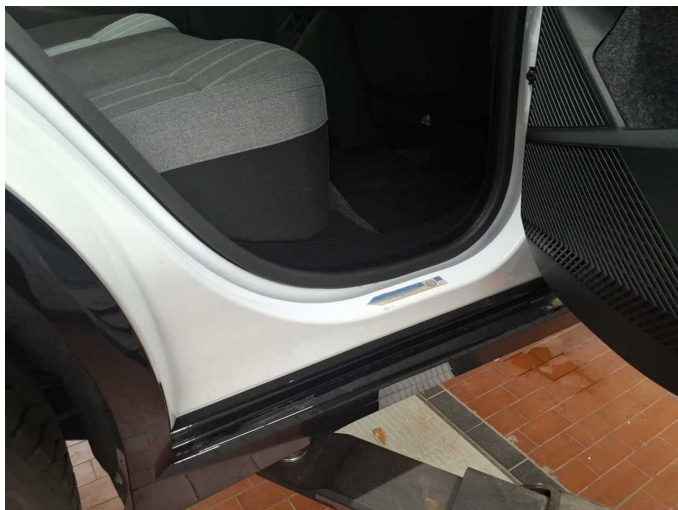
**Damage 1:** Side panel - rear right side: Sill - Scratch(es) - Smart repair

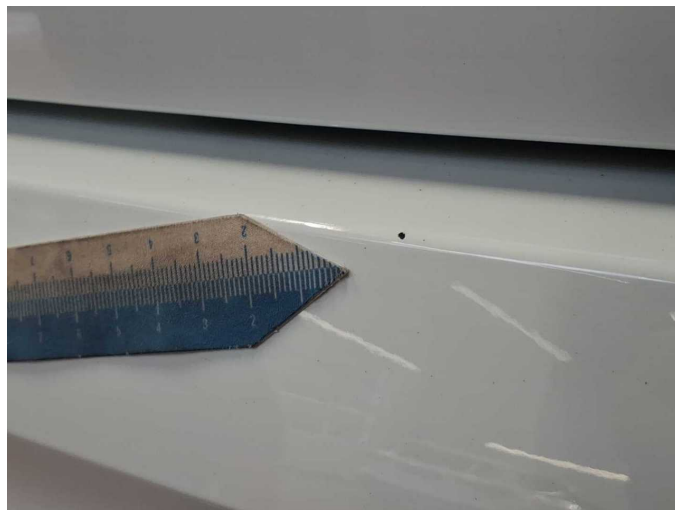
| No. | Component group | Description |
|---|---|---|
| 1 | Rear bumper | Rear bumper - Scratch(es) - No deduction |

**Wear and tear 1:** Rear bumper: Rear bumper - Scratch(es) - No deduction

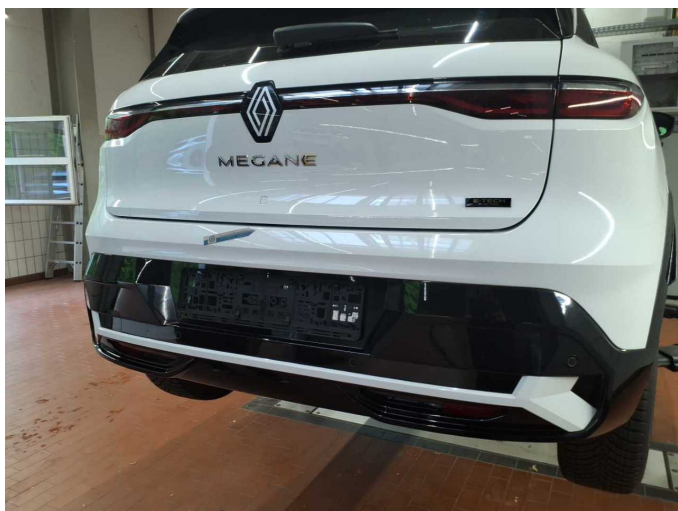
**Wear and tear 1:** Rear bumper: Rear bumper - Scratch(es) - No deduction
