Expertise

Protocol number: 46406628  
Order No. / Reference: 26566873  
Inspection date: 8 Jul 2026

Manufacturer: Mercedes-Benz

Model: C 300 e 9G-TRONIC AMG Line

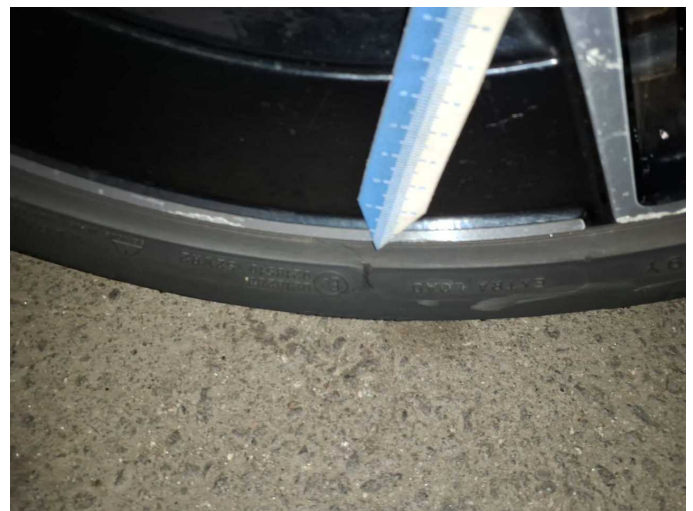
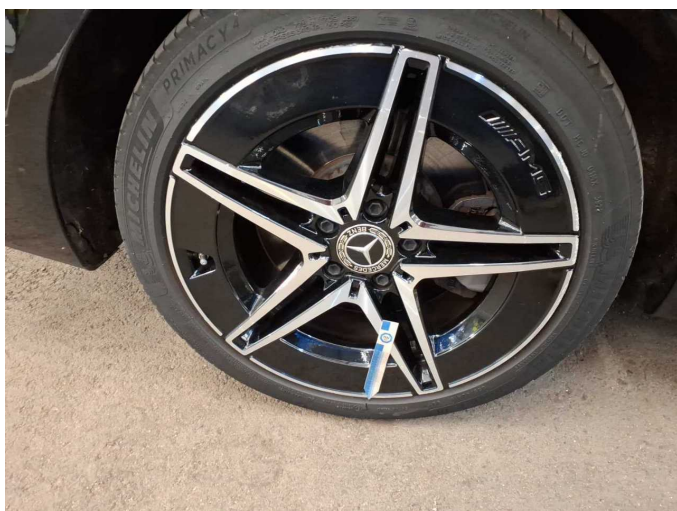
| No. | Component group | Description |
|---|---|---|
| 1 | Wheel / tyres | Tyre - rear right side (Rollfähig) - Broken / torn - Replace |

Damage 1: Wheel / tyres: Tyre - rear right side (Rollfähig) - Broken / torn  
- Replace

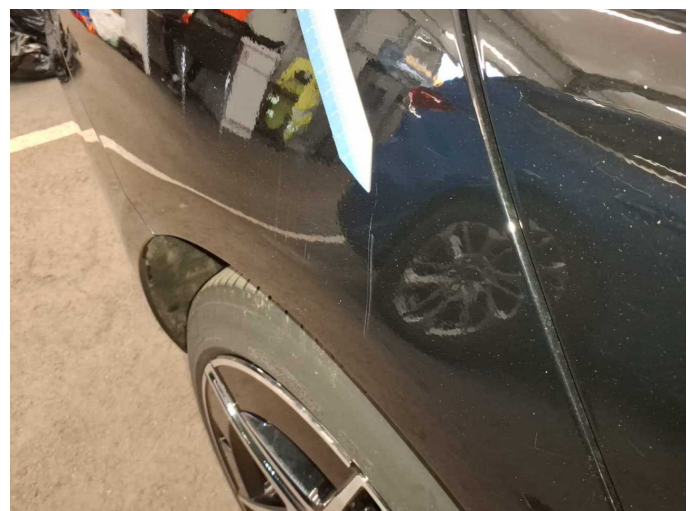
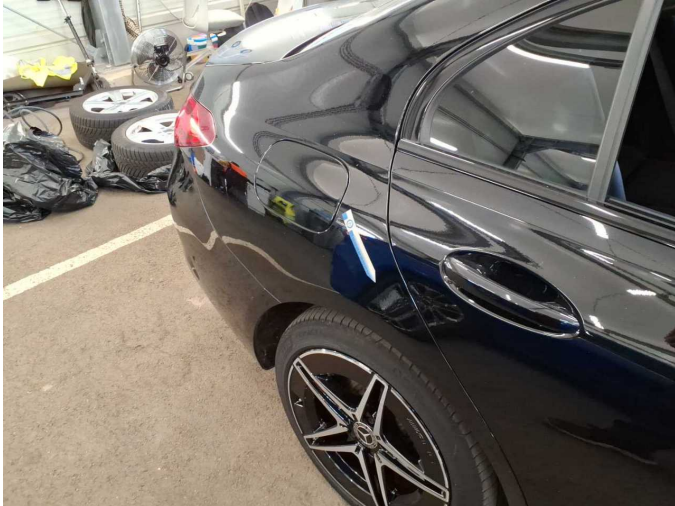
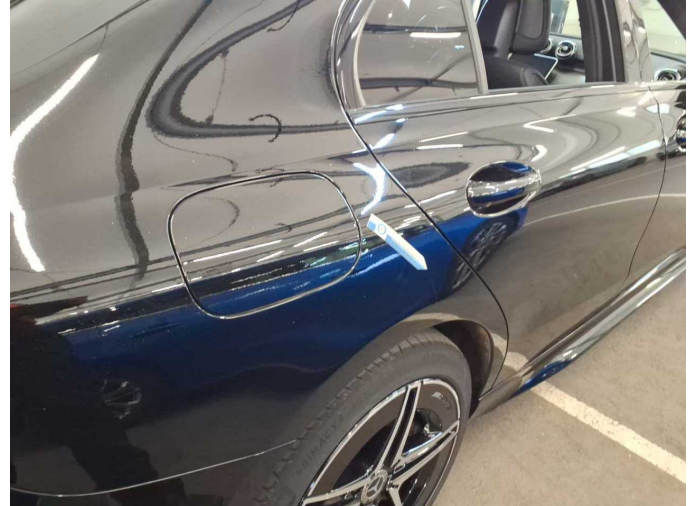
| No. | Component group | Description |
|---|---|---|
| 2 | Side panel - rear right side | Side panel - Scratch(es) - Smart repair |

Damage 2: Side panel - rear right side: Side panel - Scratch(es) - Smart  
repair

**Damage 2:** Side panel - rear right side: Side panel - Scratch(es) - Smart repair

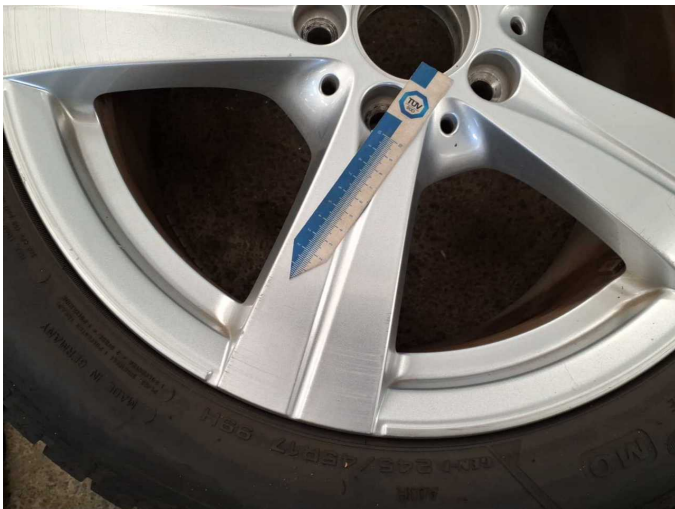
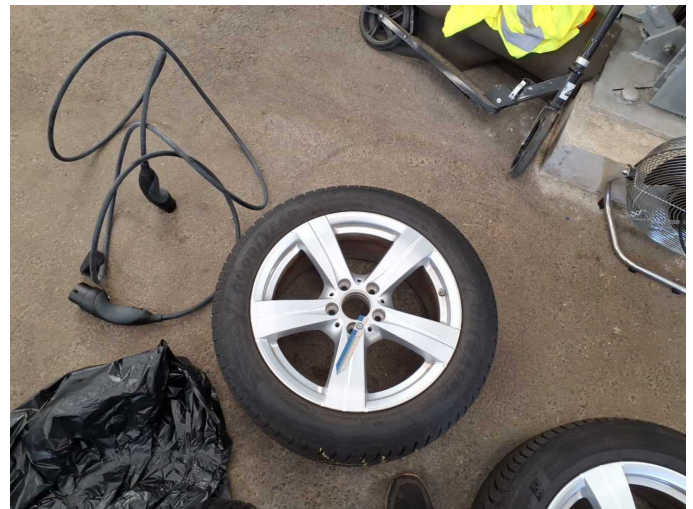
| No. | Component group | Description |
|---|---|---|
| 3 | 2nd wheel set | 1 alloy rim - Scratch(es) - Loss in value |

**Damage 3:** 2nd wheel set: 1 alloy rim - Scratch(es) - Loss in value

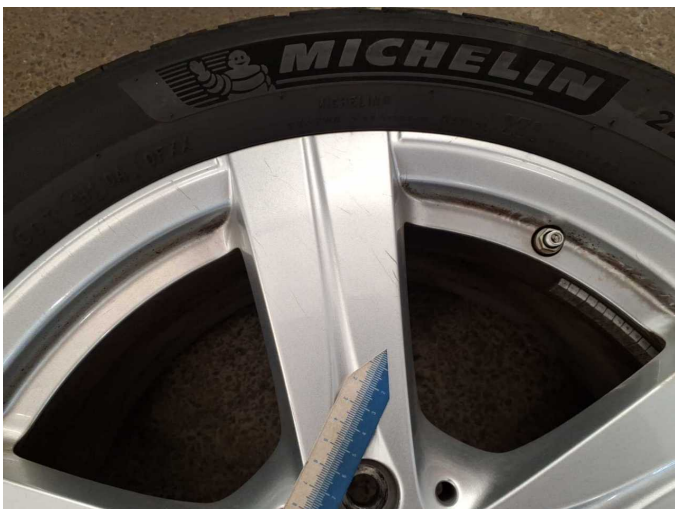
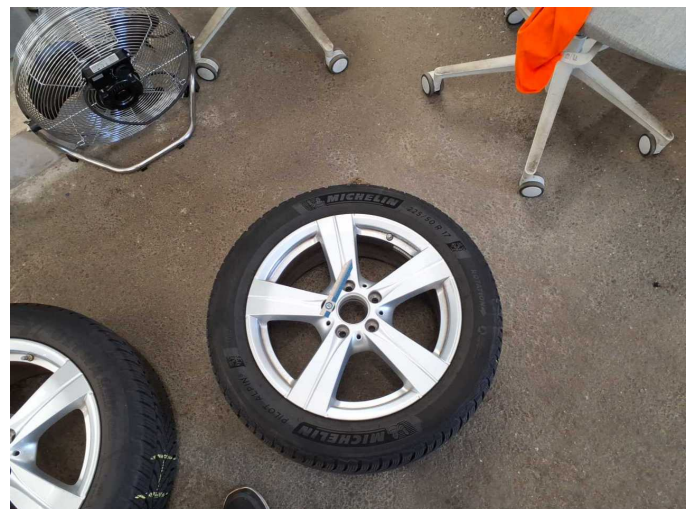
| No. | Component group | Description |
|---|---|---|
| 4 | 2nd wheel set | 1 alloy rim - Scratch(es) - Loss in value |

**Damage 4:** 2nd wheel set: 1 alloy rim - Scratch(es) - Loss in value

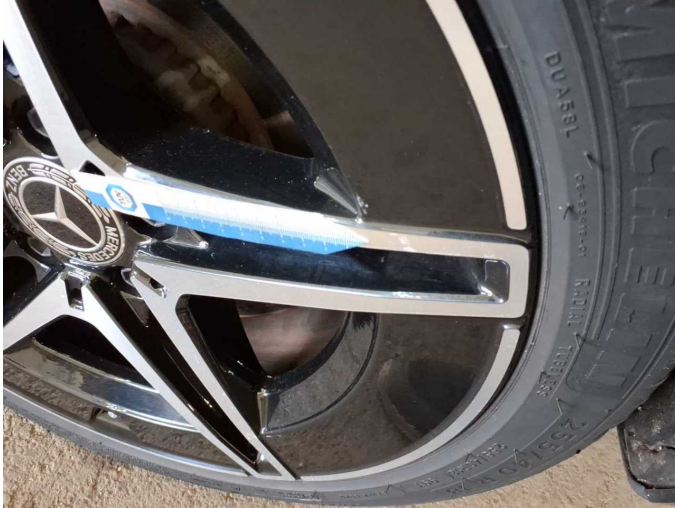
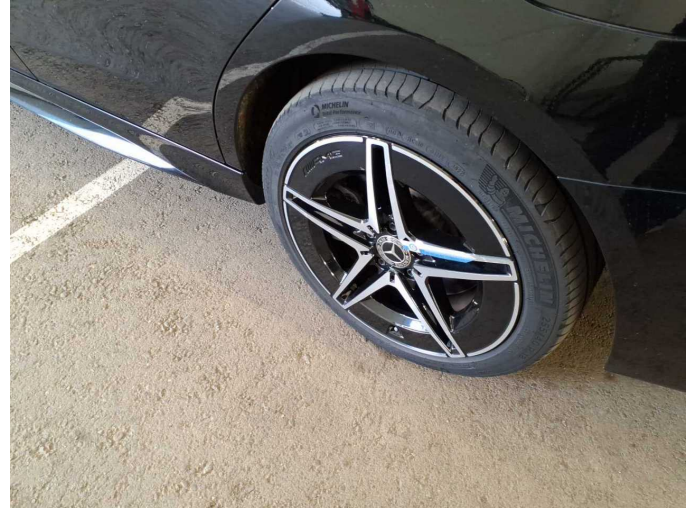
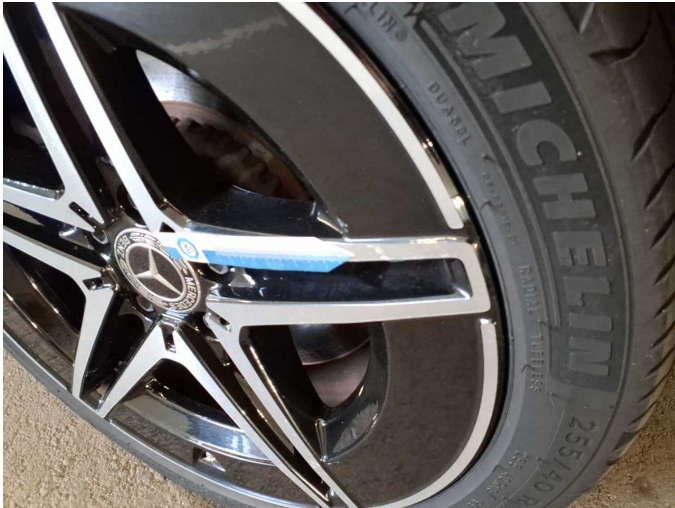
| No. | Component group | Description |
|---|---|---|
| 5 | Wheel / tyres | Alloy rim - rear left side - Scratch(es) - Loss in value |

**Damage 5:** Wheel / tyres: Alloy rim - rear left side - Scratch(es) - Loss in value

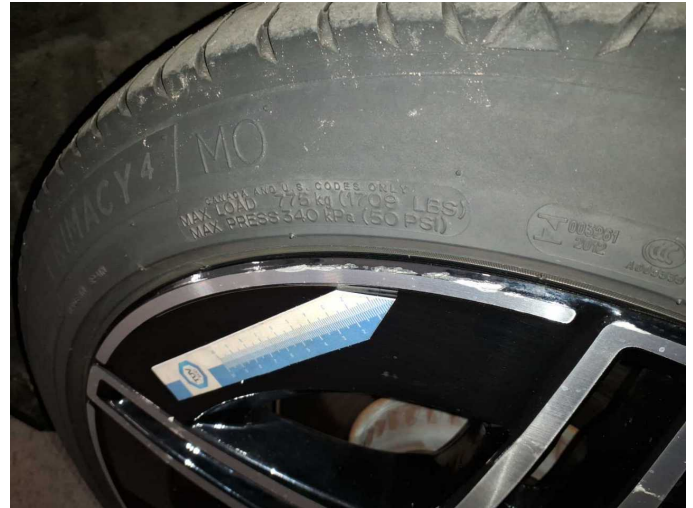
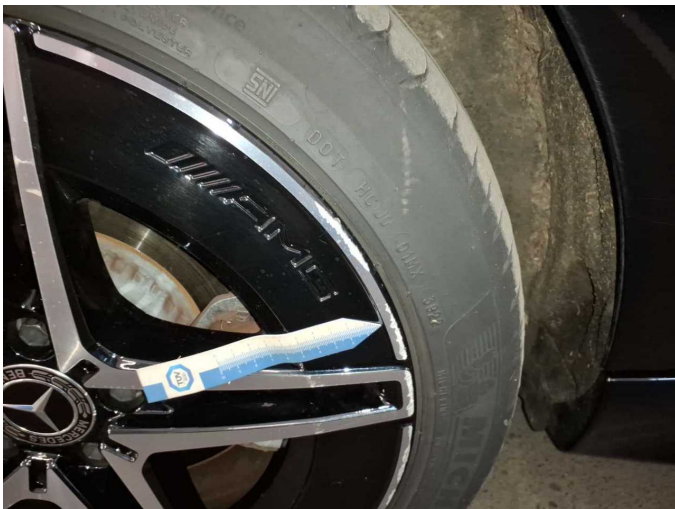
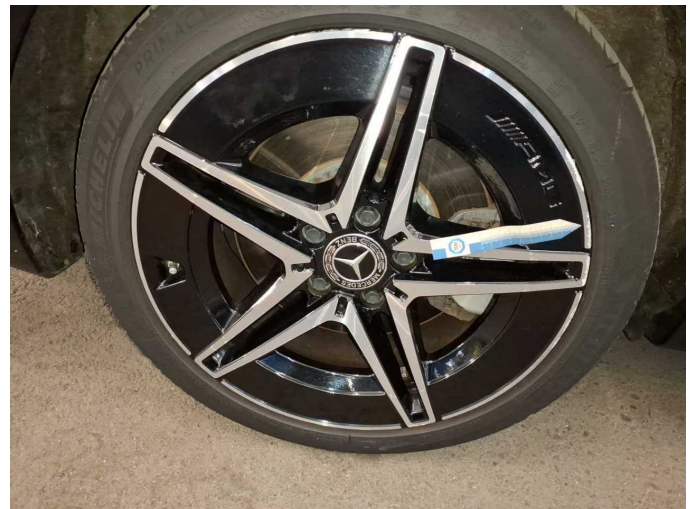
| No. | Component group | Description |
|---|---|---|
| 6 | Wheel / tyres | Alloy rim - rear right side - Scratched - Replace |

**Damage 6:** Wheel / tyres: Alloy rim - rear right side - Scratched - Replace

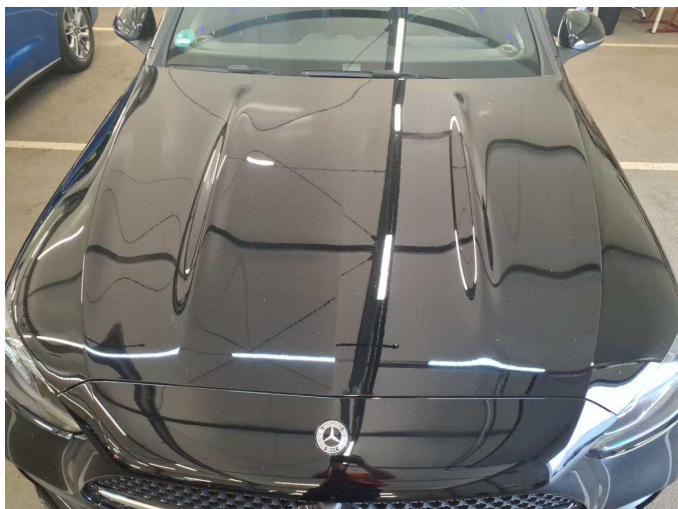
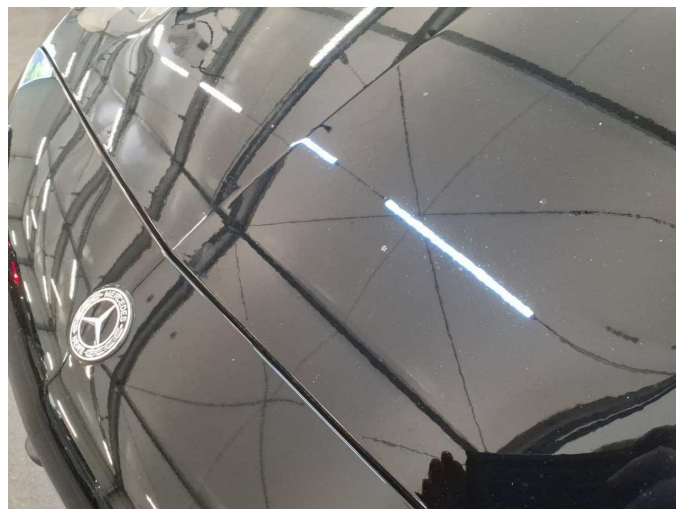
| No. | Component group | Description |
|---|---|---|
| 1 | Bonnet | Bonnet - Stone chips - No deduction |

**Wear and tear 1:** Bonnet: Bonnet - Stone chips - No deduction

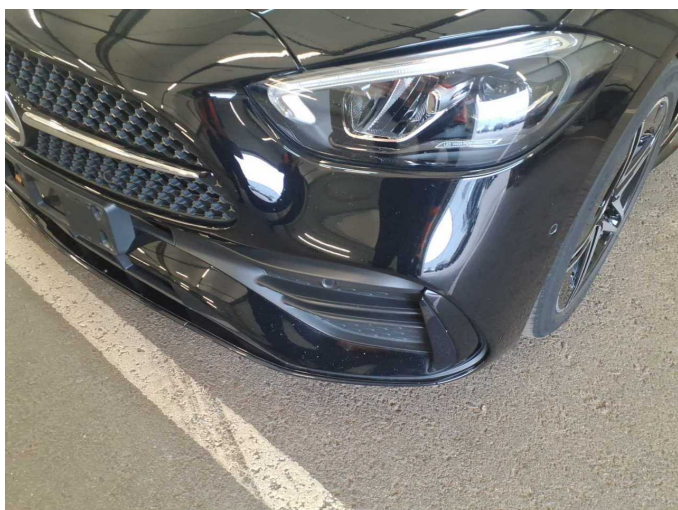
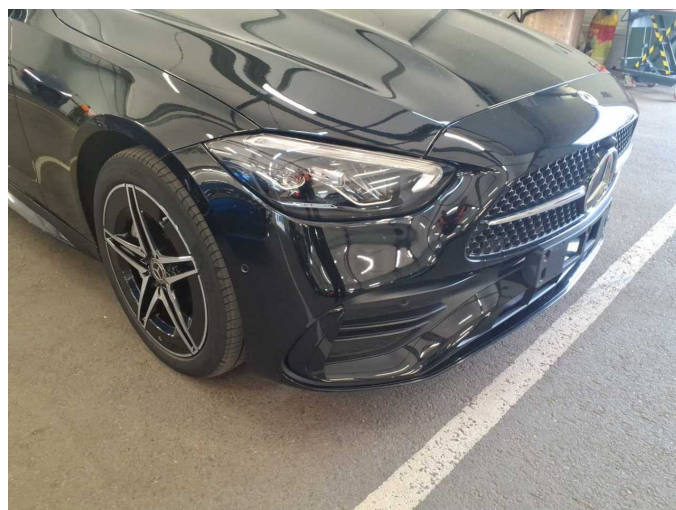
| No. | Component group | Description |
|---|---|---|
| 2 | Front bumper | Front bumper - Stone chips - No deduction |

**Wear and tear 2:** Front bumper: Front bumper - Stone chips - No deduction

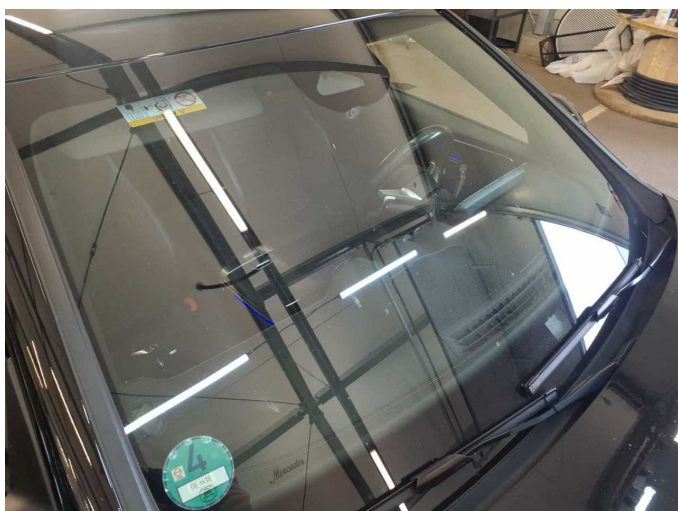
| No. | Component group | Description |
|---|---|---|
| 4 | Vehicle glazing | Windscreen - Stone chips - No deduction |

**Wear and tear 4:** Vehicle glazing: Windscreen - Stone chips - No deduction

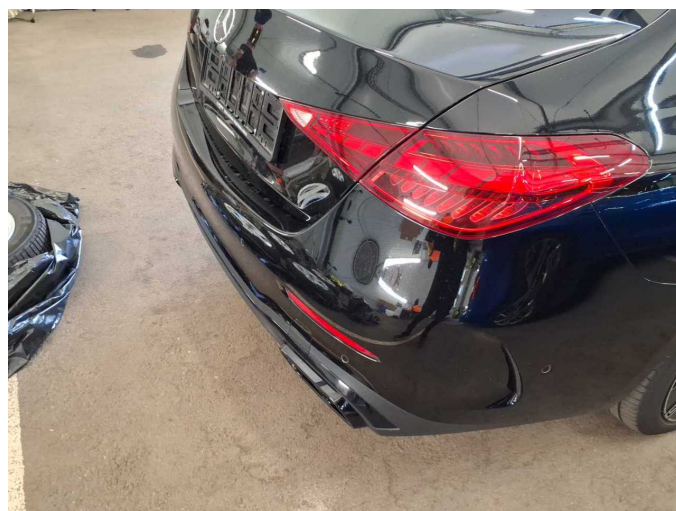
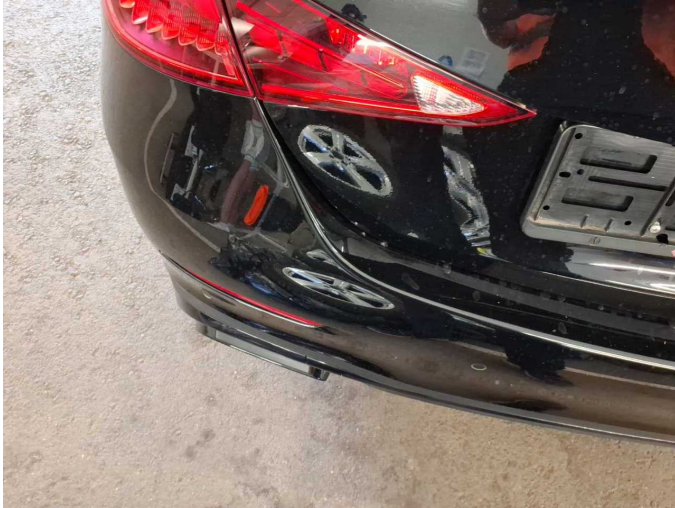
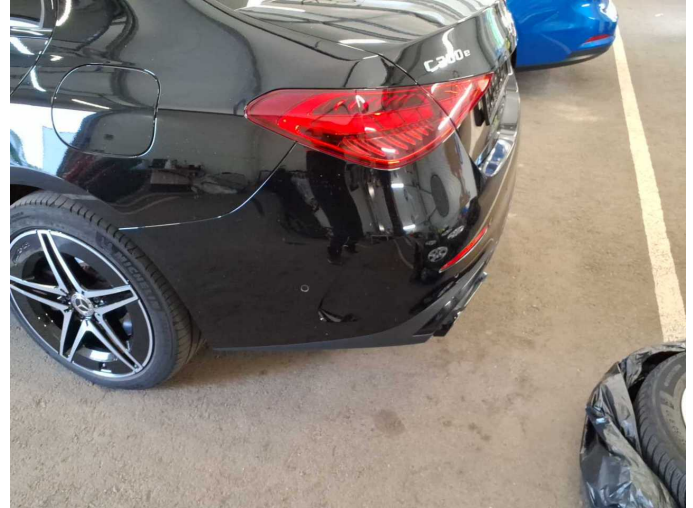
| No. | Component group | Description |
|---|---|---|
| 5 | Rear bumper | Rear bumper - Scratch(es) - No deduction |

**Wear and tear 5:** Rear bumper: Rear bumper - Scratch(es) - No deduction
