Expertise

Protocol number: 46416515  
Order No. / Reference: 26628534  
Inspection date: 9 Jul 2026

Manufacturer: Audi

Model: Q5 40 TDI quattro S tronic advanced

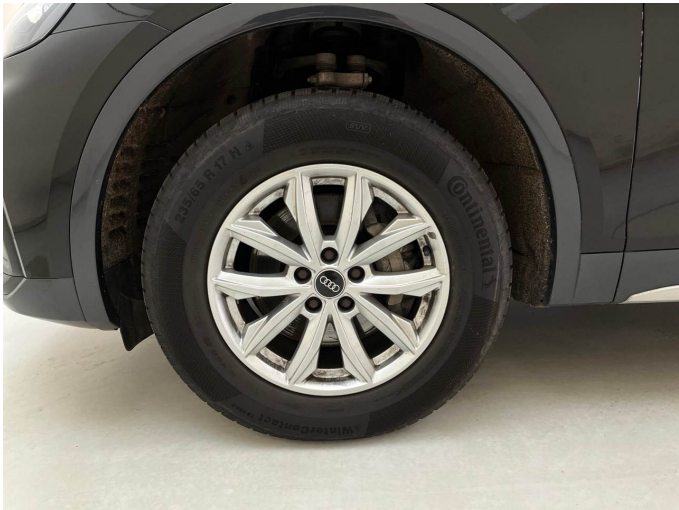
Figure 12: Mounted tyres

| # | Tyre size | Type of tyre | Manufacturer | Tread depth |
|---|---|---|---|---|
| 1) | 235/65 R17 104H | Winter tyres on Light alloy | Continental | 5mm / 5mm |
| 2) | 235/65 R17 104H | Winter tyres on Light alloy | Continental | 6mm / 6mm |

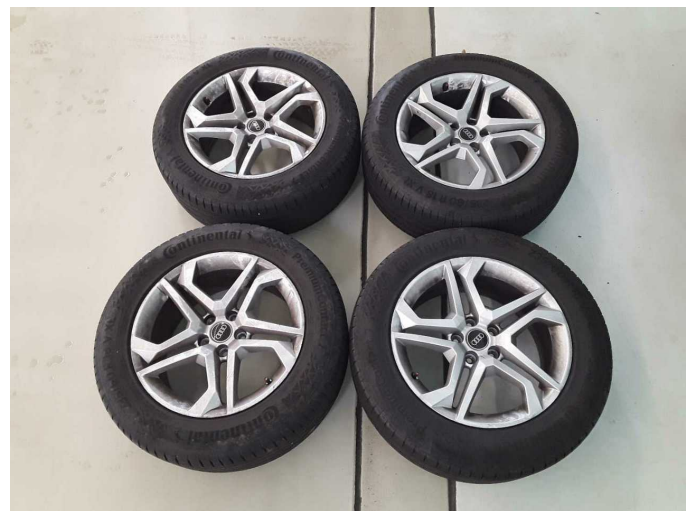
Figure 16: Additional tyres

| # | Tyre size | Type of tyre | Manufacturer | Tread depth |
|---|---|---|---|---|
| 1) | 235/60 R18 107V | Summer tyres on Light alloy | Continental | 5mm / 5mm |
| 2) | 235/60 R18 107V | Summer tyres on Light alloy | Continental | 5mm / 5mm |

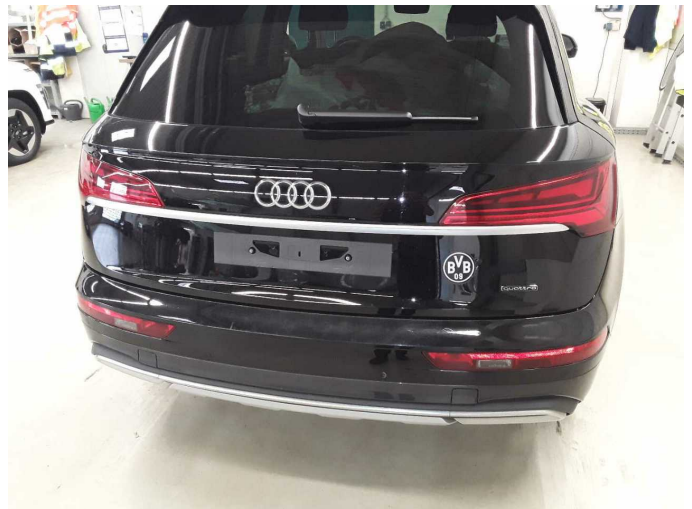
**Damage 1:** Boot lid / rear door: Boot lid - Glued / labelled - De-glue / neutralise

| No. | Component group | Description |
|---|---|---|
| 1 | Boot lid / rear door | Boot lid - Glued / labelled - De-glue / neutralise |

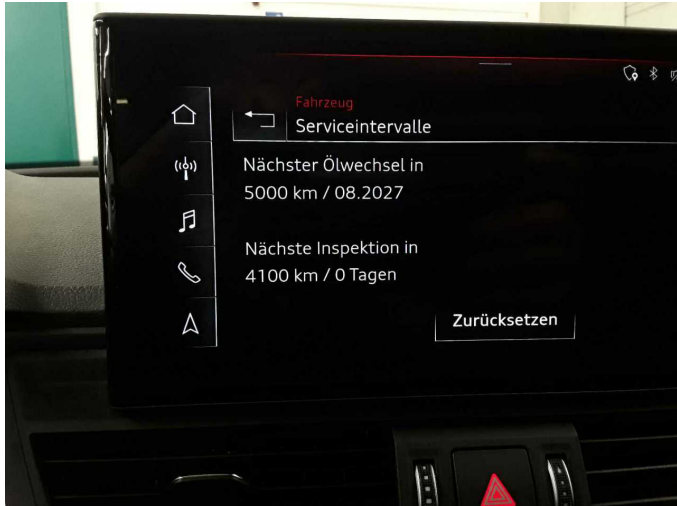
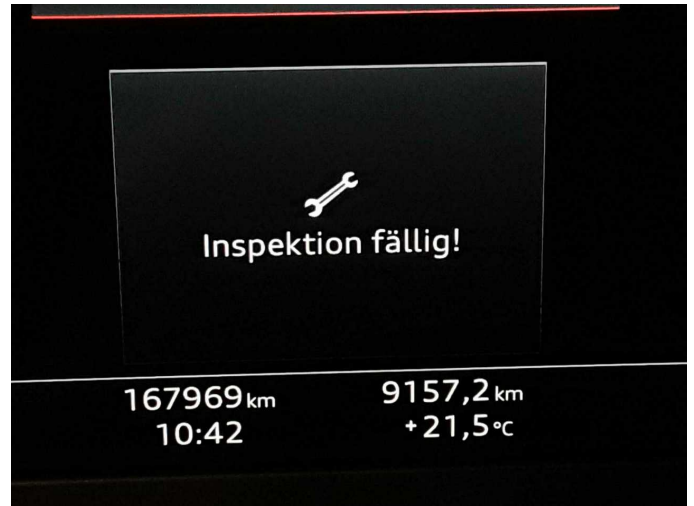
**Damage 2:** Misc.: Inspection / maintenance - Due - Perform

| No. | Component group | Description |
|---|---|---|
| 2 | Misc. | Inspection / maintenance - Due - Perform |

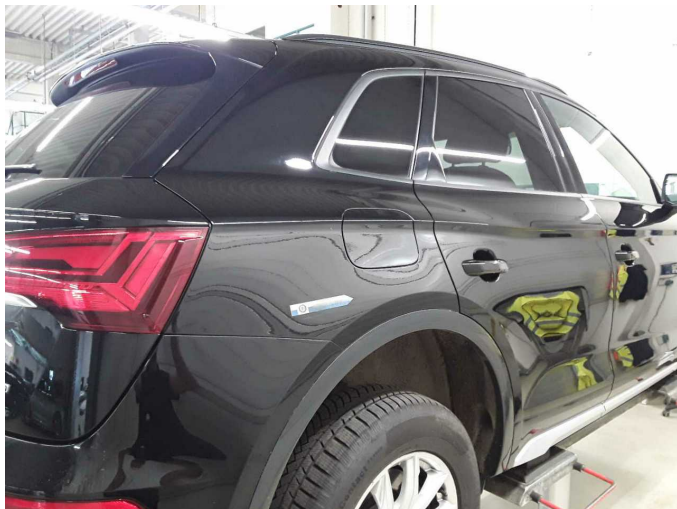
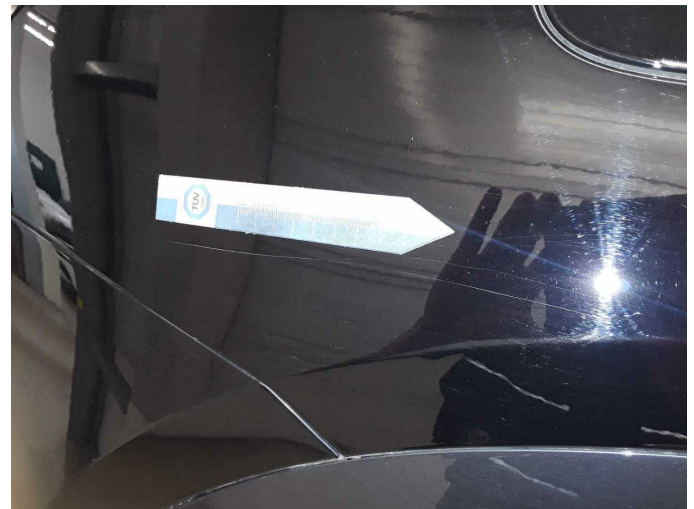
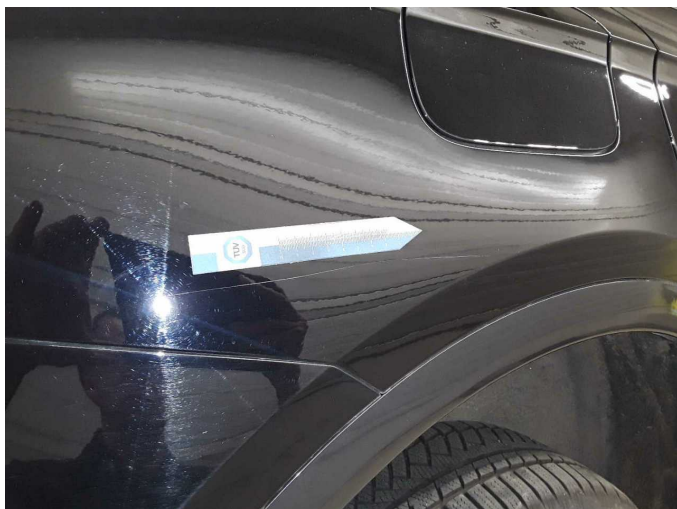
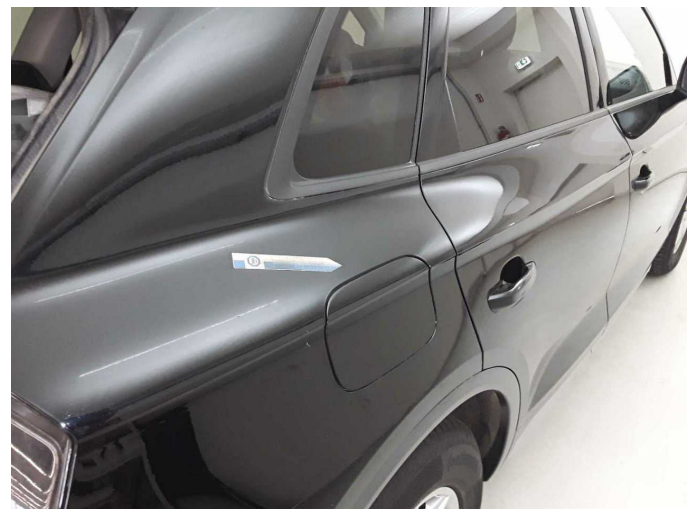
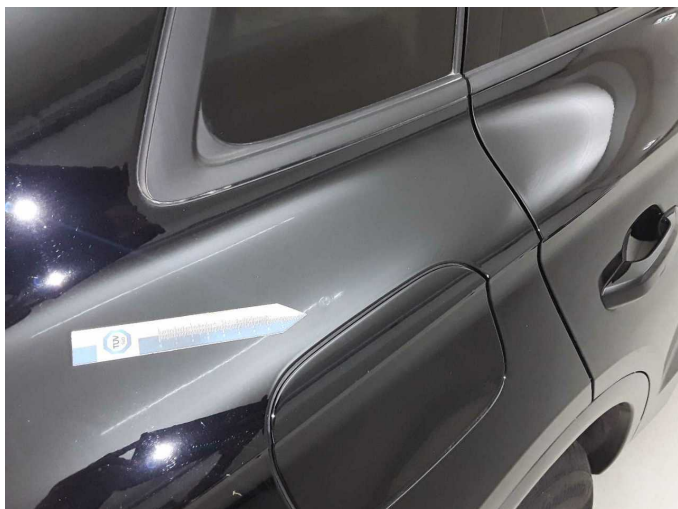
**Damage 3:** Side panel - rear right side: Side panel - Dent / paintcoat damage - Repair and paint

| No. | Component group | Description |
|---|---|---|
| 3 | Side panel - rear right side | Side panel - Dent / paintcoat damage - Repair and paint |

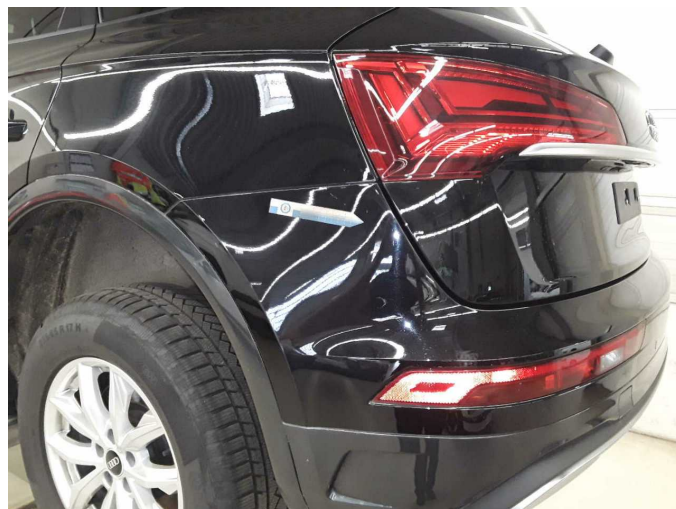
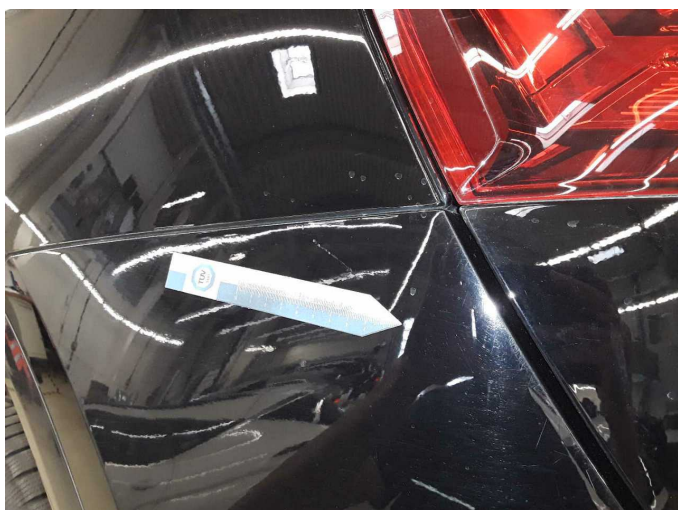
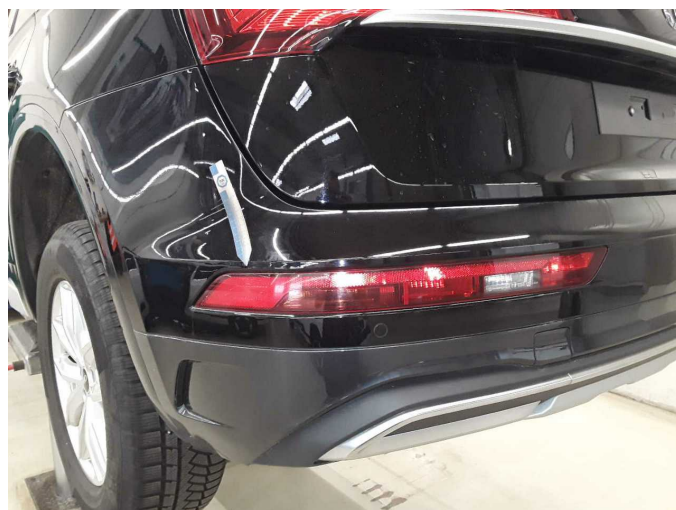
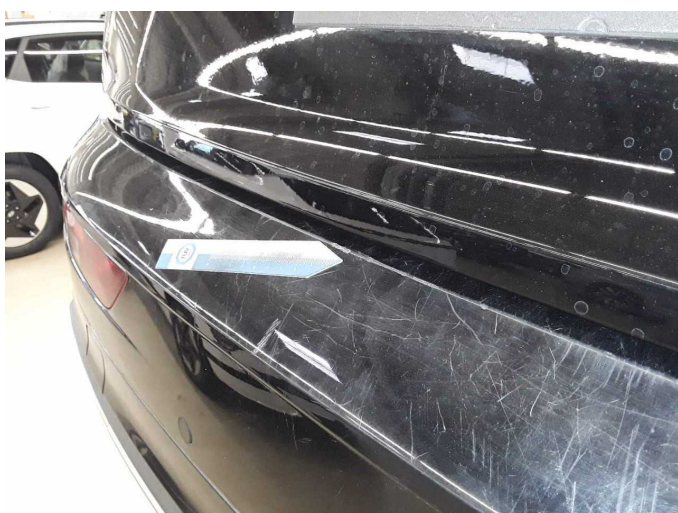
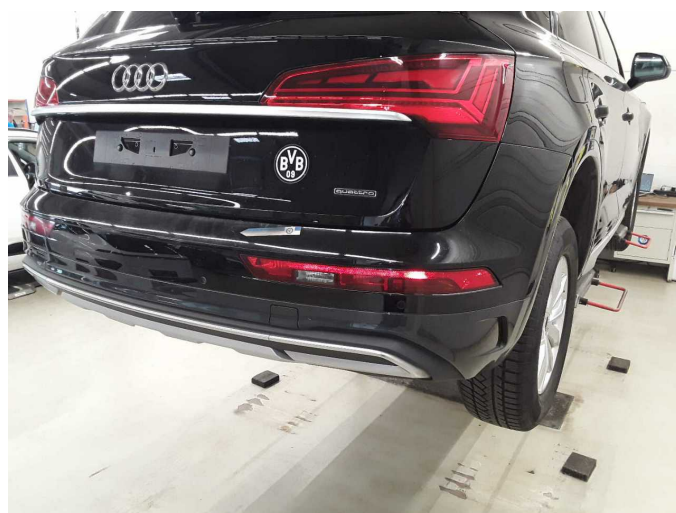
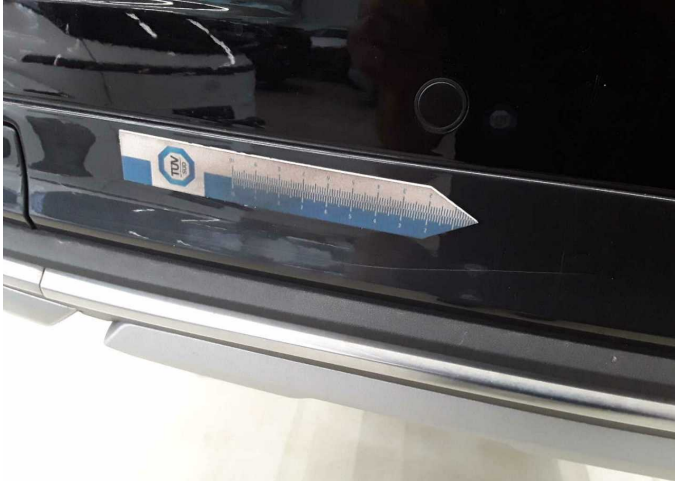
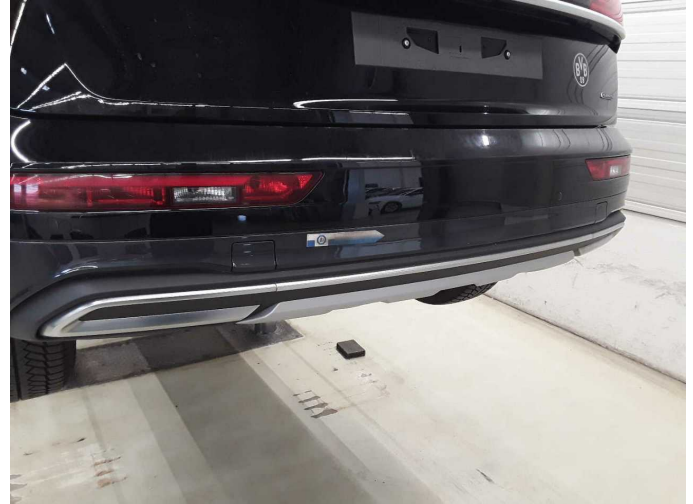
**Damage 4:** Rear bumper: Rear bumper (Incl. Blende grau) - Scratched - Repair and paint

| No. | Component group | Description |
|---|---|---|
| 4 | Rear bumper | Rear bumper (Incl. Blende grau) - Scratched - Repair and paint |

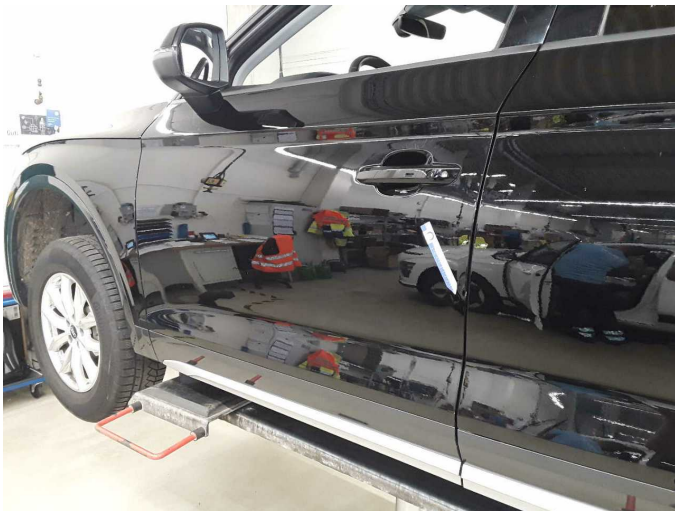
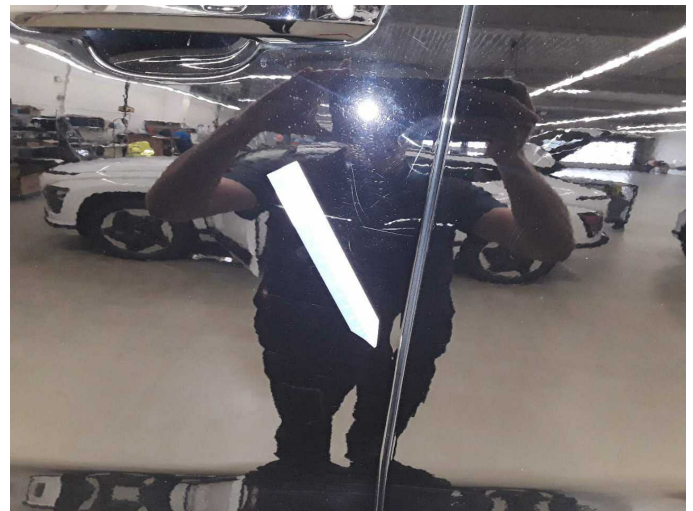
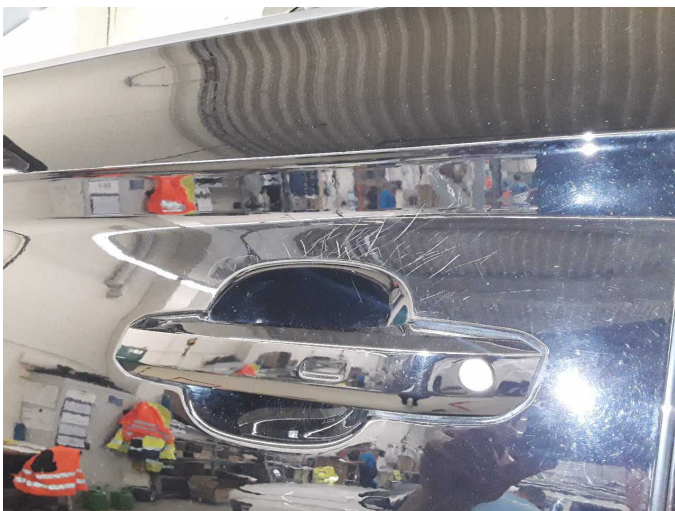
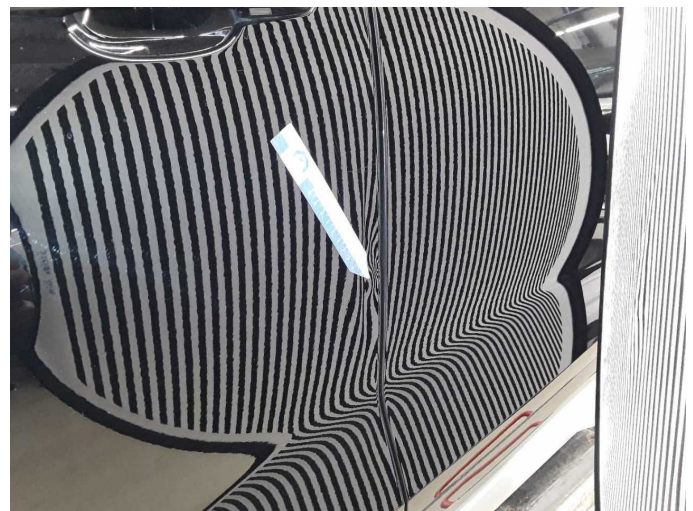
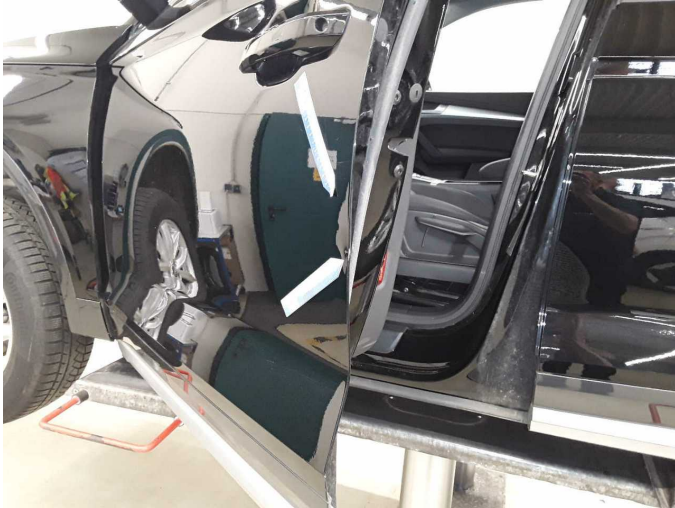
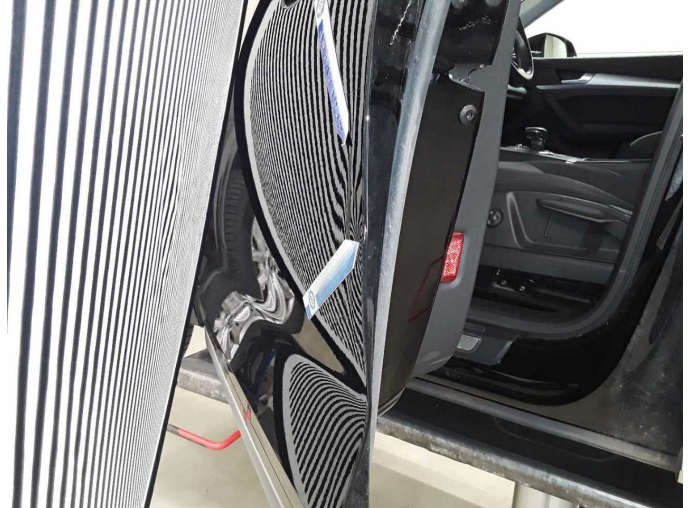
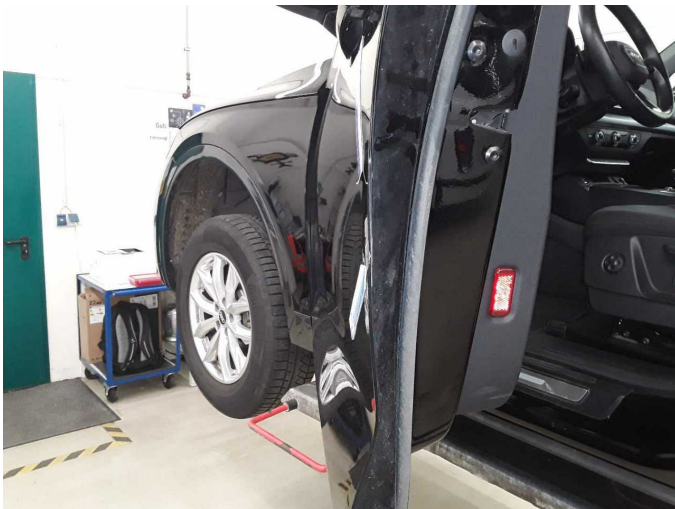
**Damage 5:** Door - front left side: Door - Dent / paintcoat damage - Repair and paint

| No. | Component group | Description |
|---|---|---|
| 5 | Door - front left side | Door - Dent / paintcoat damage - Repair and paint |

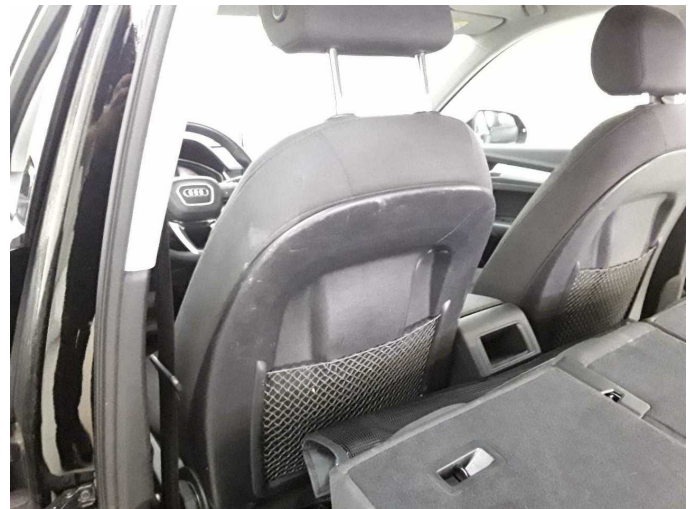
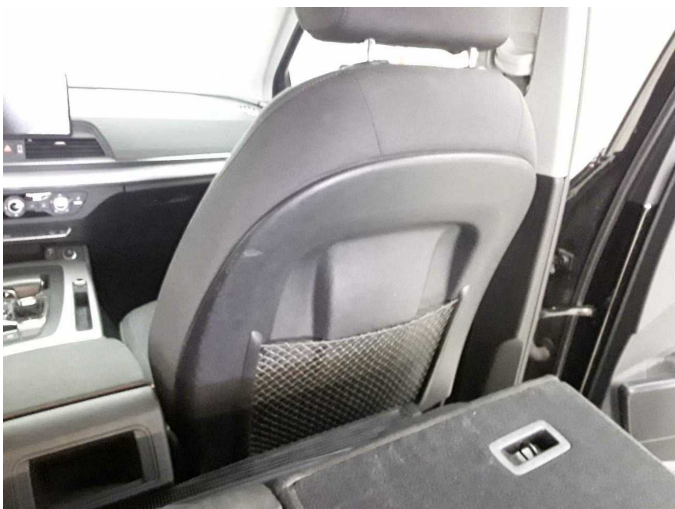
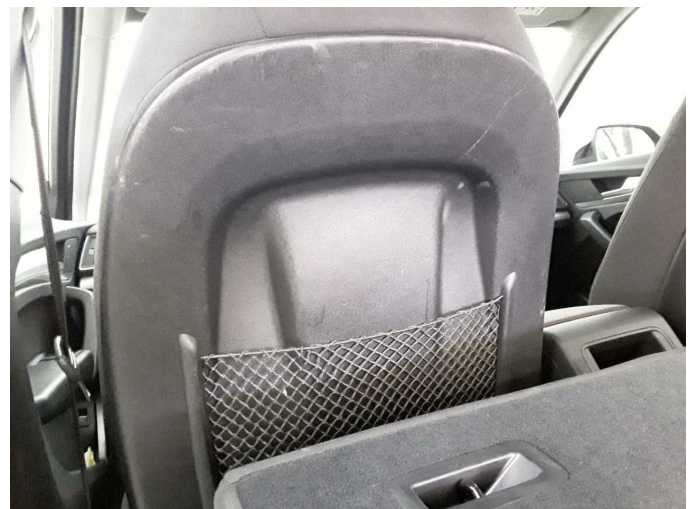
**Wear and tear 1:** Seat - front: Seat base trim - left side - Scratch(es) - No deduction

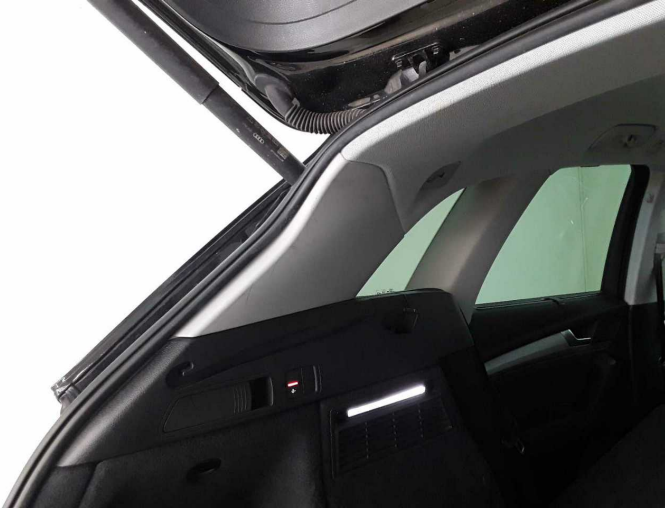
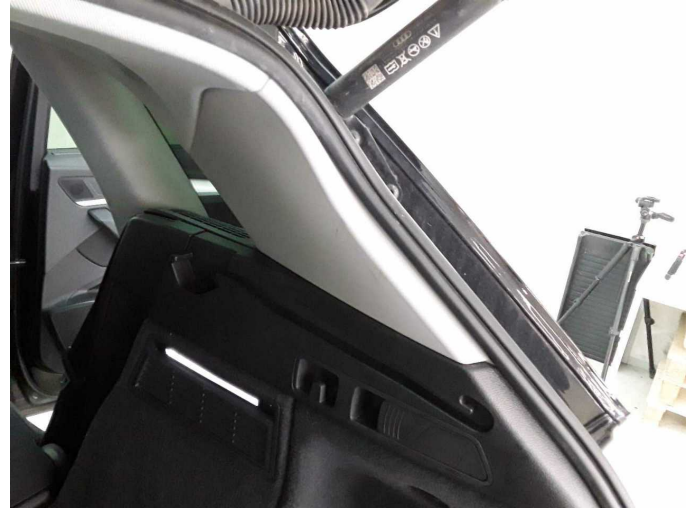
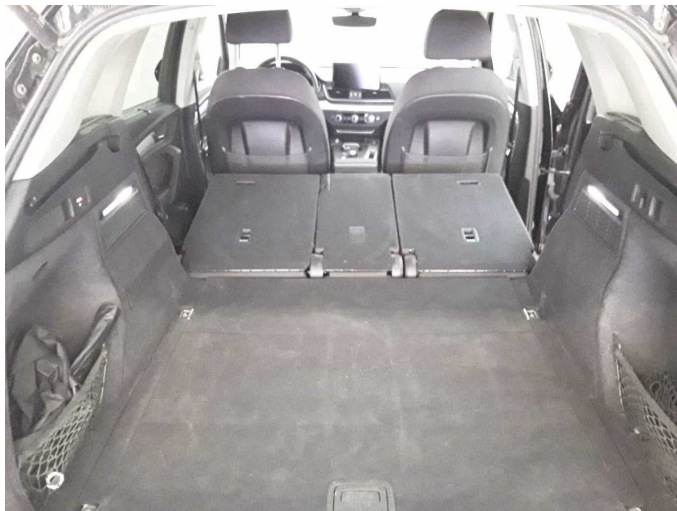
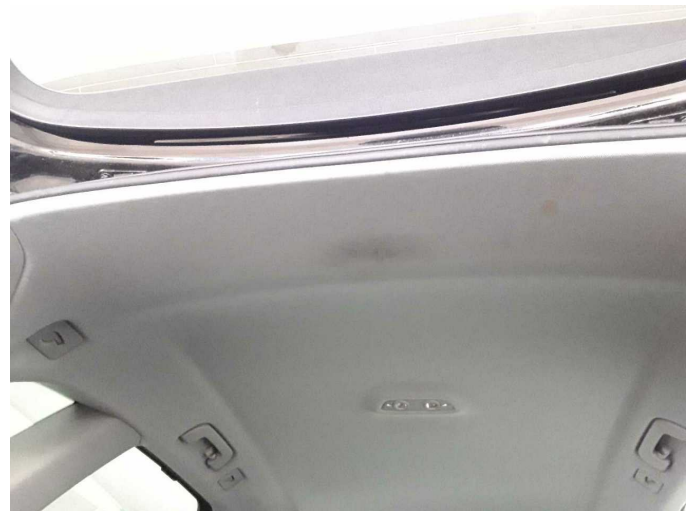
**Wear and tear 2:** Trim / covers: Boot lining - Scratch(es) - No deduction
