Expertise

Protocol number: 46443465  
Order No. / Reference: 26472861-1  
Inspection date: 26 Jun 2026

Model: Transporter T6.1 DSG 4MOTION Kurz

VIN: WV1ZZZ7H3PX039248

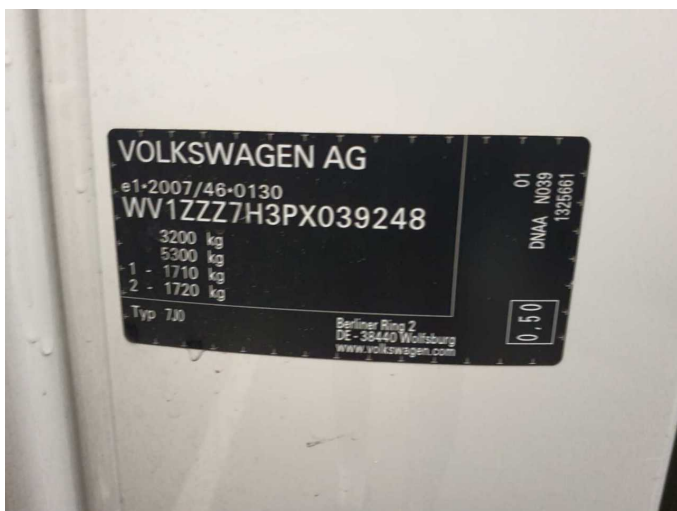
| VIN comparison | The vehicle identification number (VIN) was read from the vehicle and its conformity with the submitted documents was confirmed by the undersigned during the inspection. |

Figure 11: VIN

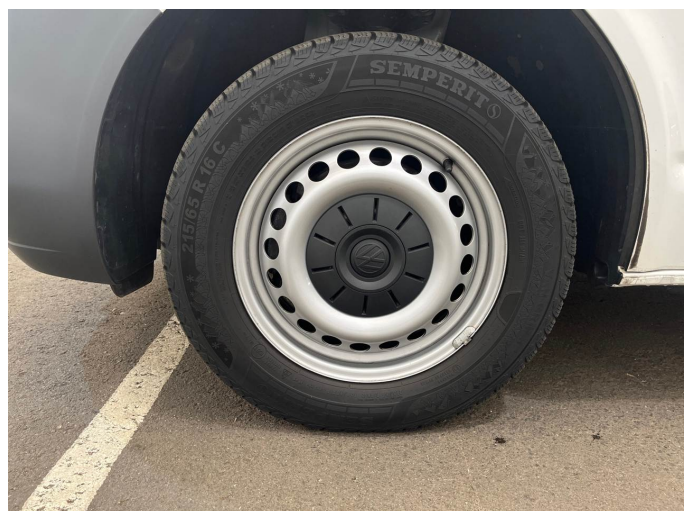
| # | Tyre size | Type of tyre | Manufacturer | Tread depth |
|---|---|---|---|---|
| 1) | 215/65 R16 107R | Winter tyres on Steel rim with wheel cover | Semperit | 9mm / 9mm |
| 2) | 215/65 R16 107R | Winter tyres on Steel rim with wheel cover | Semperit | 9mm / 9mm |

Figure 12: Mounted tyres

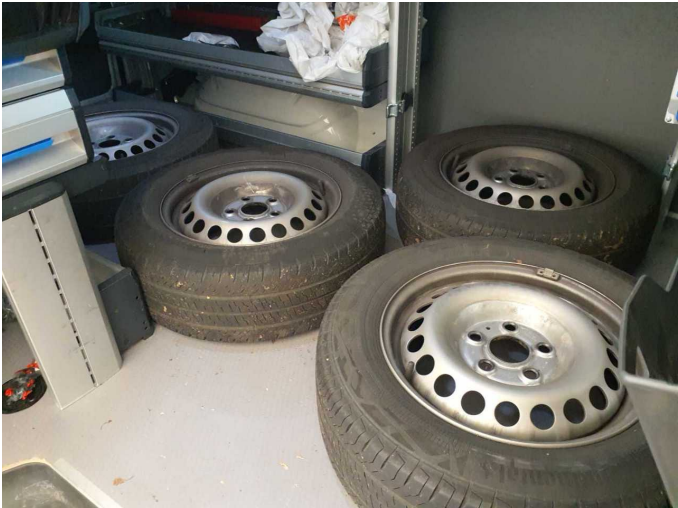
| # | Tyre size | Type of tyre | Manufacturer | Tread depth |
|---|---|---|---|---|
| 1) | 205/65 R16 103T | Summer tyres on Steel | Continental | 6mm / 6mm |
| 2) | 205/65 R16 103T | Summer tyres on Steel | Continental | 6mm / 6mm |

Figure 16: Additional tyres

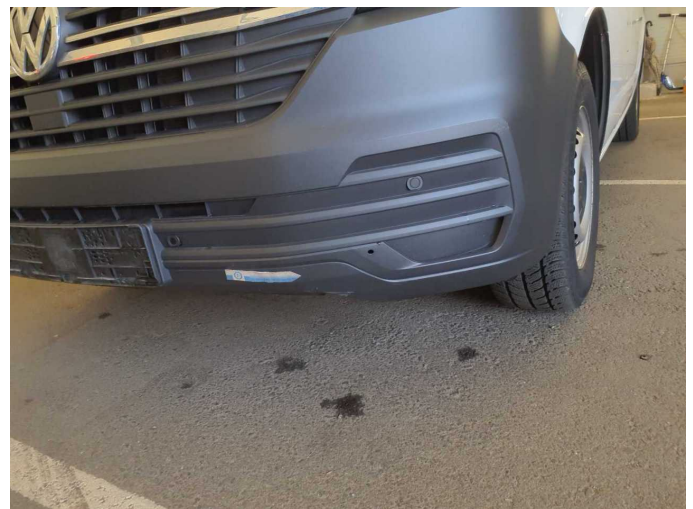
Damage 2: Front bumper: Front bumper - Scratch(es) - Loss in value

| No. | Component group | Description |
|---|---|---|
| 2 | Front bumper | Front bumper - Scratch(es) - Loss in value |

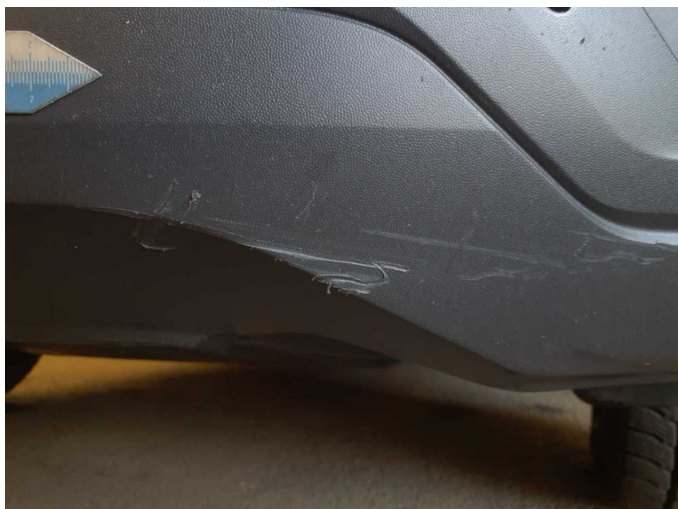
**Damage 2:** Front bumper: Front bumper - Scratch(es) - Loss in value

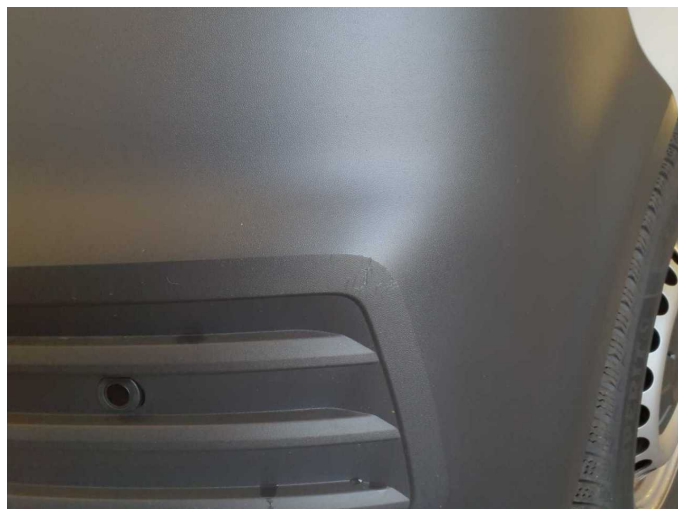
**Damage 2:** Front bumper: Front bumper - Scratch(es) - Loss in value
