Expertise

Protocol number: 46149217  
Order No. / Reference: 26381426  
Inspection date: 25 Jun 2026

Manufacturer: Skoda  
VIN: TMBJR9NP5P7040810

Model: Superb Combi 2.0 TDI DSG Sportline

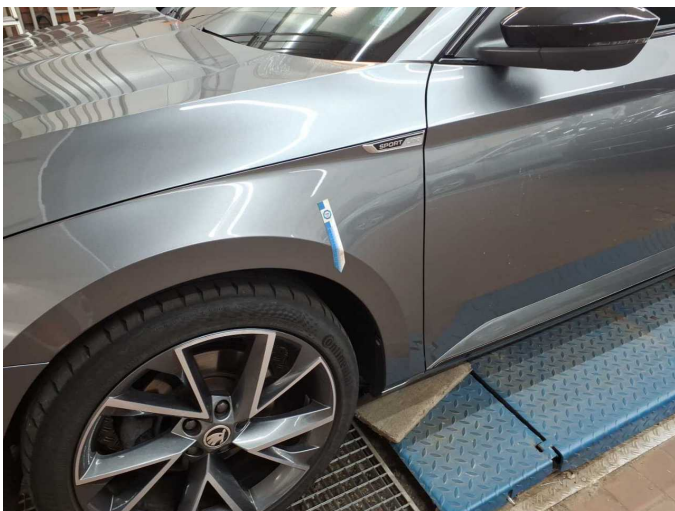
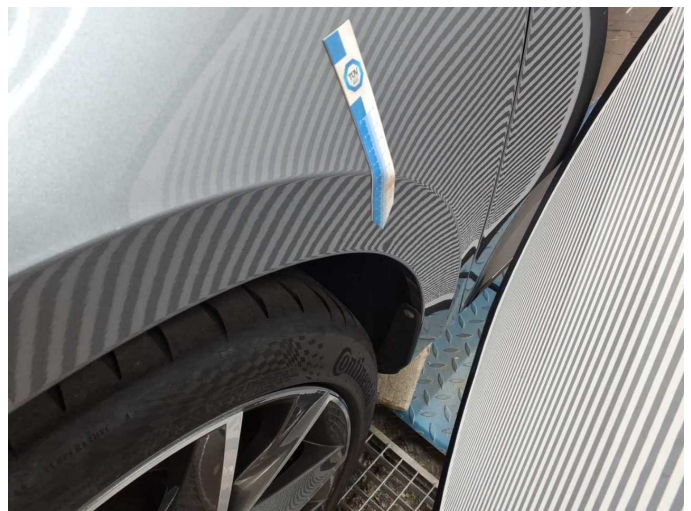
| No. | Component group | Description |
|---|---|---|
| 1 | Mudguard - left side | Mudguard - left side - dent(s) - Smooth repair work |

**Damage 1:** Mudguard - left side: Mudguard - left side - dent(s) - Smooth repair work

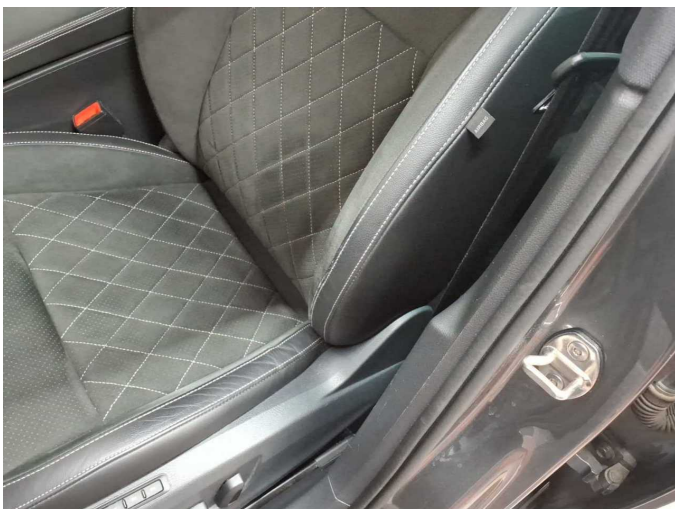
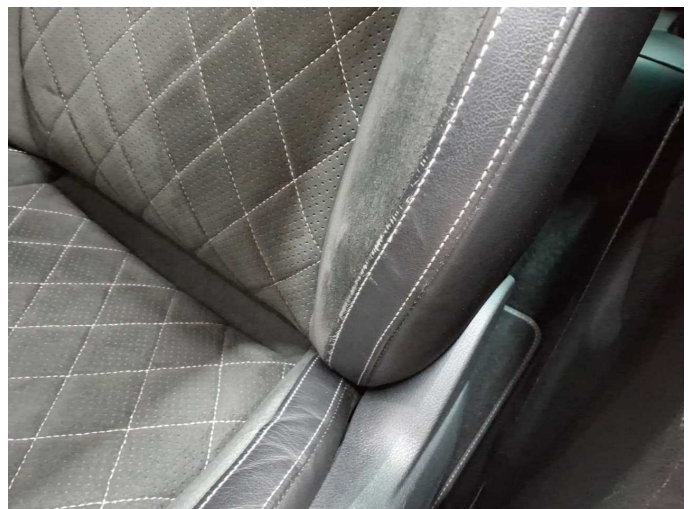
| No. | Component group | Description |
|---|---|---|
| 2 | Seat - front | Seat cover - left side - Abrasion - Loss in value |

**Damage 2:** Seat - front: Seat cover - left side - Abrasion - Loss in value

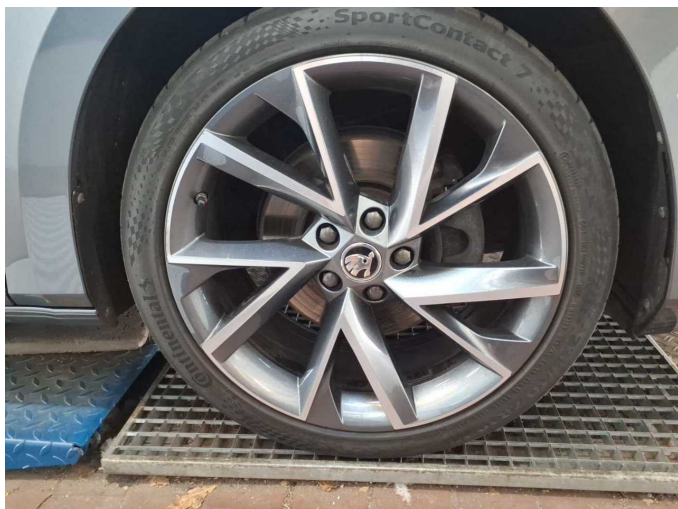
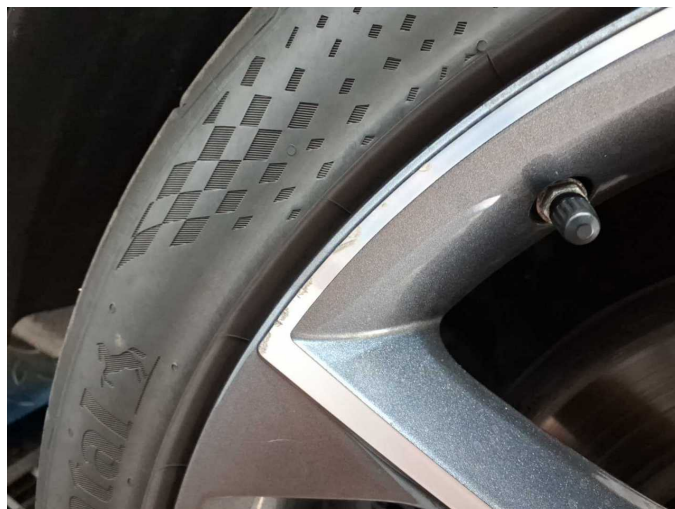
| No. | Component group | Description |
|---|---|---|
| 3 | Wheel / tyres | Alloy rim - front right side - Scratched - Loss in value |

**Damage 3:** Wheel / tyres: Alloy rim - front right side - Scratched - Loss in value

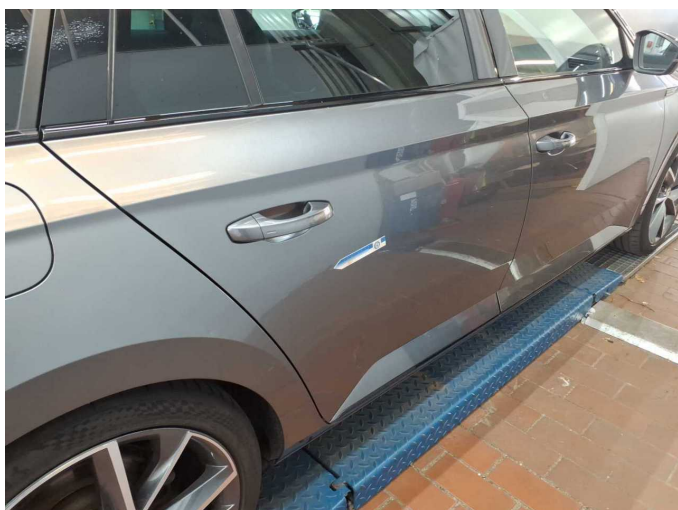
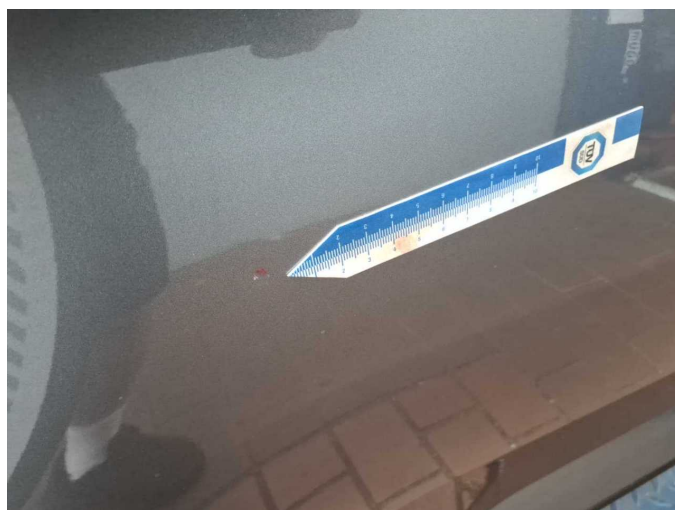
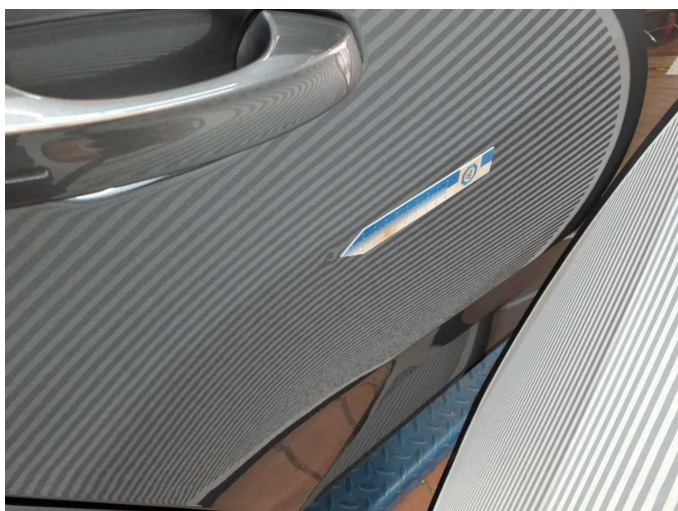
| No. | Component group | Description |
|---|---|---|
| 4 | Door - rear right side | Door - Dent / paintcoat damage - Repair and paint |

**Damage 4:** Door - rear right side: Door - Dent / paintcoat damage - Repair and paint

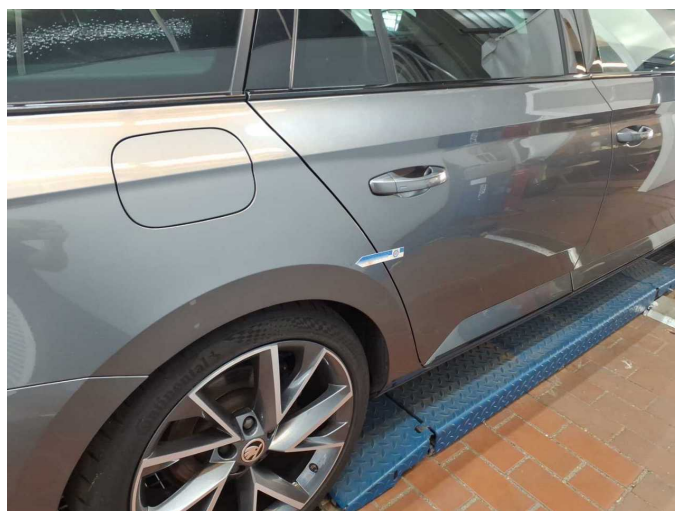
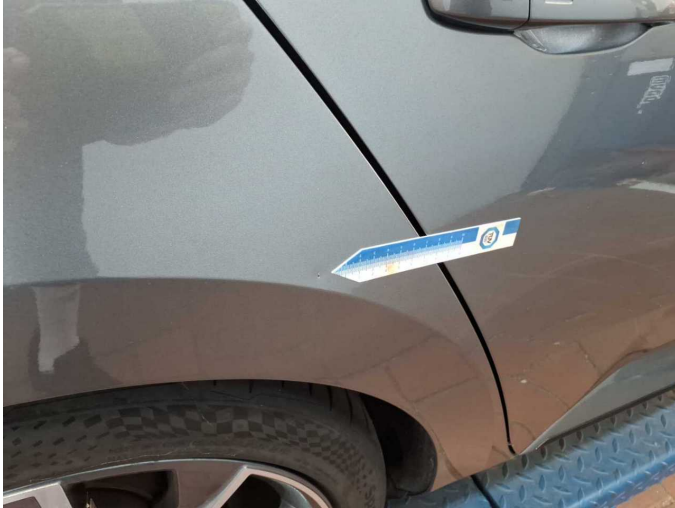
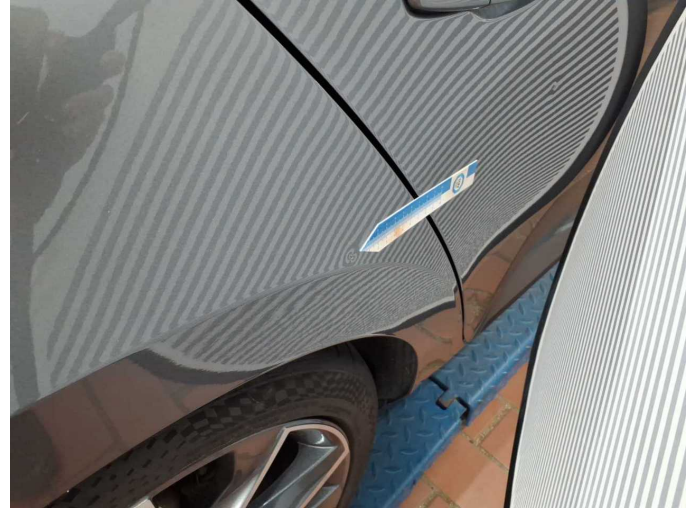
| No. | Component group | Description |
|---|---|---|
| 5 | Side panel - rear right side | Side panel - Dent / paintcoat damage - Repair and paint |

**Damage 5:** Side panel - rear right side: Side panel - Dent / paintcoat damage - Repair and paint
