Expertise

Protocol number: 46631610  
Order No. / Reference: 26536854  
Inspection date: 22 Jul 2026

Manufacturer: Lexus  
VIN: JTJCKBFZ702030333

Model: NX 450h+ E-FOUR Luxury-Paket

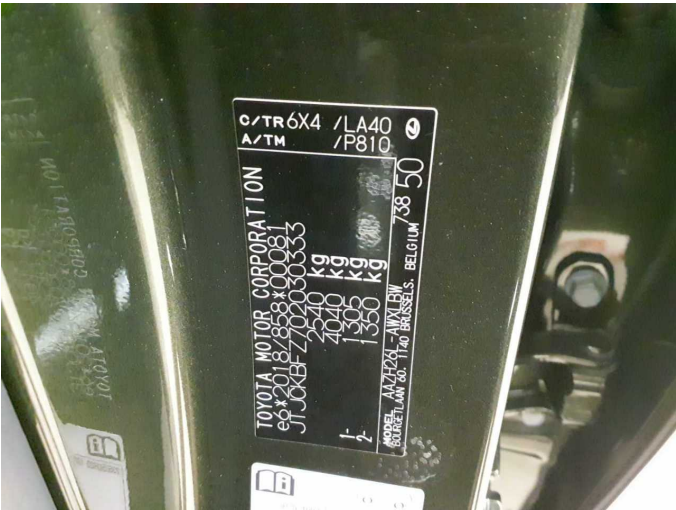
Figure 11: VIN

| VIN comparison | The vehicle identification number (VIN) was read from the vehicle and its conformity with the submitted documents was confirmed by the undersigned during the inspection. |

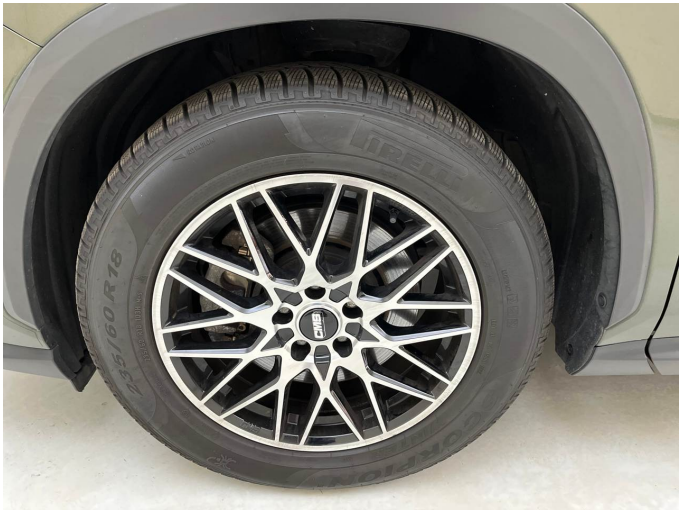
Figure 12: Mounted tyres

| # | Tyre size | Type of tyre | Manufacturer | Tread depth |
|---|---|---|---|---|
| 1) | 235/60 R18 103H | Winter tyres on Light alloy | Pirelli | 5mm / 5mm |
| 2) | 235/60 R18 103H | Winter tyres on Light alloy | Pirelli | 7mm / 7mm |

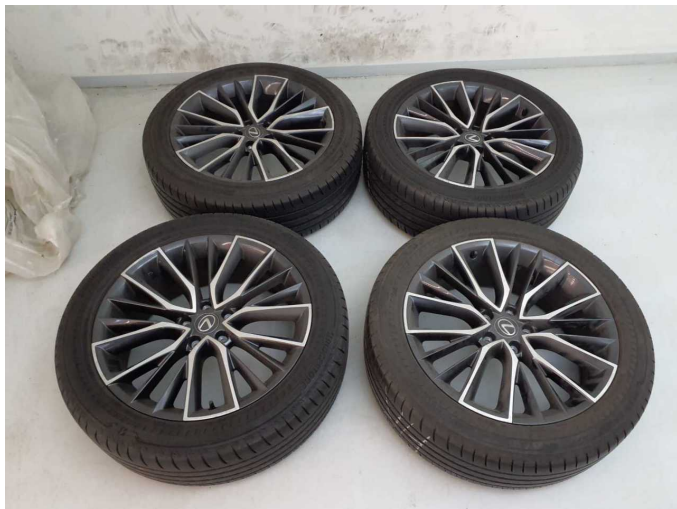
Figure 15: Additional tyres

| # | Tyre size | Type of tyre | Manufacturer | Tread depth |
|---|---|---|---|---|
| 1) | 235/50 R20 100V | Summer tyres on Light alloy | Bridgestone | 6mm / 6mm |
| 2) | 235/50 R20 100V | Summer tyres on Light alloy | Bridgestone | 6mm / 6mm |

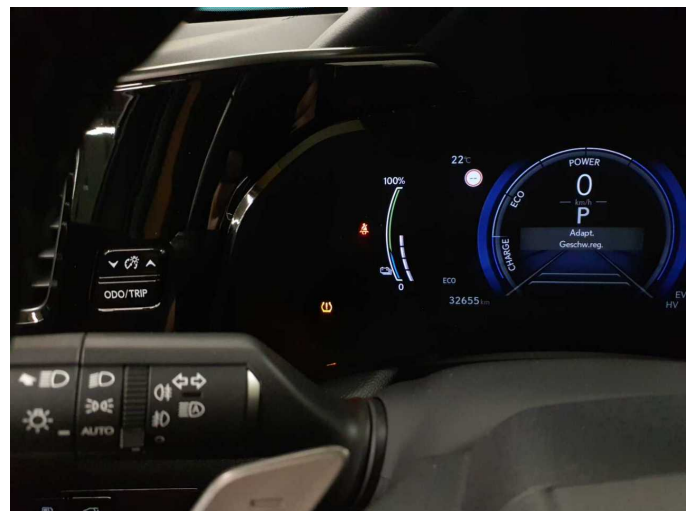
Damage 1: Instrument panel: Indicator light (Reifendruckkontrollsystem) - on - Perform diagnosis

| No. | Component group | Description |
|---|---|---|
| 1 | Instrument panel | Indicator light (Reifendruckkontrollsystem) - on - Perform diagnosis |

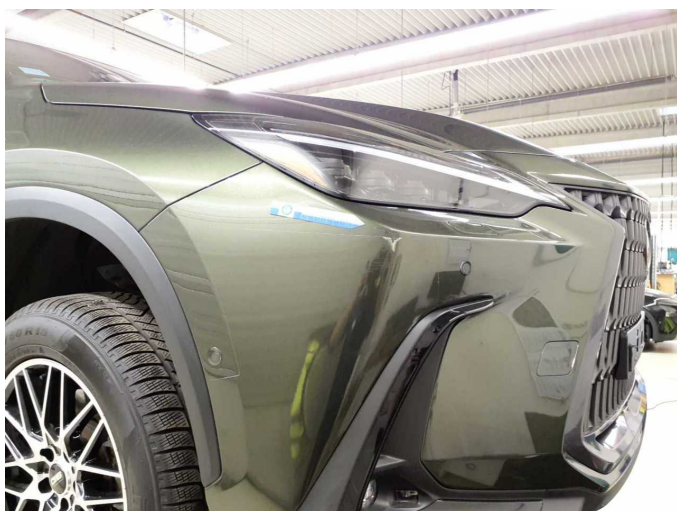
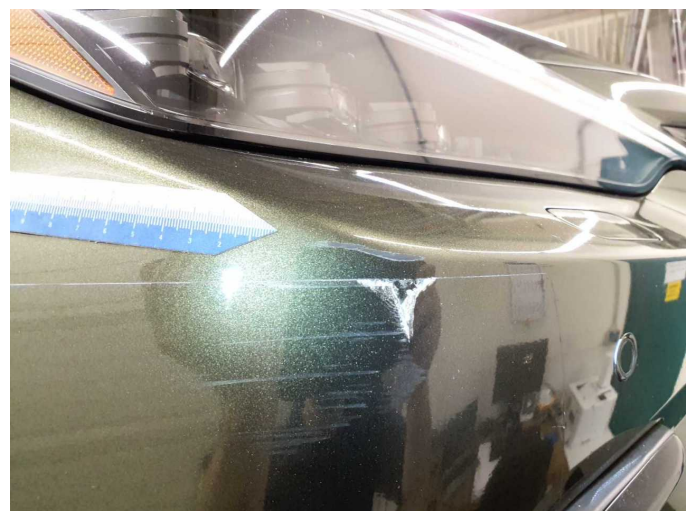
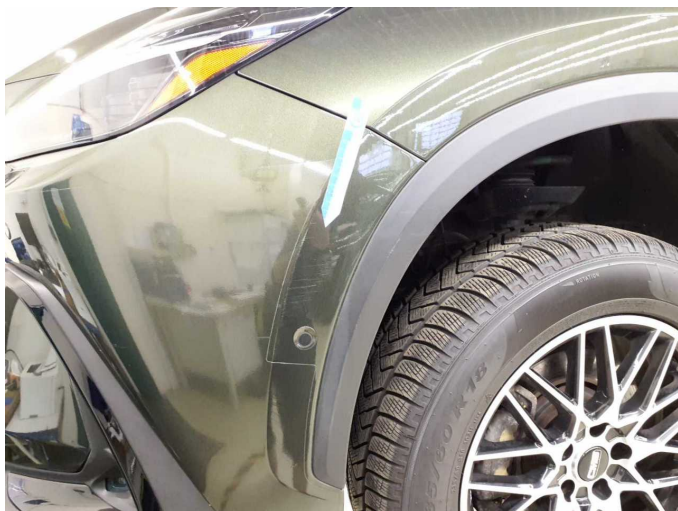
Damage 2: Front bumper: Bumper with Parktronic - Scratched - Smart repair

**Damage 2:** Front bumper: Bumper with Parktronic - Scratched - Smart repair

| No. | Component group | Description |
|---|---|---|
| 2 | Front bumper | Bumper with Parktronic - Scratched - Smart repair |

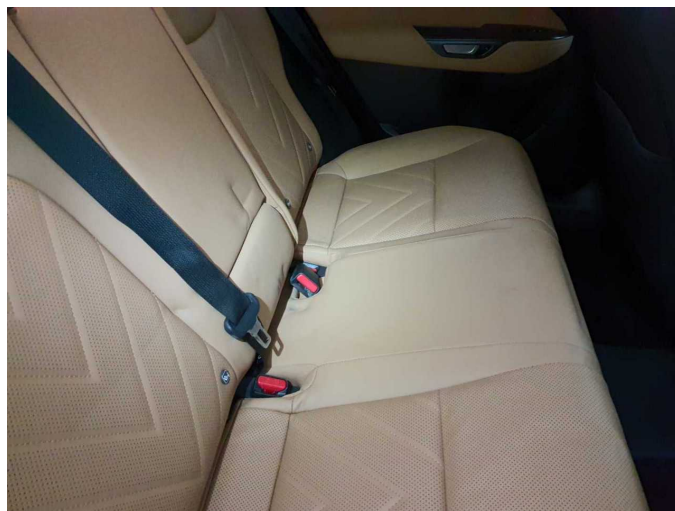
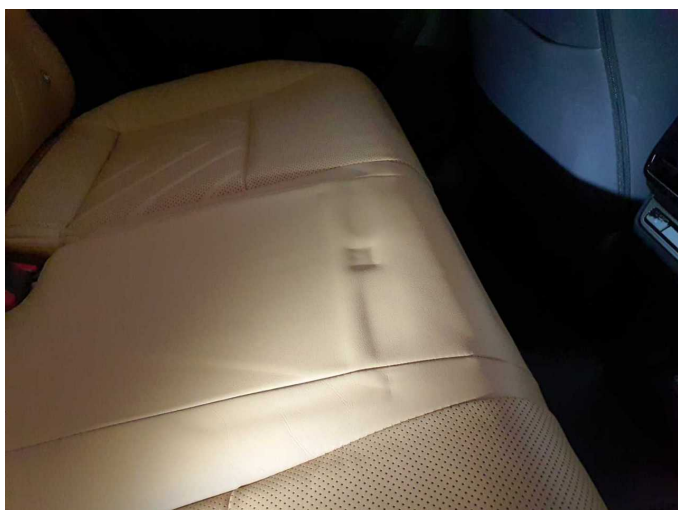
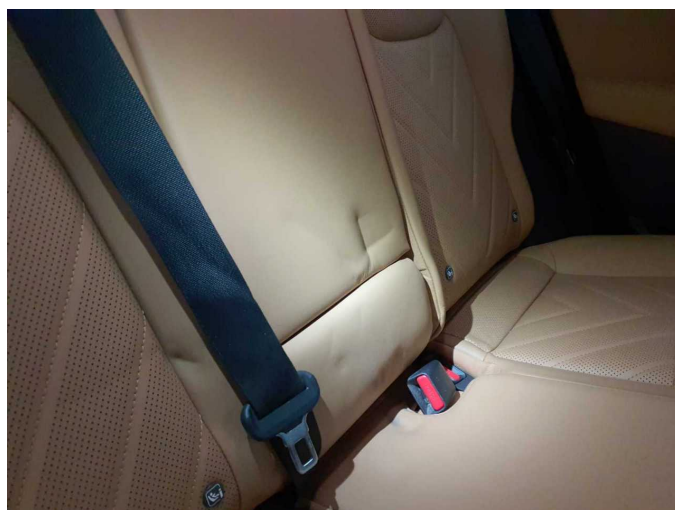
**Damage 3:** Seat - rear: Back seat - Deformed - Smart repair

| No. | Component group | Description |
|---|---|---|
| 3 | Seat - rear | Back seat - Deformed - Smart repair |

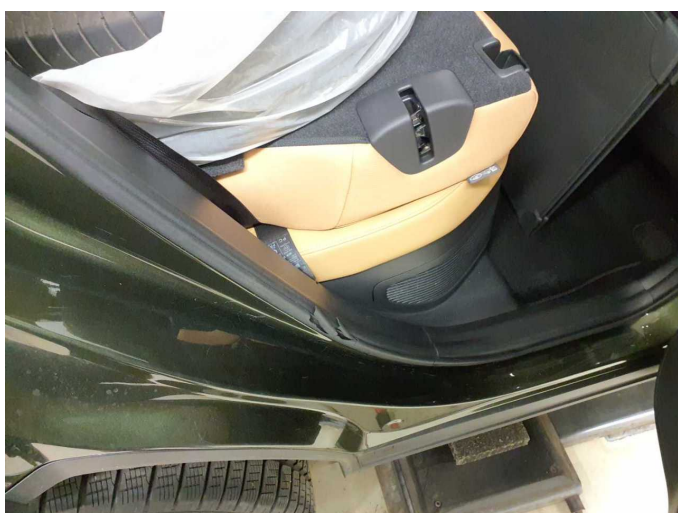
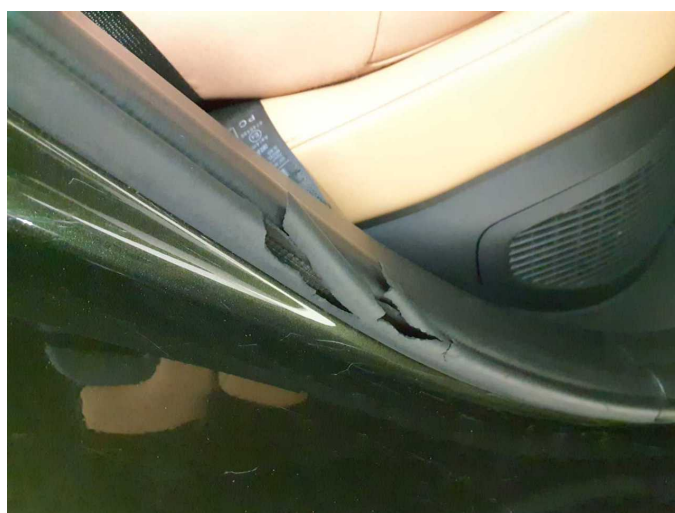
**Damage 4:** Door - rear right side: Door seal - Broken / torn - Replace

| No. | Component group | Description |
|---|---|---|
| 4 | Door - rear right side | Door seal - Broken / torn - Replace |

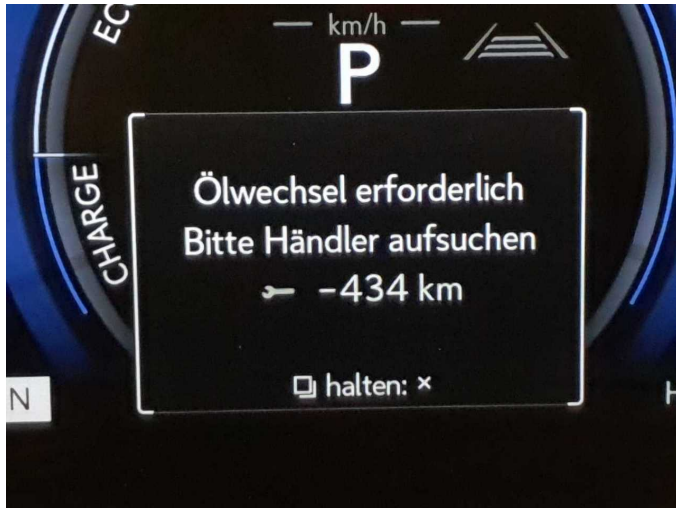
**Damage 5:** Misc.: Inspection / maintenance - Due - Perform

| No. | Component group | Description |
|---|---|---|
| 5 | Misc. | Inspection / maintenance - Due - Perform |
