Expertise

Protocol number: 46900875  
Order No. / Reference: 26768106  
Inspection date: 5 Aug 2026

Manufacturer: Volkswagen

Model: Tiguan Allspace 2.0 TDI SCR 4Motion DSG R-Line

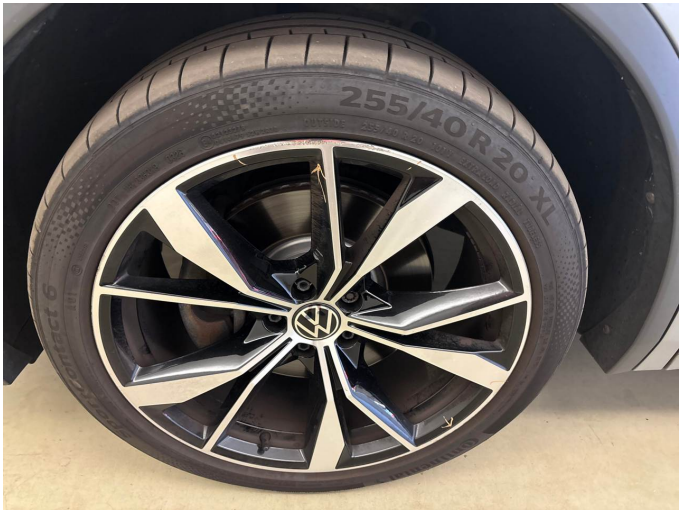
| # | Tyre size | Type of tyre | Manufacturer | Tread depth |
|---|---|---|---|---|
| 1) | 255/40 R20 101Y | Summer tyres on Light alloy | Continental | 5mm / 5mm |
| 2) | 255/40 R20 101Y | Summer tyres on Light alloy | Continental | 6mm / 6mm |

Figure 12: Mounted tyres

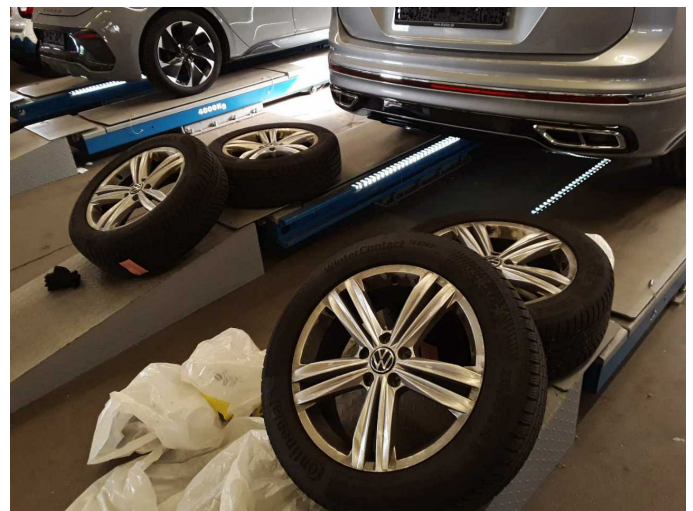
| # | Tyre size | Type of tyre | Manufacturer | Tread depth |
|---|---|---|---|---|
| 1) | 235/55 R18 100H | Winter tyres on Light alloy | Continental | 5mm / 5mm |
| 2) | 235/55 R18 100H | Winter tyres on Light alloy | Continental | 6mm / 6mm |

Figure 16: Additional tyres

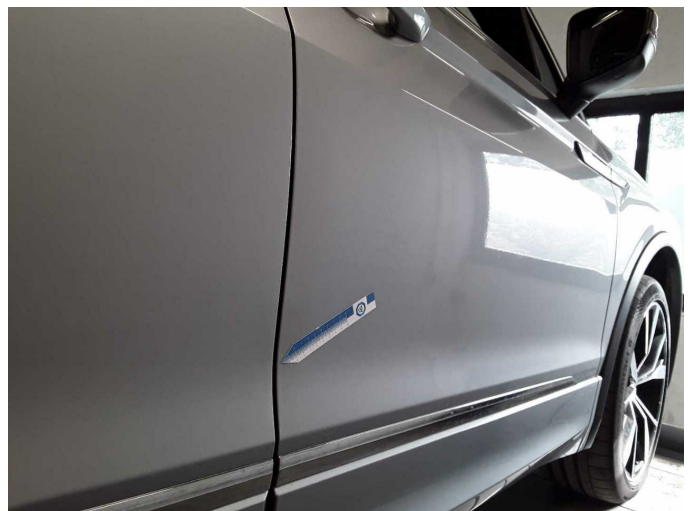
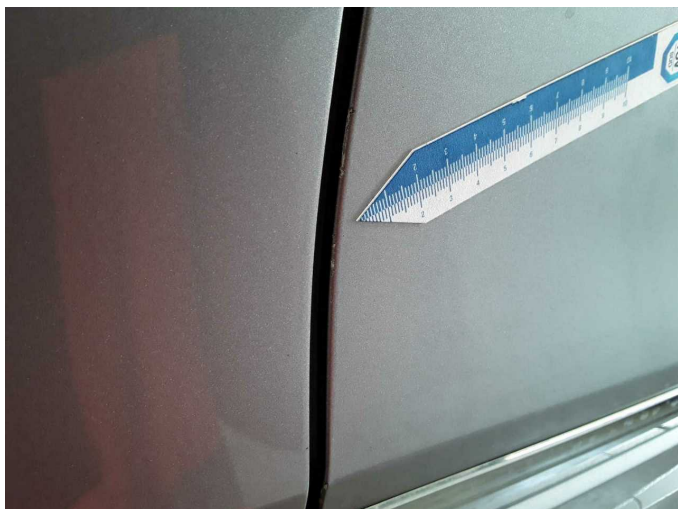
| No. | Component group | Description |
|---|---|---|
| 1 | Door - front right side | Door edge - Scratched - Smart repair |

Damage 1: Door - front right side: Door edge - Scratched - Smart repair

**Damage 1:** Door - front right side: Door edge - Scratched - Smart repair

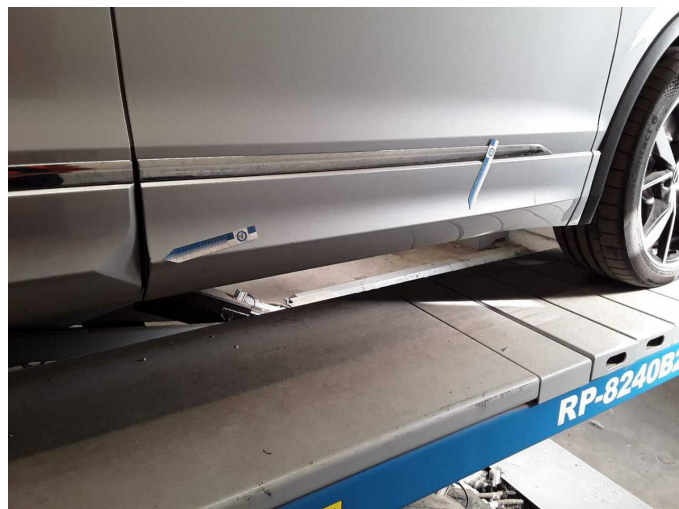
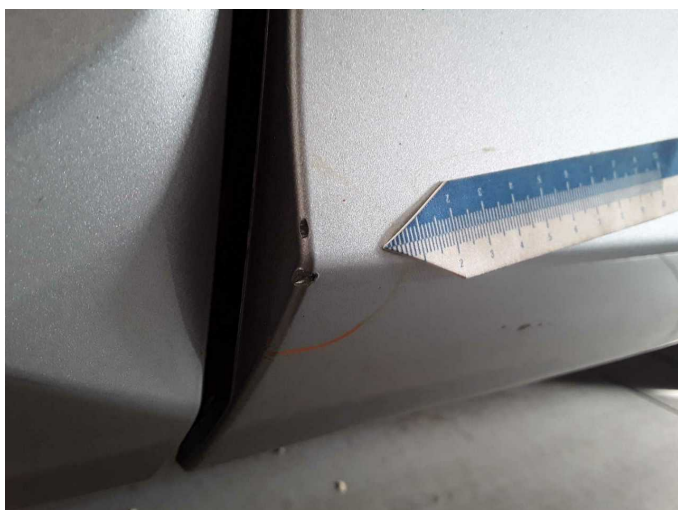
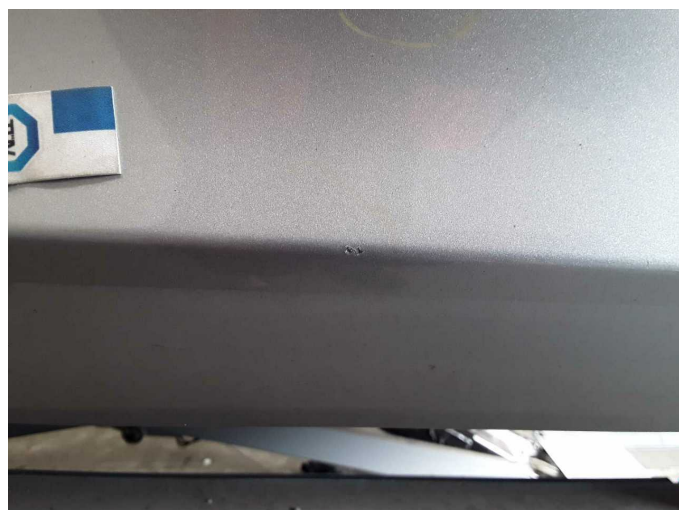
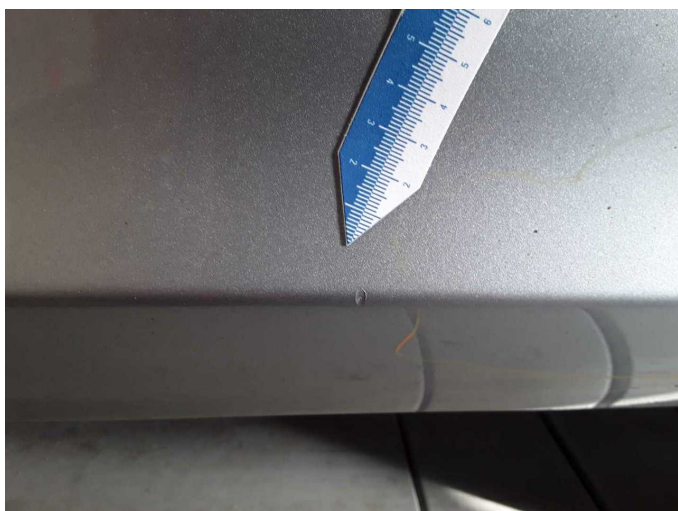
| No. | Component group | Description |
|---|---|---|
| 2 | Door - front right side | Brightware - lower - Scratch(es) - Paint |

**Damage 2:** Door - front right side: Brightware - lower - Scratch(es) - Paint

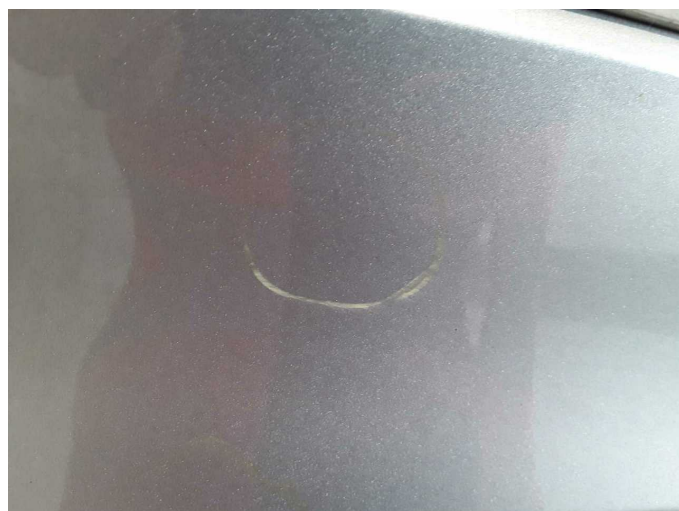
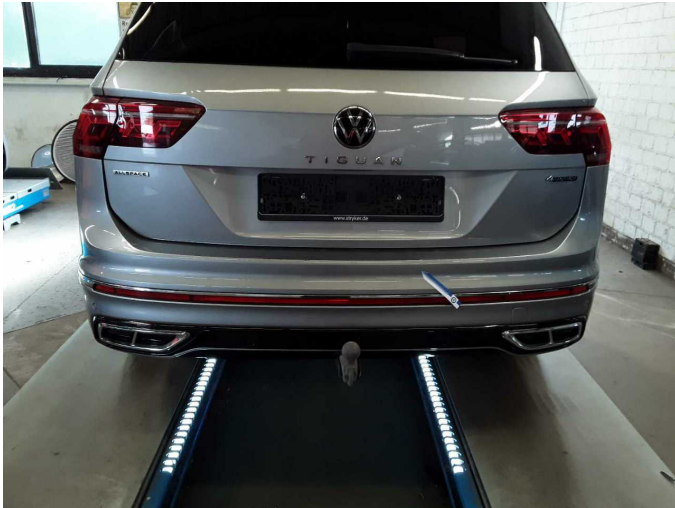
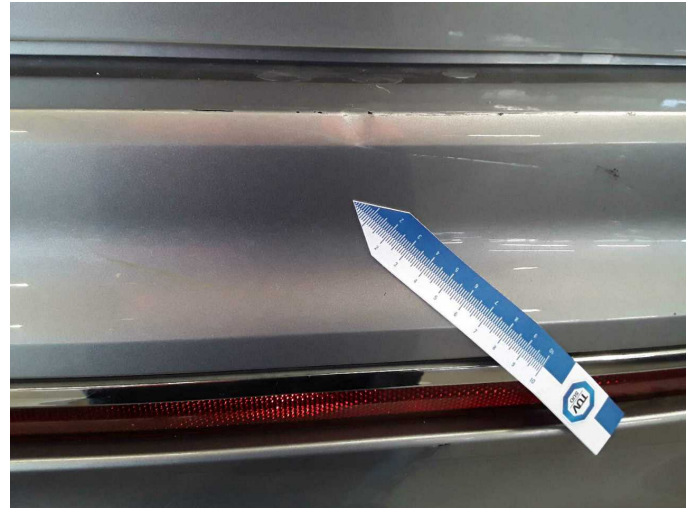
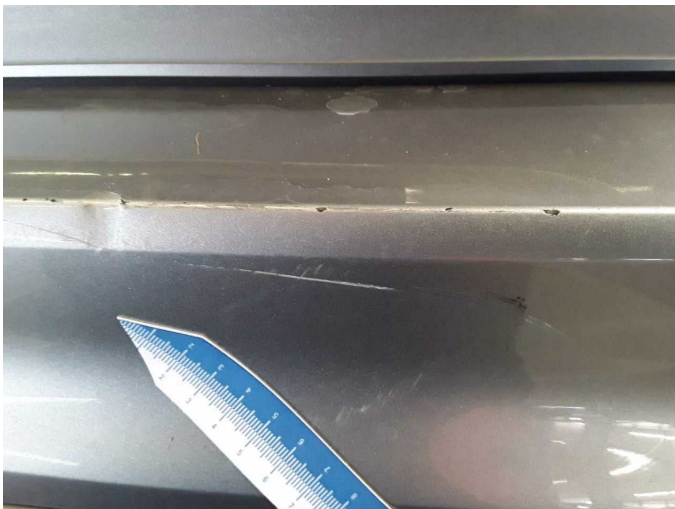
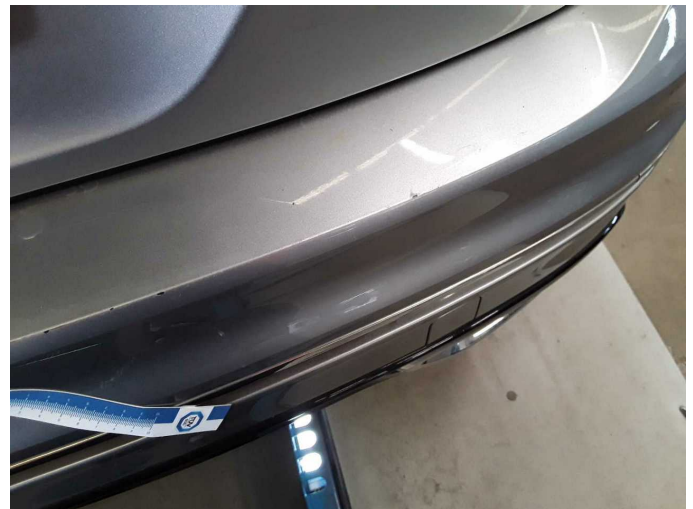
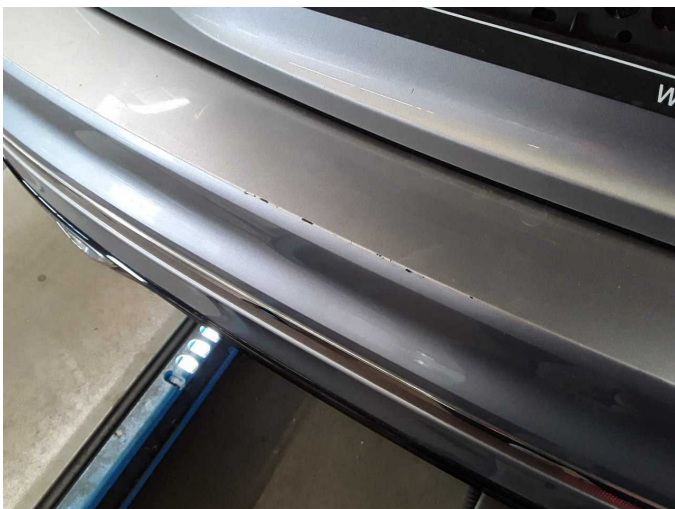
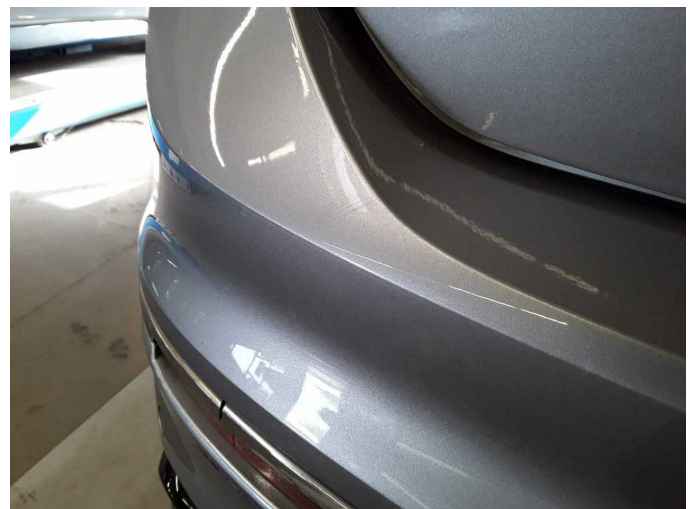
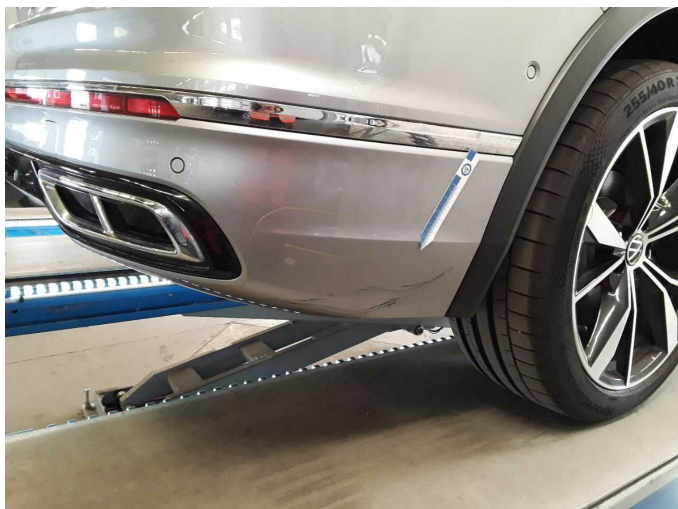
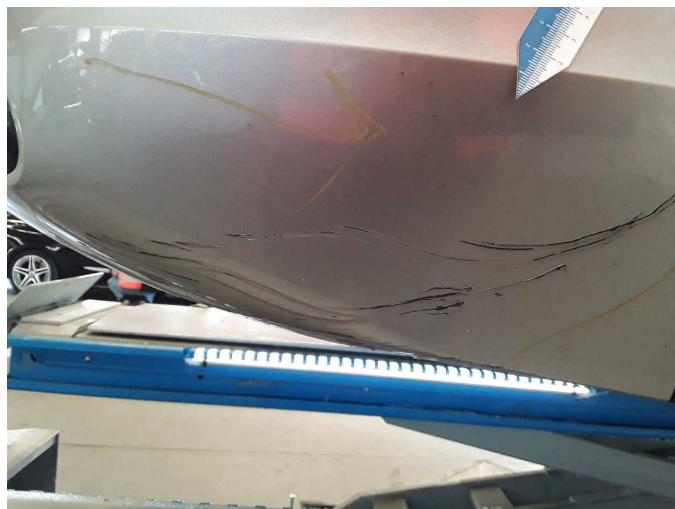
| No. | Component group | Description |
|---|---|---|
| 3 | Rear bumper | Rear bumper - Scratched - Paint |

**Damage 2:** Door - front right side: Brightware - lower - Scratch(es) - Paint

**Damage 3:** Rear bumper: Rear bumper - Scratched - Paint

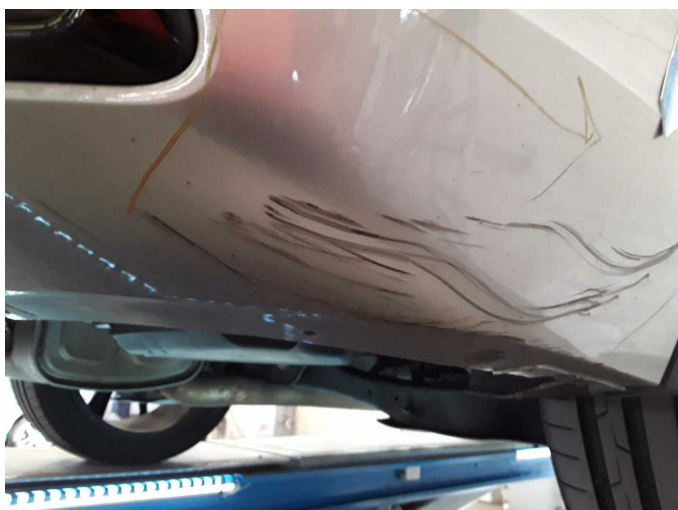
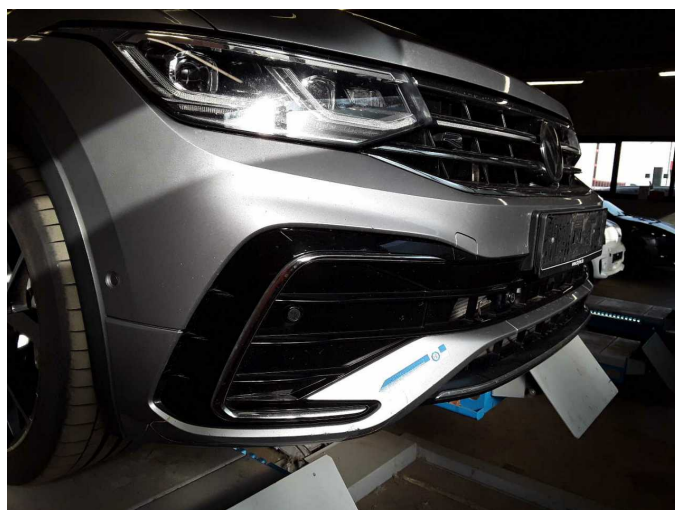
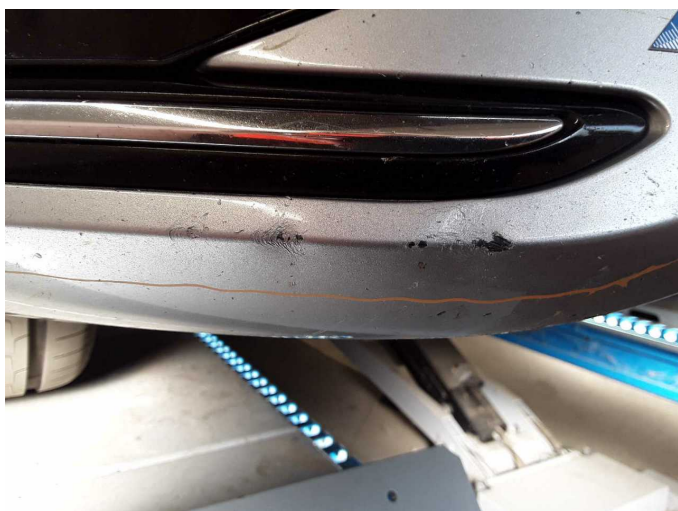
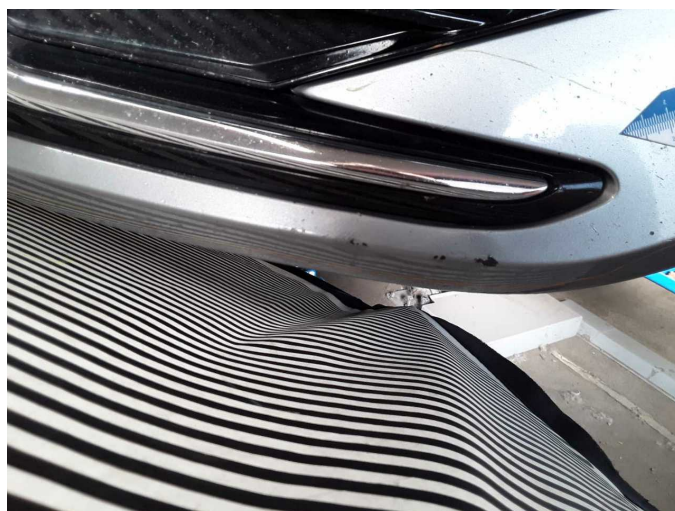
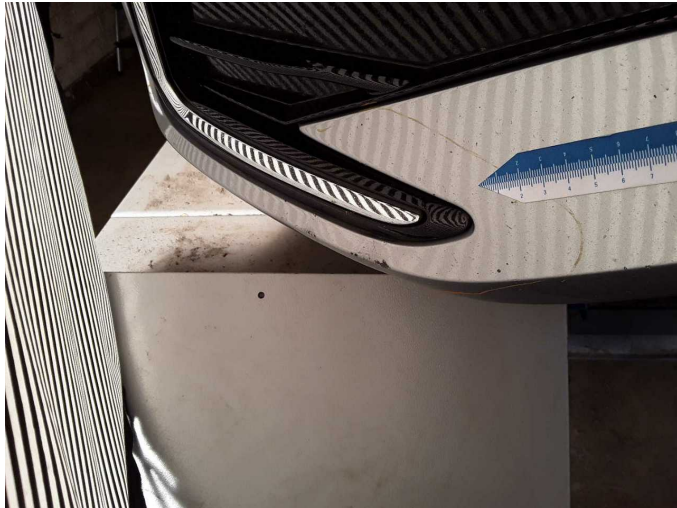
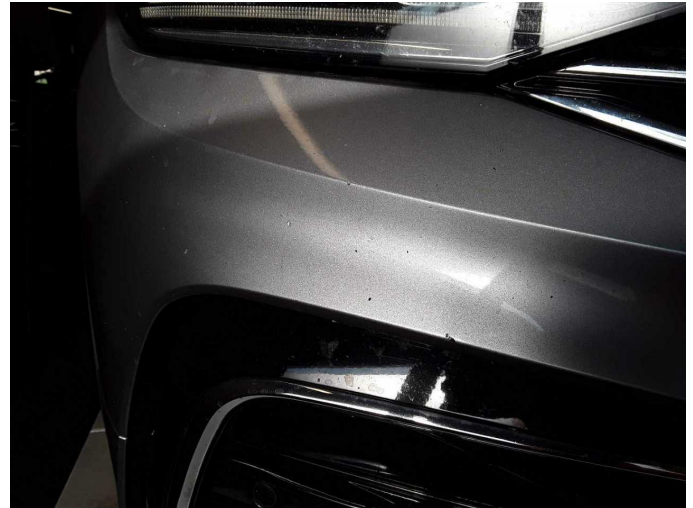
| No. | Component group | Description |
|---|---|---|
| 4 | Front bumper | Front bumper - Dent / paintcoat damage - Repair and paint |

**Damage 3:** Rear bumper: Rear bumper - Scratched - Paint

**Damage 4:** Front bumper: Front bumper - Dent / paintcoat damage - Repair and paint

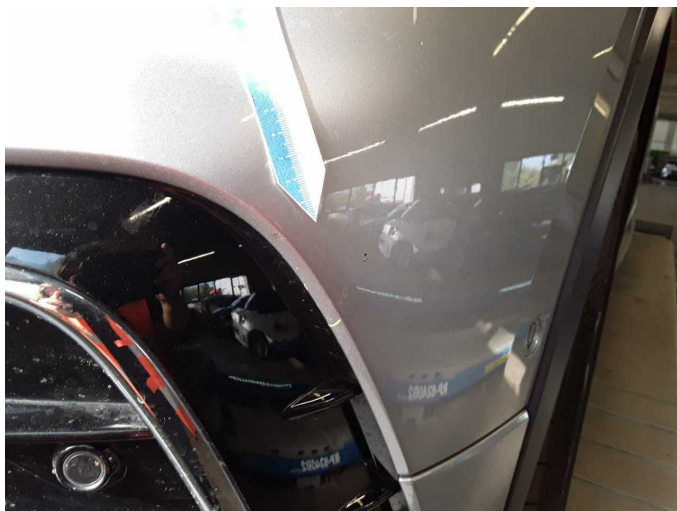
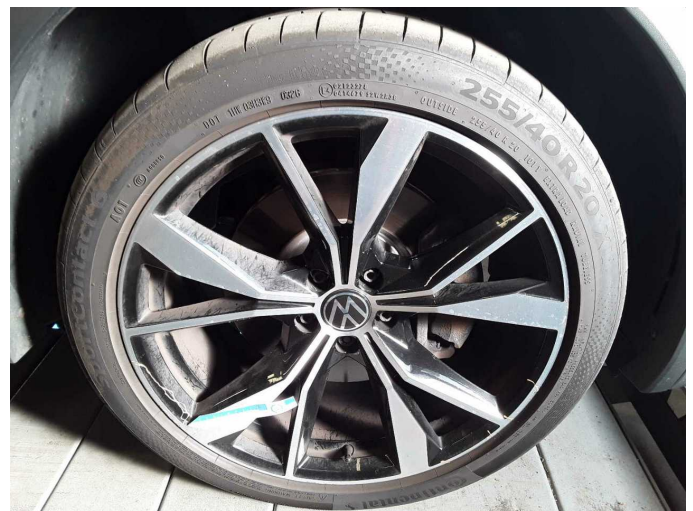
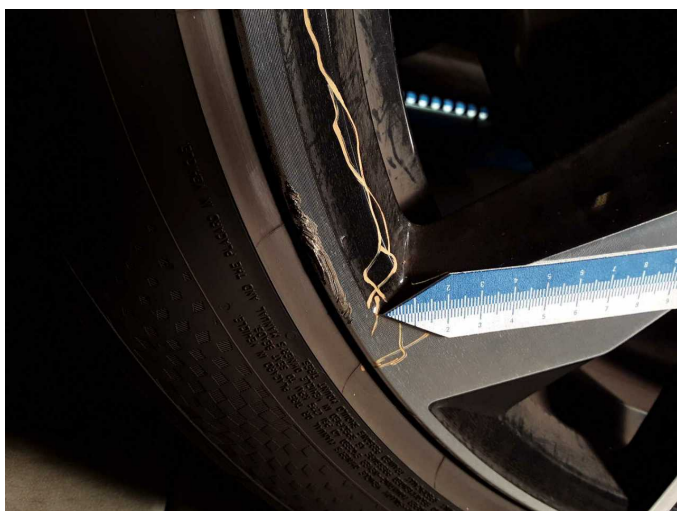
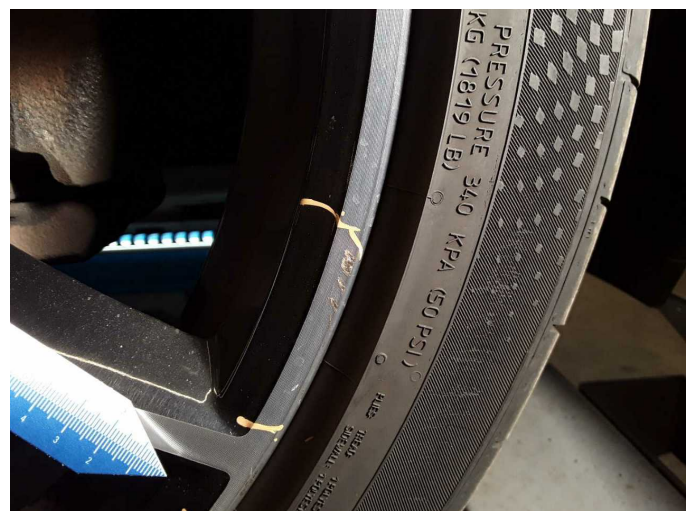
| No. | Component group | Description |
|---|---|---|
| 5 | Wheel / tyres | Alloy rim - front right side (Materialabtrag) - Scratched - Replace |

**Damage 4:** Front bumper: Front bumper - Dent / paintcoat damage - Repair and paint

**Damage 5:** Wheel / tyres: Alloy rim - front right side (Materialabtrag) - Scratched - Replace

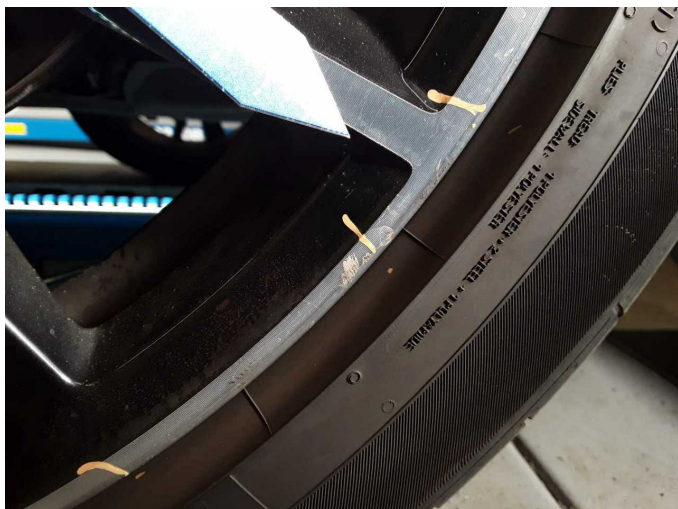
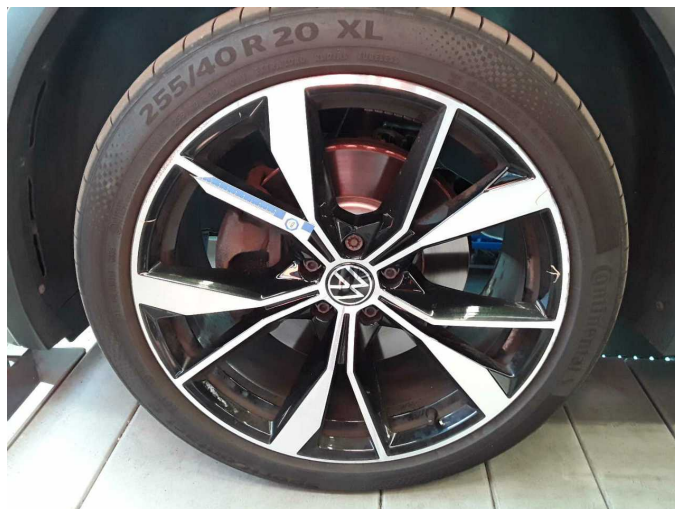
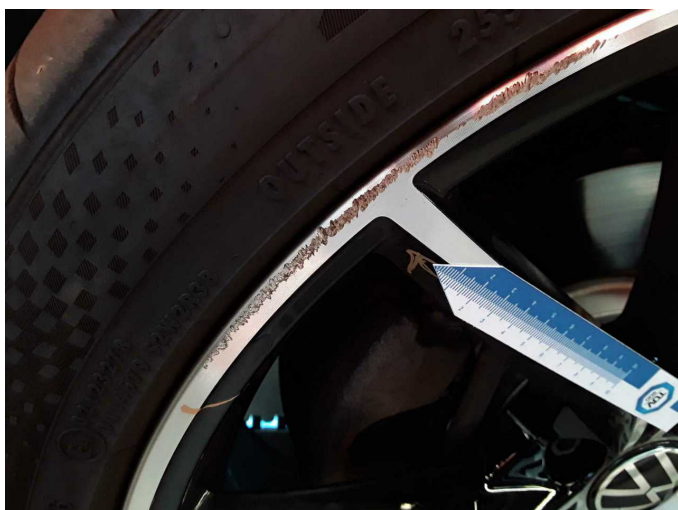
| No. | Component group | Description |
|---|---|---|
| 6 | Wheel / tyres | Alloy rim - front left side (Materialabtrag) - Scratched - Replace |

**Damage 5:** Wheel / tyres: Alloy rim - front right side (Materialabtrag) - Scratched - Replace

**Damage 6:** Wheel / tyres: Alloy rim - front left side (Materialabtrag) - Scratched - Replace

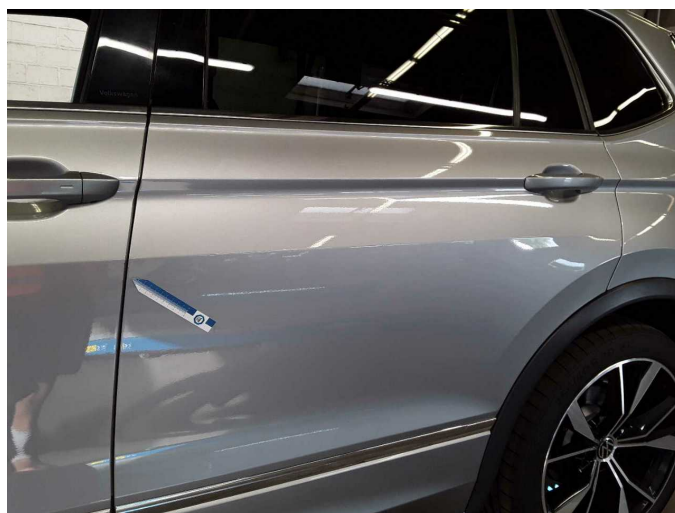
| No. | Component group | Description |
|---|---|---|
| 3 | Bonnet | Bonnet - Stone chips - No deduction |

**Wear and tear 2:** Door - rear left side: Door - Scratch(es) - No deduction

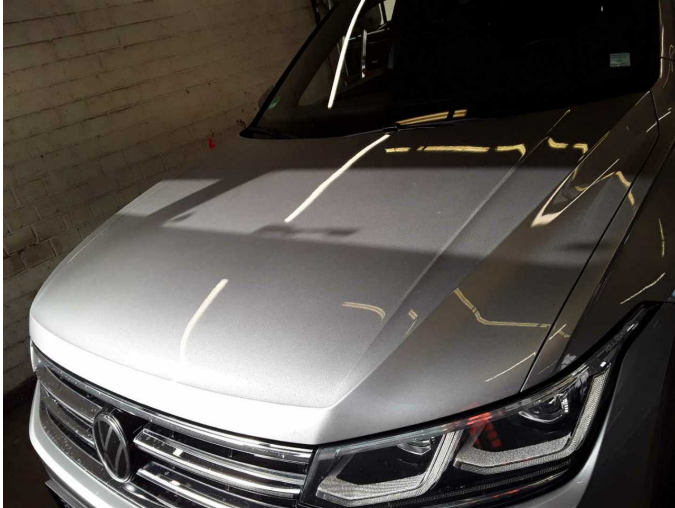
| No. | Component group | Description |
|---|---|---|
| 4 | Door - rear right side | Door edge - Scratched - No deduction |

**Wear and tear 3:** Bonnet: Bonnet - Stone chips - No deduction
