Expertise

Protocol number: 46024216
Order No. / Reference: 26465908
Inspection date: 18 Jun 2026

Manufacturer: Volvo

Model: XC60 B4 D AWD Geartronic RDesign

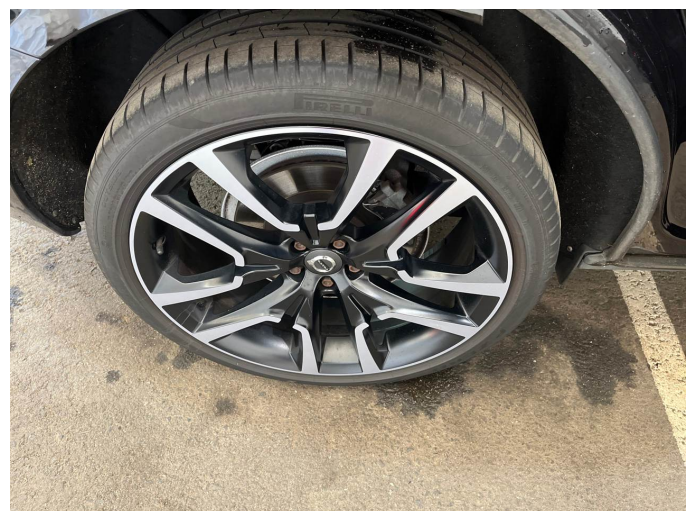
Figure 12: Mounted tyres

| # | Tyre size | Type of tyre | Manufacturer | Tread depth |
|---|---|---|---|---|
| 1) | 265/35 R22 102V | Summer tyres on Light alloy | Pirelli | 5mm / 5mm |

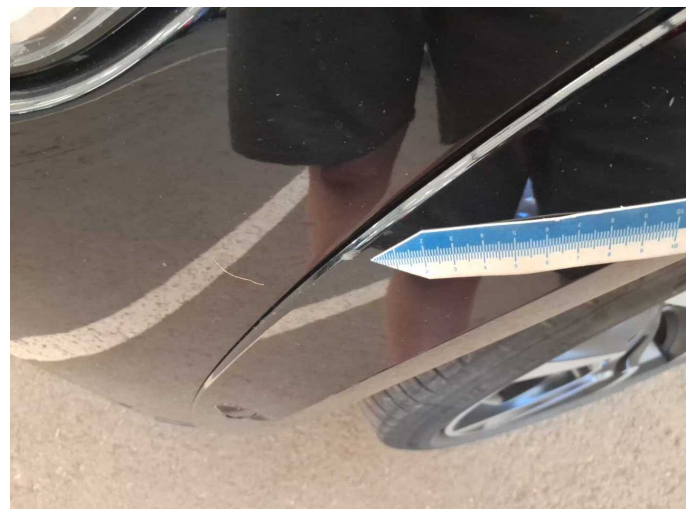
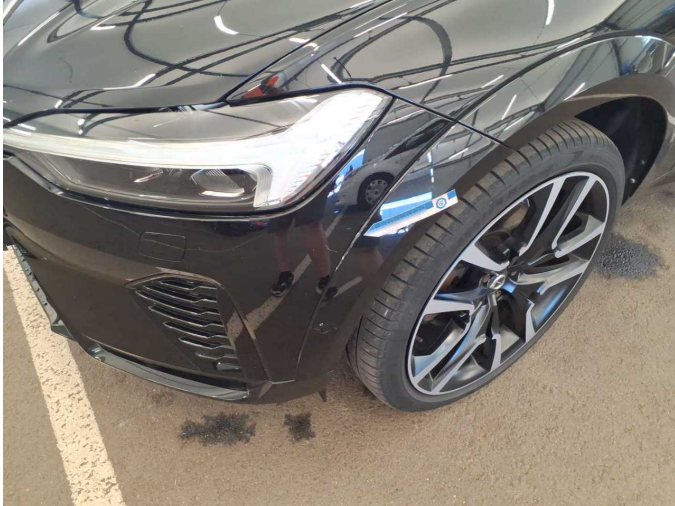
Damage 3: Front bumper: Cover bumper - front - Scratch(es) - Smart repair

| No. | Component group | Description |
|---|---|--|
| 3 | Front bumper | Cover bumper - front - Scratch(es) - Smart repair |

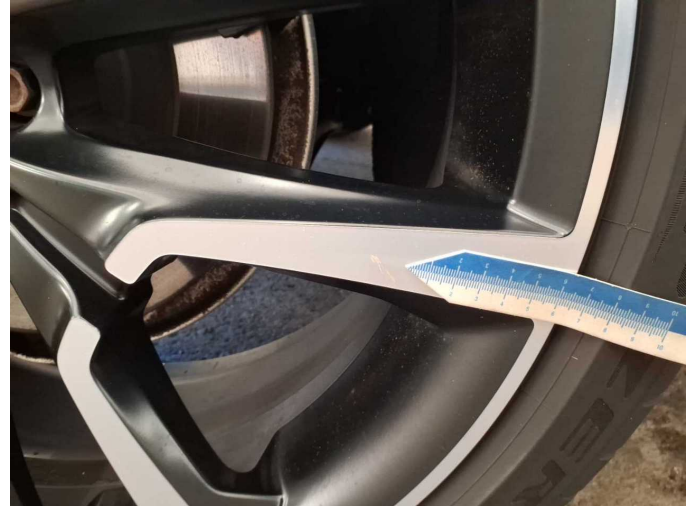
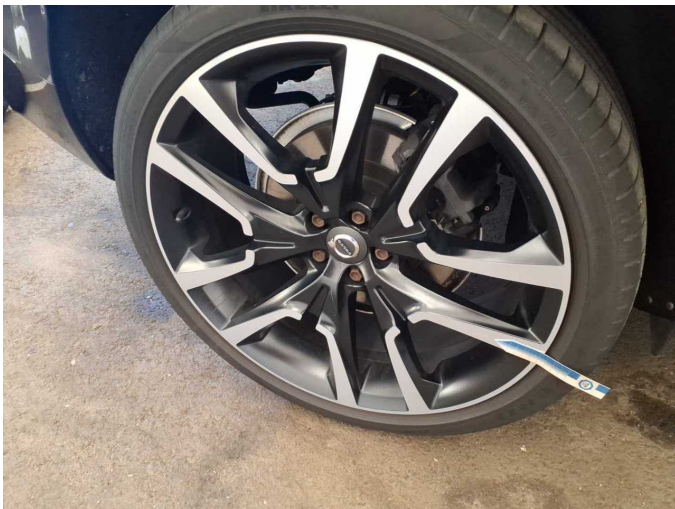
Damage 4: Wheel / tyres: Alloy rim - rear right side - Scratch(es) - Loss in value

| No. | Component group | Description |
|---|---|--|
| 4 | Wheel / tyres | Alloy rim - rear right side - Scratch(es) - Loss in value |

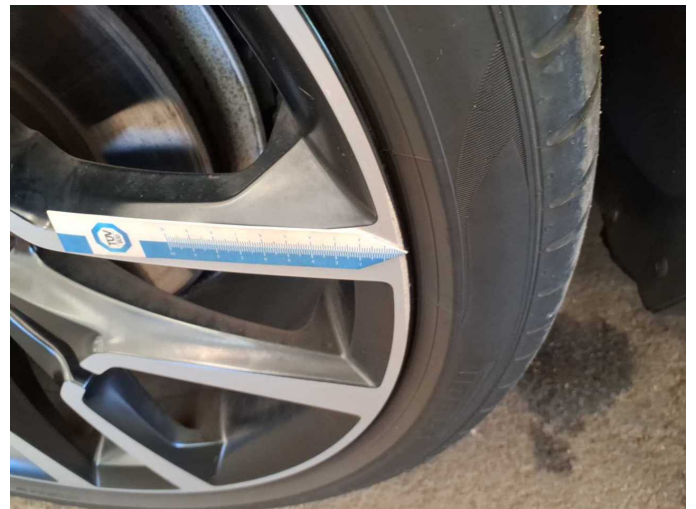
Damage 5: Wheel / tyres: Alloy rim - front left side - Scratch(es) - Loss in value

| No. | Component group | Description |
|---|---|--|
| 5 | Wheel / tyres | Alloy rim - front left side - Scratch(es) - Loss in value |

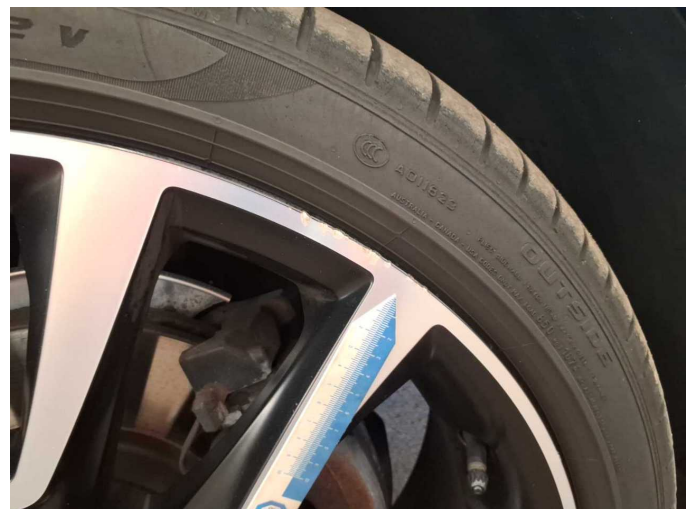
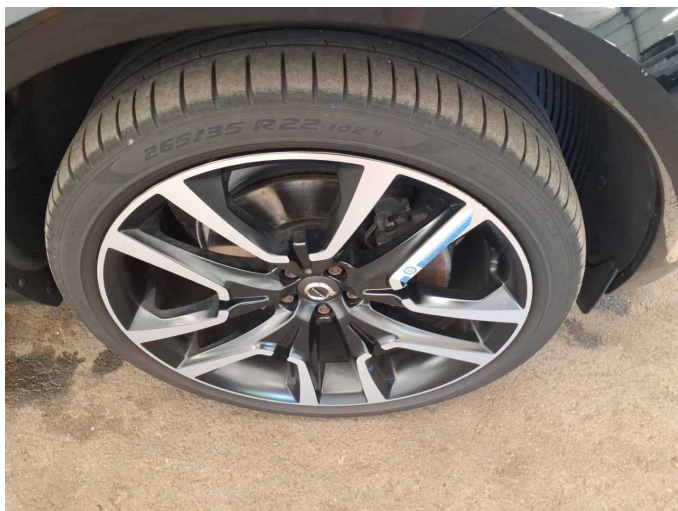
Damage 6: Wheel / tyres: Alloy rim - front right side - Scratch(es) - Loss in value

| No. | Component group | Description |
|---|---|--|
| 6 | Wheel / tyres | Alloy rim - front right side - Scratch(es) - Loss in value |

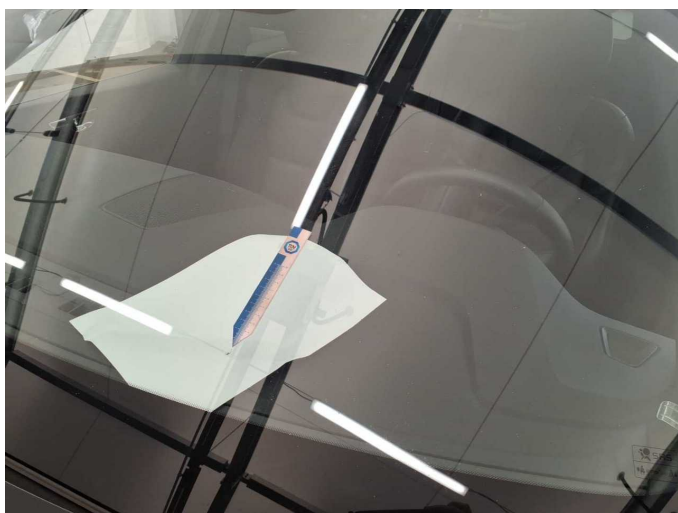
Damage 7: Vehicle glazing: Windscreen - Stone chips - Replace

| No. | Component group | Description |
|---|---|--|
| 7 | Vehicle glazing | Windscreen - Stone chips - Replace |
