Expertise

Protocol number: 46376429  
Order No. / Reference: 26670950  
Inspection date: 7 Jul 2026

Manufacturer: Skoda  
VIN: TMBJR9NPXR7025447

Model: Superb Combi 2.0 TDI DSG Style

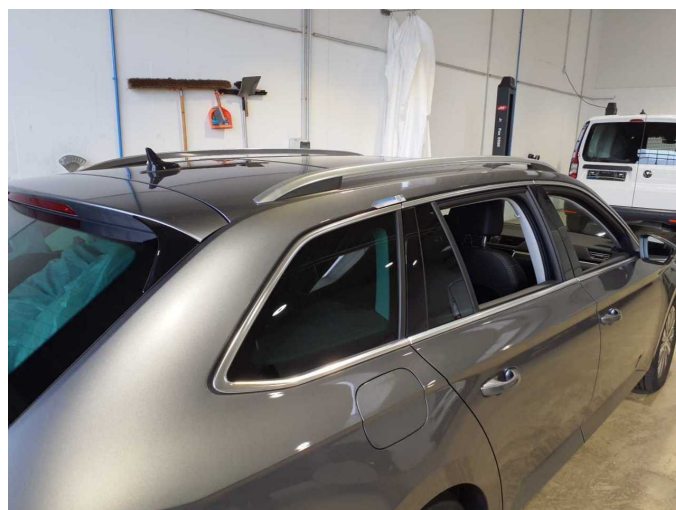
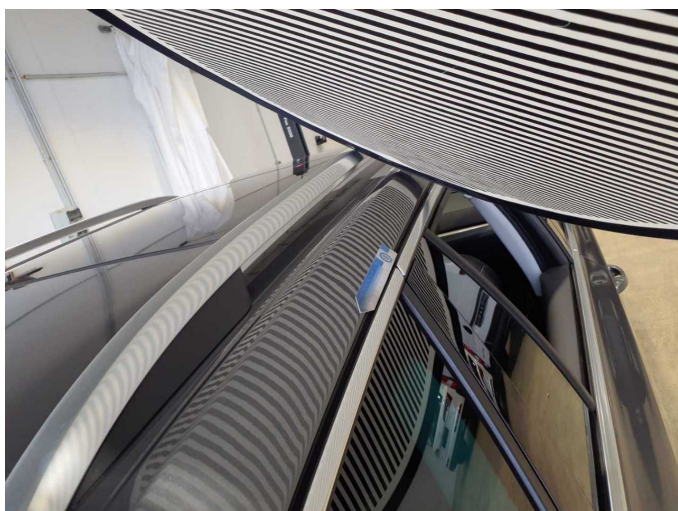
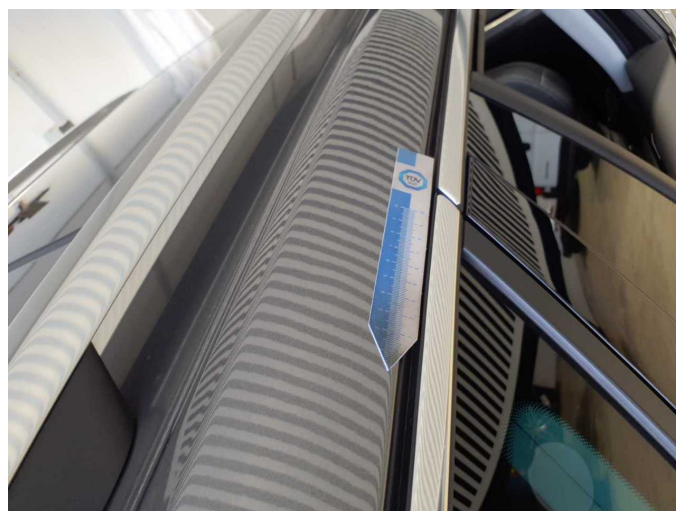
| No. | Component group | Description |
|---|---|---|
| 1 | Roof | Roof rail - right side - dent(s) - Smooth repair work |

Damage 1: Roof: Roof rail - right side - dent(s) - Smooth repair work

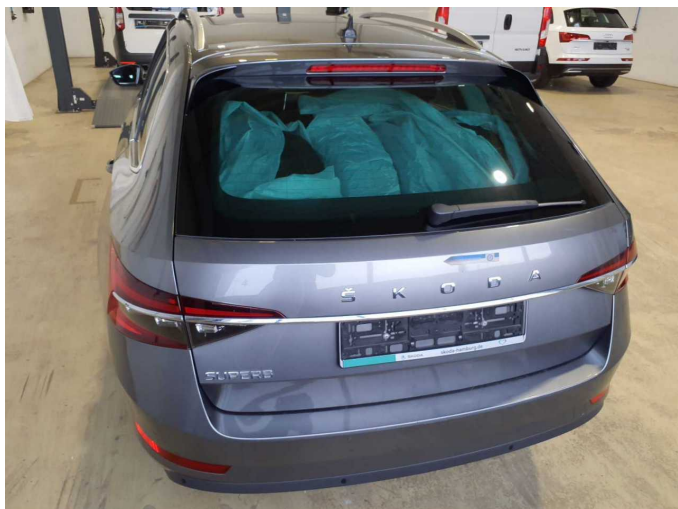
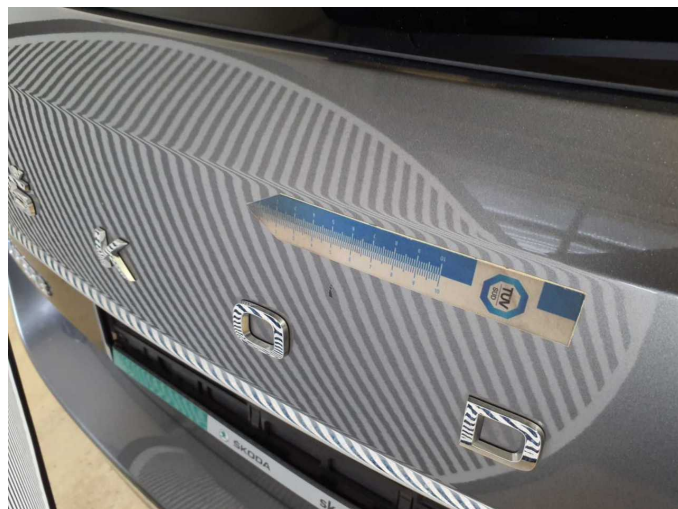
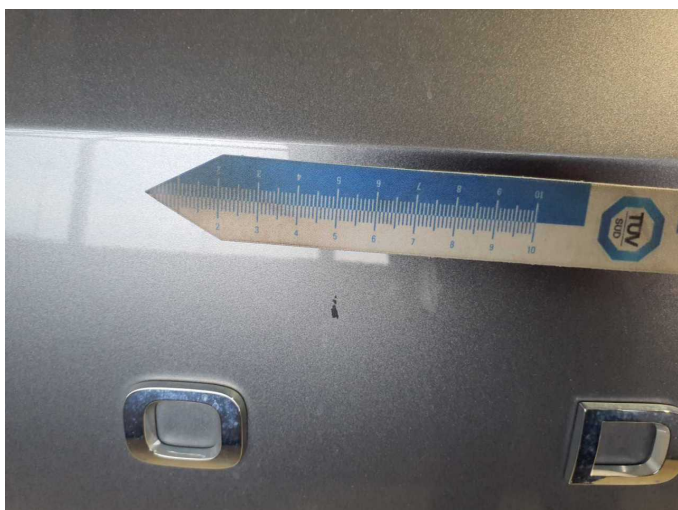
| No. | Component group | Description |
|---|---|---|
| 2 | Boot lid / rear door | Boot lid - Dent / paintcoat damage - Smart repair |

**Damage 2:** Boot lid / rear door: Boot lid - Dent / paintcoat damage - Smart repair

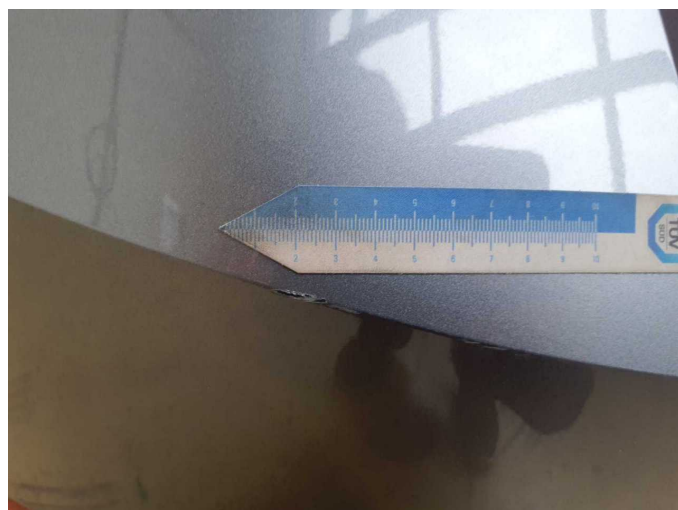
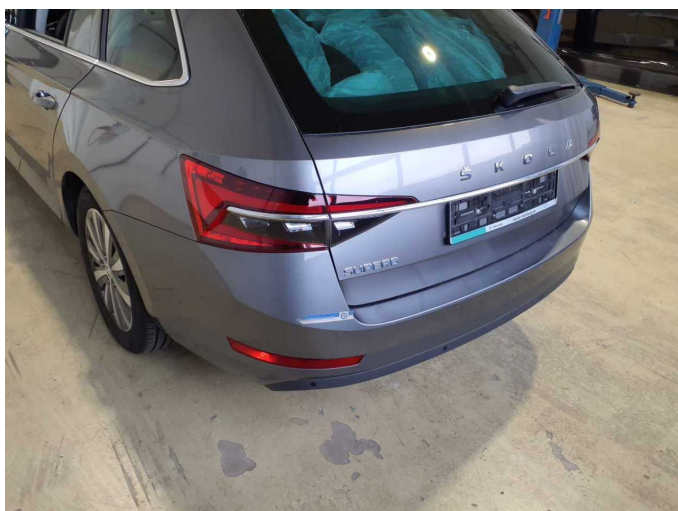
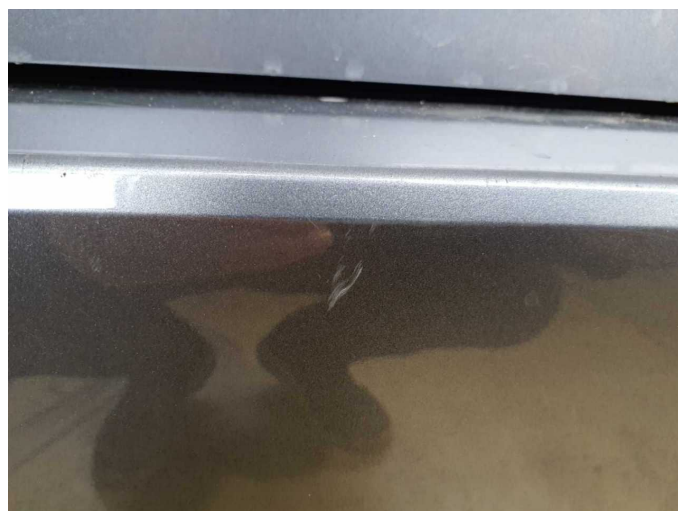
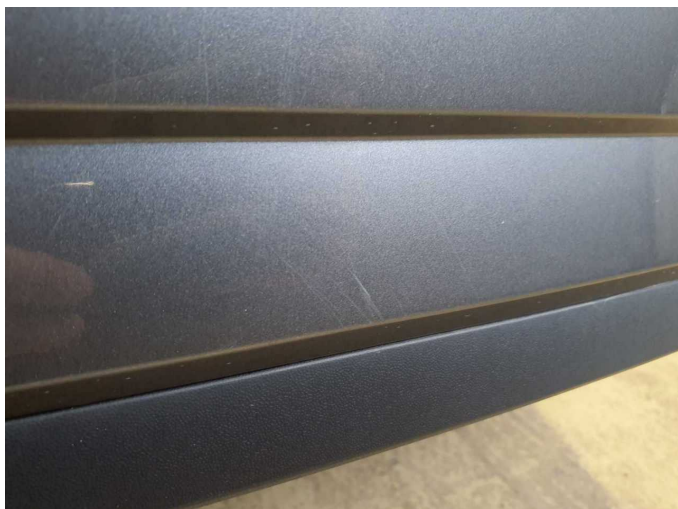
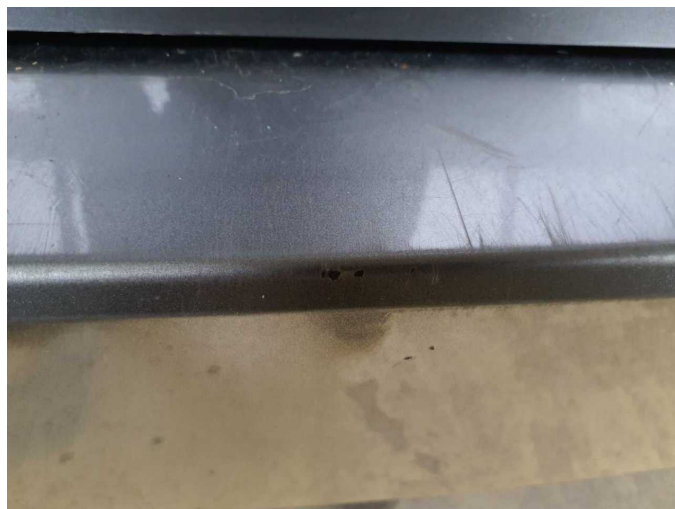
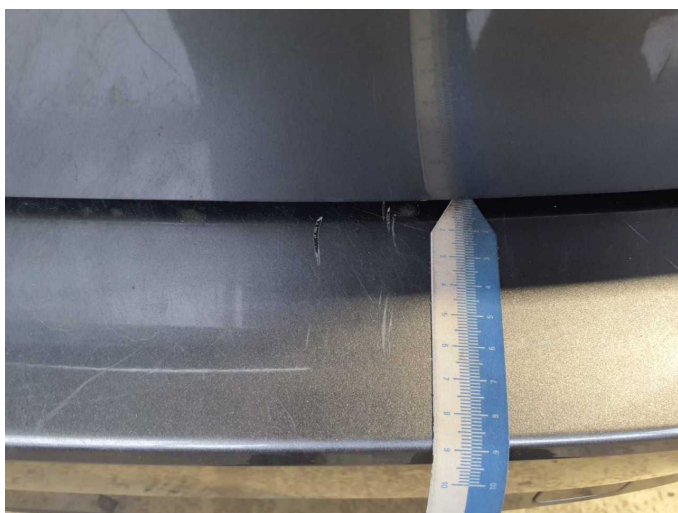
| No. | Component group | Description |
|---|---|---|
| 4 | Rear bumper | Rear bumper - Scratch(es) - Paint |

**Damage 4:** Rear bumper: Rear bumper - Scratch(es) - Paint

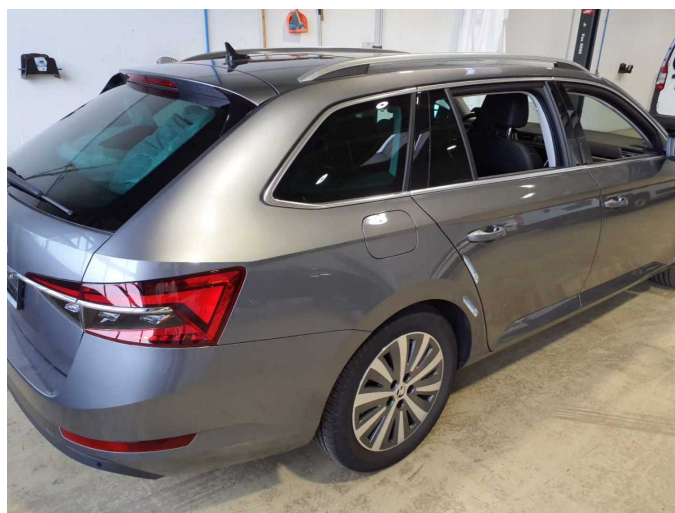
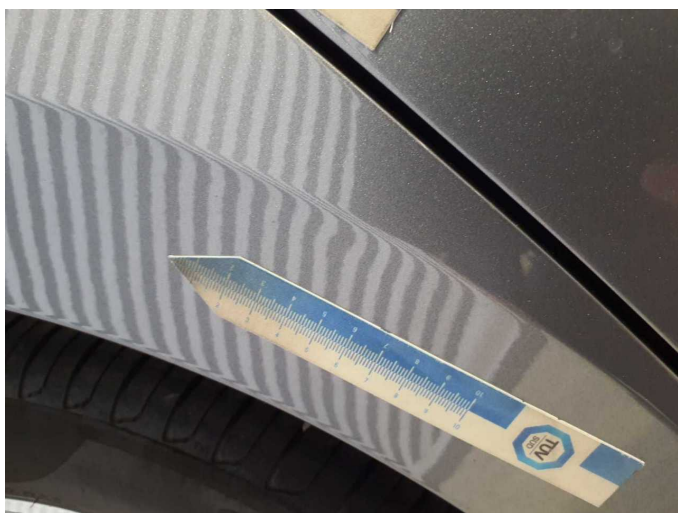
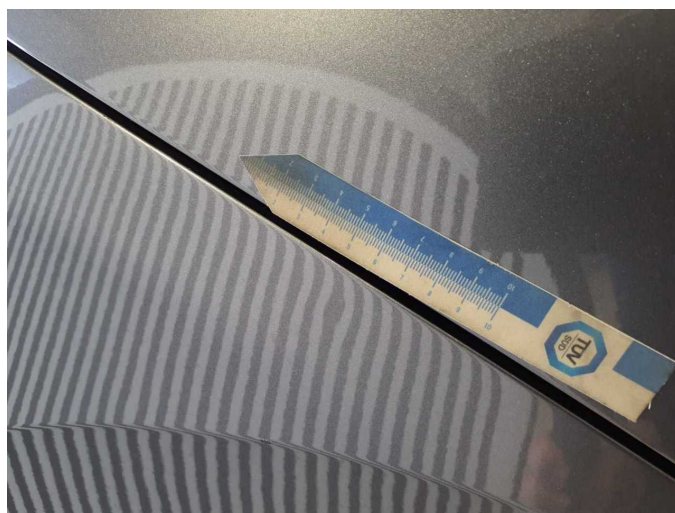
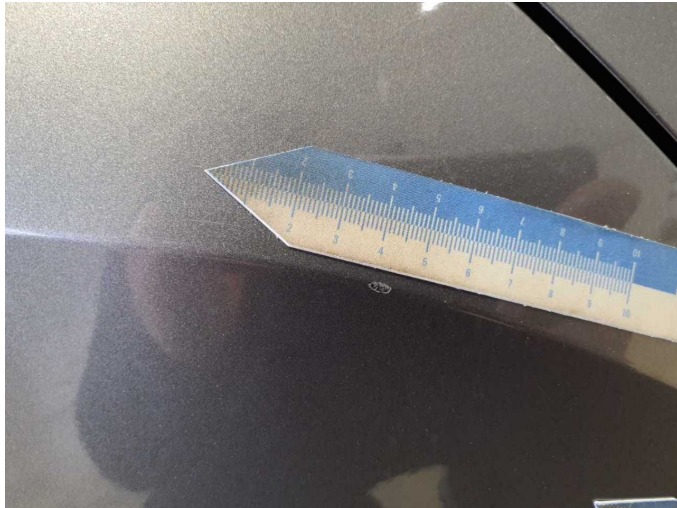
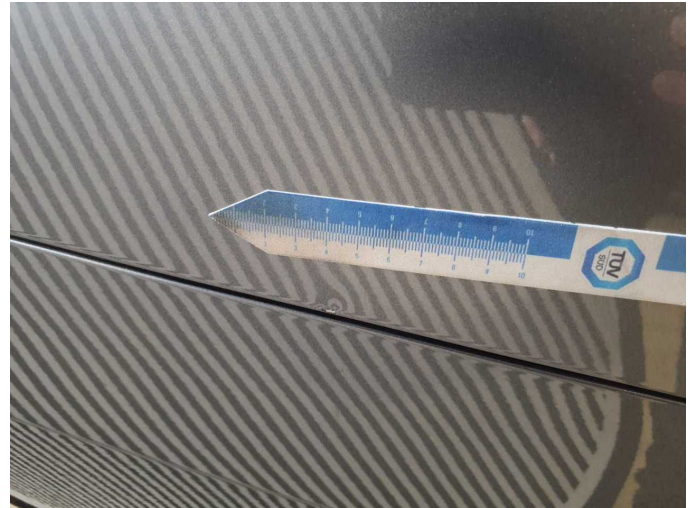
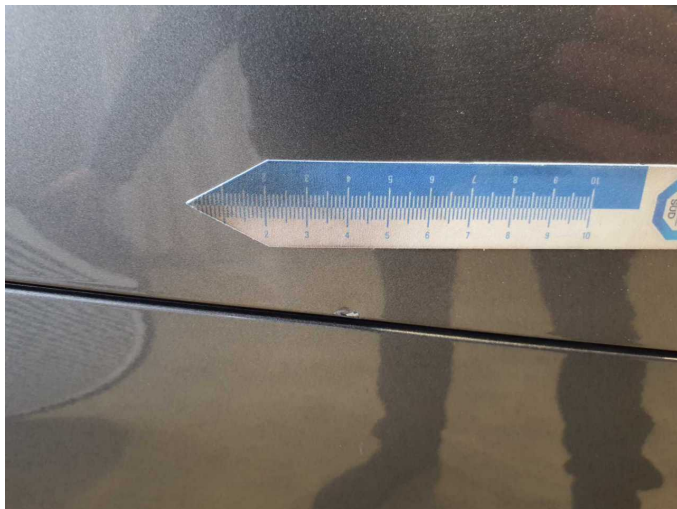
| No. | Component group | Description |
|---|---|---|
| 5 | Side panel - rear right side | Side panel - Dent / paintcoat damage - Repair and paint |

**Damage 5:** Side panel - rear right side: Side panel - Dent / paintcoat damage - Repair and paint

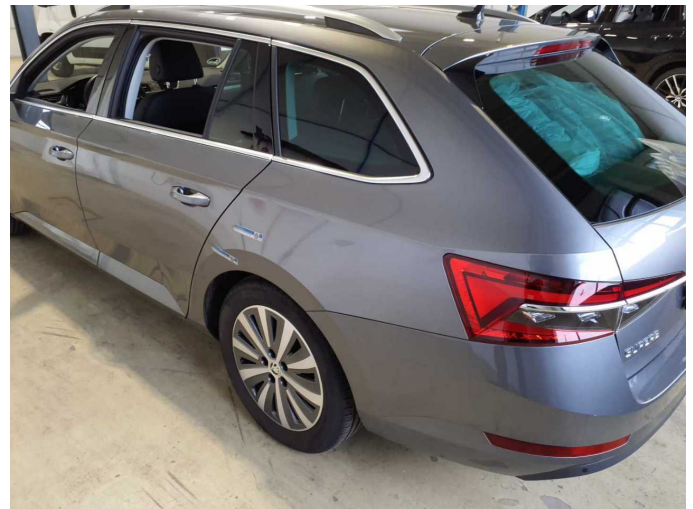
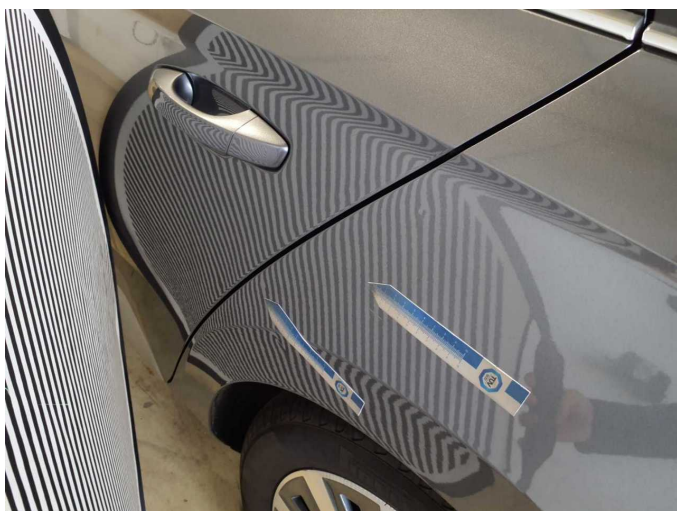
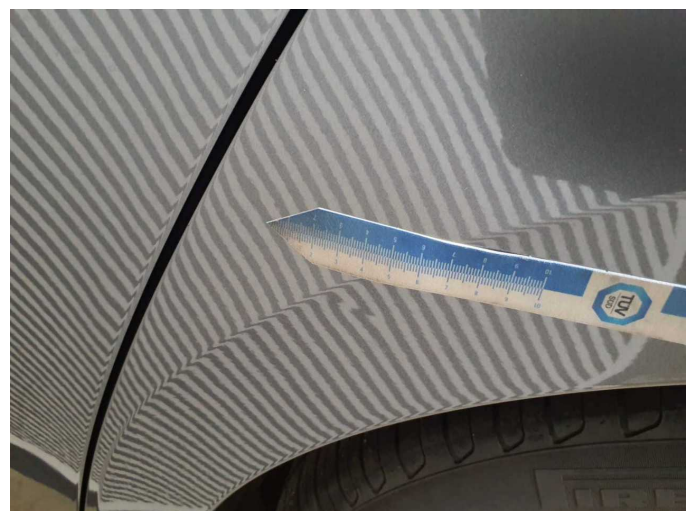
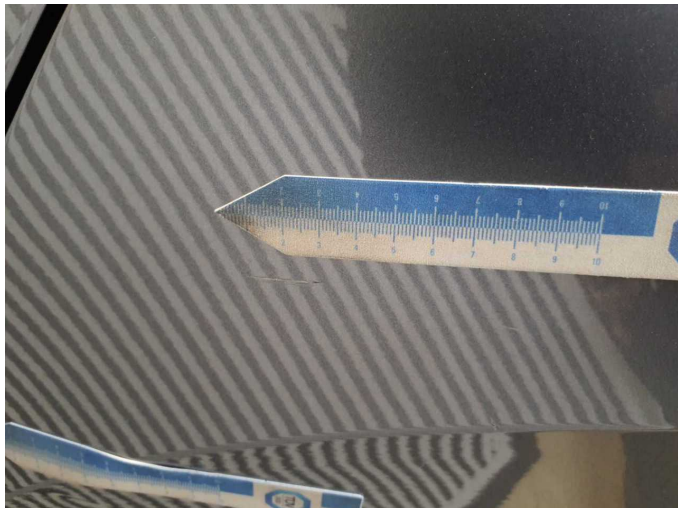
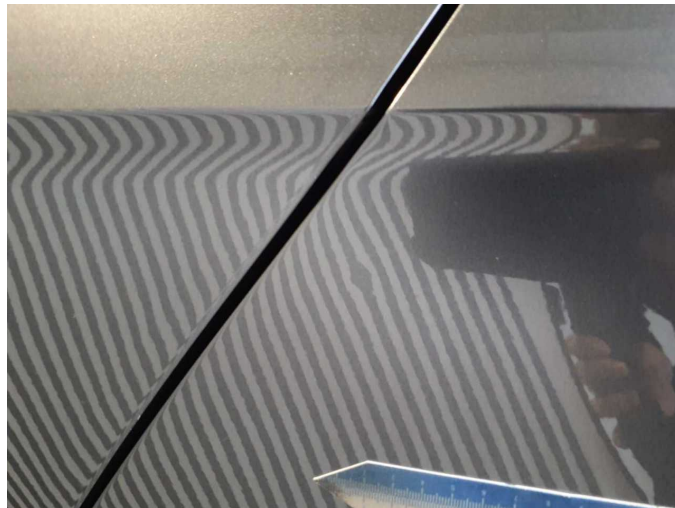
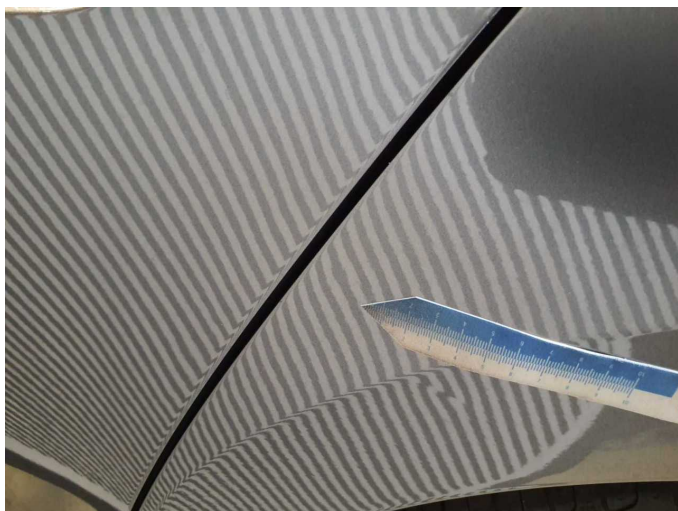
| No. | Component group | Description |
|---|---|---|
| 6 | Side panel - rear left side | Side panel - Dent / paintcoat damage - Repair and paint |

**Damage 6:** Side panel - rear left side: Side panel - Dent / paintcoat damage - Repair and paint

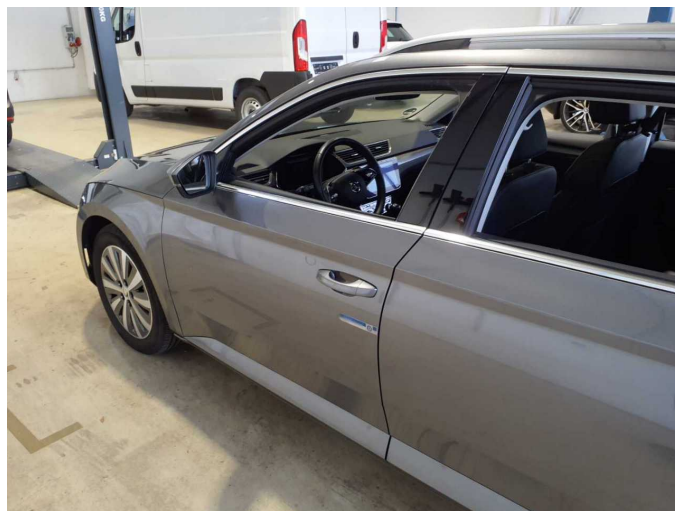
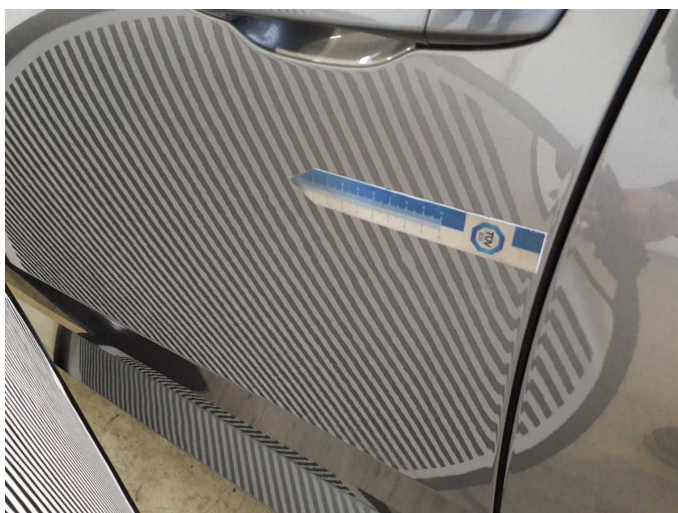
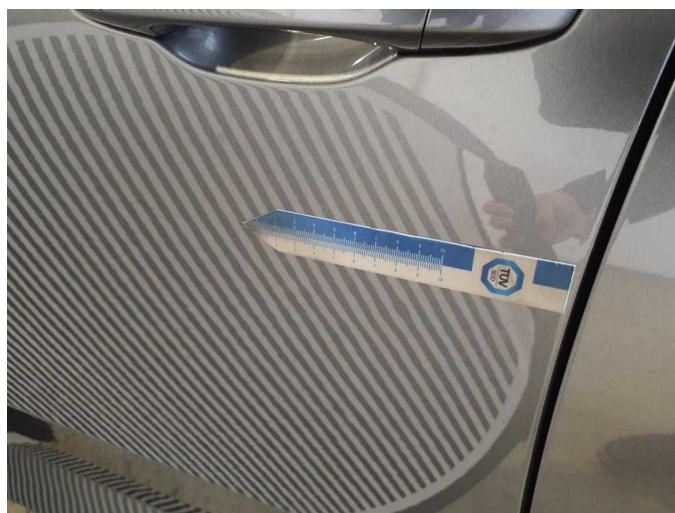
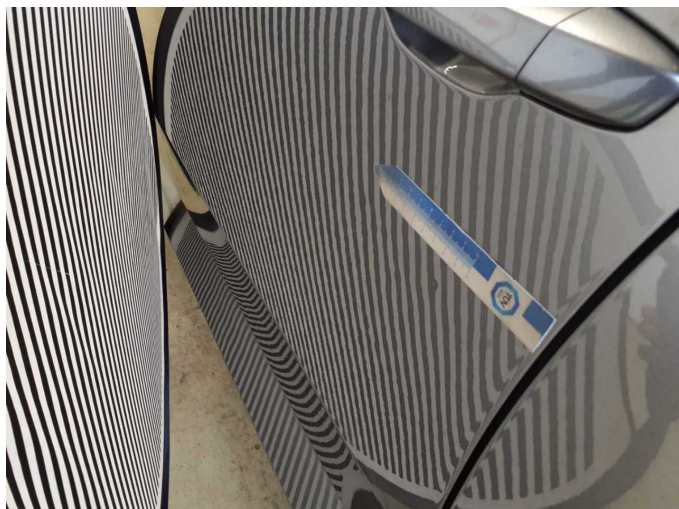
| No. | Component group | Description |
|---|---|---|
| 7 | Door - front left side | Door (Wellig) - Unprofessionally repaired - Repair and paint |

**Damage 7:** Door - front left side: Door (Wellig) - Unprofessionally repaired - Repair and paint

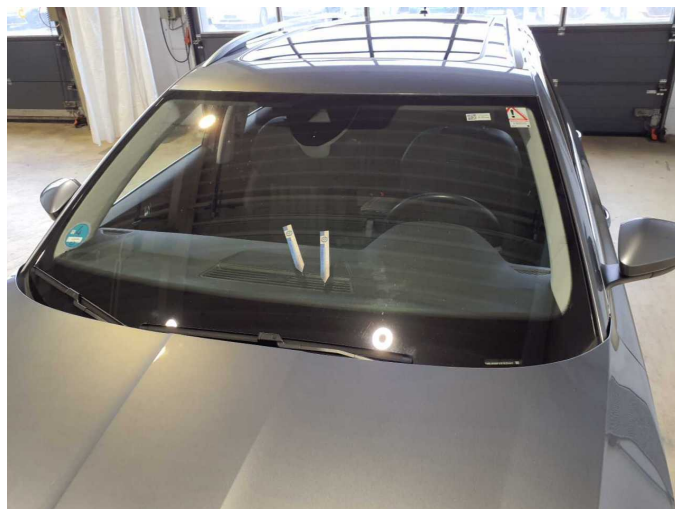
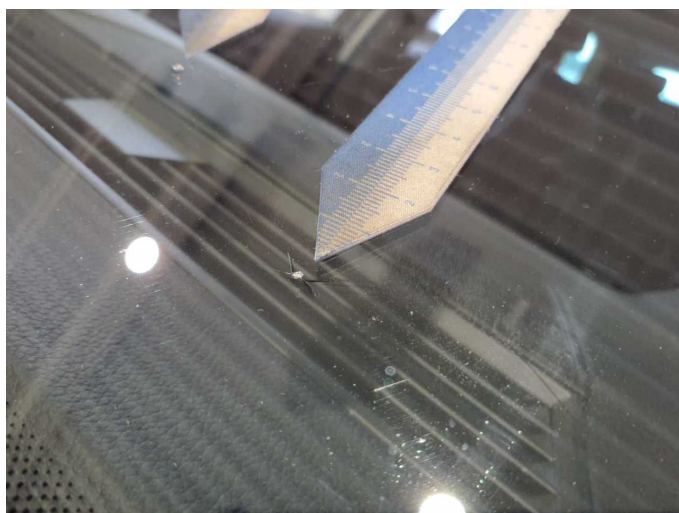
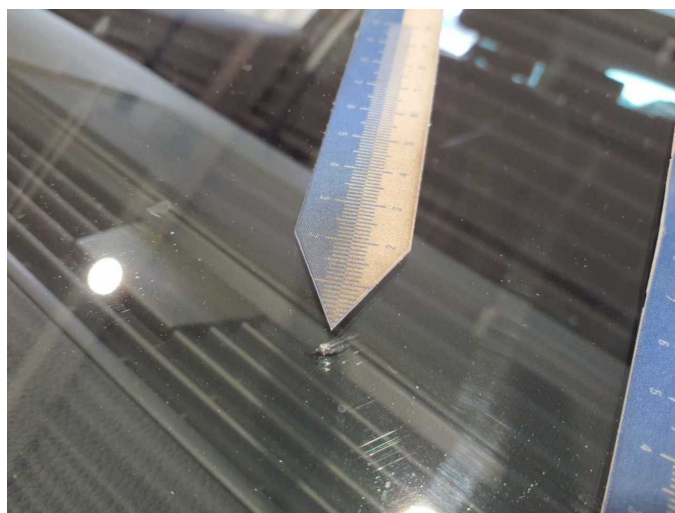
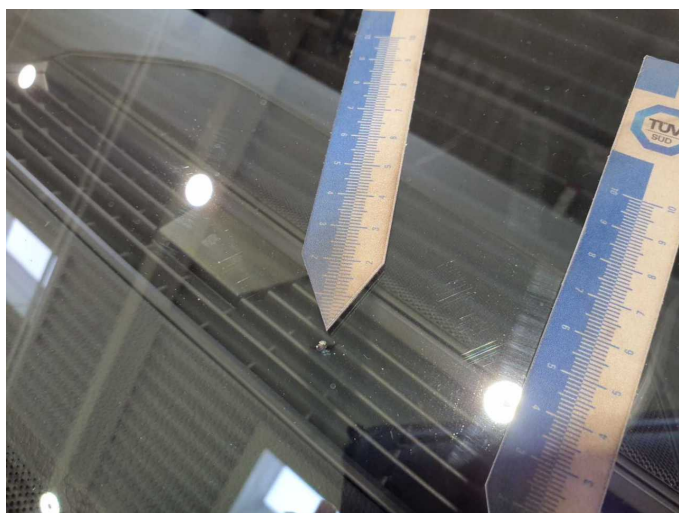
| No. | Component group | Description |
|---|---|---|
| 8 | Vehicle glazing | Windscreen - Broken / torn - Replace |

**Damage 8:** Vehicle glazing: Windscreen - Broken / torn - Replace

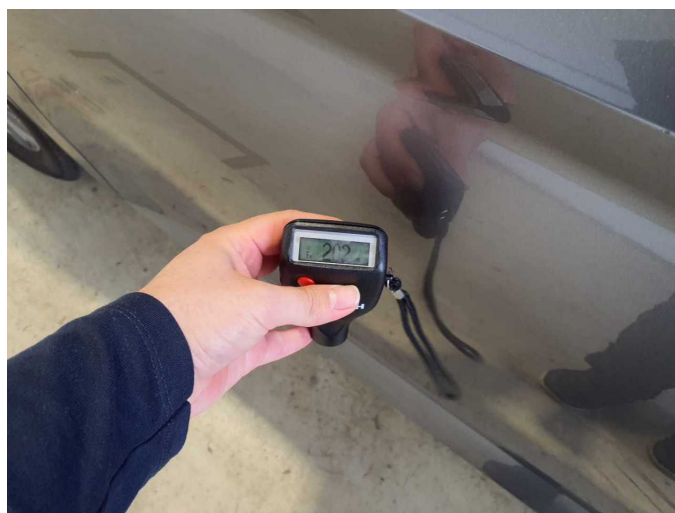
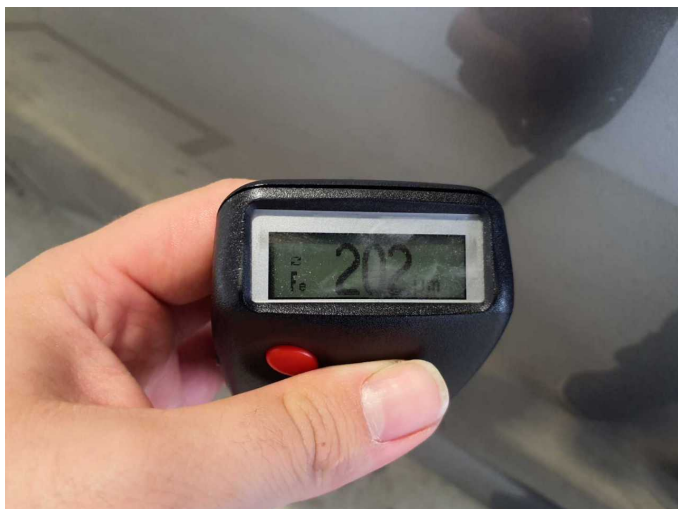
| No. | Repainting |
|---|---|
| 1 | Door - front left side, Unprofessionally carried out, Invoice of repair done Non-existent |

| Door - front left side | 202 µm |

**Repainting 1:** Door - front left side
