Expertise

Protocol number: 46026948  
Order No. / Reference: 26426849  
Inspection date: 18 Jun 2026

Model: Passat Variant 1.4 TSI Plug-In-Hybrid DSG GTE

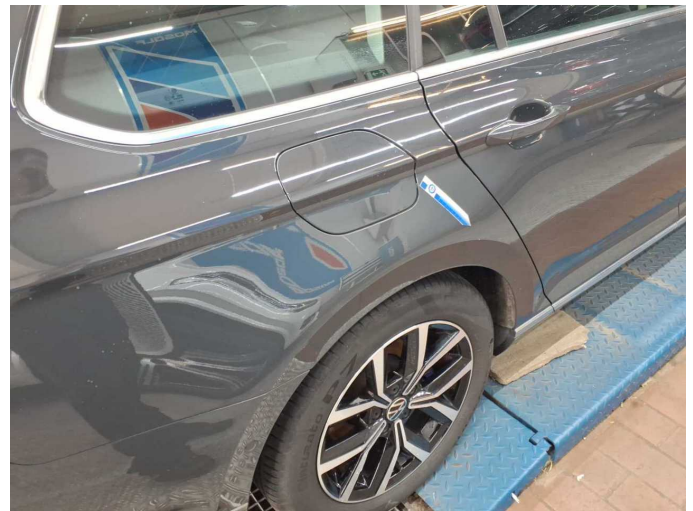
**Damage 1:** Side panel - rear right side: Side panel - dent(s) - Smooth repair work

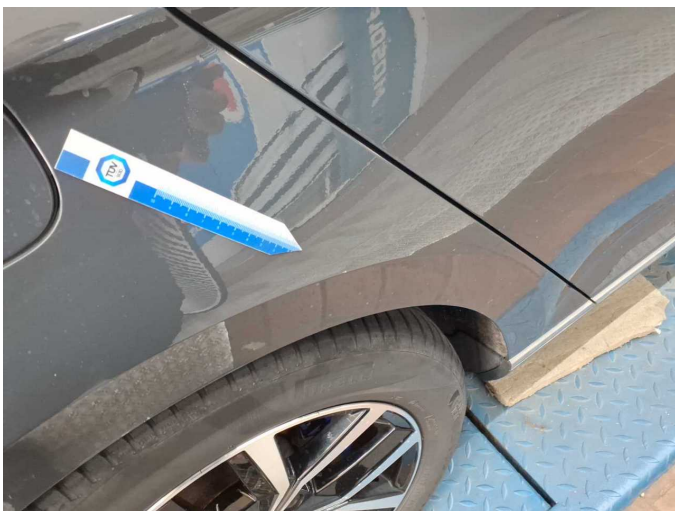
**Damage 1:** Side panel - rear right side: Side panel - dent(s) - Smooth repair work

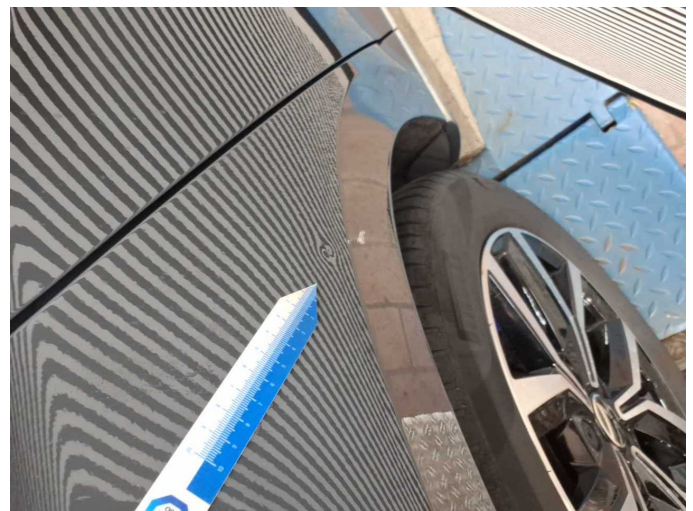
| No. | Component group | Description |
|---|---|---|
| 1 | Side panel - rear right side | Side panel - dent(s) - Smooth repair work |

**Damage 1:** Side panel - rear right side: Side panel - dent(s) - Smooth repair work

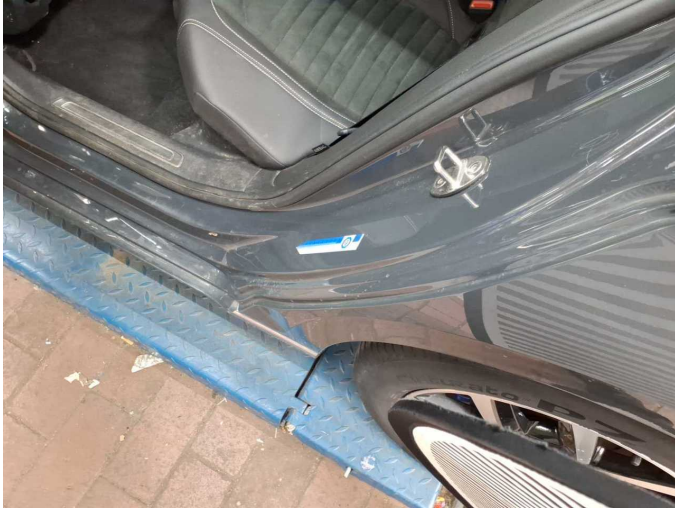
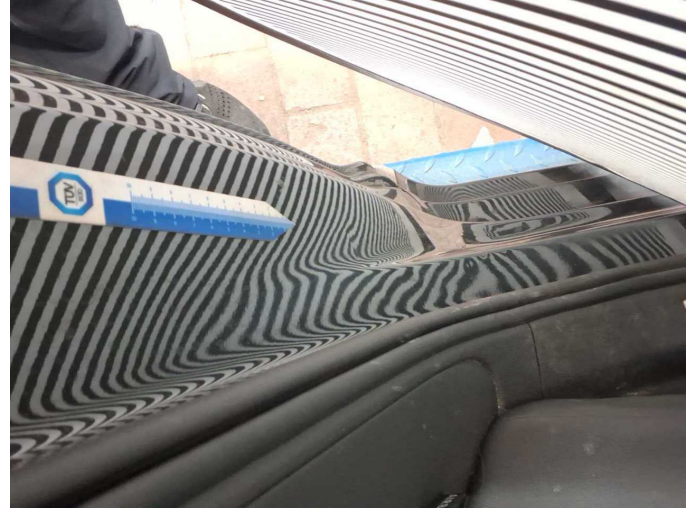
| No. | Component group | Description |
|---|---|---|
| 2 | Side panel - rear left side | Sill - dent(s) - Smooth repair work |

**Damage 2:** Side panel - rear left side: Sill - dent(s) - Smooth repair work

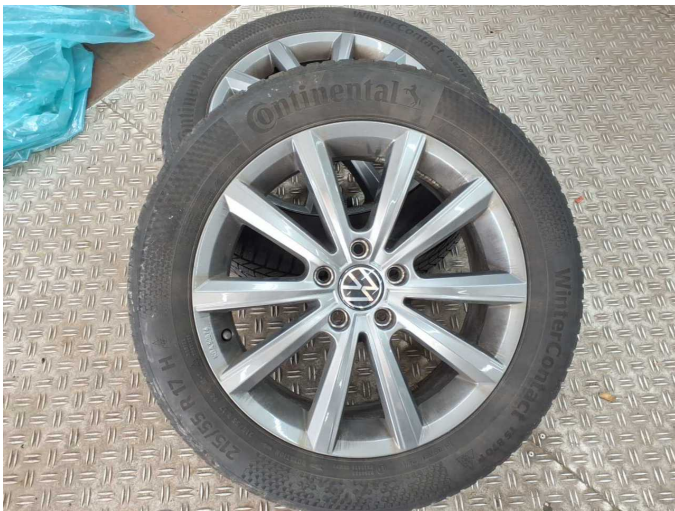
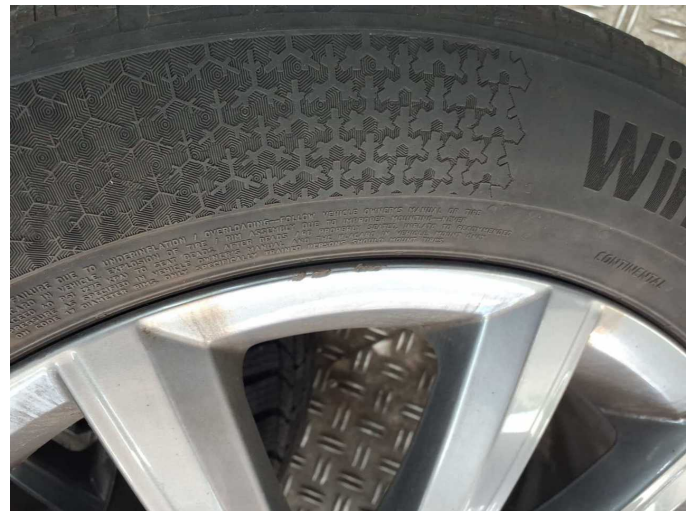
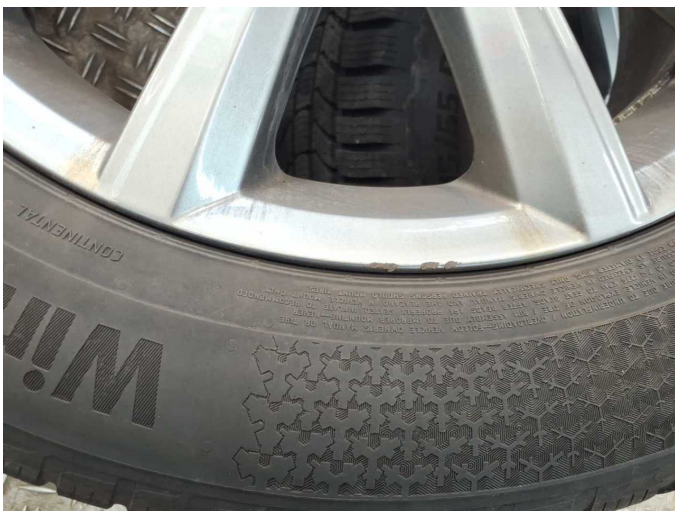
| No. | Component group | Description |
|---|---|---|
| 3 | 2nd wheel set | 1 alloy rim - Scratch(es) - Loss in value |

**Damage 3:** 2nd wheel set: 1 alloy rim - Scratch(es) - Loss in value

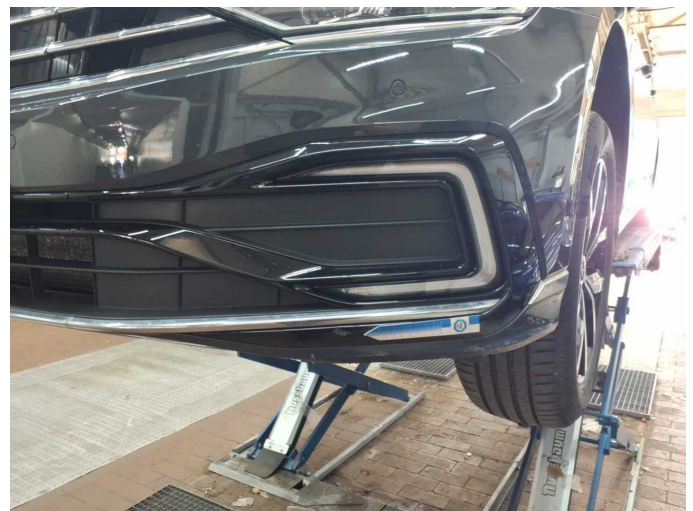
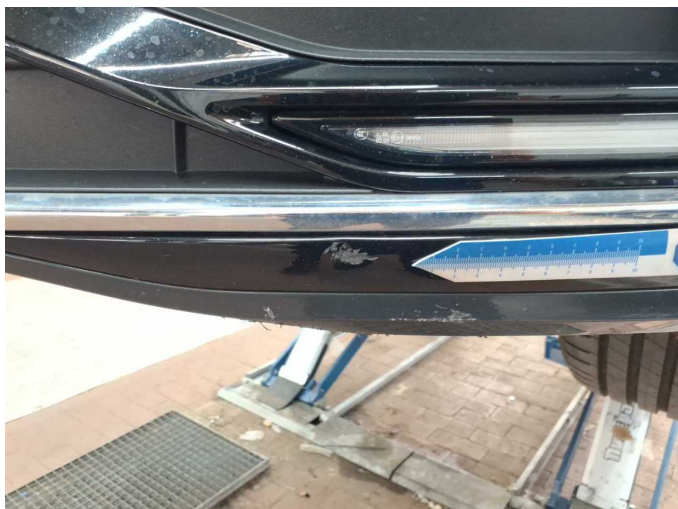
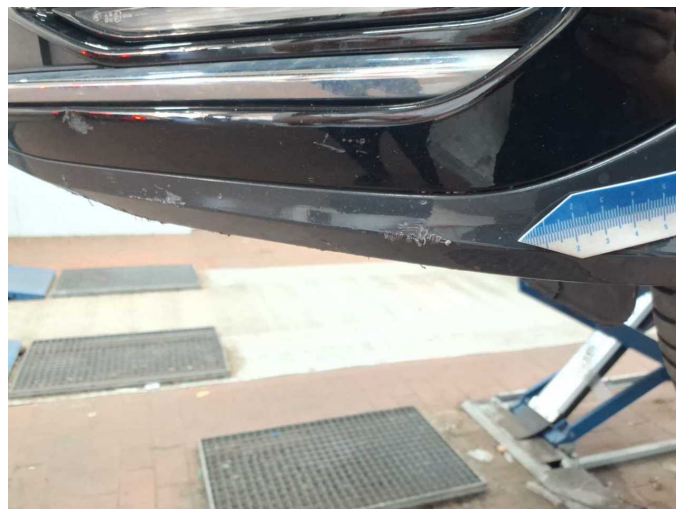
| No. | Component group | Description |
|---|---|---|
| 4 | Front bumper | Cover bumper - front - Scratch(es) - Replace |

**Damage 4:** Front bumper: Cover bumper - front - Scratch(es) - Replace

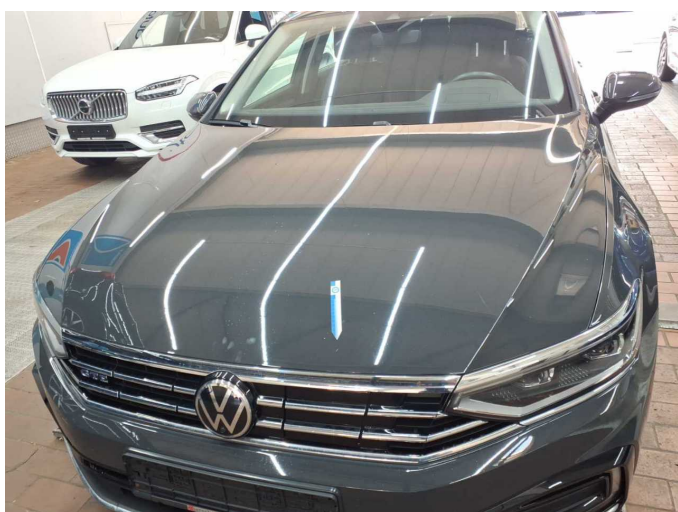
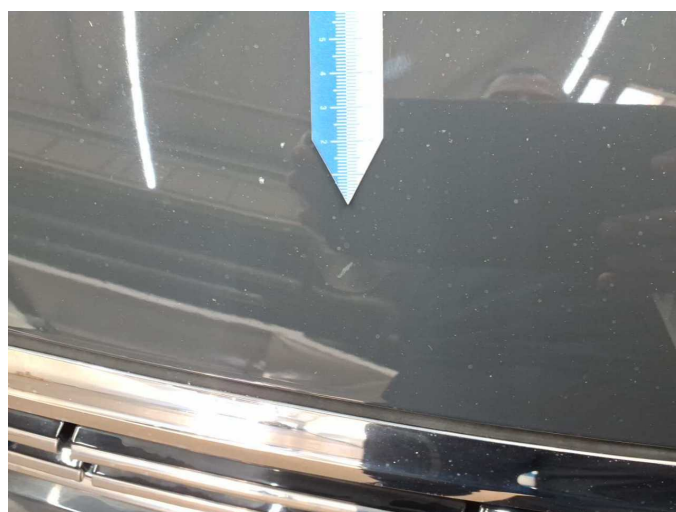
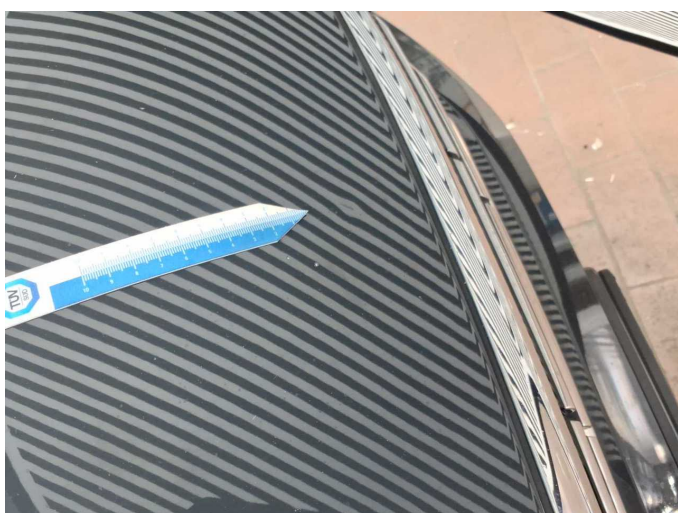
| No. | Component group | Description |
|---|---|---|
| 5 | Bonnet | Bonnet - Dent / paintcoat damage - Smart repair |

**Damage 5:** Bonnet: Bonnet - Dent / paintcoat damage - Smart repair

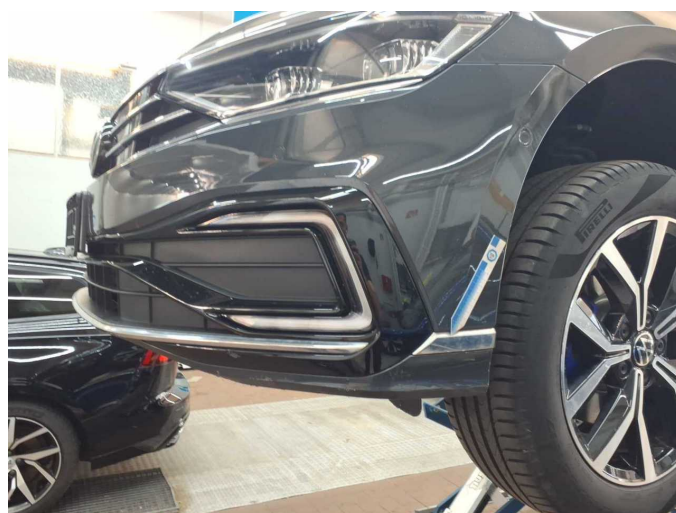
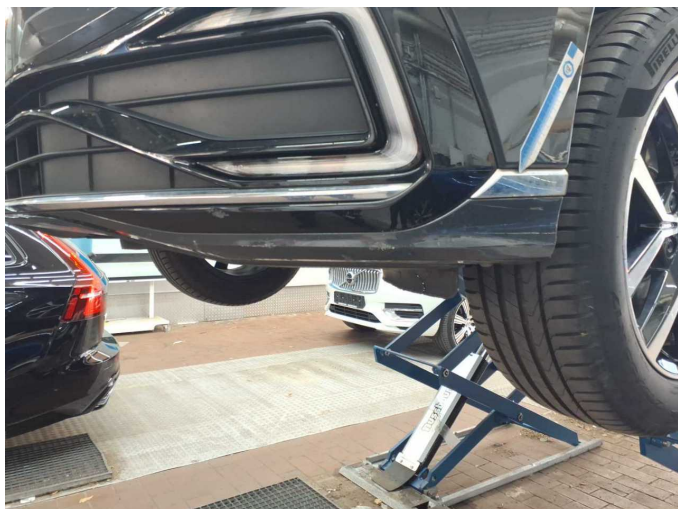
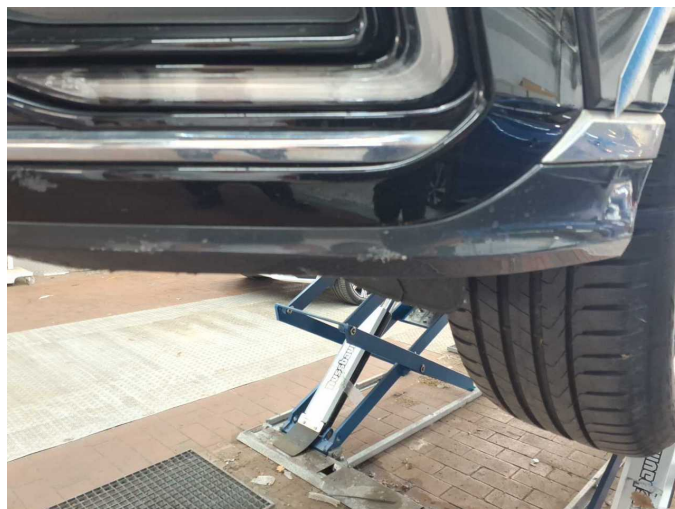
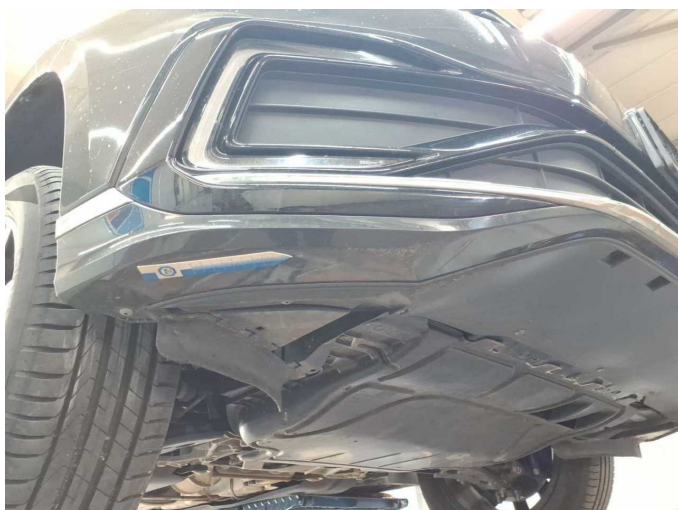
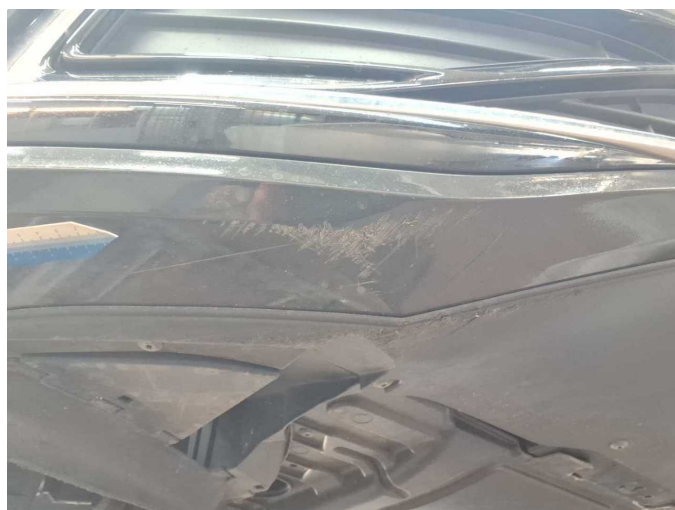
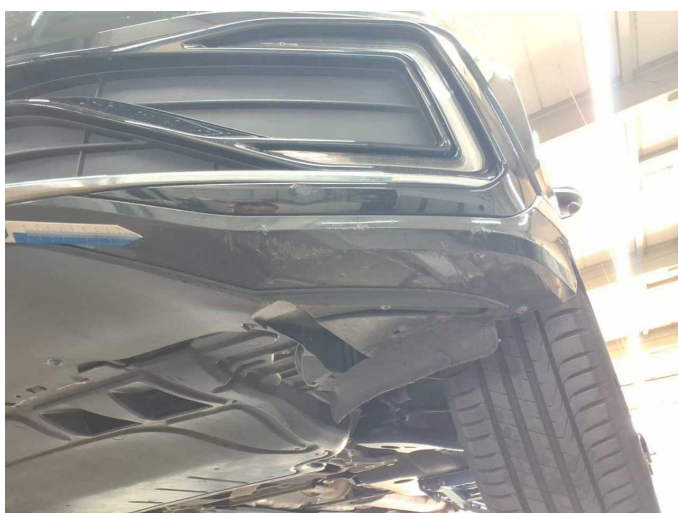
| No. | Component group | Description |
|---|---|---|
| 6 | Front bumper | Front bumper - Scratch(es) - Paint |

**Damage 6:** Front bumper: Front bumper - Scratch(es) - Paint

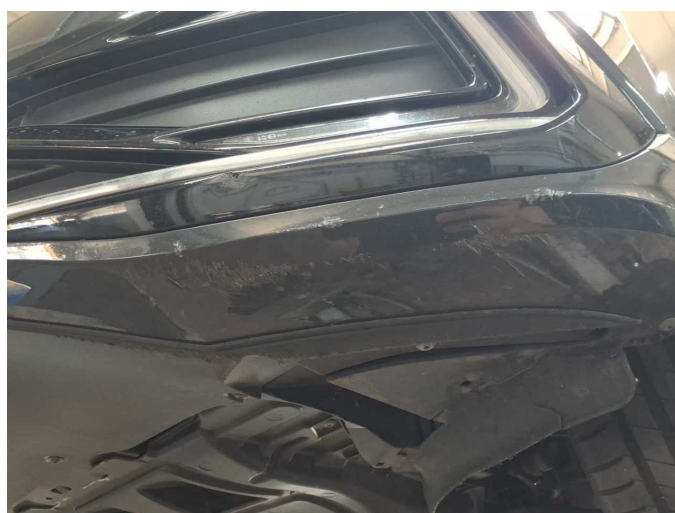
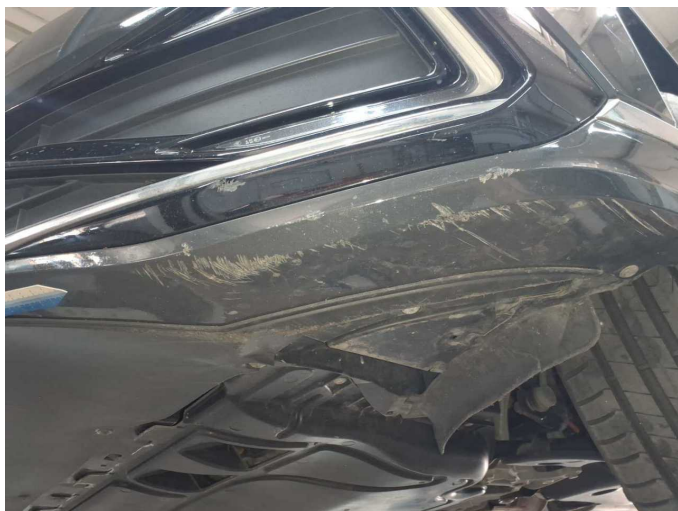
**Damage 6:** Front bumper: Front bumper - Scratch(es) - Paint

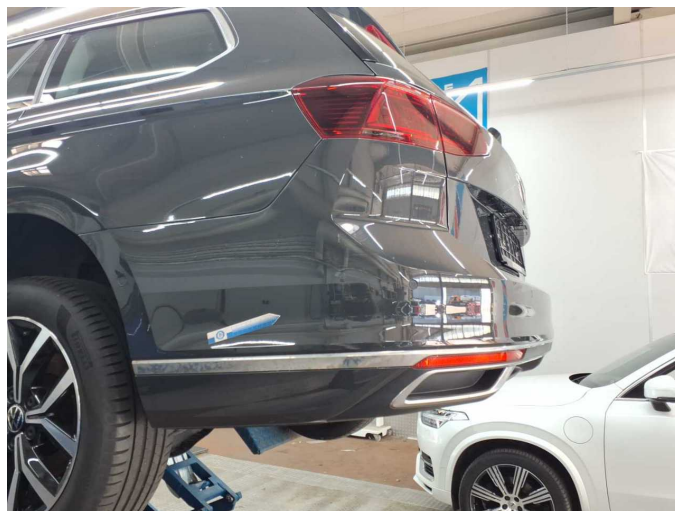
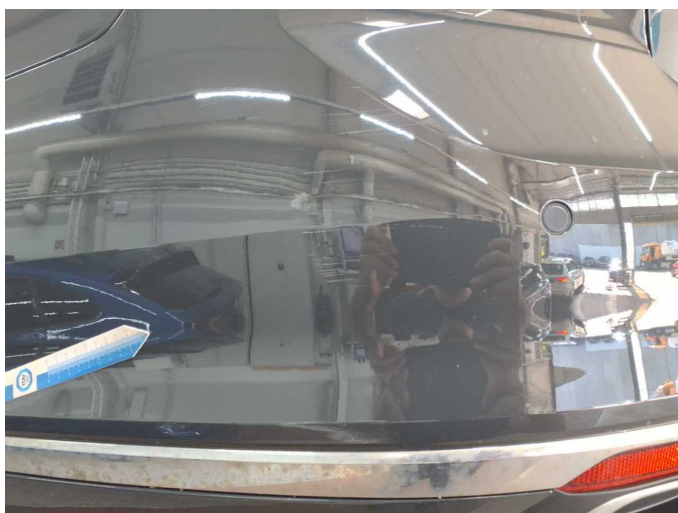
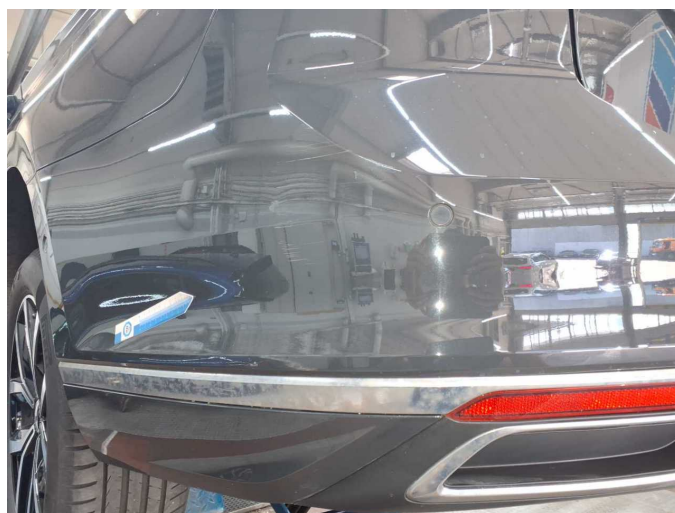
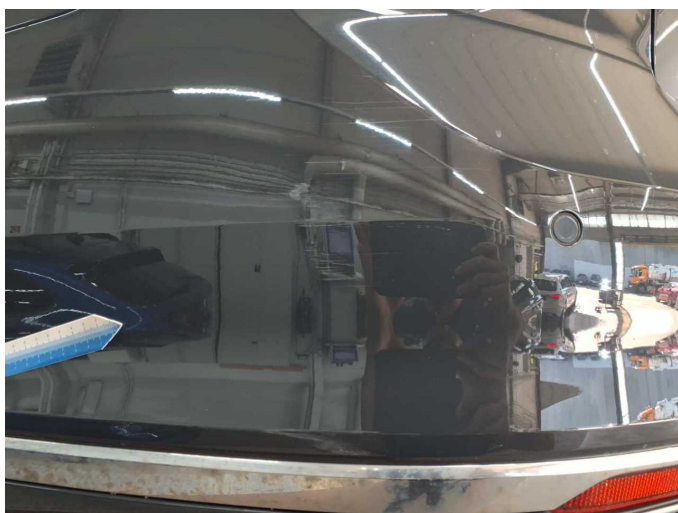
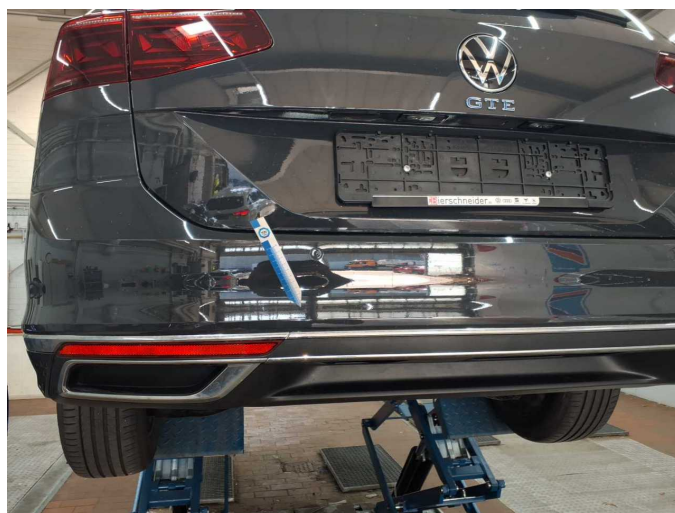
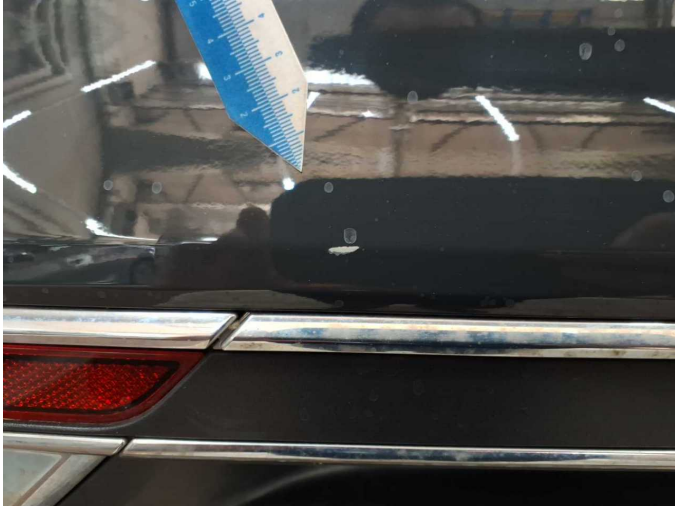
| No. | Component group | Description |
|---|---|---|
| 7 | Rear bumper | Rear bumper - Scratch(es) - Replace |

**Damage 7:** Rear bumper: Rear bumper - Scratch(es) - Replace

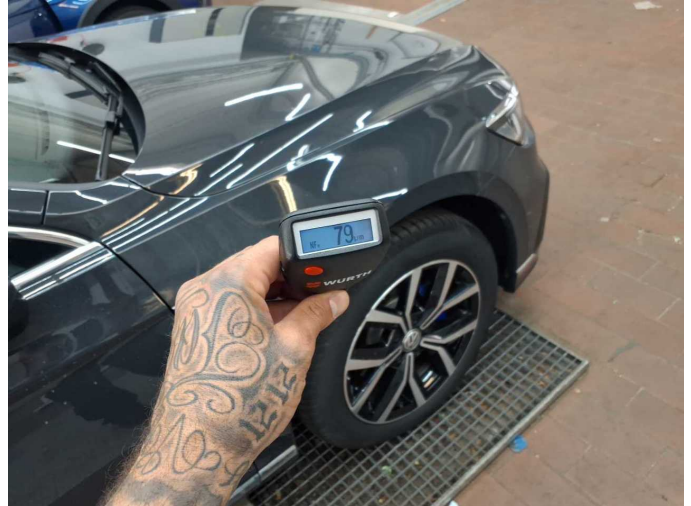
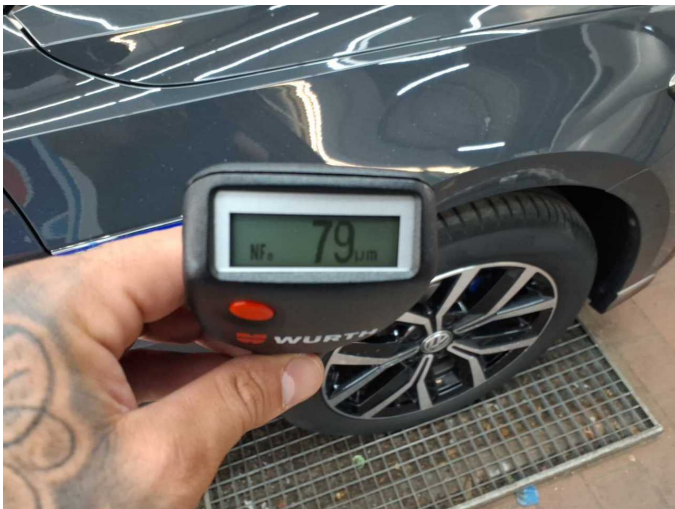
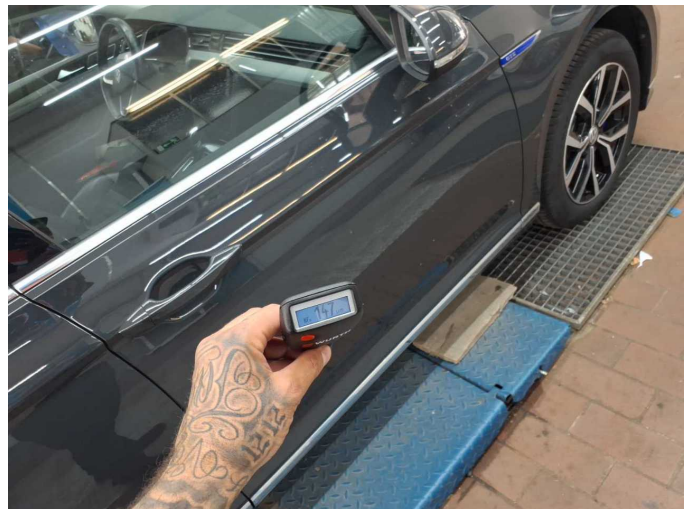
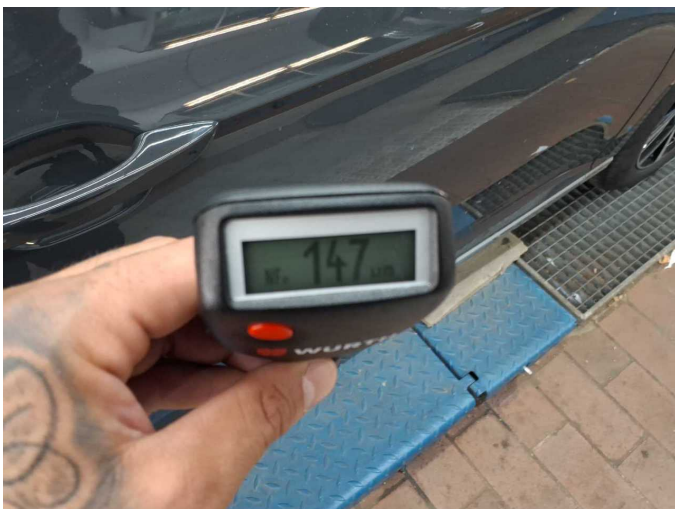
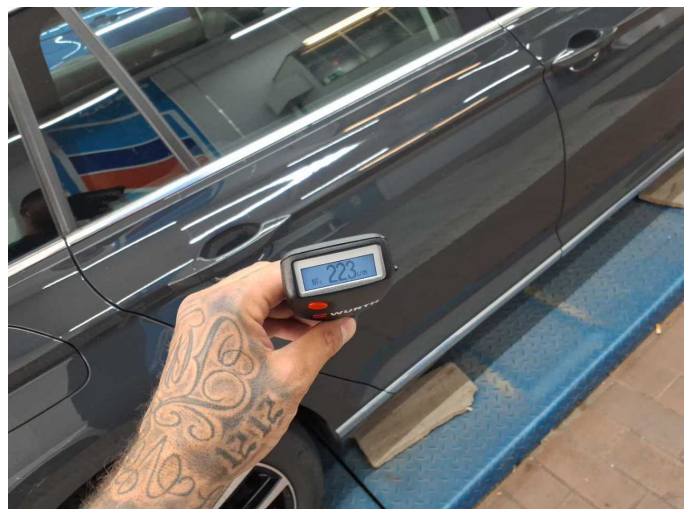
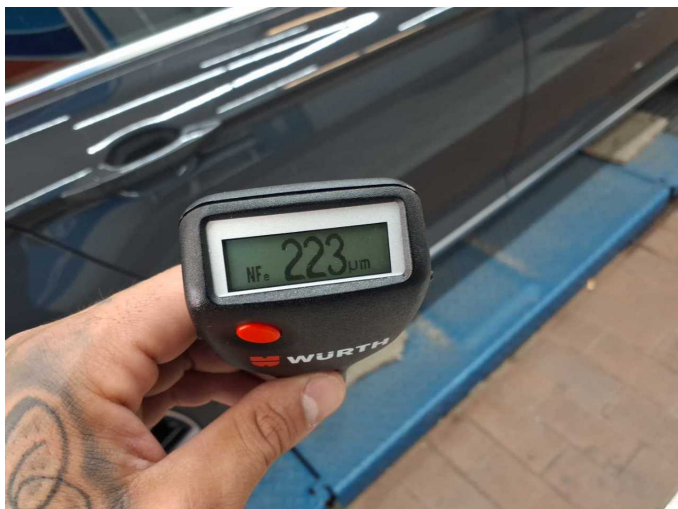
| No. | Previous damage | Extent of damage (Net) |
|---|---|---|
| 1 | Side right, Provided by user / customer, from 12 Jun 2025 | 2.473,14 € |

**Previous damage 1:** Side right

**Previous damage 1: Side right**

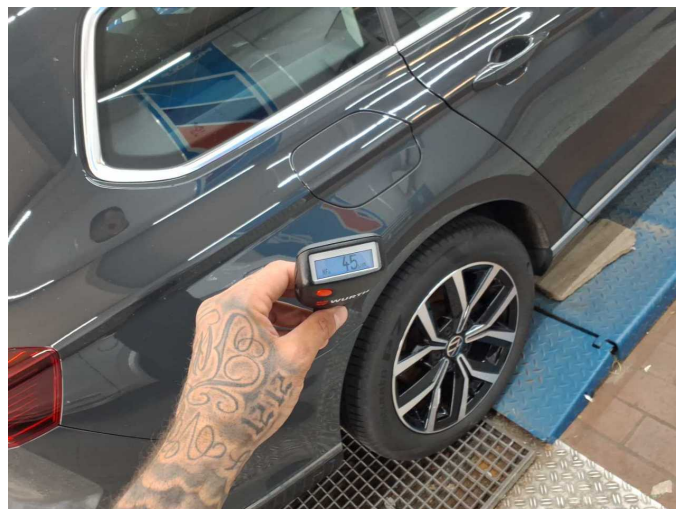
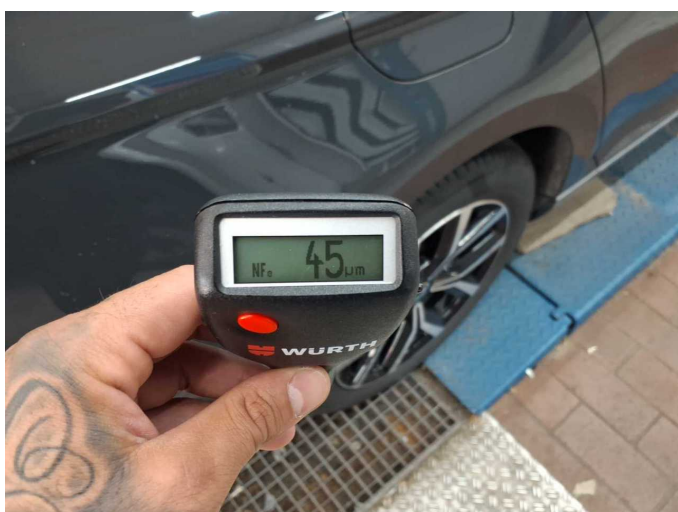
**Previous damage 1: Side right**

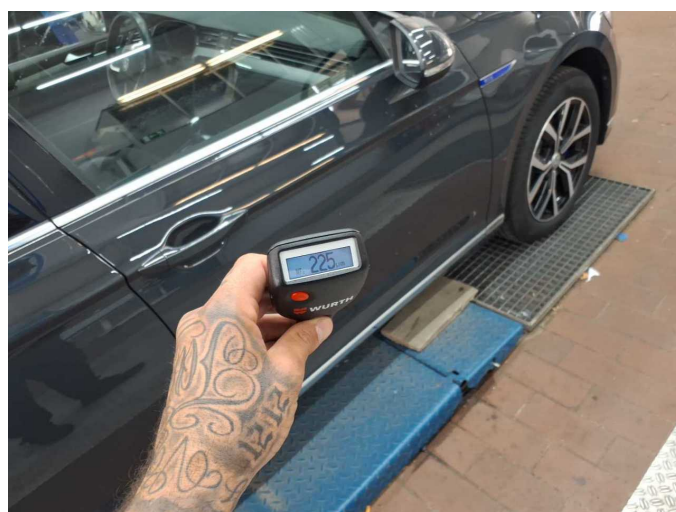
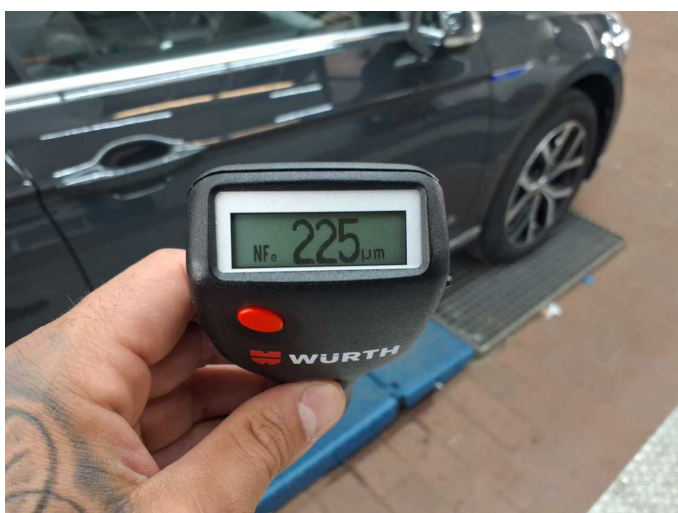
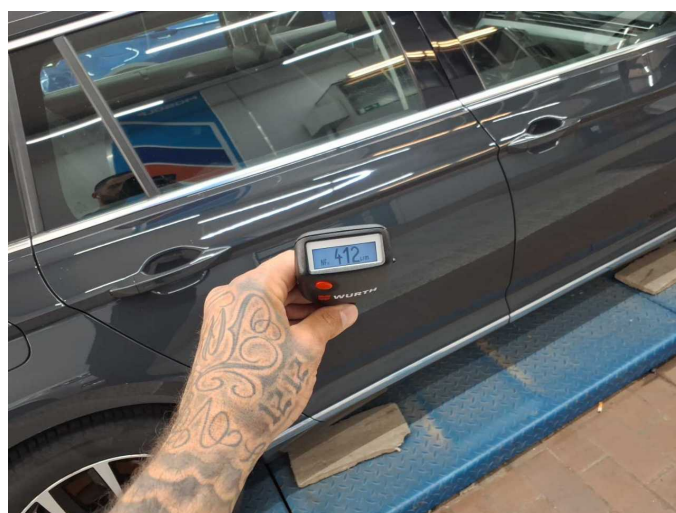
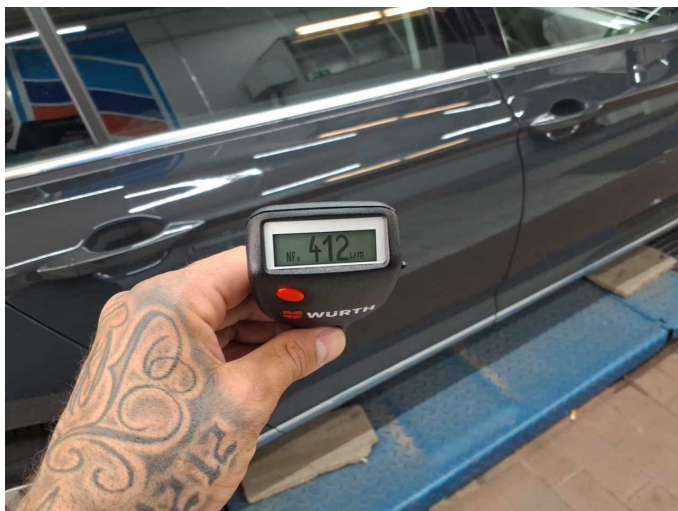
| No. | Repainting |
|---|---|
| 1 | Door - rear right side, Door - front right side, Professionally carried out |

| Door - rear right side | 412 µm | Door - front right side | 225 µm |

**Repainting 1: Door - rear right side, Door - front right side**

**Repainting 1:** Door - rear right side, Door - front right side
