Expertise

Protocol number: 46344082  
Order No. / Reference: 26588104  
Inspection date: 1 Jul 2026

Manufacturer: Mercedes-Benz

Model: GLC 220 d 4Matic 9G-TRONIC Exclusive

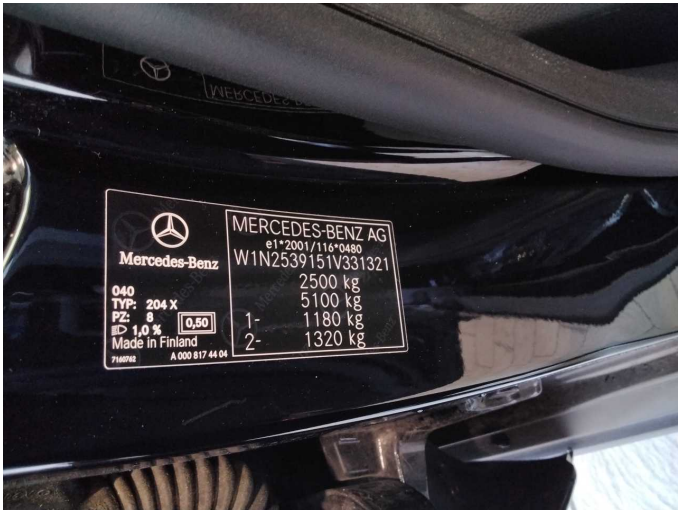
Figure 11: VIN

| VIN comparison | The vehicle identification number (VIN) was read from the vehicle and its conformity with the submitted documents was confirmed by the undersigned during the inspection. |

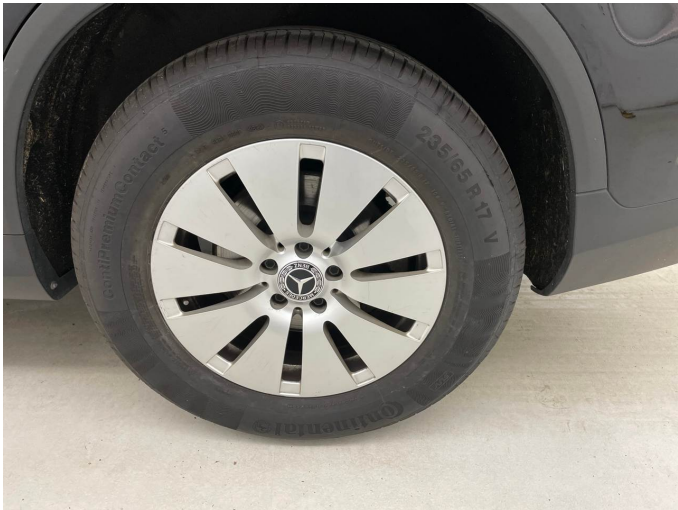
Figure 12: Mounted tyres

| # | Tyre size | Type of tyre | Manufacturer | Tread depth |
|---|---|---|---|---|
| 1) | 235/65 R17 108V | Summer tyres on Light alloy | Continental | 5mm / 5mm |
| 2) | 235/65 R17 108V | Summer tyres on Light alloy | Continental | 6mm / 6mm |

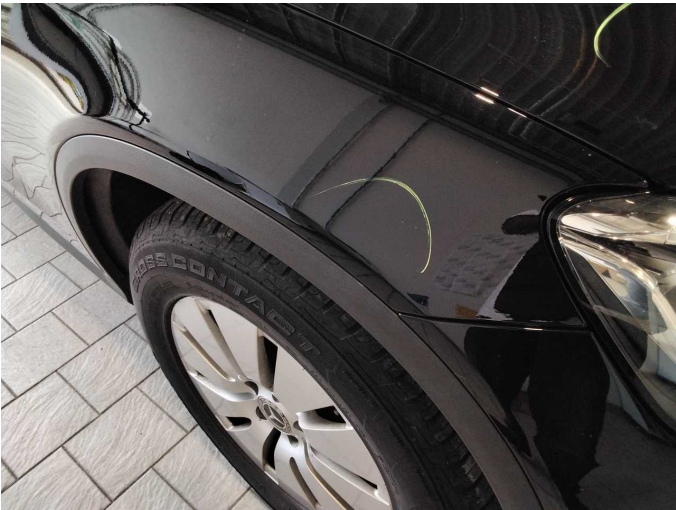
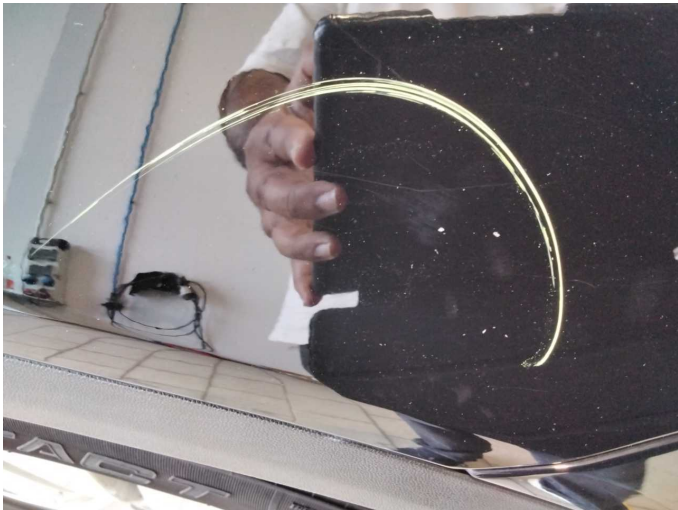
| No. | Component group | Description |
|---|---|---|
| 1 | Mudguard - right side | Mudguard - right side - Scratch(es) - Smart repair |

Damage 1: Mudguard - right side: Mudguard - right side - Scratch(es) - Smart repair

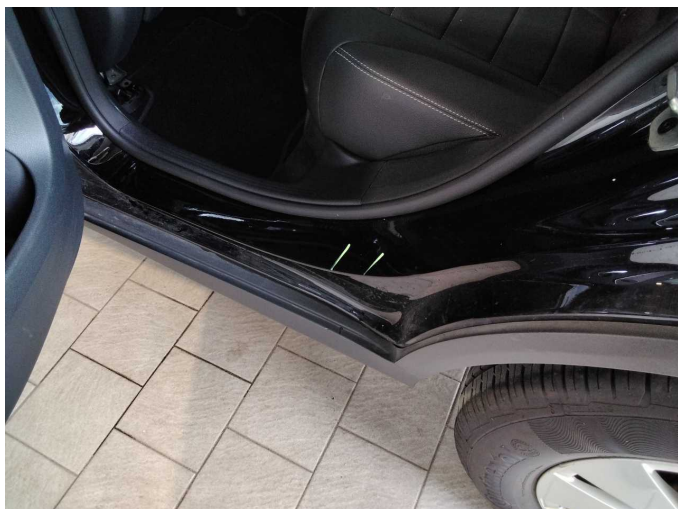
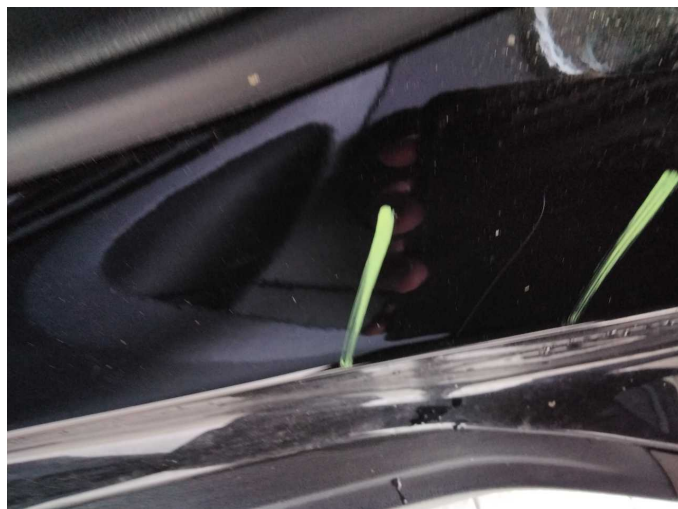
| No. | Component group | Description |
|---|---|---|
| 2 | Side panel - rear left side | Sill - Scratch(es) - Smart repair |

**Damage 2:** Side panel - rear left side: Sill - Scratch(es) - Smart repair

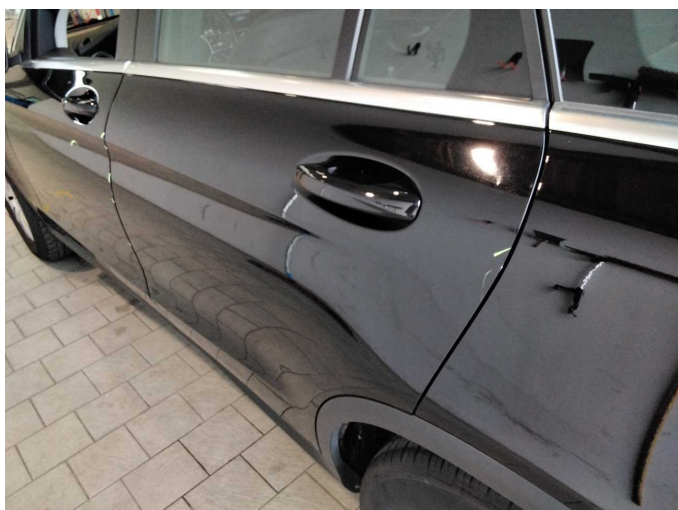
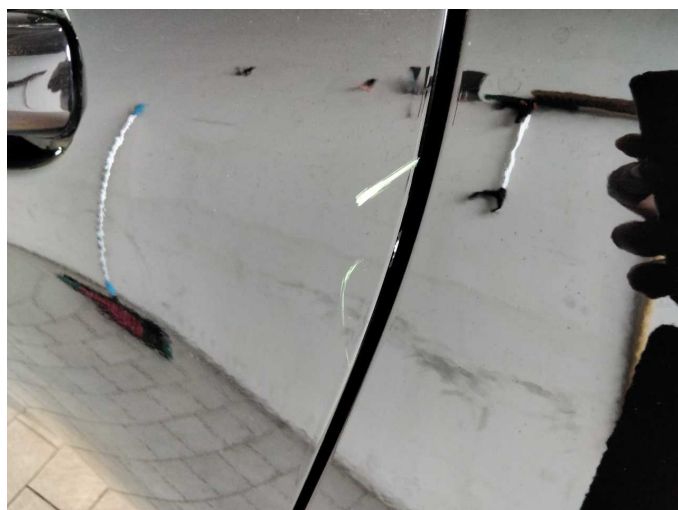
| No. | Component group | Description |
|---|---|---|
| 3 | Door - rear left side | Door edge - Scratch(es) - Smart repair |

**Damage 3:** Door - rear left side: Door edge - Scratch(es) - Smart repair

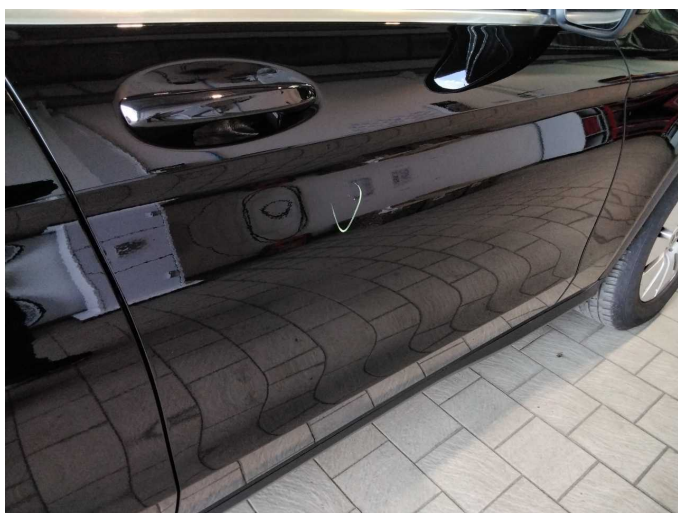
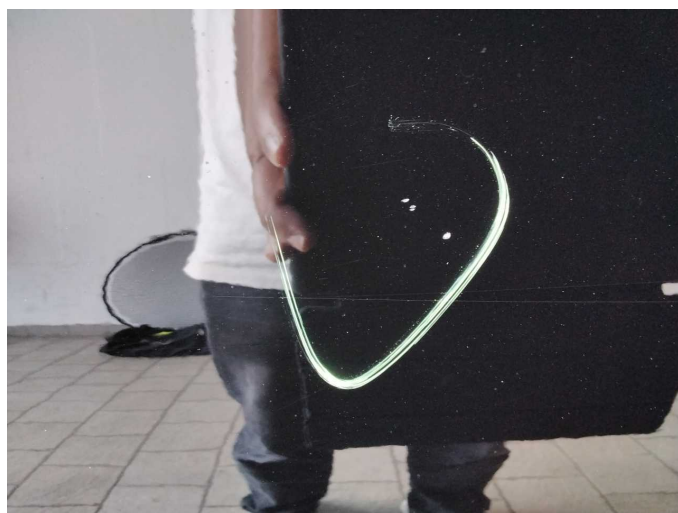
| No. | Component group | Description |
|---|---|---|
| 4 | Door - front right side | Door - Scratch(es) - Smart repair |

**Damage 4:** Door - front right side: Door - Scratch(es) - Smart repair

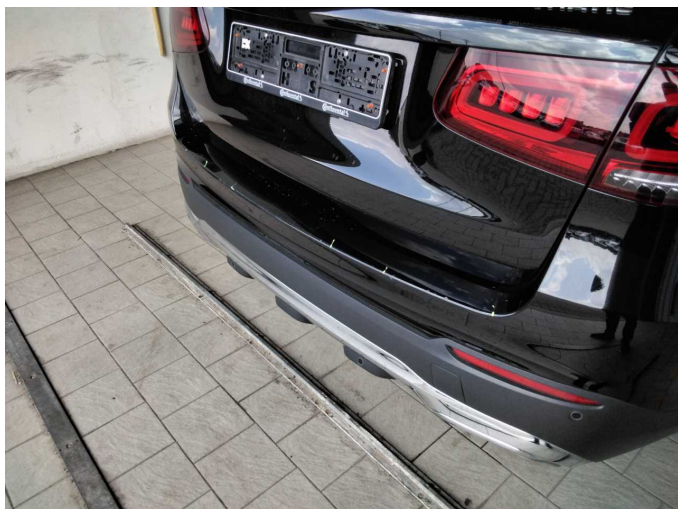
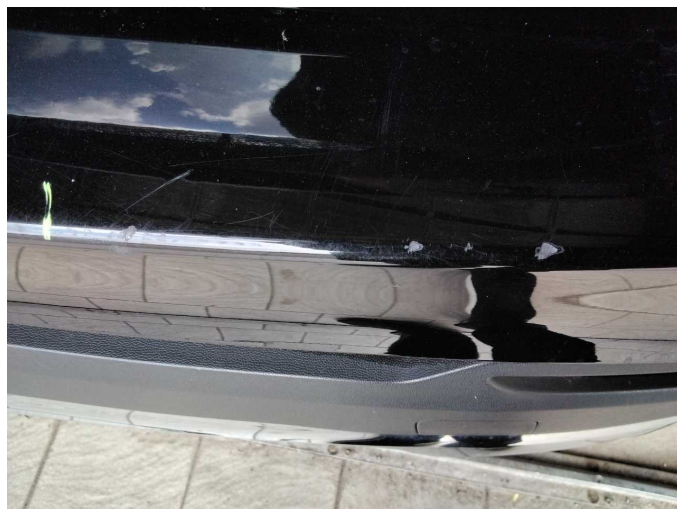
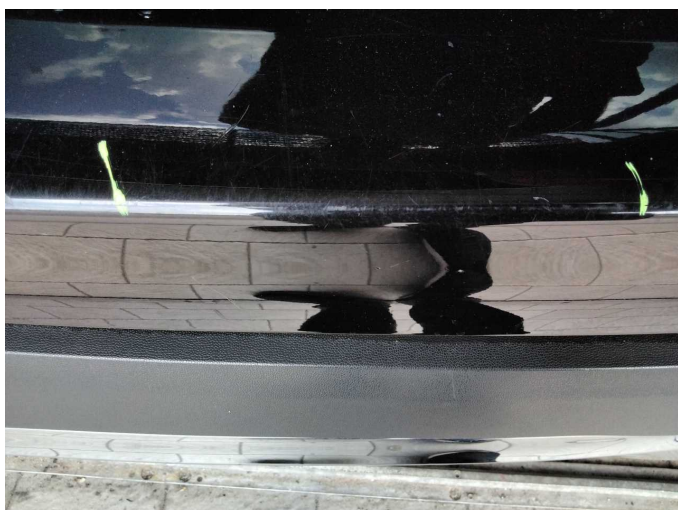
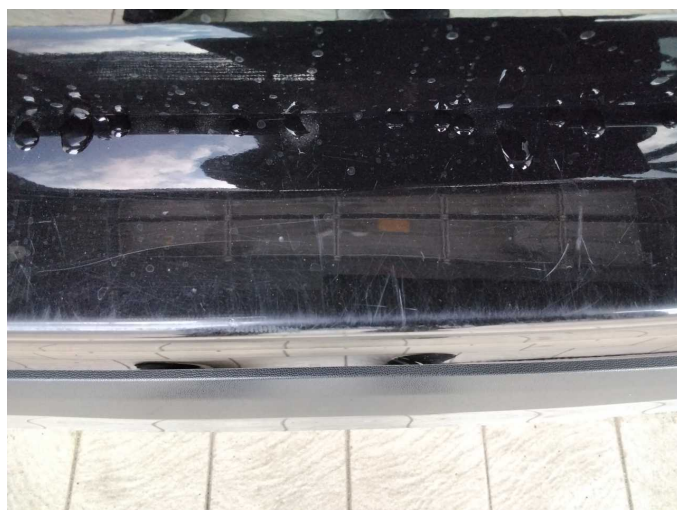
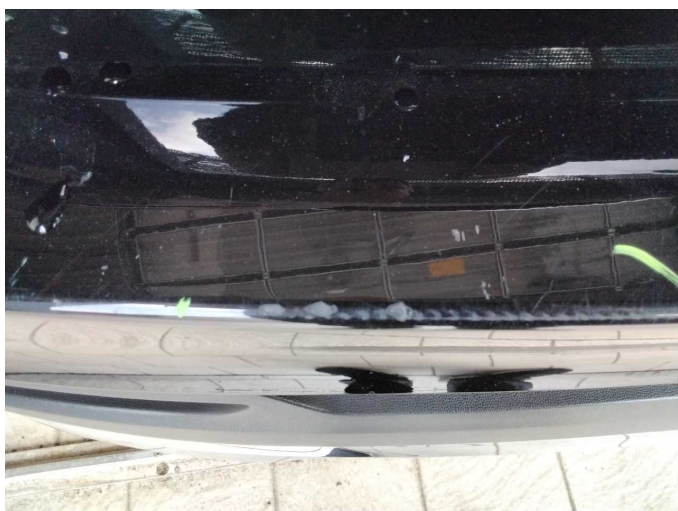
| No. | Component group | Description |
|---|---|---|
| 5 | Rear bumper | Rear bumper - Scratch(es) - Smart repair |

**Damage 5:** Rear bumper: Rear bumper - Scratch(es) - Smart repair

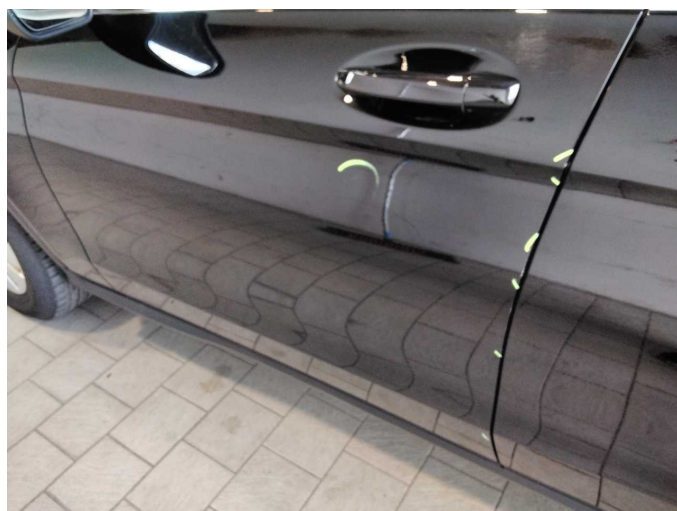
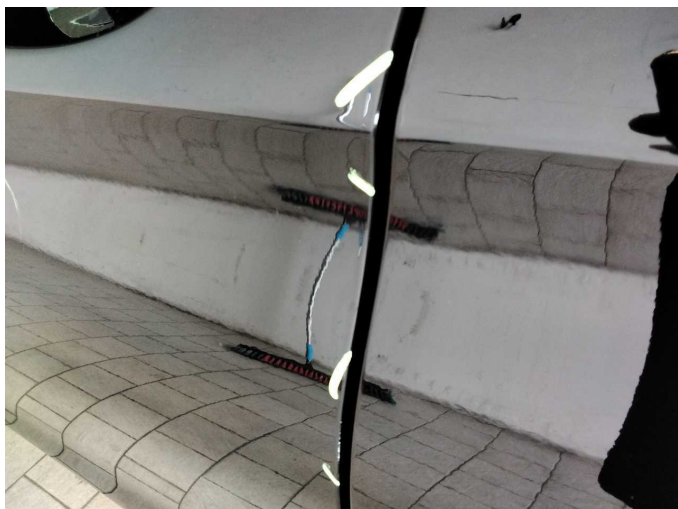
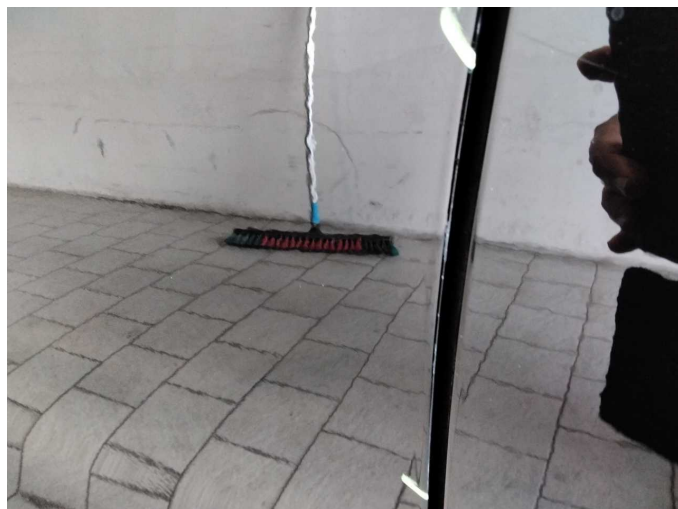
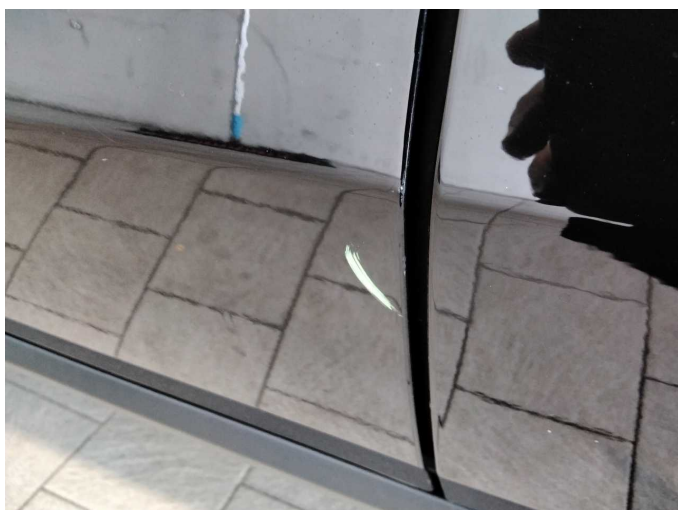
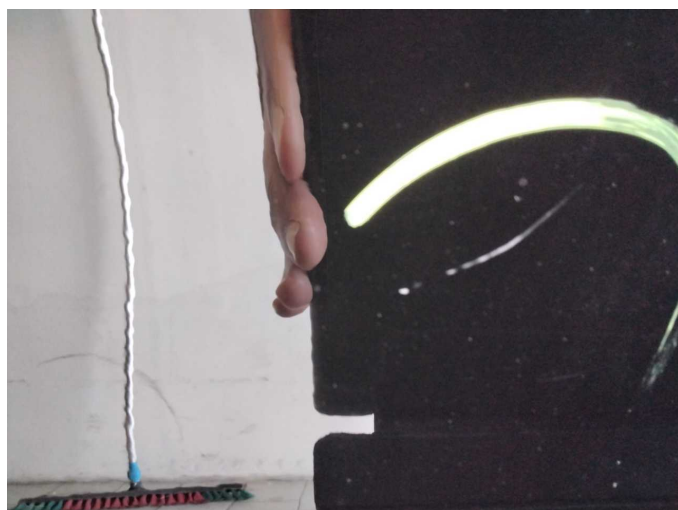
| No. | Component group | Description |
|---|---|---|
| 6 | Door - front left side | Door - Scratch(es) - Paint |

**Damage 6:** Door - front left side: Door - Scratch(es) - Paint

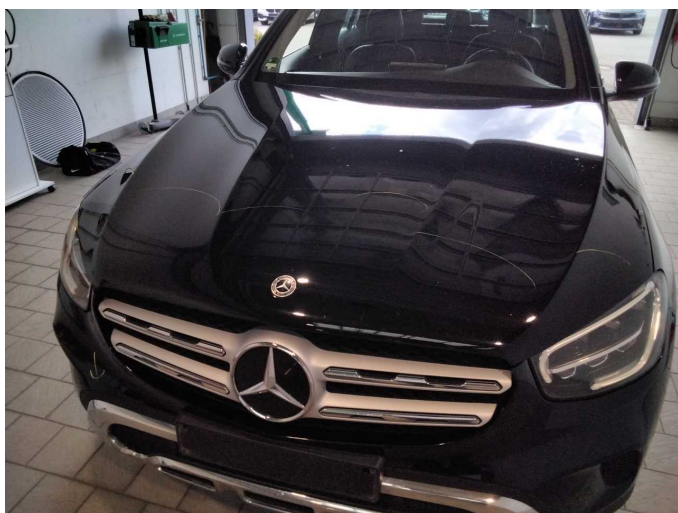
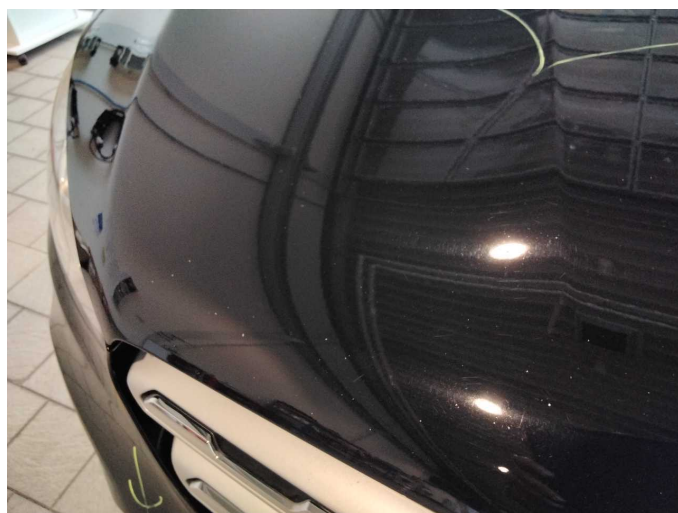
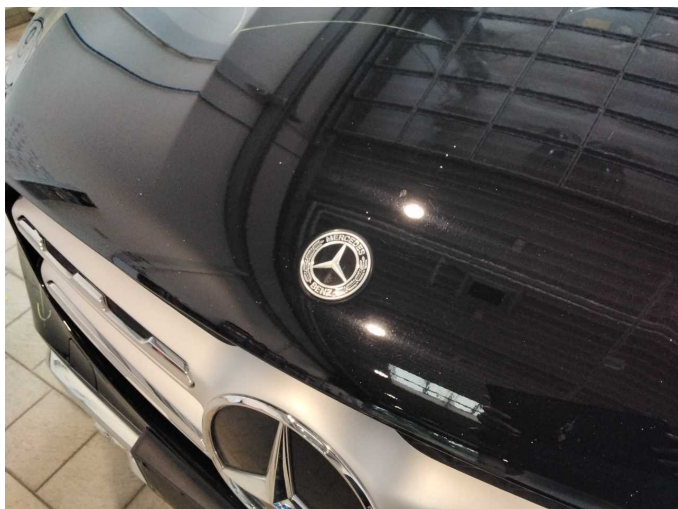
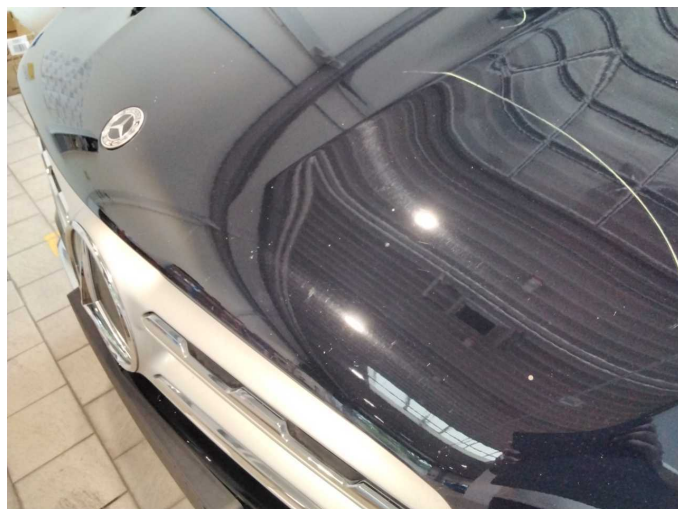
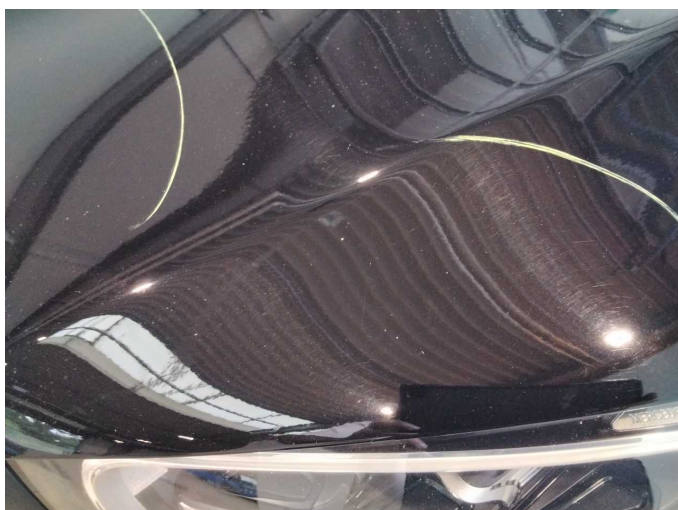
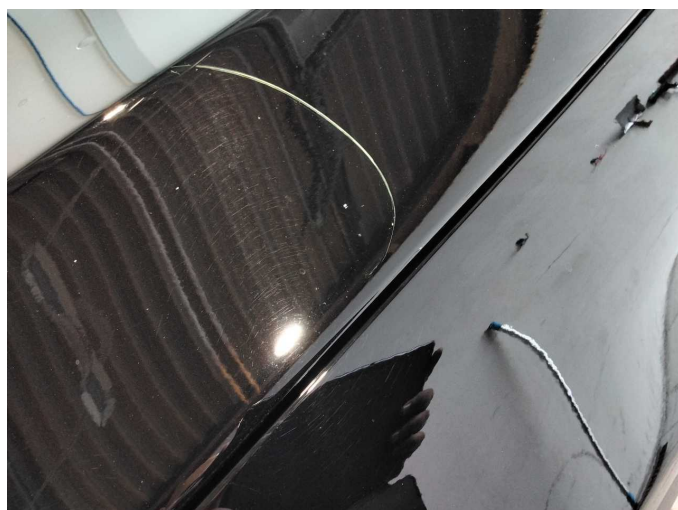
| No. | Component group | Description |
|---|---|---|
| 7 | Bonnet | Bonnet - Stone chips - Paint |

**Damage 7:** Bonnet: Bonnet - Stone chips - Paint

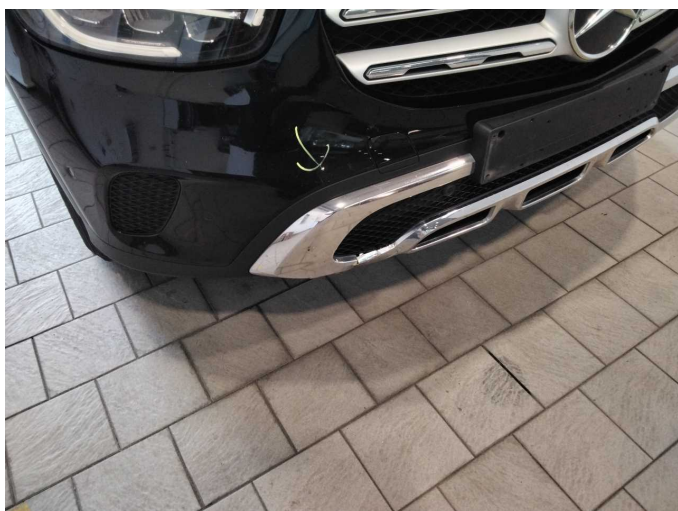
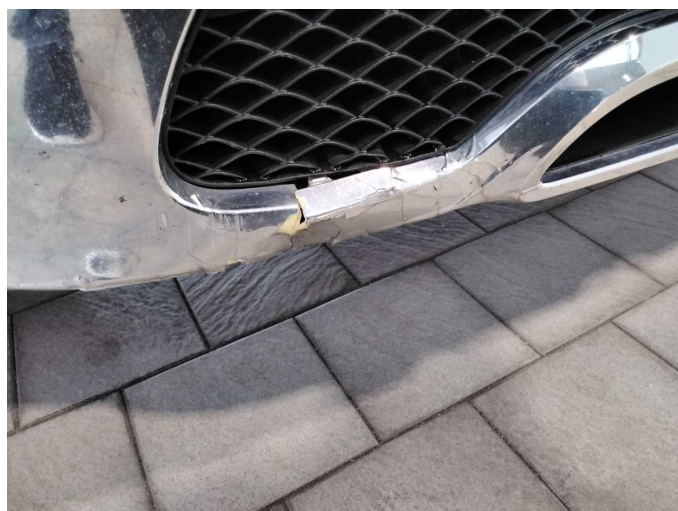
| No. | Component group | Description |
|---|---|---|
| 8 | Front bumper | Spoiler - Broken / torn - Replace |

**Damage 8:** Front bumper: Spoiler - Broken / torn - Replace
