Expertise

Protocol number: 46355501  
Order No. / Reference: 26373355  
Inspection date: 6 Jul 2026

Manufacturer: Volvo

Model: V90 T6 Recharge AWD Plus Bright

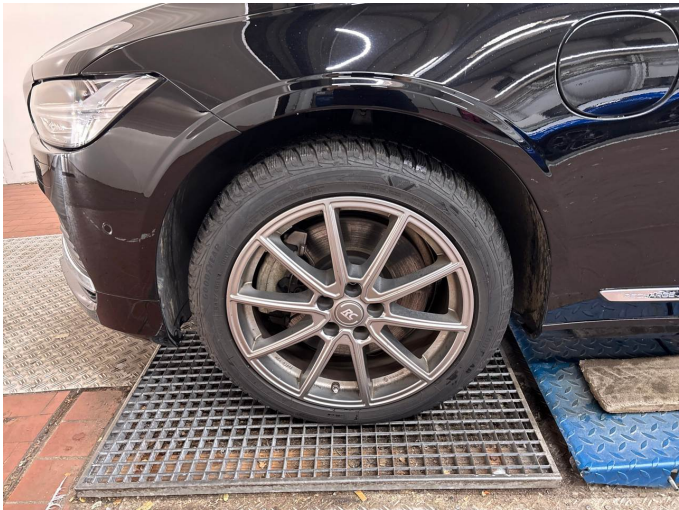
Figure 12: Mounted tyres

| # | Tyre size | Type of tyre | Manufacturer | Tread depth |
|---|---|---|---|---|
| 1) | 245/45 R18 100V | Winter tyres on Light alloy | Goodyear | 7mm / 7mm |
| 2) | 245/45 R18 100V | Winter tyres on Light alloy | Goodyear | 6mm / 6mm |

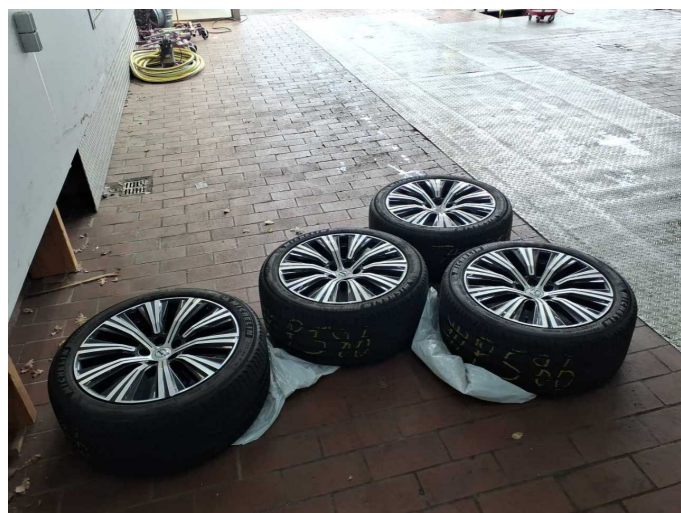
Figure 17: Additional tyres

| # | Tyre size | Type of tyre | Manufacturer | Tread depth |
|---|---|---|---|---|
| 1) | 255/40 R19 100W | Summer tyres on Light alloy | Michelin | 4mm / 4mm |
| 2) | 255/40 R19 100W | Summer tyres on Light alloy | Michelin | 4mm / 4mm |

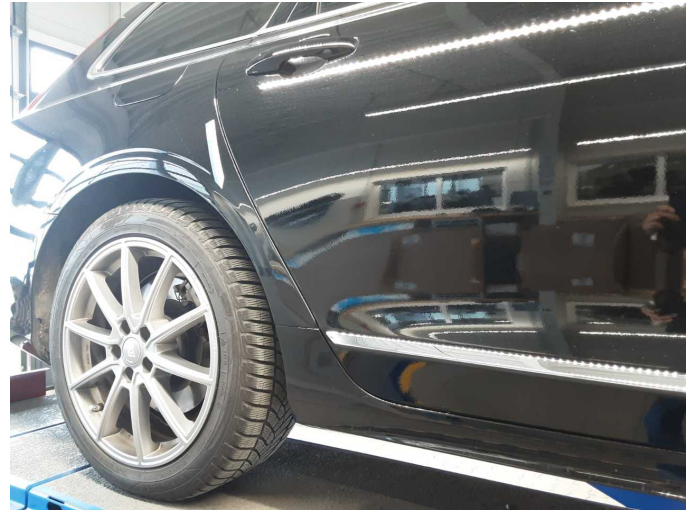
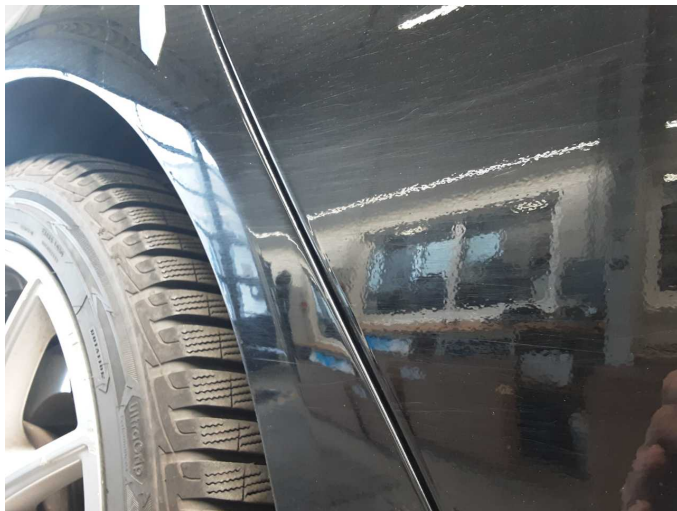
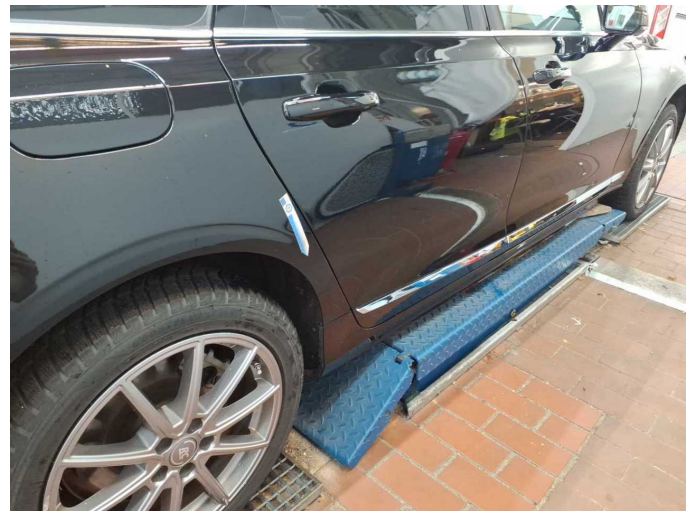
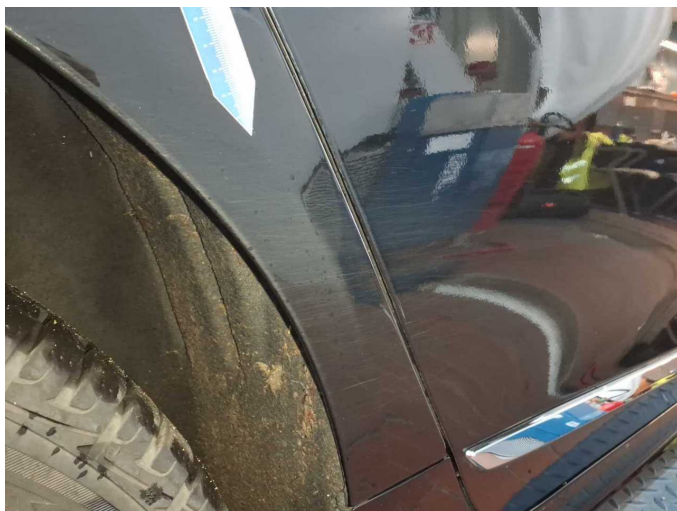
| No. | Component group | Description |
|---|---|---|
| 1 | Side panel - rear right side | Side panel - Scratched - Conditioning |

**Damage 1:** Side panel - rear right side: Side panel - Scratched - Conditioning

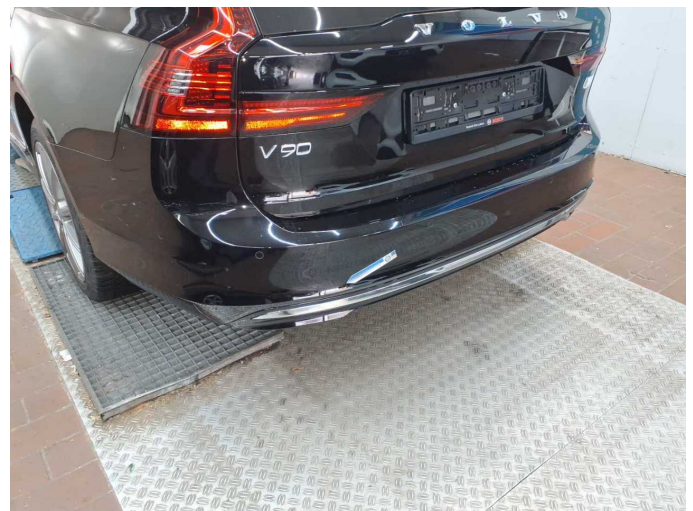
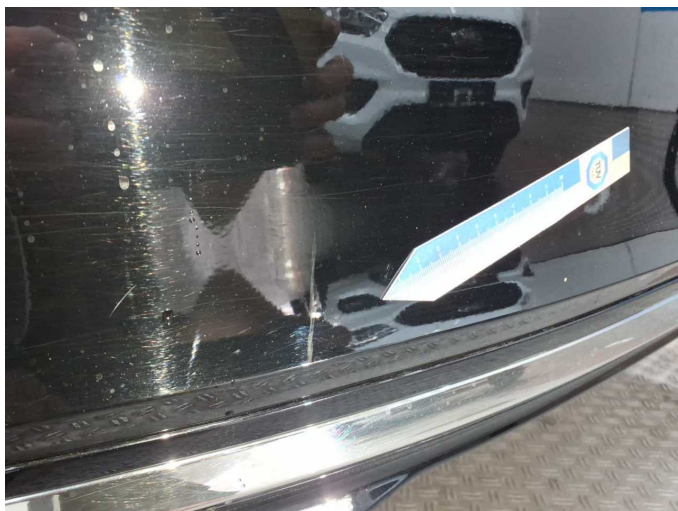
| No. | Component group | Description |
|---|---|---|
| 2 | Rear bumper | Rear bumper - Scratch(es) - Smart repair |

**Damage 2:** Rear bumper: Rear bumper - Scratch(es) - Smart repair

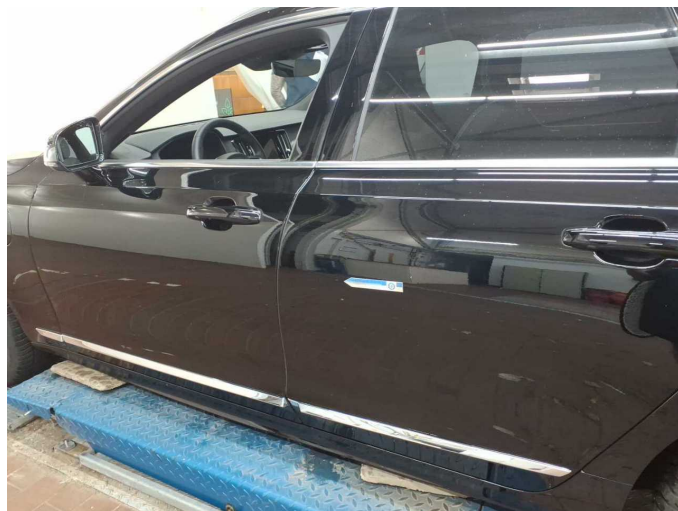
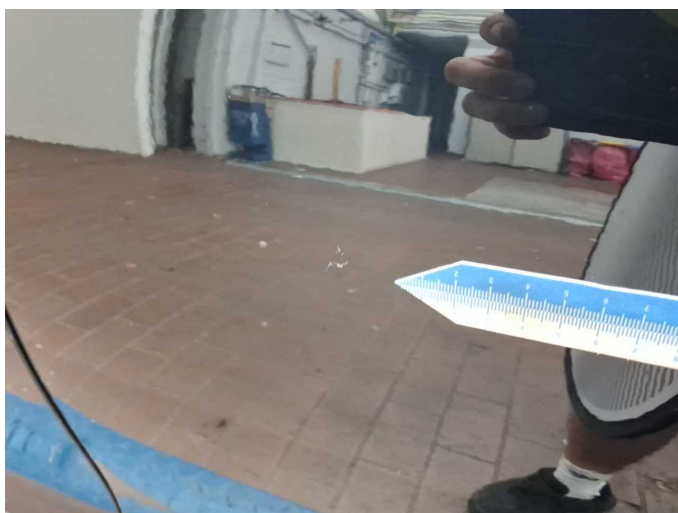
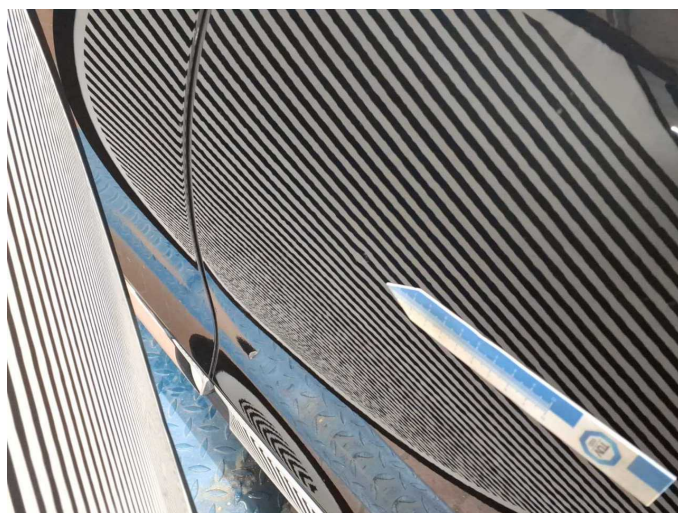
| No. | Component group | Description |
|---|---|---|
| 3 | Door - rear left side | Door (Mit Kratzer) - dent(s) - Smart repair |

**Damage 3:** Door - rear left side: Door (Mit Kratzer) - dent(s) - Smart repair

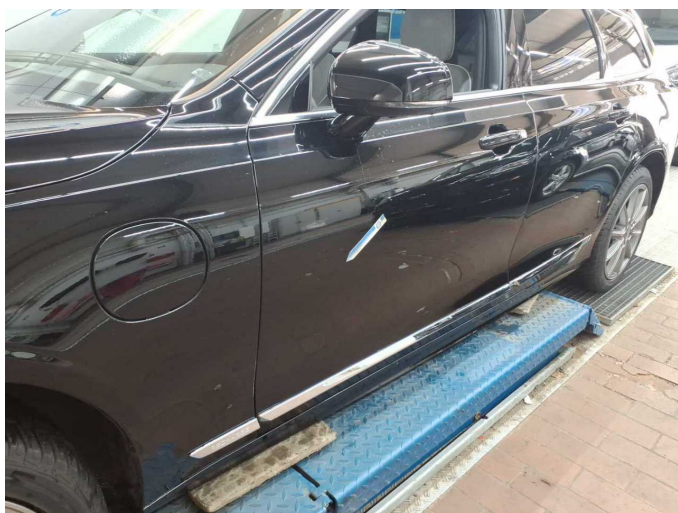
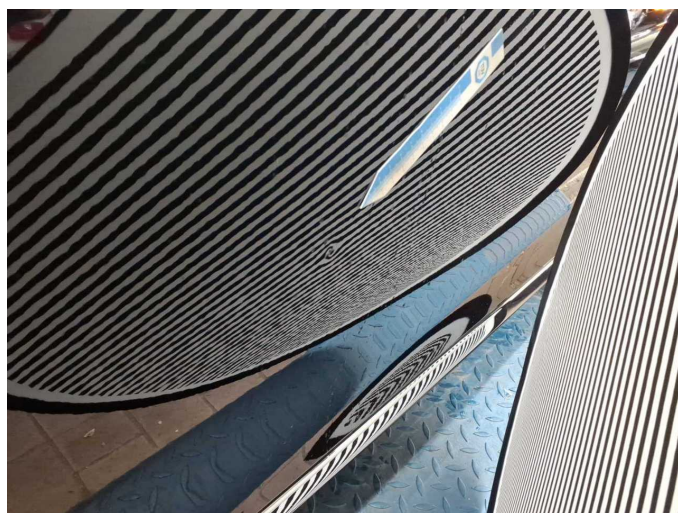
| No. | Component group | Description |
|---|---|---|
| 4 | Door - front left side | Door - dent(s) - Smart repair |

**Damage 4:** Door - front left side: Door - dent(s) - Smart repair

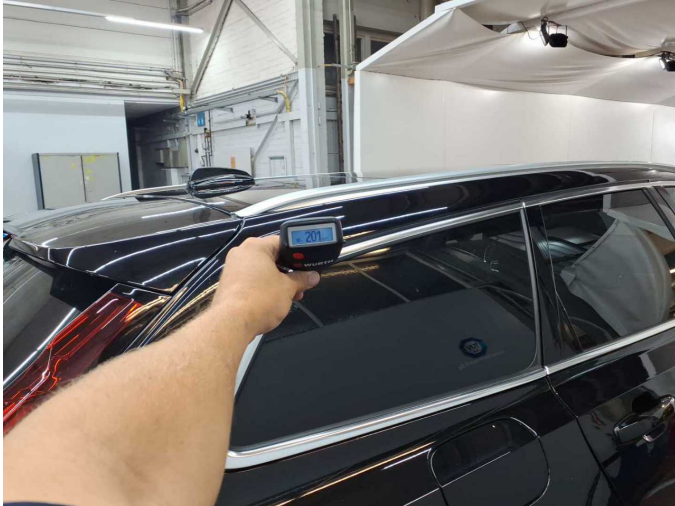
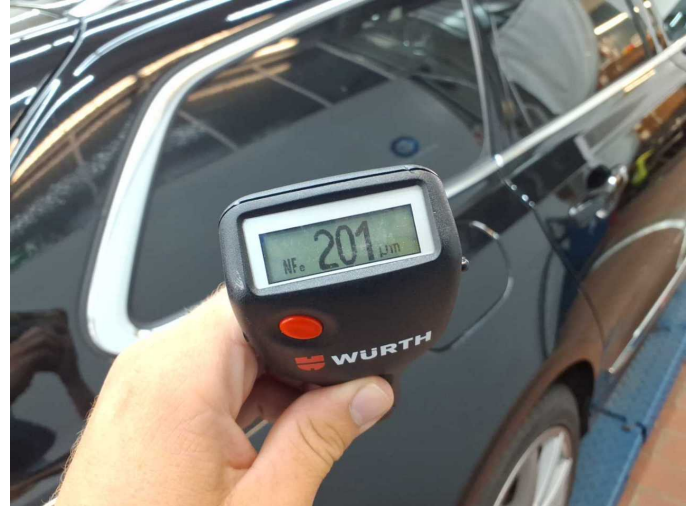
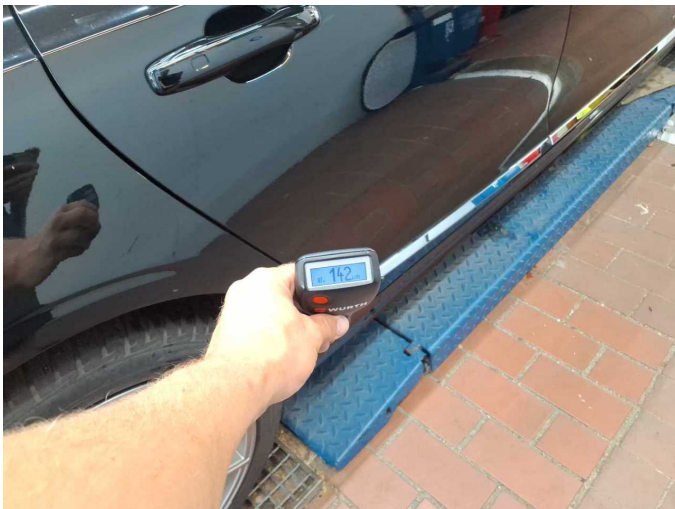
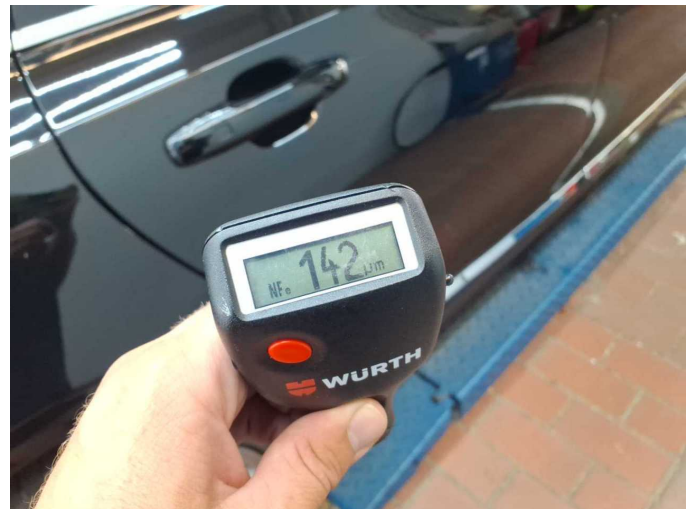
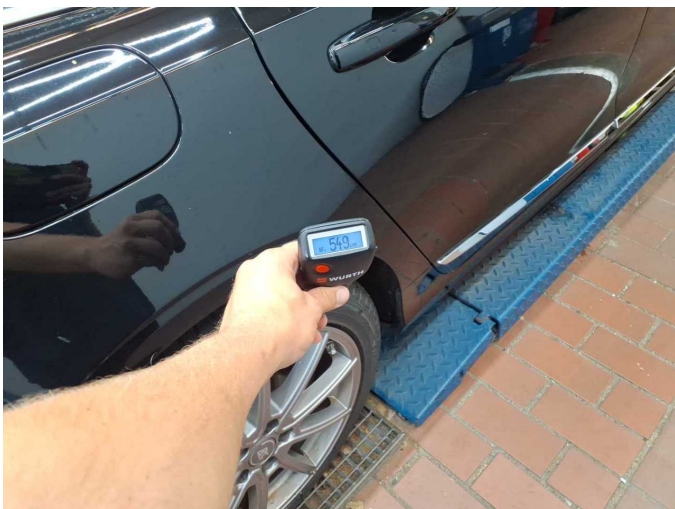
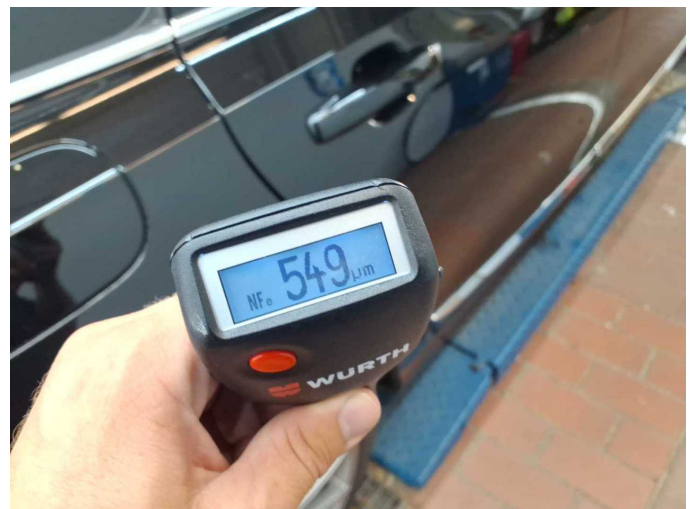
1 Roof rail - right side, Side panel - rear right side, Door - rear right side, Professionally carried out, Invoice of repair done Non-existent

| Roof rail - right side | 201 µm | Side panel - rear right side | 549 µm |
| Door - rear right side | 142 µm | | |

**Repainting 1:** Roof rail - right side, Side panel - rear right side, Door - rear right side
