Expertise

Protocol number: 46674161  
Order No. / Reference: 26543035  
Inspection date: 23 Jul 2026

Manufacturer: Audi

Model: Q5 50 TFSIe quattro S tronic

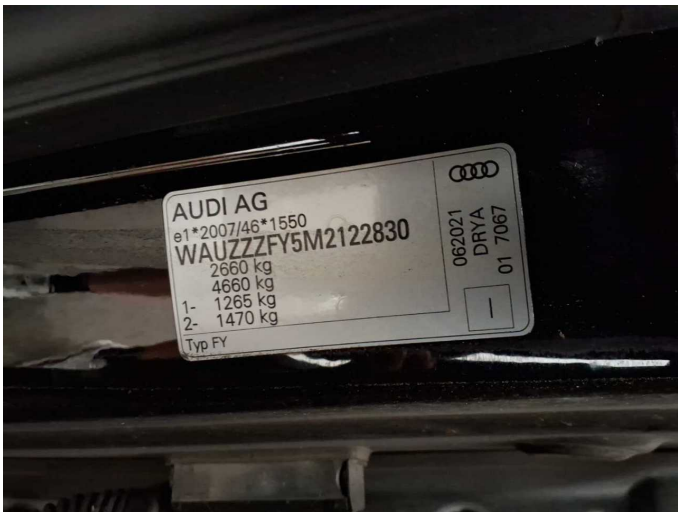
| VIN comparison | The vehicle identification number (VIN) was read from the vehicle and its conformity with the submitted documents was confirmed by the undersigned during the inspection. |

Figure 11: VIN

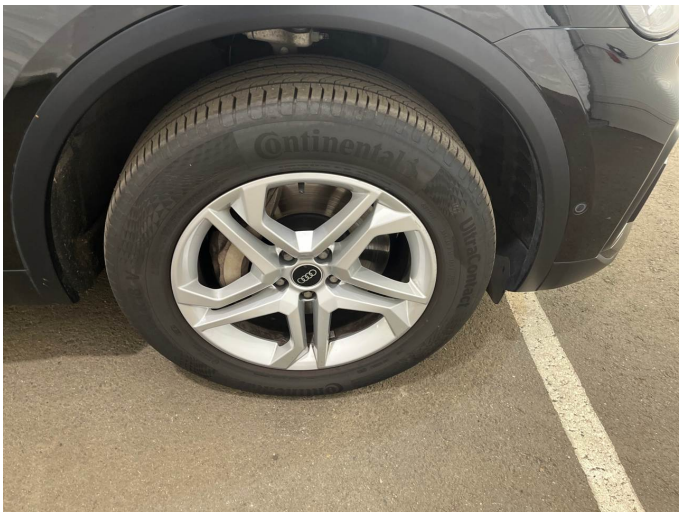
| # | Tyre size | Type of tyre | Manufacturer | Tread depth |
|---|---|---|---|---|
| 1) | 235/60 R18 103V | Summer tyres on Light alloy | Continental | 6mm / 6mm |
| 2) | 235/60 R18 103V | Summer tyres on Light alloy | Continental | 7mm / 7mm |

Figure 12: Mounted tyres

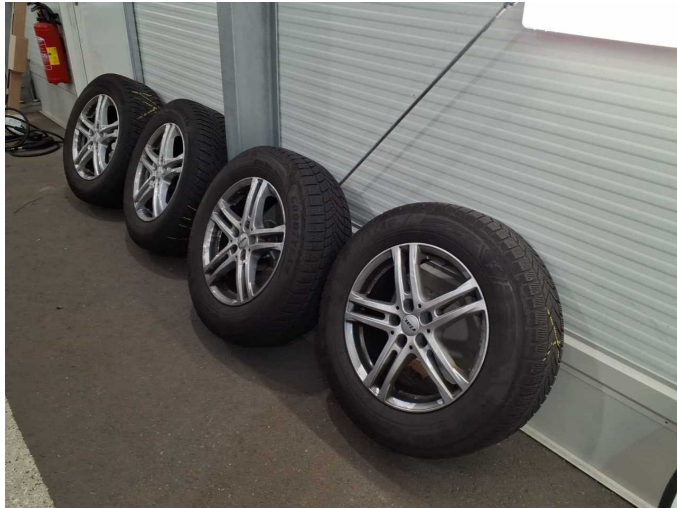
| # | Tyre size | Type of tyre | Manufacturer | Tread depth |
|---|---|---|---|---|
| 1) | 235/65 R17 104H | Winter tyres on Light alloy | Goodyear | 5mm / 5mm |
| 2) | 235/65 R17 104H | Winter tyres on Light alloy | Goodyear | 7mm / 7mm |

Figure 19: Additional tyres

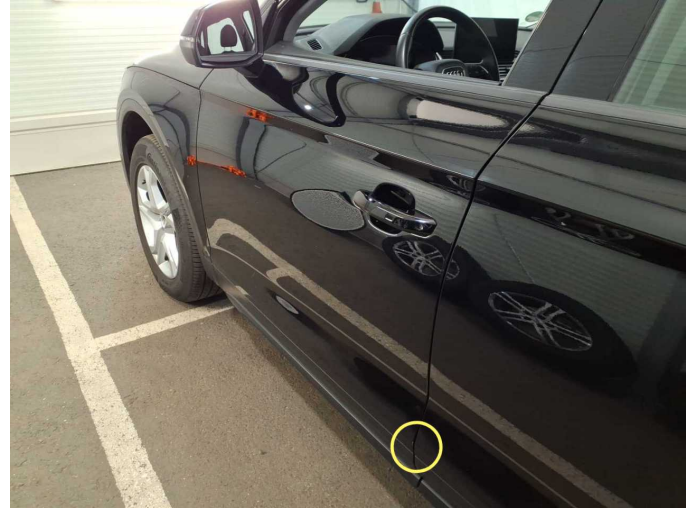
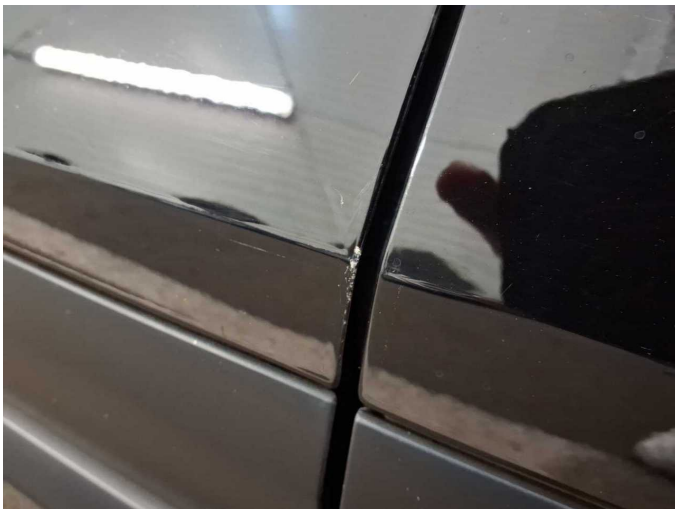
| No. | Component group | Description |
|---|---|---|
| 1 | Door - front left side | Door edge - Scratch(es) - Smart repair |

**Damage 1:** Door - front left side: Door edge - Scratch(es) - Smart repair

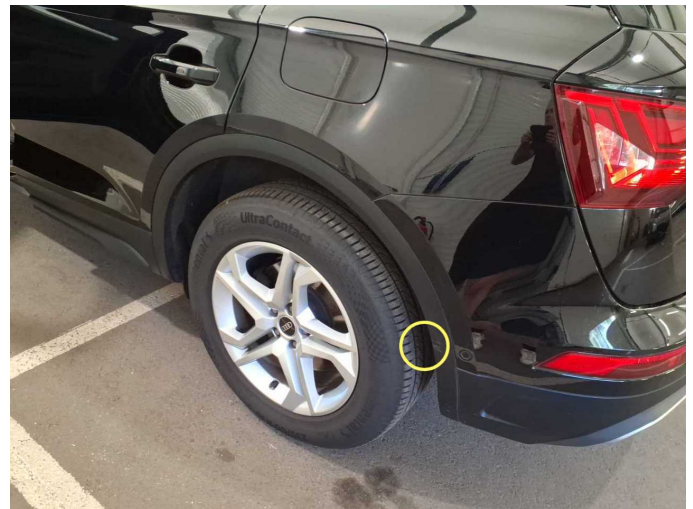
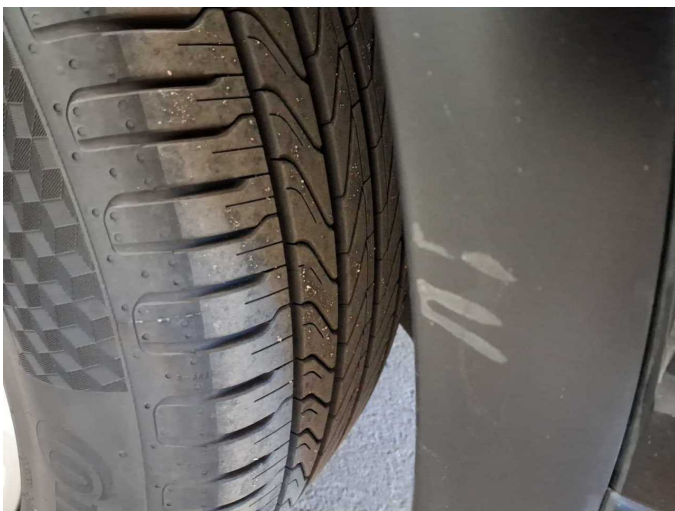
| No. | Component group | Description |
|---|---|---|
| 2 | Side panel - rear left side | Wheel well extension - Scratch(es) - Loss in value |

**Damage 2:** Side panel - rear left side: Wheel well extension - Scratch(es)  
- Loss in value

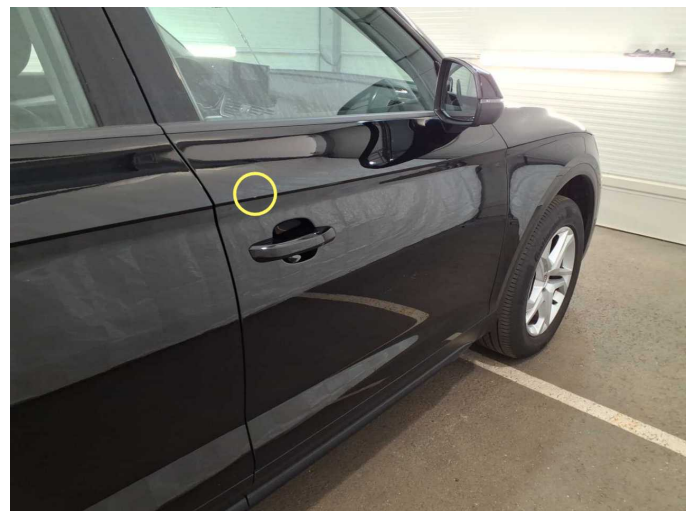
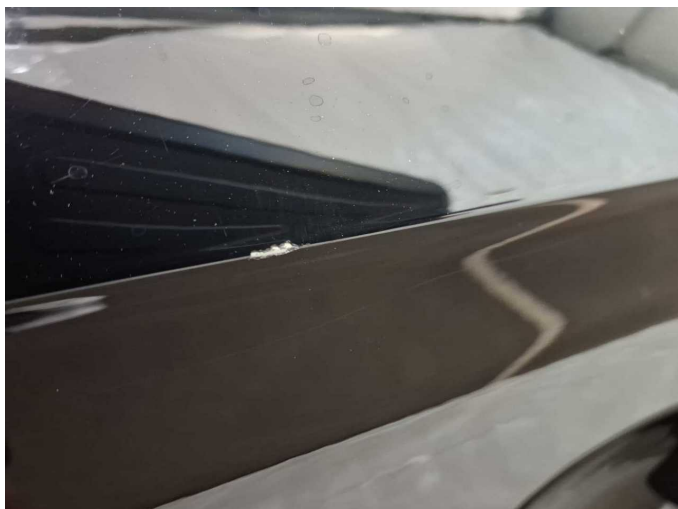
| No. | Component group | Description |
|---|---|---|
| 3 | Door - front right side | Door - Scratch(es) - Smart repair |

**Damage 3:** Door - front right side: Door - Scratch(es) - Smart repair

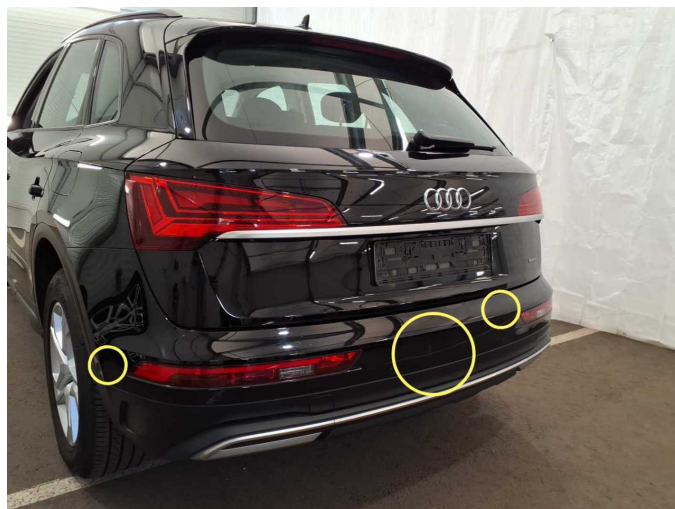
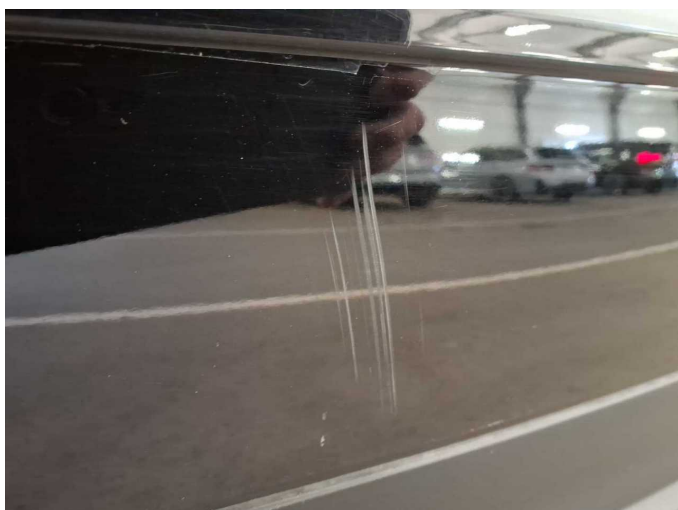
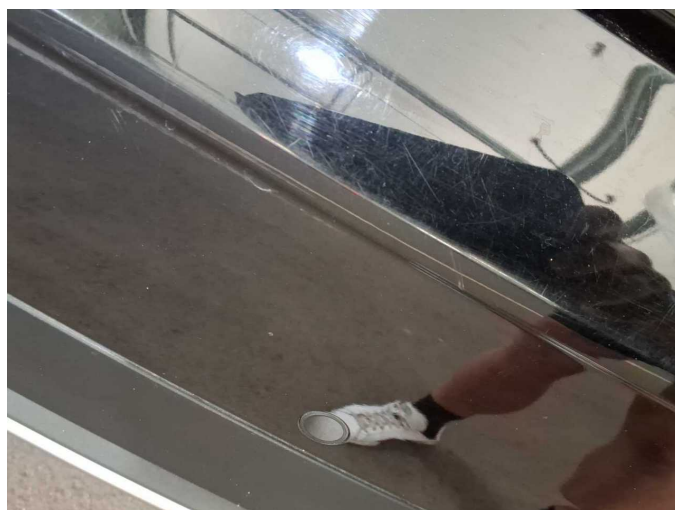
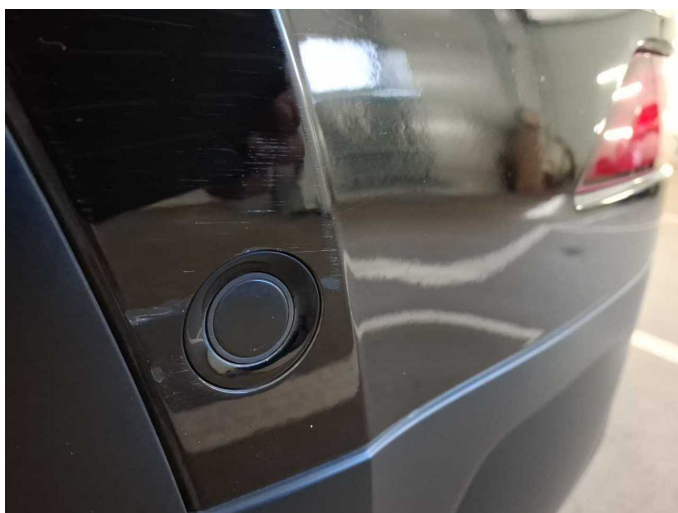
| No. | Component group | Description |
|---|---|---|
| 4 | Rear bumper | Rear bumper - Scratch(es) - Paint |

**Damage 4:** Rear bumper: Rear bumper - Scratch(es) - Paint

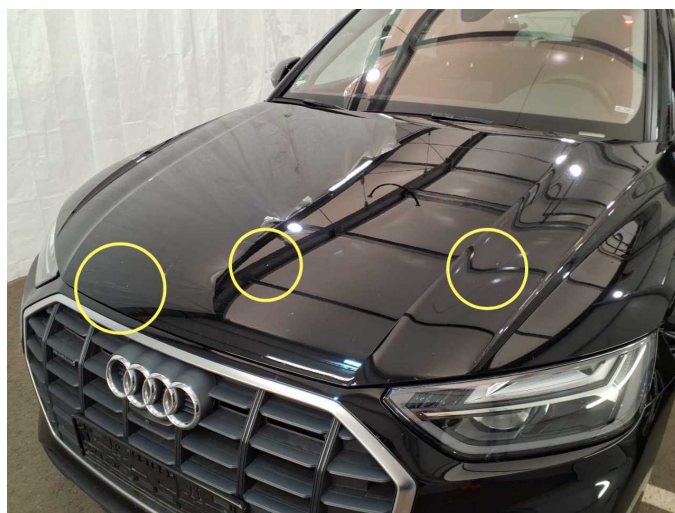
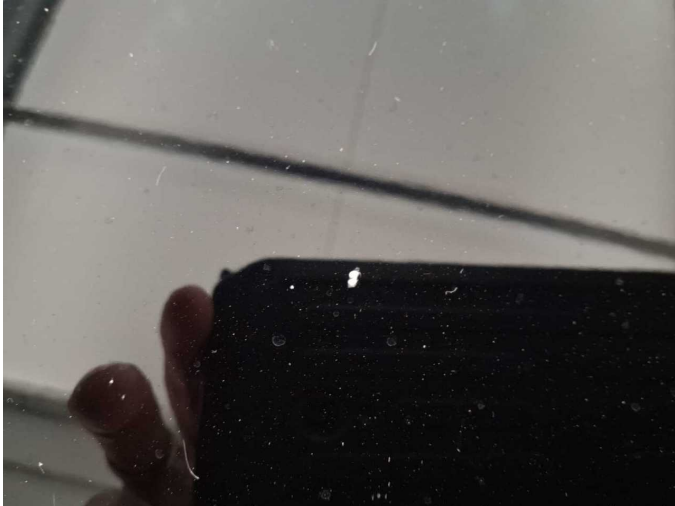
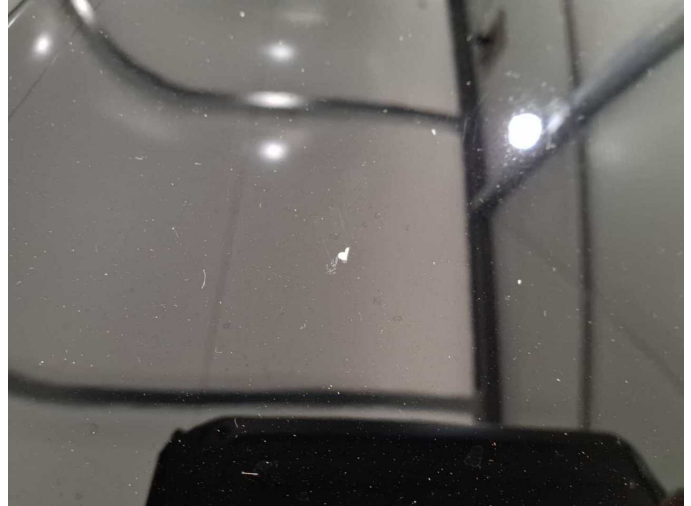
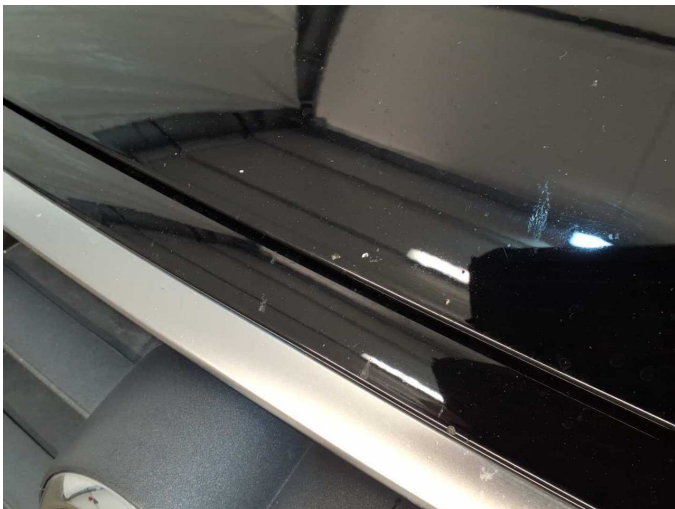
| No. | Component group | Description |
|---|---|---|
| 5 | Bonnet | Bonnet - Stone chips - Paint |

**Damage 5:** Bonnet: Bonnet - Stone chips - Paint
