Expertise

Protocol number: 46831785  
Order No. / Reference: 26830934  
Inspection date: 16 Jul 2026

Manufacturer: Opel

Model: Zafira Life 2.0 D L Aut. Edition

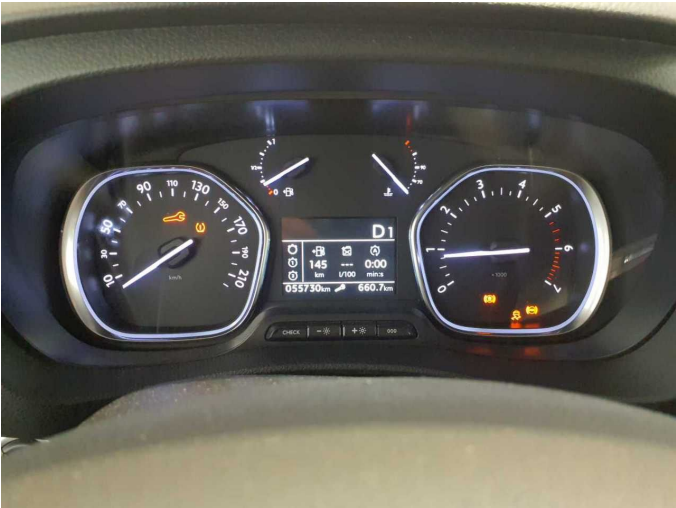
Mileage (Read) 55,730 km

Figure 7: Instrument cluster

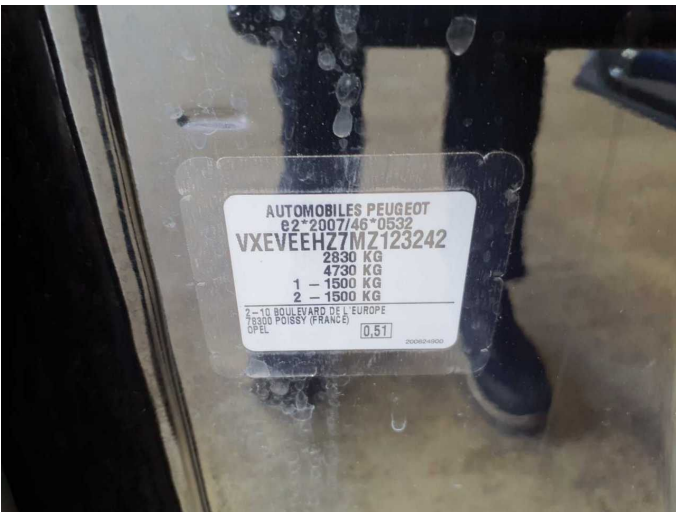
Figure 11: VIN

| VIN comparison | The vehicle identification number (VIN) was read from the vehicle and its conformity with the submitted documents was confirmed by the undersigned during the inspection. |

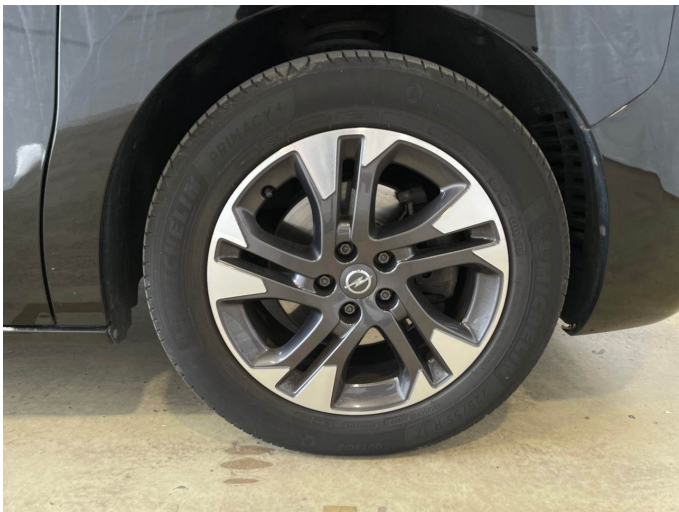
| # | Tyre size | Type of tyre | Manufacturer | Tread depth |
|---|---|---|---|---|
| 1) | 225/55 R17 101V | Summer tyres on Light alloy | Michelin | 4mm / 4mm |
| 2) | 225/55 R17 101V | Summer tyres on Light alloy | Michelin | 5mm / 5mm |

Figure 12: Mounted tyres

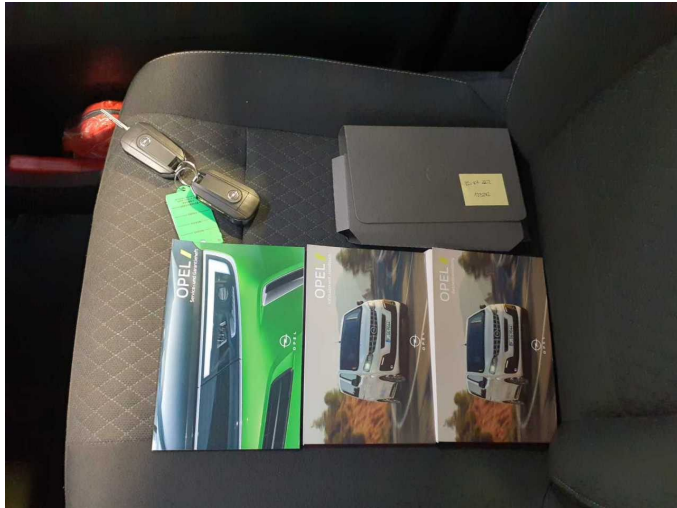
| Documents submitted | At the time of the inspection, the vehicle registration certificate Part 2 (title) was available, but the vehicle registration certificate Part 1 (document) was not. (Copy) |

Figure 13: Documents

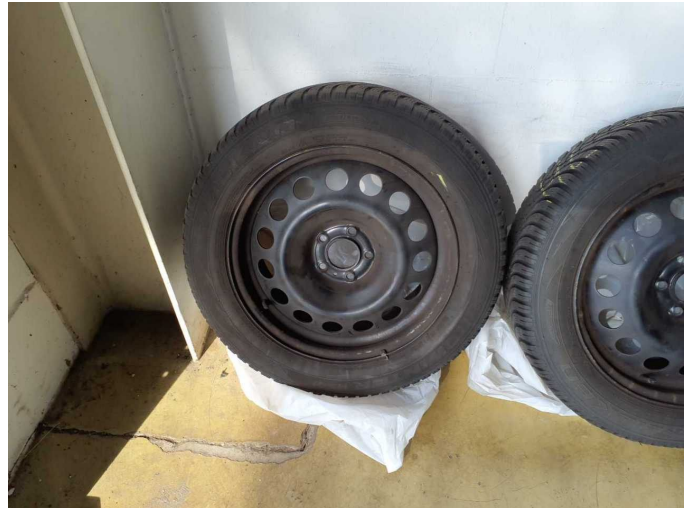
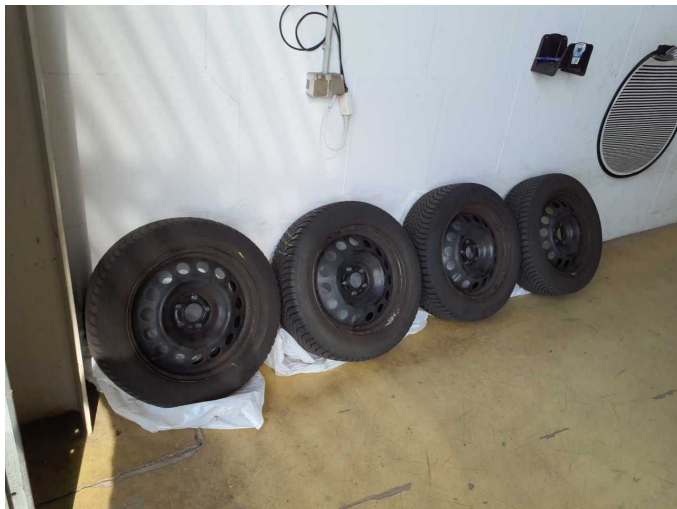
| # | Tyre size | Type of tyre | Manufacturer | Tread depth |
|---|---|---|---|---|
| 1) | 225/55 R17 101V | Winter tyres on Steel rim with wheel cover | Falken | 5mm / 5mm |
| 2) | 225/55 R17 101V | Winter tyres on Steel rim with wheel cover | Falken | 7mm / 7mm |

Figure 14: Additional tyres

Figure 15: Additional tyres

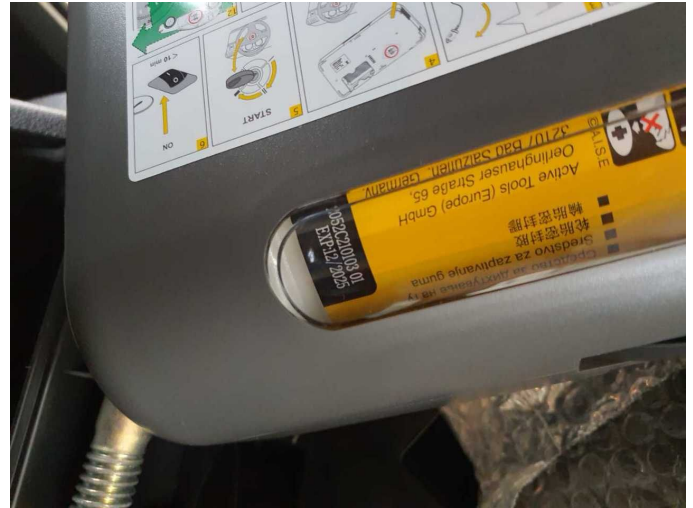
**Damage 1:** Equipment: Tirefit filler - Expired - Replace

| No. | Component group | Description |
|---|---|---|
| 1 | Equipment | Tirefit filler - Expired - Replace |

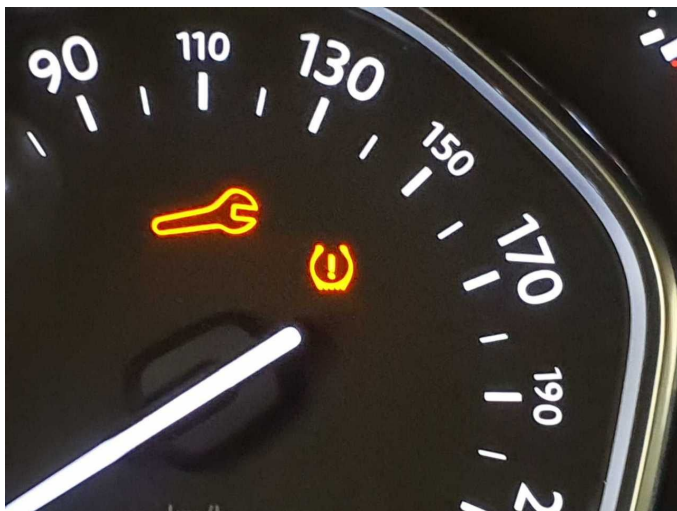
**Damage 2:** Misc.: Misc. (Reifendruckkontrolle) - on - Perform diagnosis

| No. | Component group | Description |
|---|---|---|
| 2 | Misc. | Misc. (Reifendruckkontrolle) - on - Perform diagnosis |

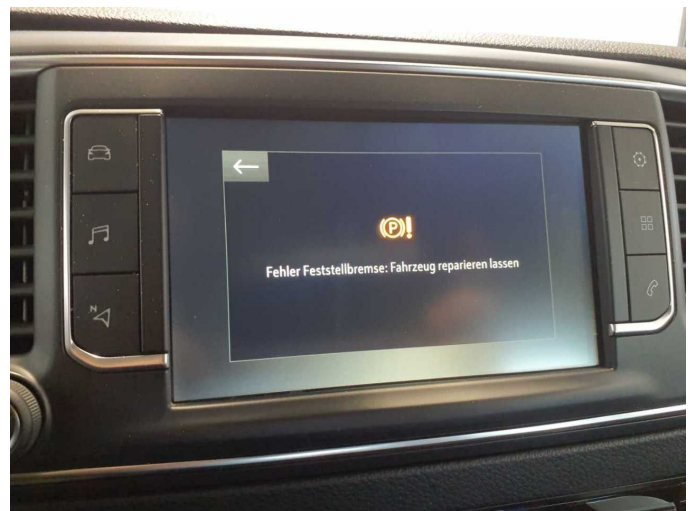
**Damage 3:** Braking system: Parking brake / hand brake (Feststellbremse) - Functional / admissibility - Perform diagnosis

| No. | Component group | Description |
|---|---|---|
| 3 | Braking system | Parking brake / hand brake (Feststellbremse) - Functional / admissibility - Perform diagnosis |

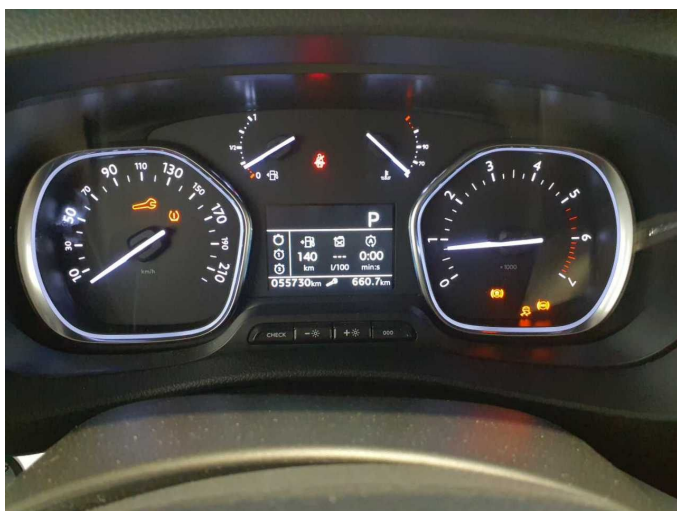
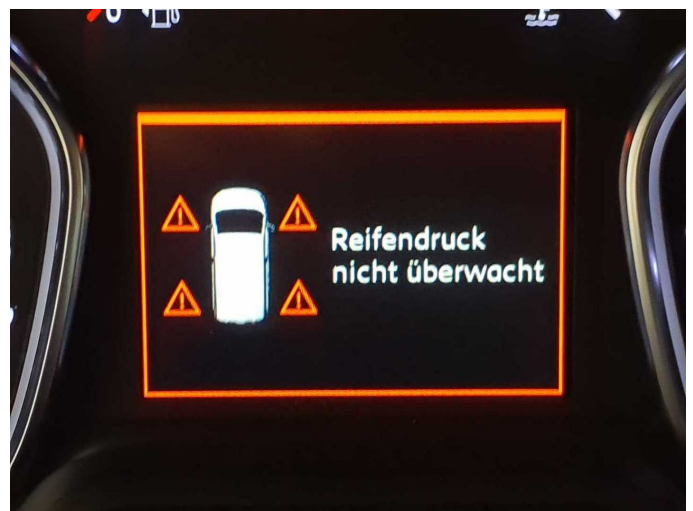
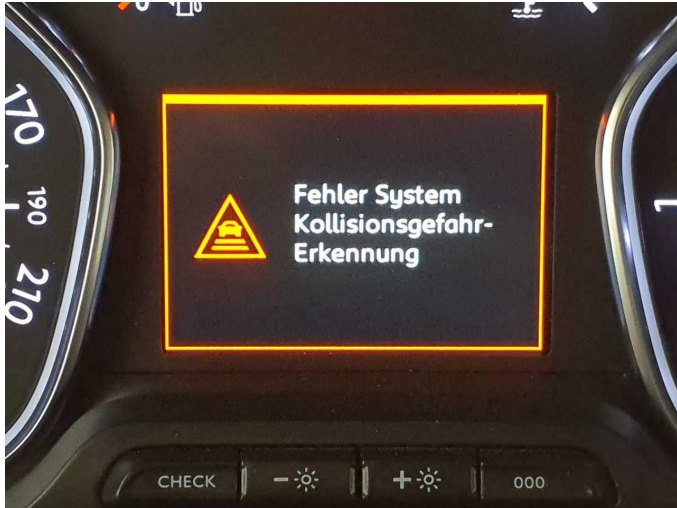
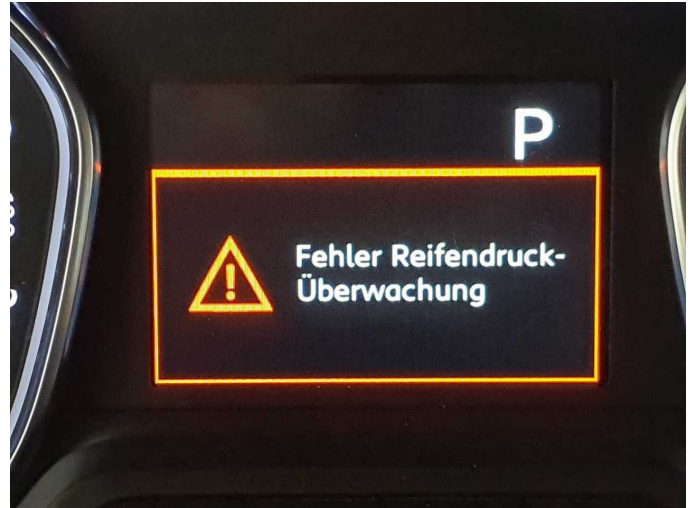
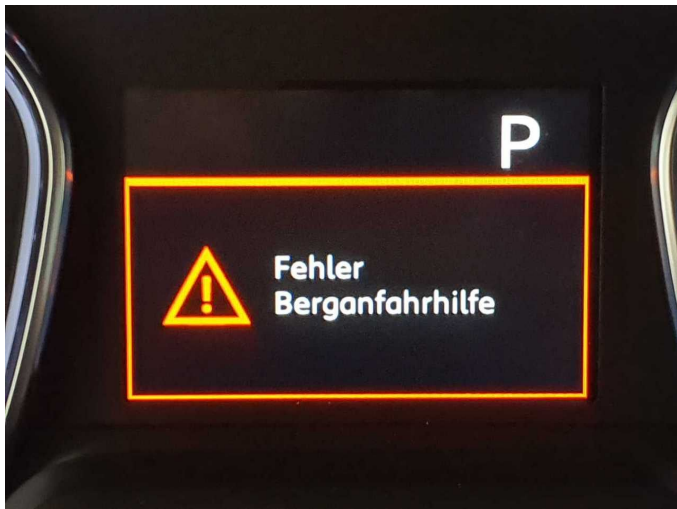
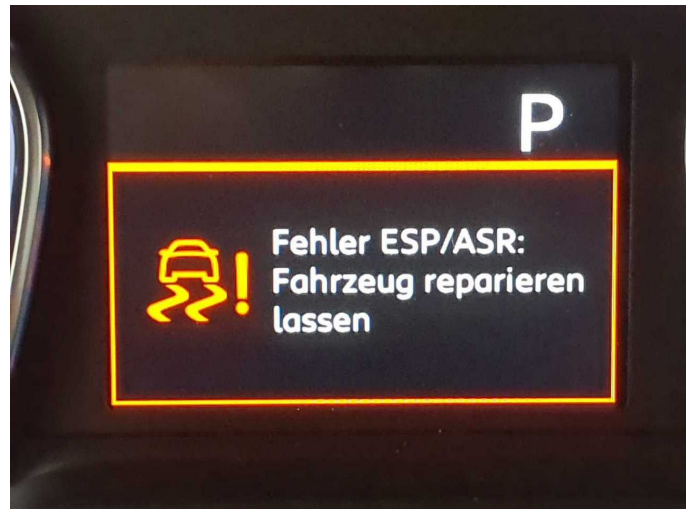
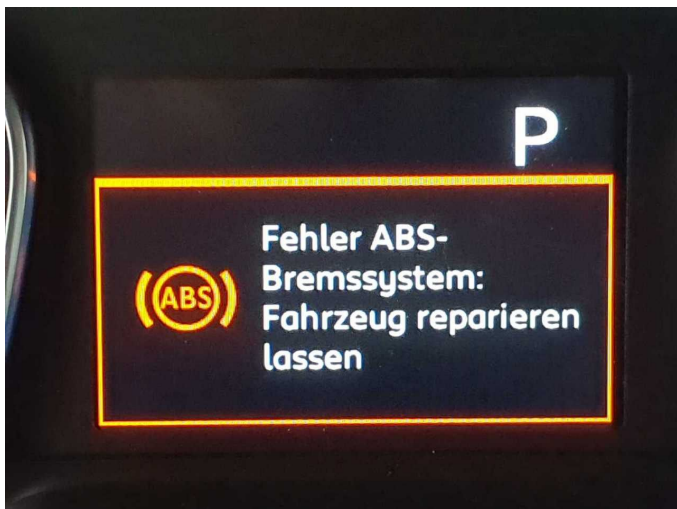
**Damage 4:** Electronic systems: Electronic systems - Functional / admissibility - Perform diagnosis

| No. | Component group | Description |
|---|---|---|
| 4 | Electronic systems | Electronic systems - Functional / admissibility - Perform diagnosis |

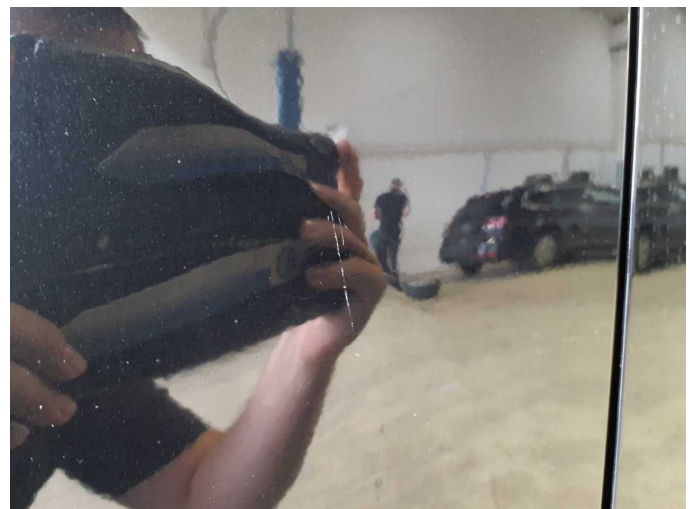
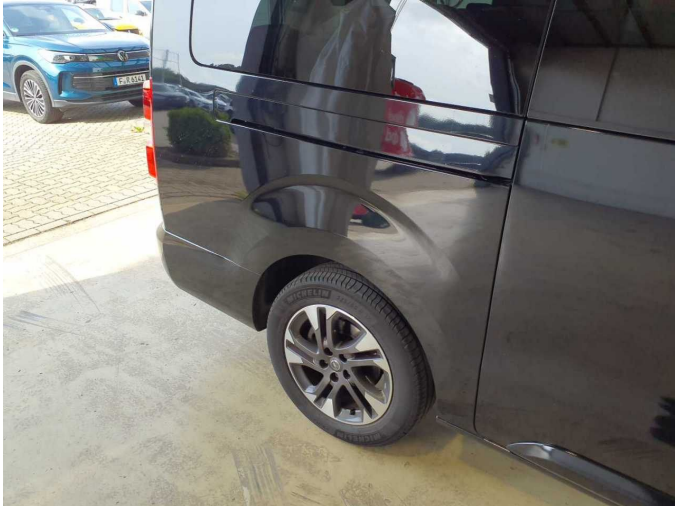
**Wear and tear 9:** Side panel - rear right side: Side panel - Scratch(es) - No deduction

**Wear and tear 9:** Side panel - rear right side: Side panel - Scratch(es) -  
No deduction

| No. | Component group | Description |
|---|---|---|
| 9 | Side panel - rear right side | Side panel - Scratch(es) - No deduction |
