Expertise

Protocol number: 46244862  
Order No. / Reference: 26571549  
Inspection date: 24 Jun 2026

Model: Tiguan Allspace 2.0 TDI SCR DSG Life

VIN: WVGZZZ5NZNM121817

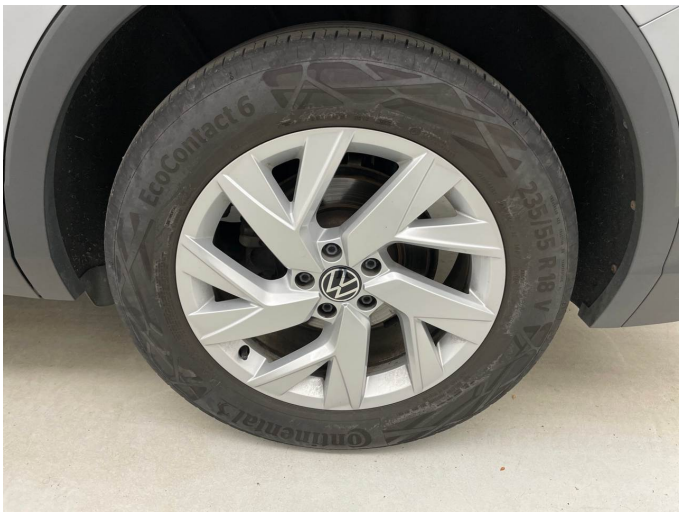
Figure 12: Mounted tyres

| Tyres | | | | |
|---|---|---|---|---|
| 1) | 235/55 R18 100V | Summer tyres on Light alloy | Continental | 4mm / 4mm |
| 2) | 235/55 R18 100V | Summer tyres on Light alloy | Continental | 5mm / 5mm |

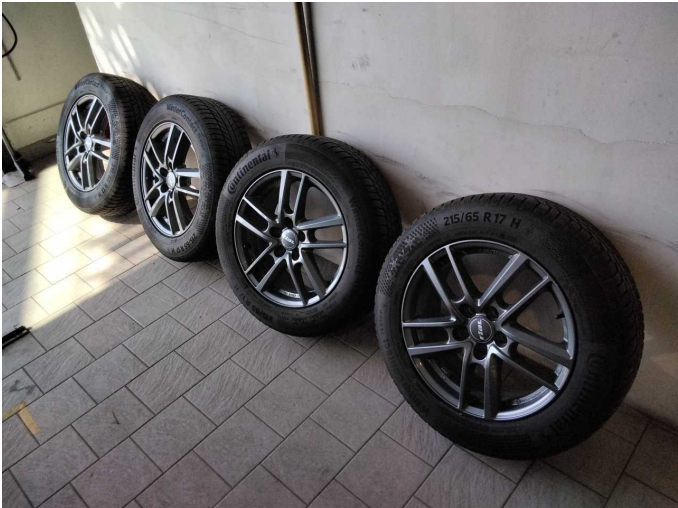
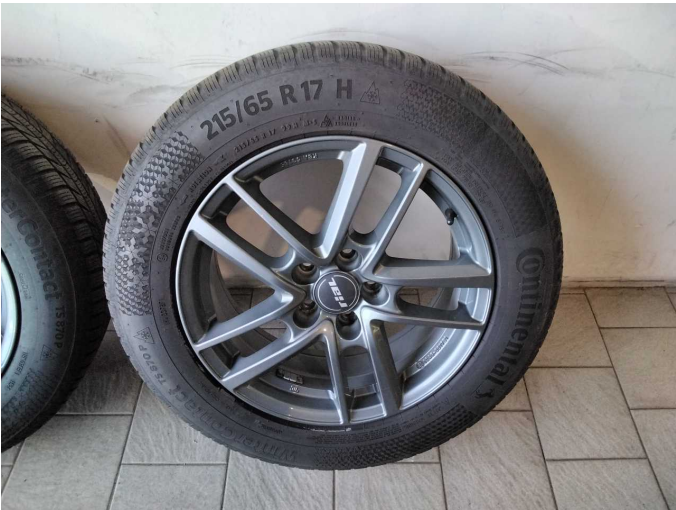
Figure 16: Additional tyres

| Tyres | | | | |
|---|---|---|---|---|
| 1) | 215/65 R17 99H | Winter tyres on Light alloy | Continental | 6mm / 6mm |
| 2) | 215/65 R17 99H | Winter tyres on Light alloy | Continental | 7mm / 7mm |

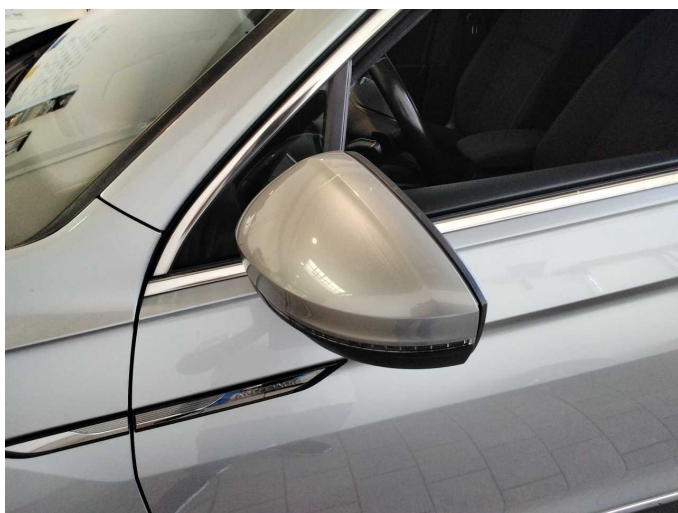
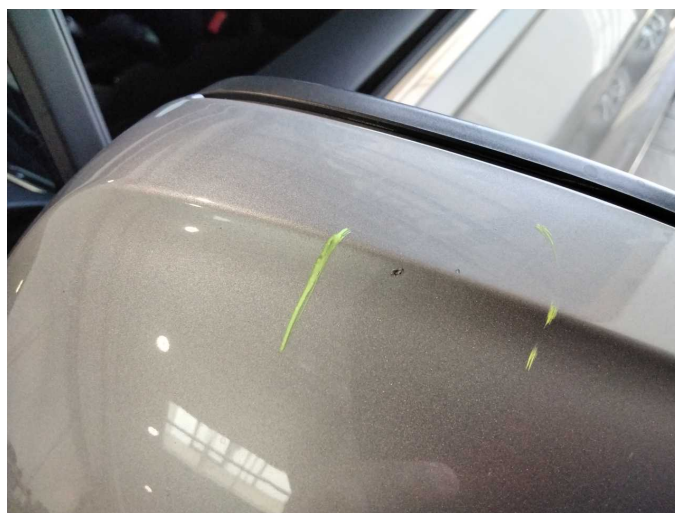
**Damage 1:** Wing mirror - left side: Cap - Scratch(es) - Smart repair

| No. | Component group | Description |
|---|---|---|
| 1 | Wing mirror - left side | Cap - Scratch(es) - Smart repair |

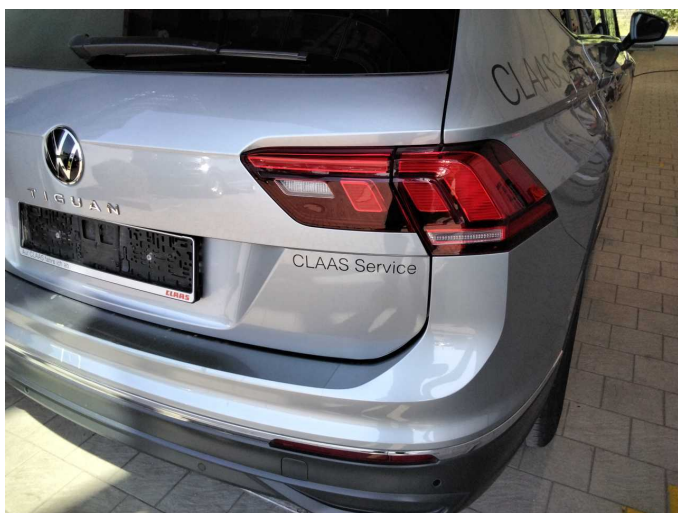
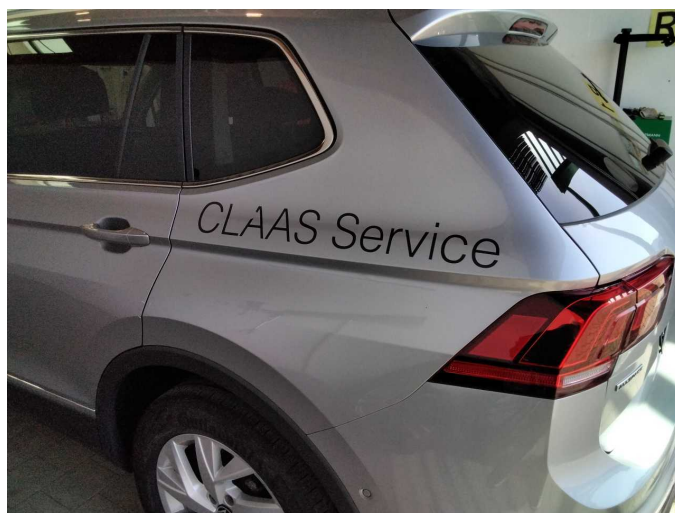
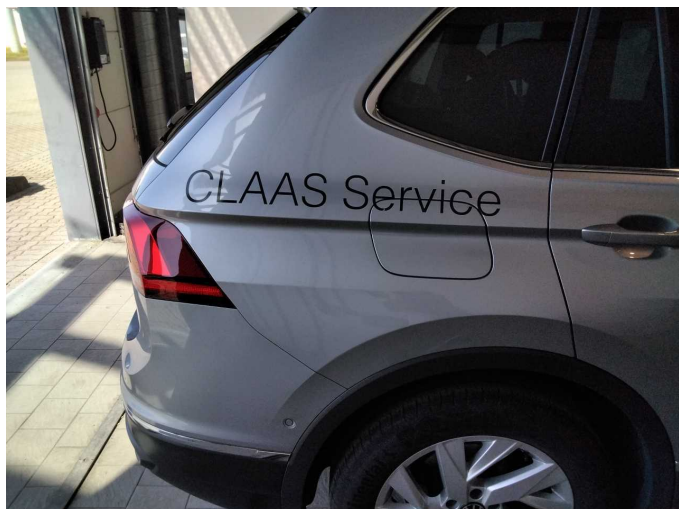
**Damage 2:** Body: Body - Glued / labelled - De-glue / neutralise

| No. | Component group | Description |
|---|---|---|
| 2 | Body | Body - Glued / labelled - De-glue / neutralise |

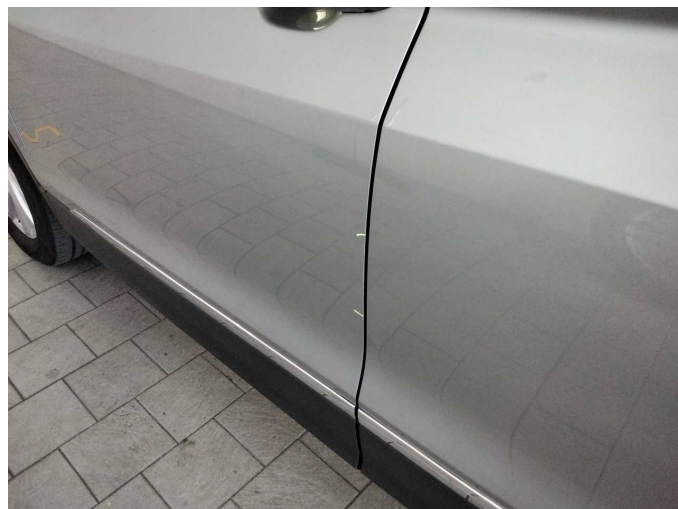
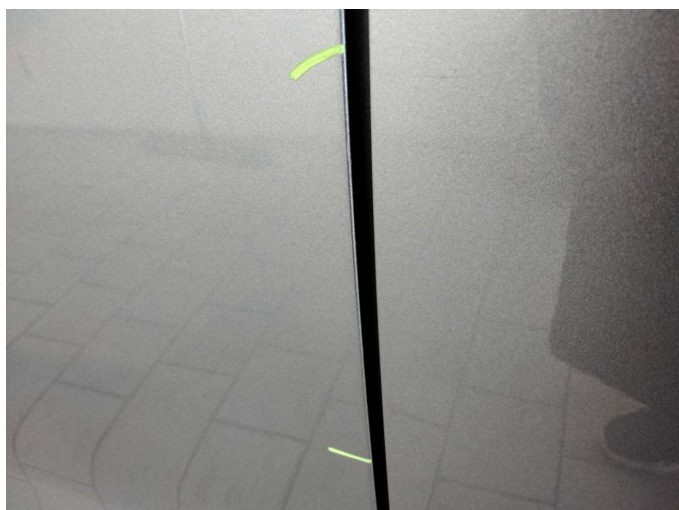
**Damage 3:** Door - front left side: Door edge - Scratch(es) - Smart repair

| No. | Component group | Description |
|---|---|---|
| 3 | Door - front left side | Door edge - Scratch(es) - Smart repair |

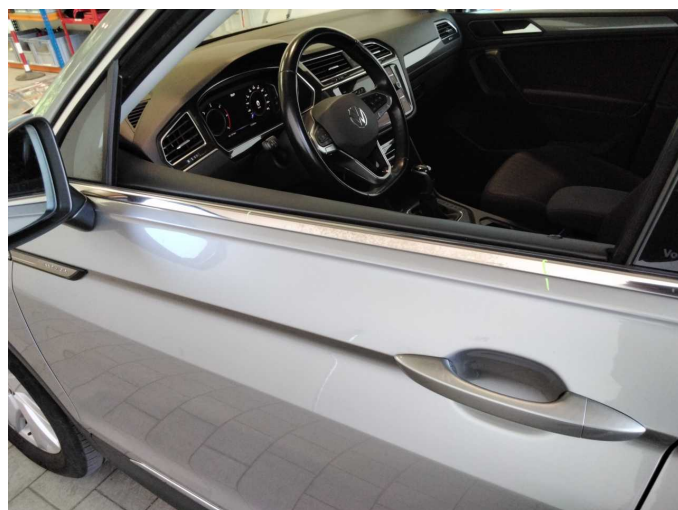
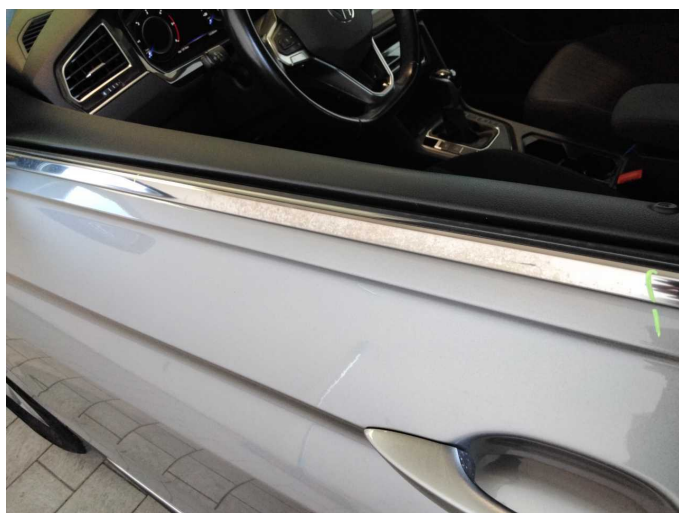
**Damage 4:** Door - front left side: Strip - outer - Paint defect - Replace

| No. | Component group | Description |
|---|---|---|
| 4 | Door - front left side | Strip - outer - Paint defect - Replace |

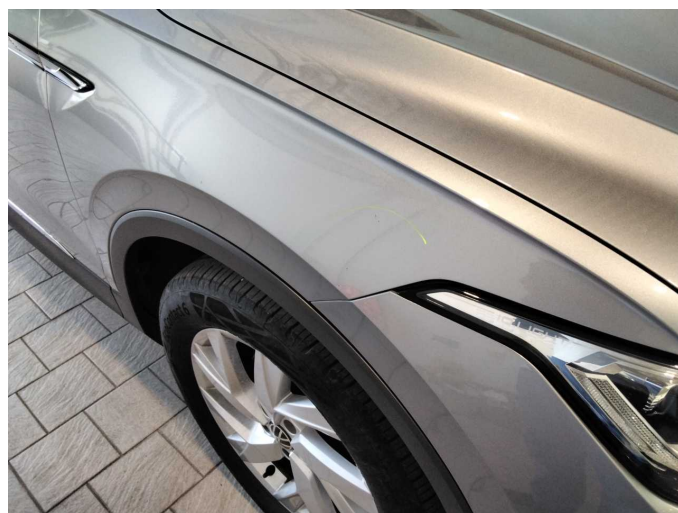
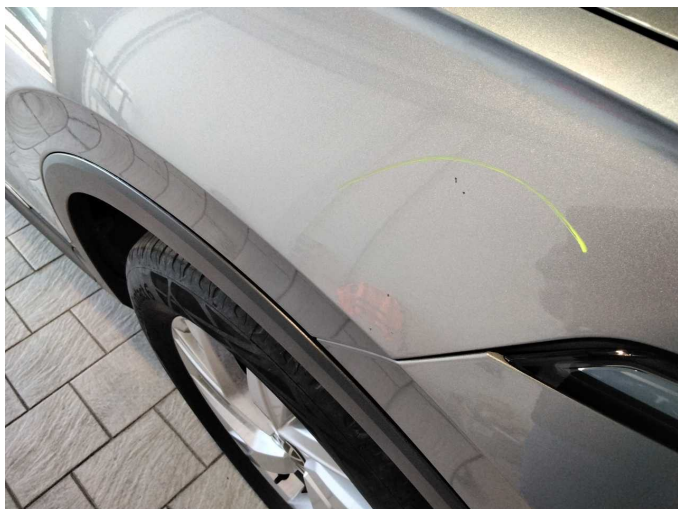
**Damage 5:** Mudguard - right side: Mudguard - right side - Scratch(es) - Loss in value

| No. | Component group | Description |
|---|---|---|
| 5 | Mudguard - right side | Mudguard - right side - Scratch(es) - Loss in value |

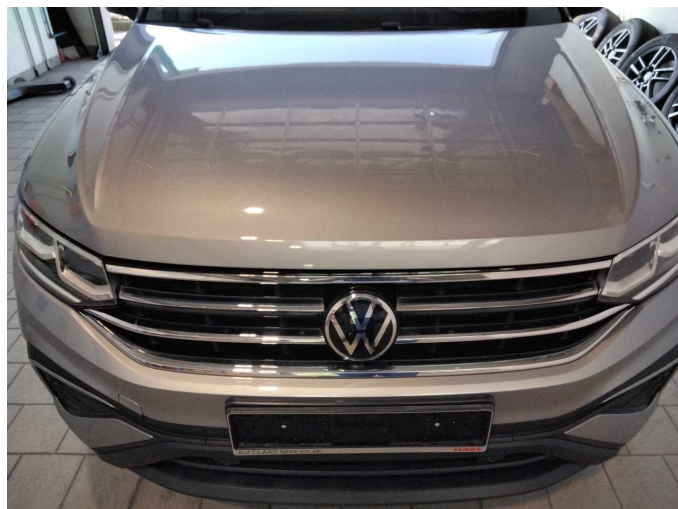
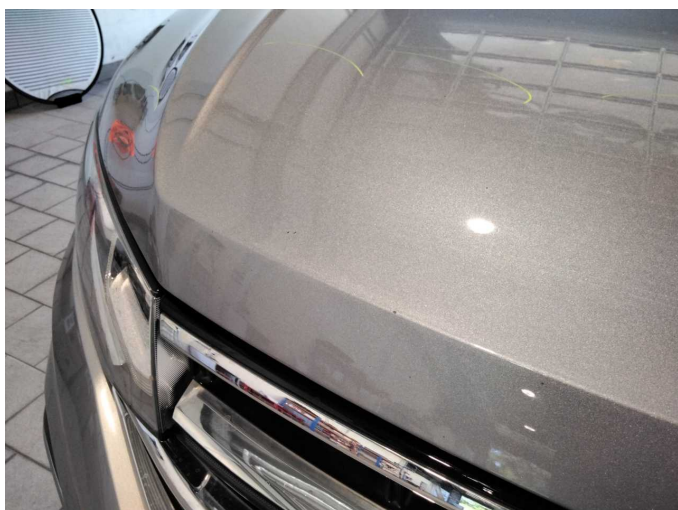
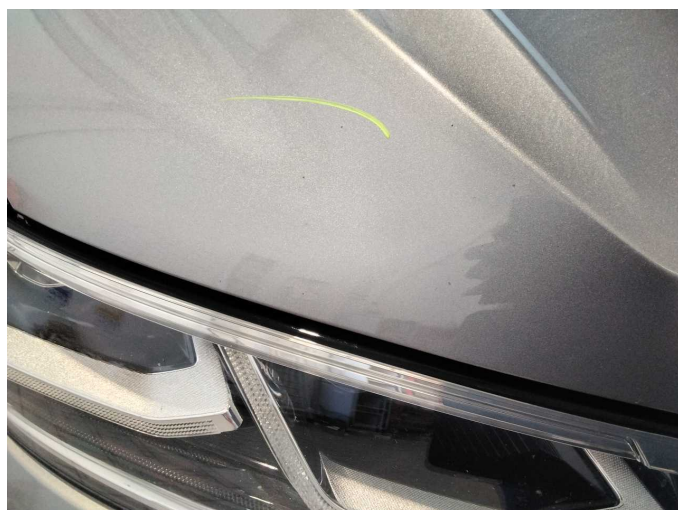
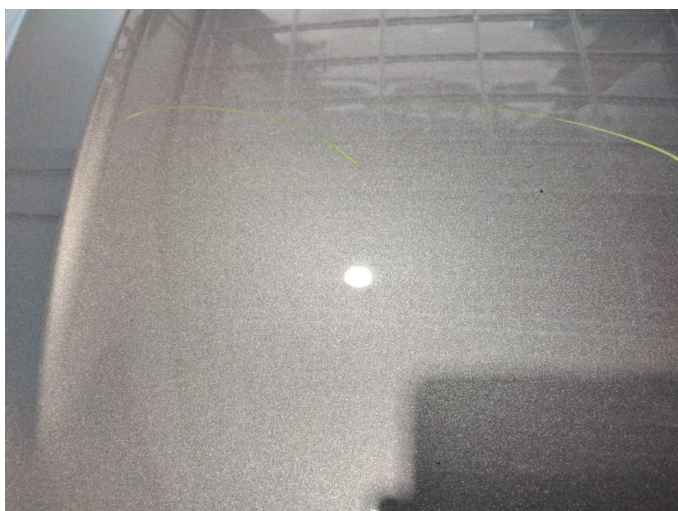
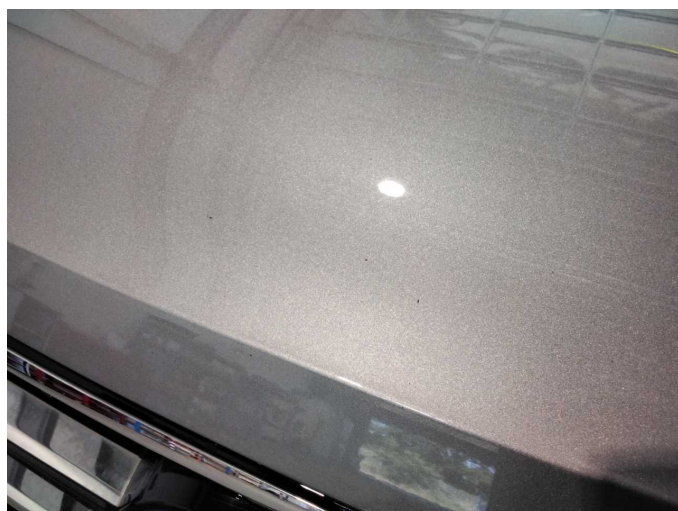
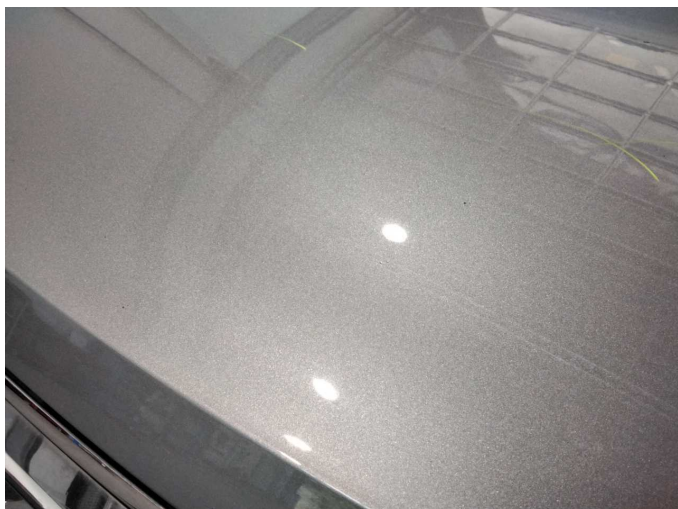
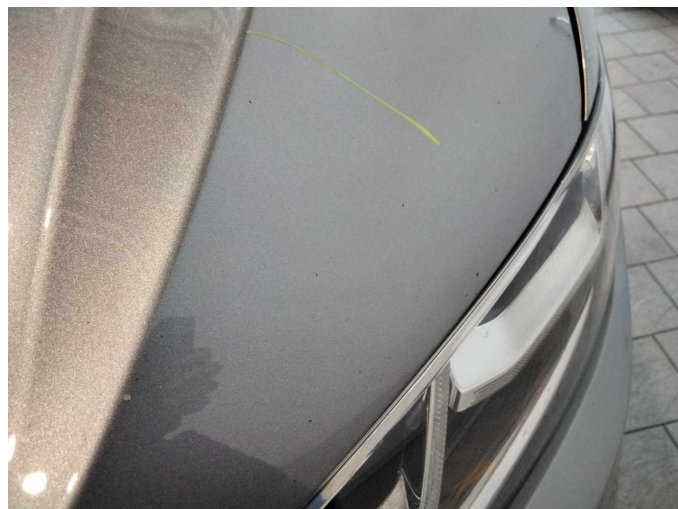
**Damage 6:** Bonnet: Bonnet - Stone chips - Paint

| No. | Component group | Description |
|---|---|---|
| 6 | Bonnet | Bonnet - Stone chips - Paint |

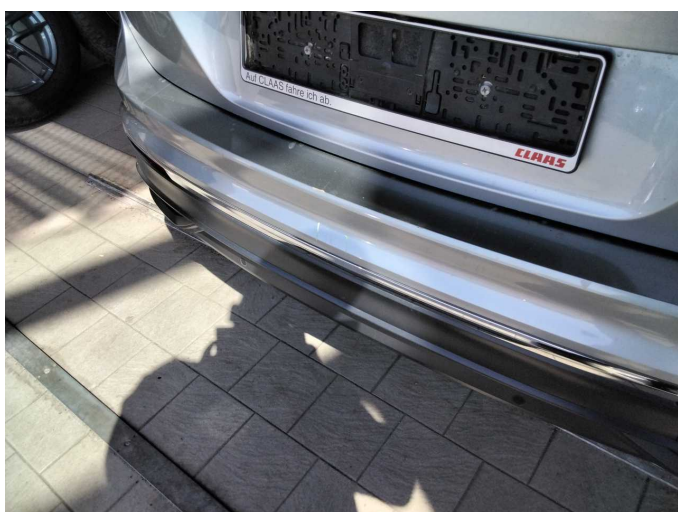
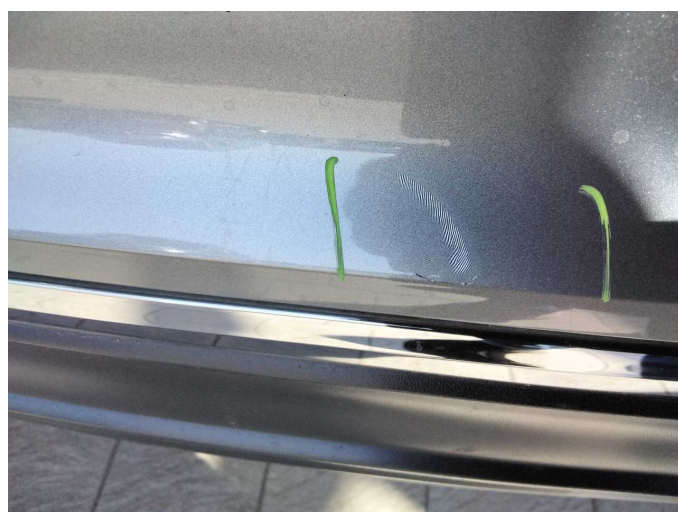
**Damage 7:** Rear bumper: Rear bumper - Scratch(es) - Paint

| No. | Component group | Description |
|---|---|---|
| 7 | Rear bumper | Rear bumper - Scratch(es) - Paint |

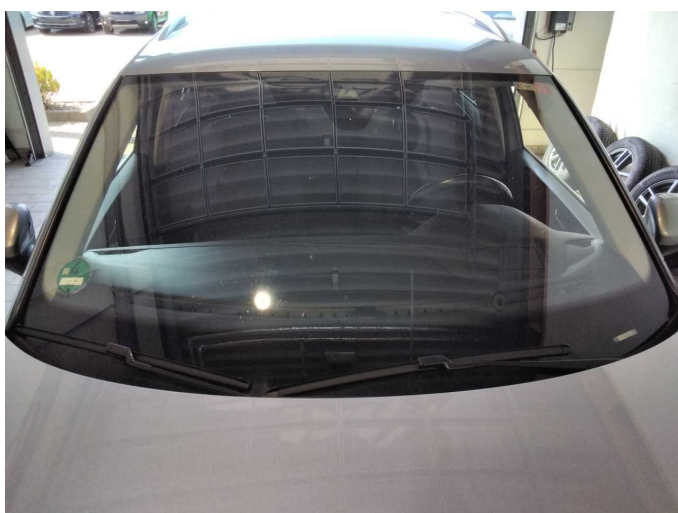
| No. | Component group | Description |
|---|---|---|
| 1 | Vehicle glazing | Windscreen - Stone chips - No deduction |

**Wear and tear 1:** Vehicle glazing: Windscreen - Stone chips - No deduction

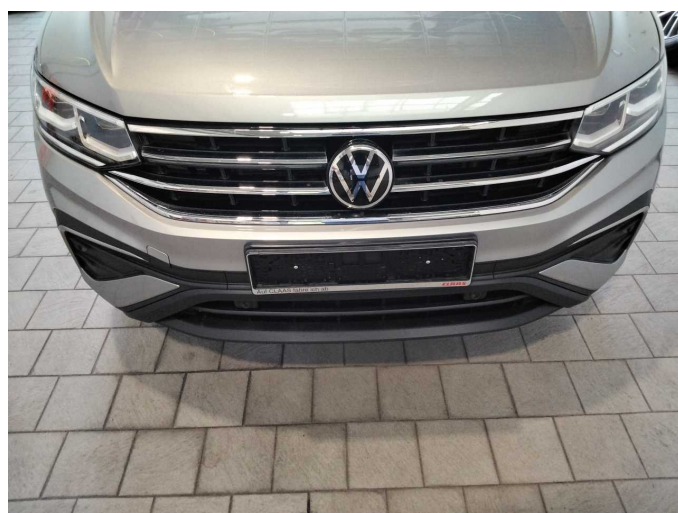
| No. | Component group | Description |
|---|---|---|
| 2 | Front bumper | Front bumper - Stone chips - No deduction |

**Wear and tear 2:** Front bumper: Front bumper - Stone chips - No deduction

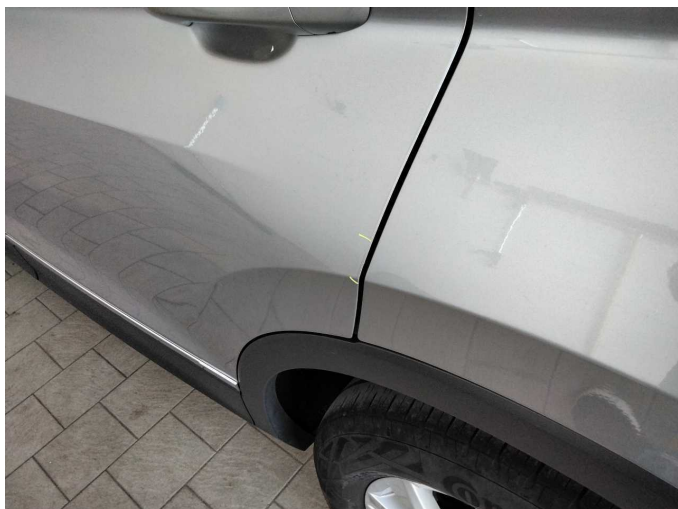
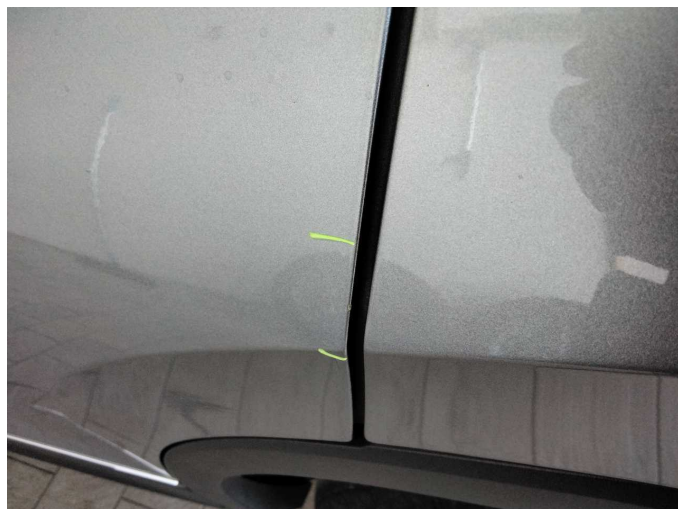
| No. | Component group | Description |
|---|---|---|
| 3 | Door - rear left side | Door edge - Scratch(es) - No deduction |

**Wear and tear 3:** Door - rear left side: Door edge - Scratch(es) - No deduction
