Expertise

Protocol number: 46119861
Order No. / Reference: 26508505
Inspection date: 24 Jun 2026

Model: Focus Turnier 1.0 EcoBoost Start-Stopp-System Aut. TITANIUM X

VIN: WF0PXXGCHPMC81582

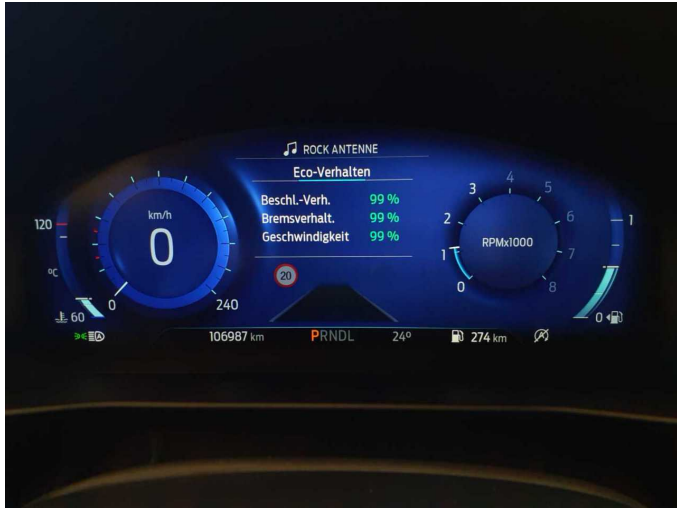
Mileage (Read) 106,987 km

Figure 7: Instrument cluster

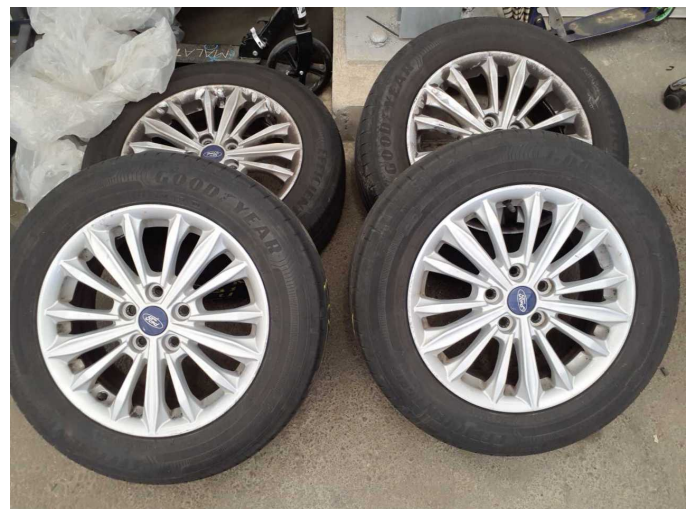
#	Tyre size	Type of tyre	Manufacturer	Tread depth
1)	205/60 R16 92V	Summer tyres on Light alloy	Goodyear	5mm / 5mm
2)	205/60 R16 92V	Summer tyres on Light alloy	Goodyear	5mm / 5mm

Figure 18: Additional tyres

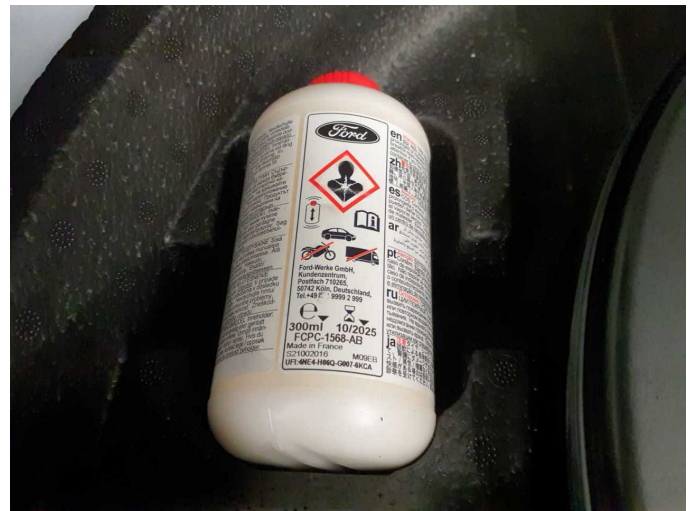
Damage 1: Equipment: Tirefit filler - Expired - Replace

No.	Component group	Description
1	Equipment	Tirefit filler - Expired - Replace
2	Side panel - rear right side	Sill - dent(s) - Smart repair

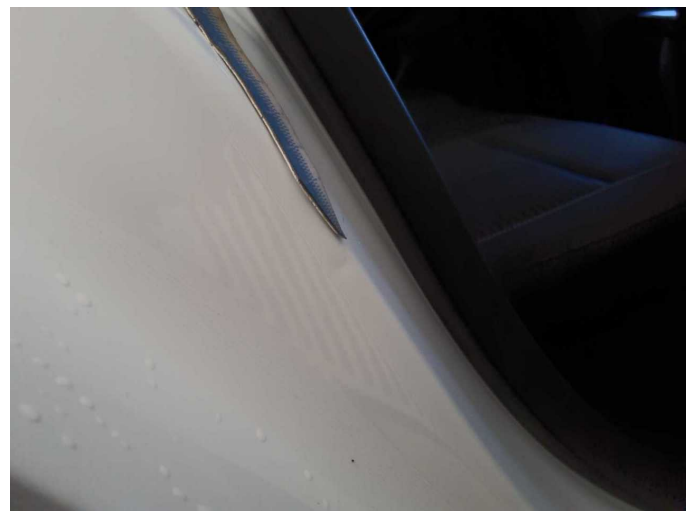
Damage 2: Side panel - rear right side: Sill - dent(s) - Smart repair
