Expertise

Protocol number: 46569713  
Order No. / Reference: 26666997  
Inspection date: 16 Jul 2026

Manufacturer: Skoda  
VIN: TMBJG8NX1RY009907

Model: Octavia Combi 2.0 TDI DSG Style

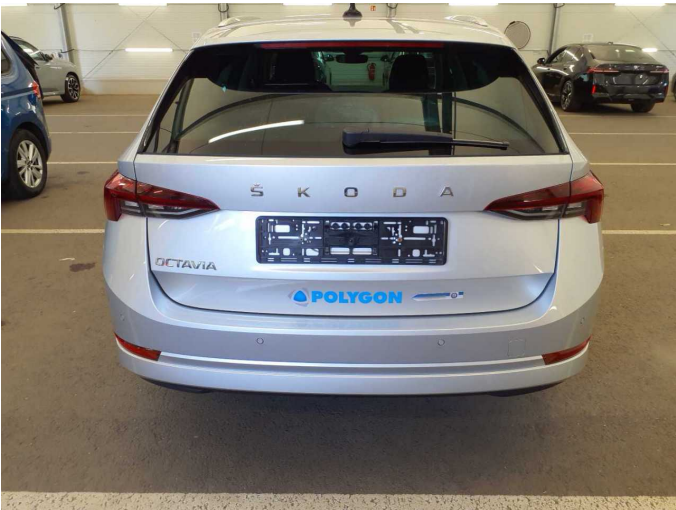
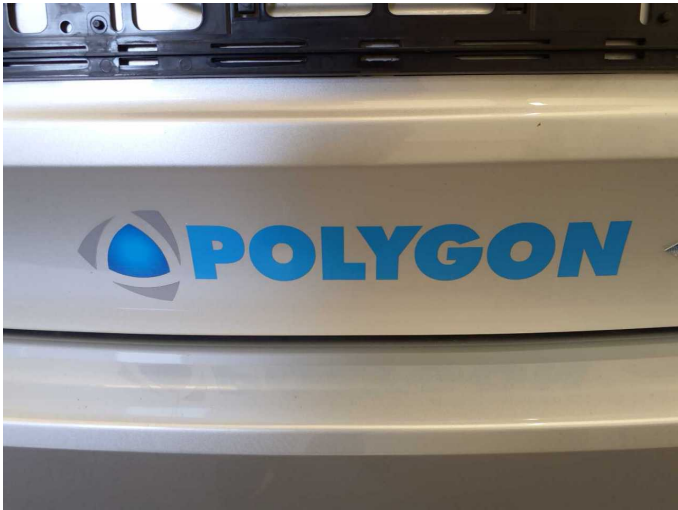
| No. | Component group | Description |
|---|---|---|
| 1 | Boot lid / rear door | Boot lid - Glued / labelled - De-glue / neutralise |

Damage 1: Boot lid / rear door: Boot lid - Glued / labelled - De-glue / neutralise

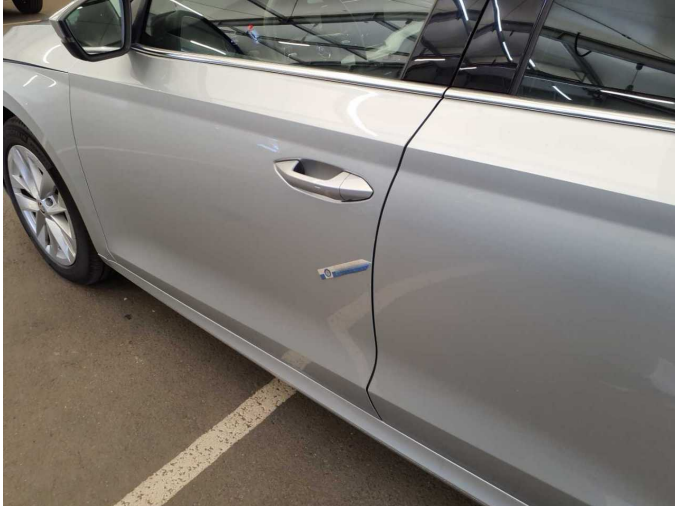
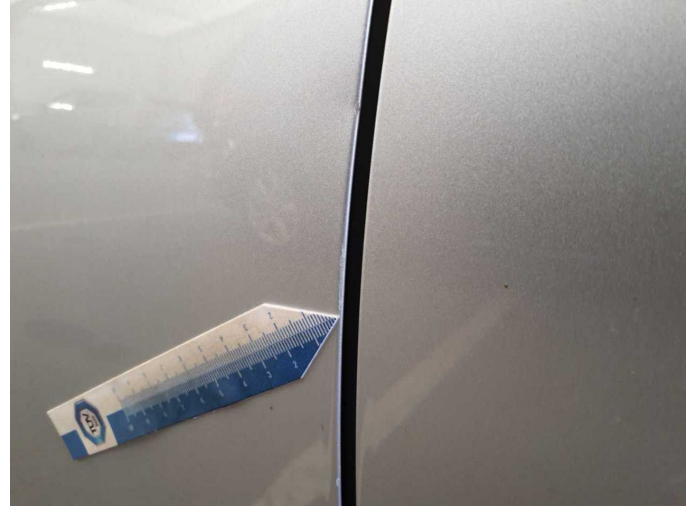
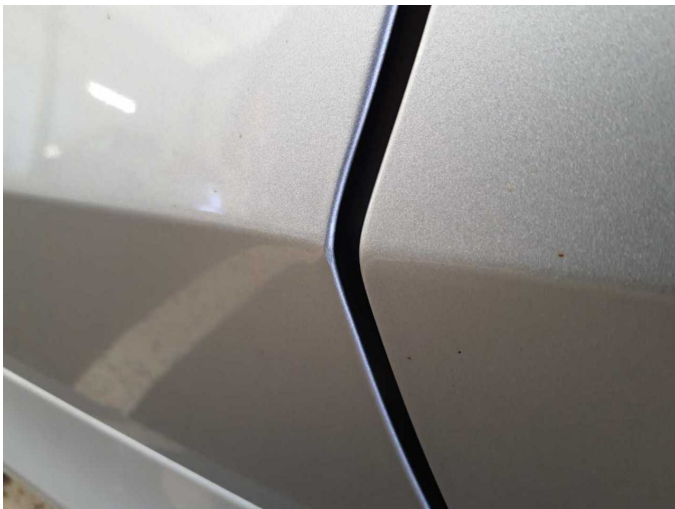
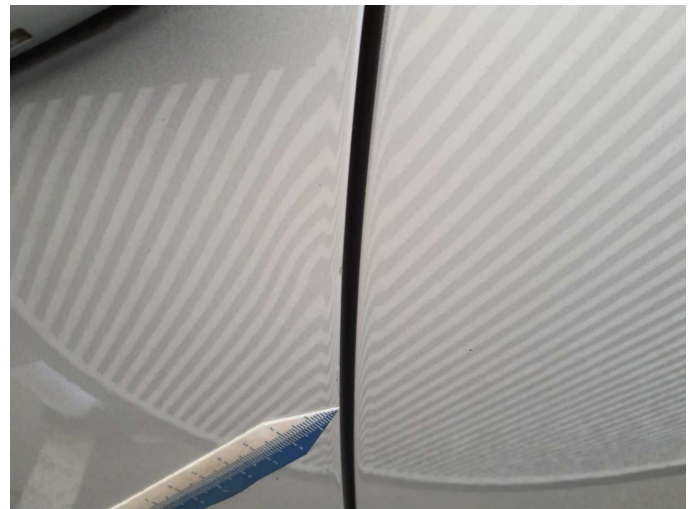
| No. | Component group | Description |
|---|---|---|
| 2 | Door - front left side | Door edge - Dent / paintcoat damage - Smart repair |

**Damage 2:** Door - front left side: Door edge - Dent / paintcoat damage - Smart repair

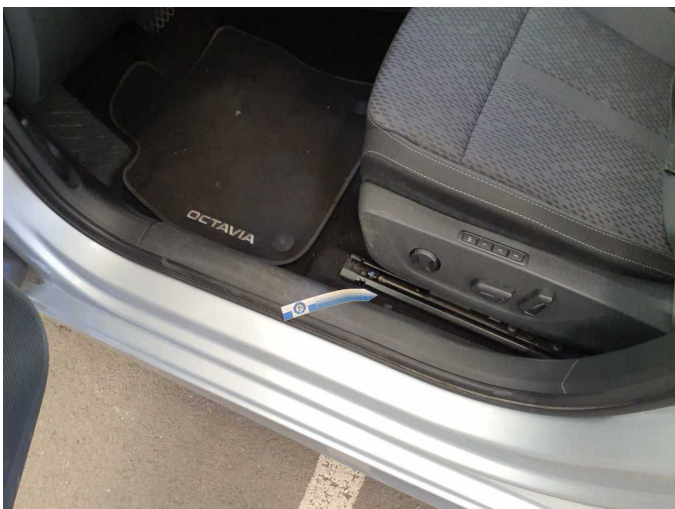
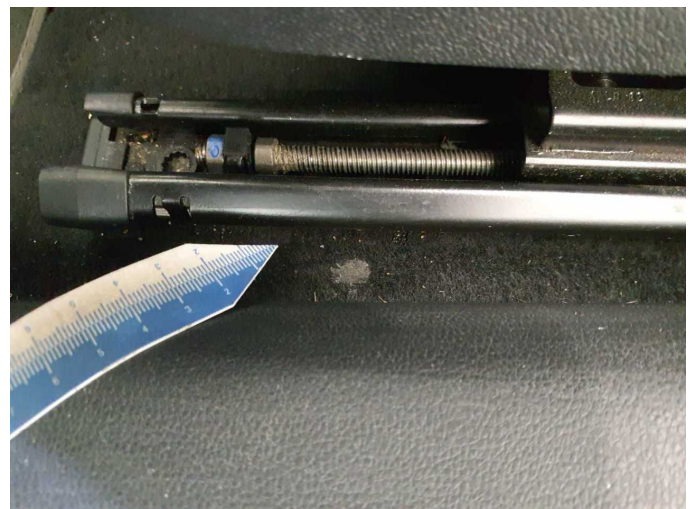
| No. | Component group | Description |
|---|---|---|
| 3 | Trim / covers | Carpet - front left side - Burn hole (cigarettes) - Smart repair |

**Damage 3:** Trim / covers: Carpet - front left side - Burn hole (cigarettes) - Smart repair

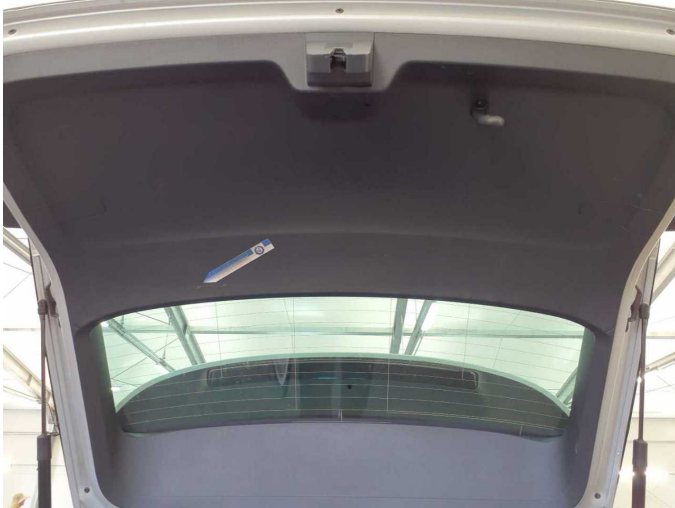
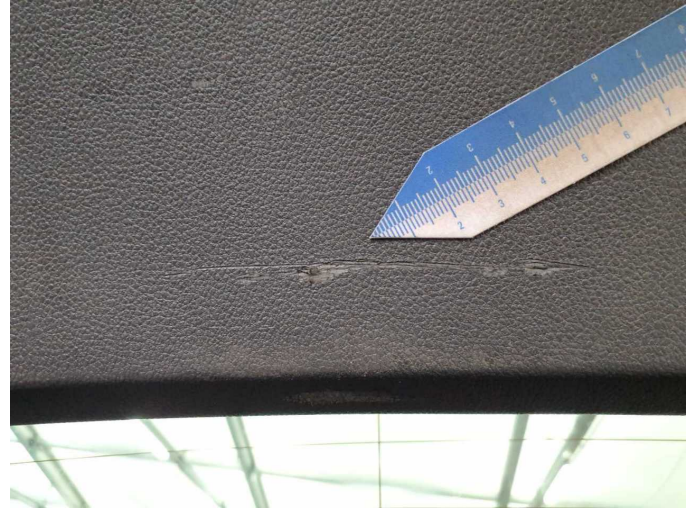
| No. | Component group | Description |
|---|---|---|
| 5 | Trim / covers | Boot lid - interior trim - Scratch(es) - Loss in value |

**Damage 5:** Trim / covers: Boot lid - interior trim - Scratch(es) - Loss in value

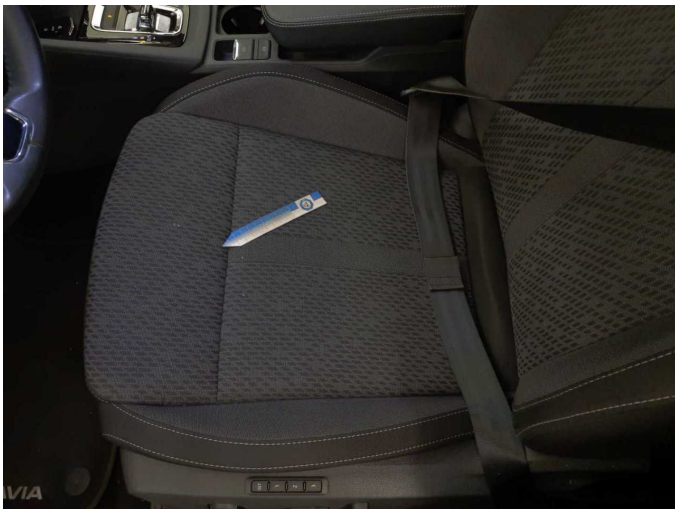
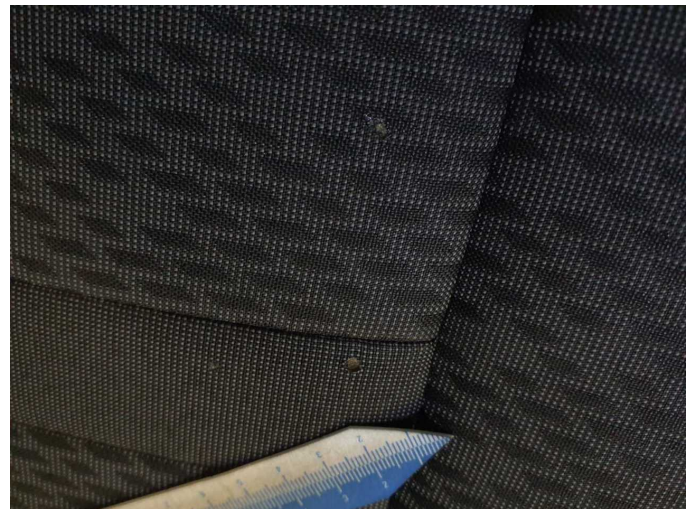
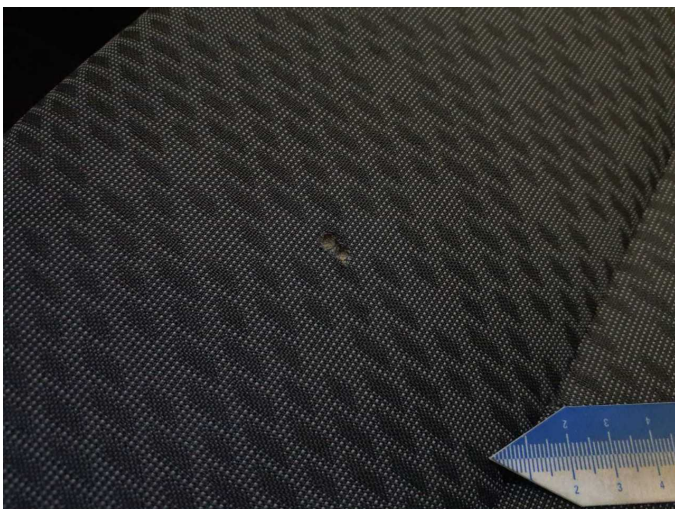
| No. | Component group | Description |
|---|---|---|
| 6 | Seat - front | Seat cover - left side - Burn hole (cigarettes) - Replace |

**Damage 6:** Seat - front: Seat cover - left side - Burn hole (cigarettes) - Replace

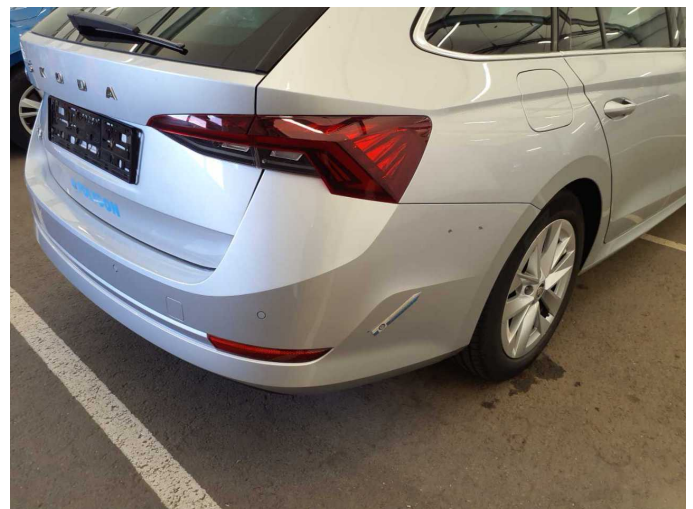
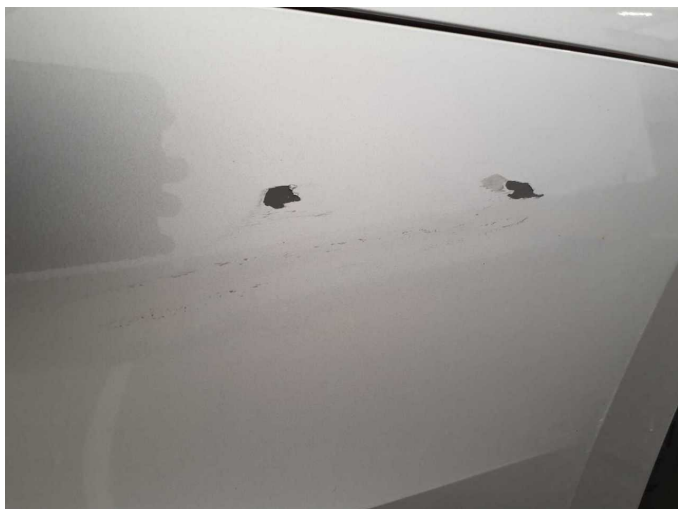
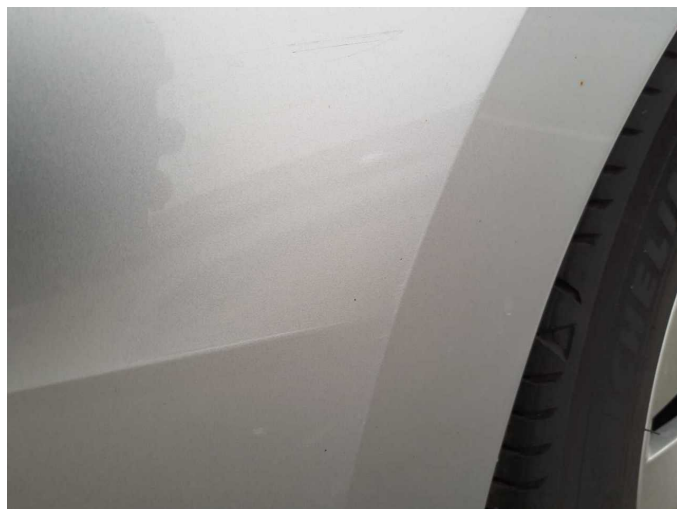
| No. | Component group | Description |
|---|---|---|
| 7 | Rear bumper | Rear bumper - Scratched - Paint |

**Damage 7:** Rear bumper: Rear bumper - Scratched - Paint

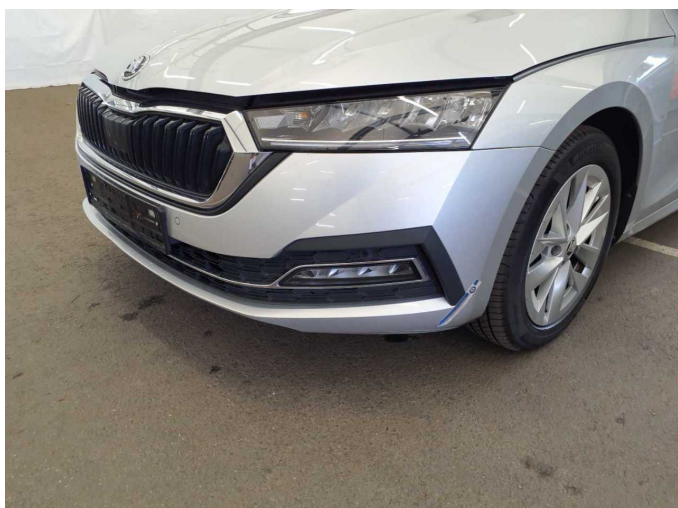
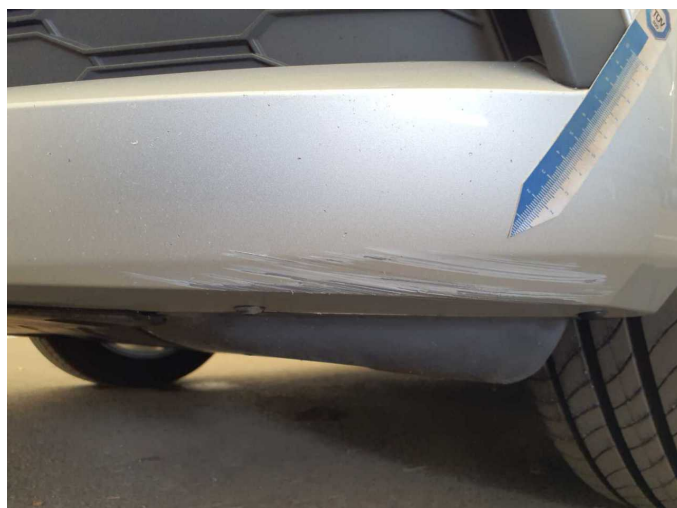
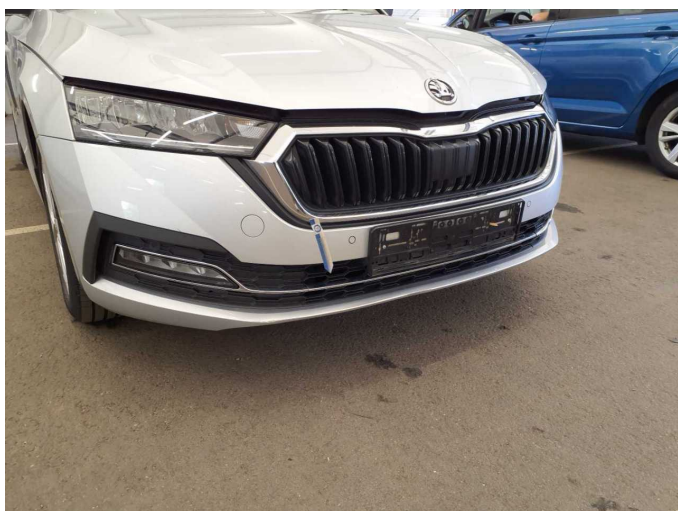
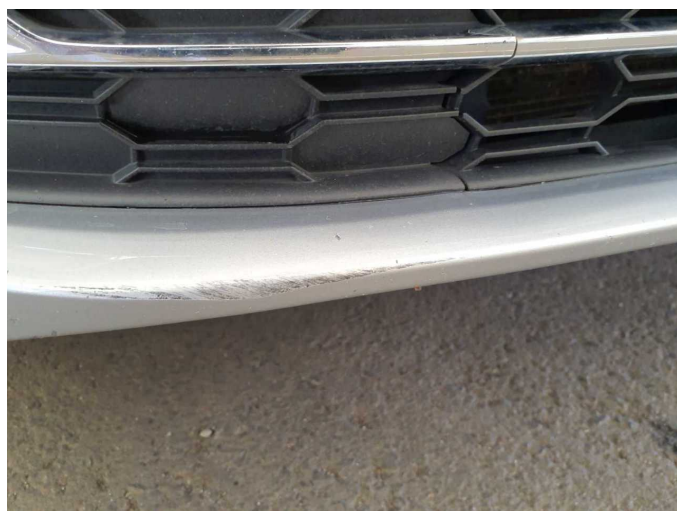
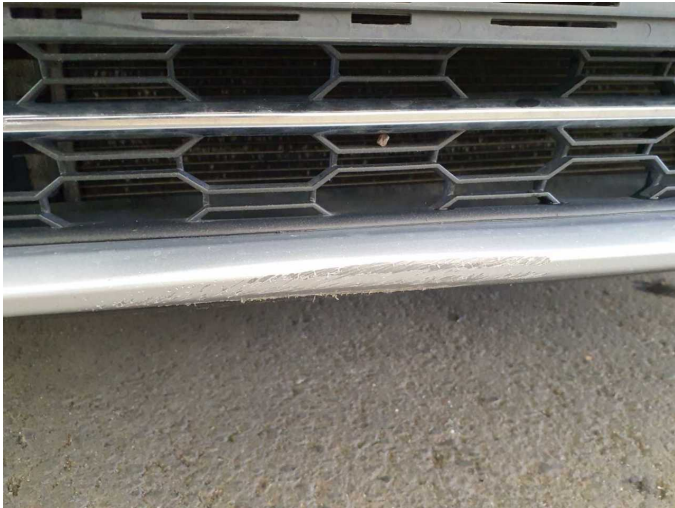
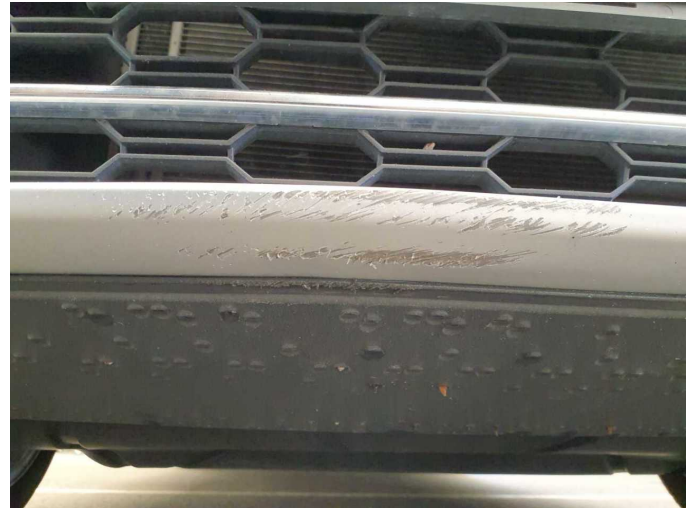
| No. | Component group | Description |
|---|---|---|
| 8 | Front bumper | Front bumper - Scratched - Repair and paint |

**Damage 8:** Front bumper: Front bumper - Scratched - Repair and paint

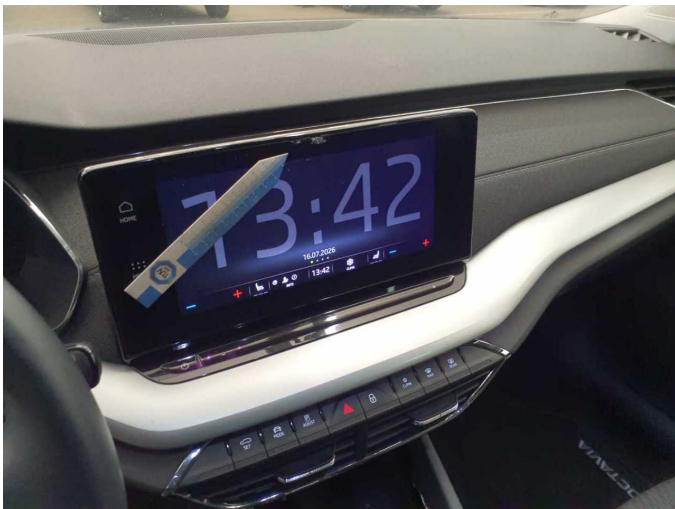
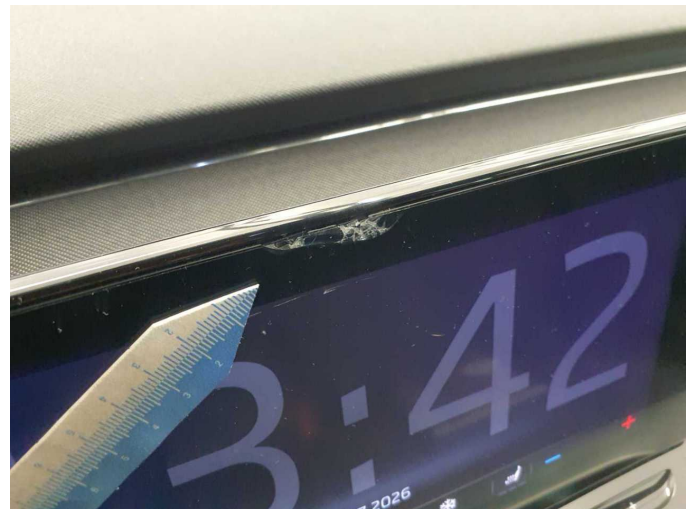
| No. | Component group | Description |
|---|---|---|
| 9 | Multimedia system | Navigation system - Damaged - Replace |

**Damage 9:** Multimedia system: Navigation system - Damaged - Replace
