Expertise

Protocol number: 45675261  
Order No. / Reference: 26412551  
Inspection date: 29 May 2026

Manufacturer: Opel  
VIN: VXKUHZKXZN4406884

Model: Corsa-e Elegance

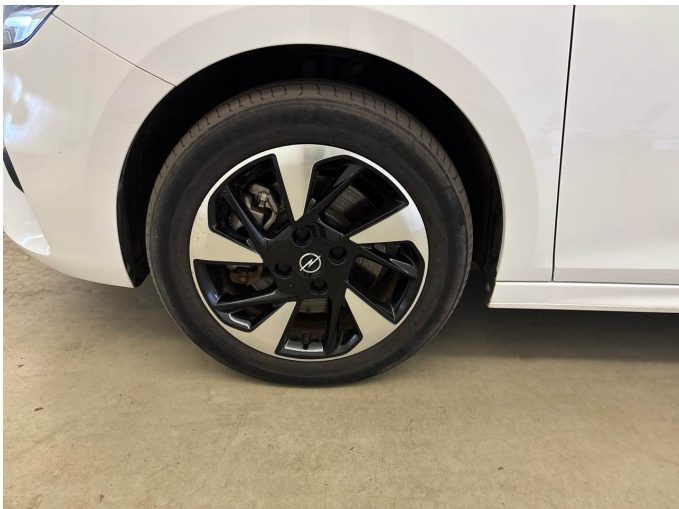
Figure 12: Mounted tyres

| Tyres | | | | |
|---|---|---|---|---|
| 1) | 195/55 R16 91H | Summer tyres on Light alloy | Michelin | 4mm / 4mm |
| 2) | 195/55 R16 91H | Summer tyres on Light alloy | Michelin | 5mm / 5mm |

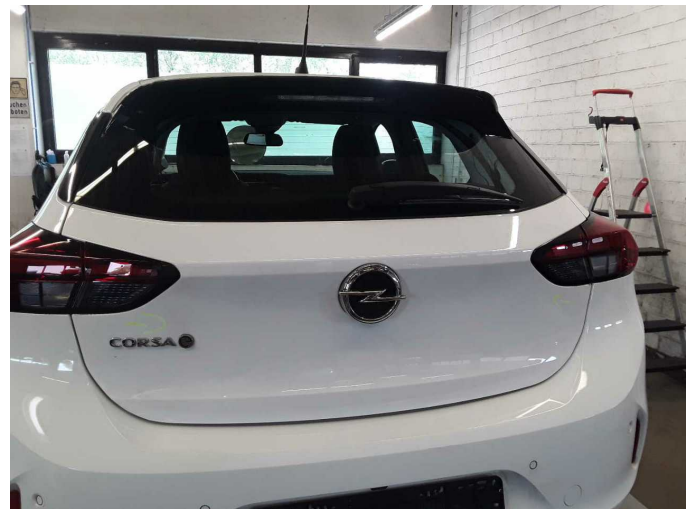
Damage 2: Boot lid / rear door: Boot lid - Deformed - Repair and paint

| No. | Component group | Description |
|---|---|---|
| 2 | Boot lid / rear door | Boot lid - Deformed - Repair and paint |

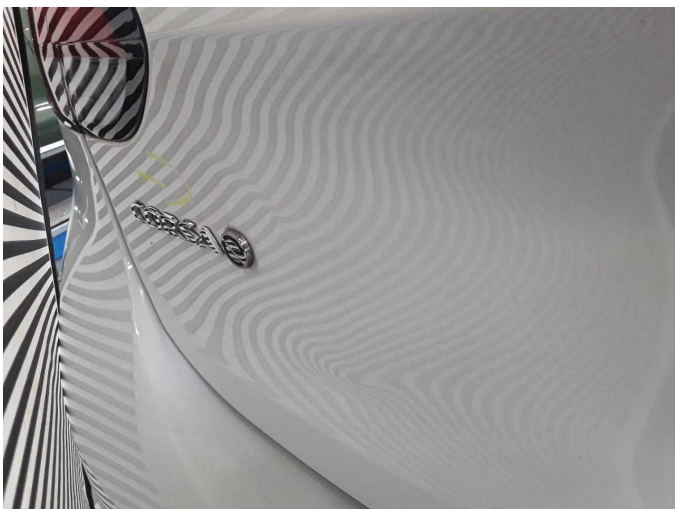
Damage 2: Boot lid / rear door: Boot lid - Deformed - Repair and paint

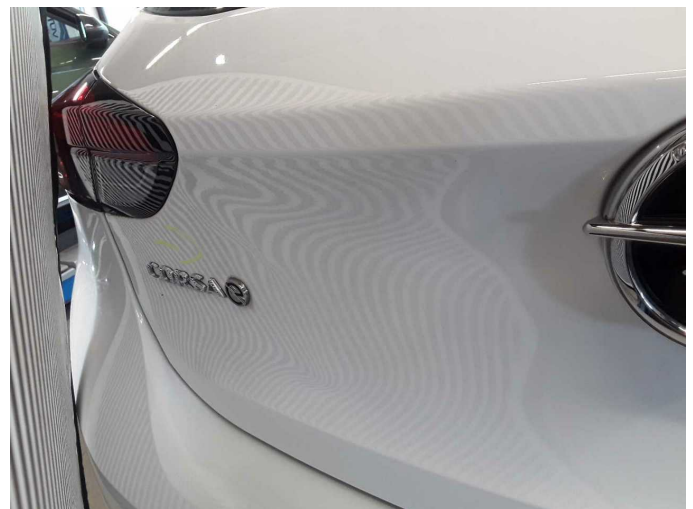
Damage 2: Boot lid / rear door: Boot lid - Deformed - Repair and paint

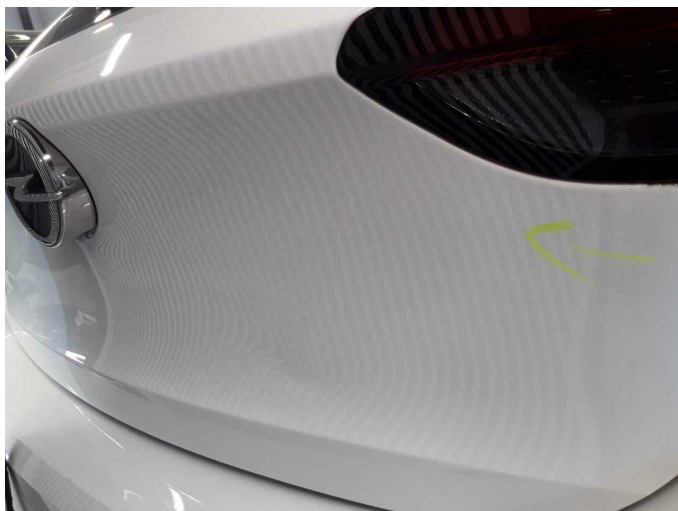
**Damage 2:** Boot lid / rear door: Boot lid - Deformed - Repair and paint

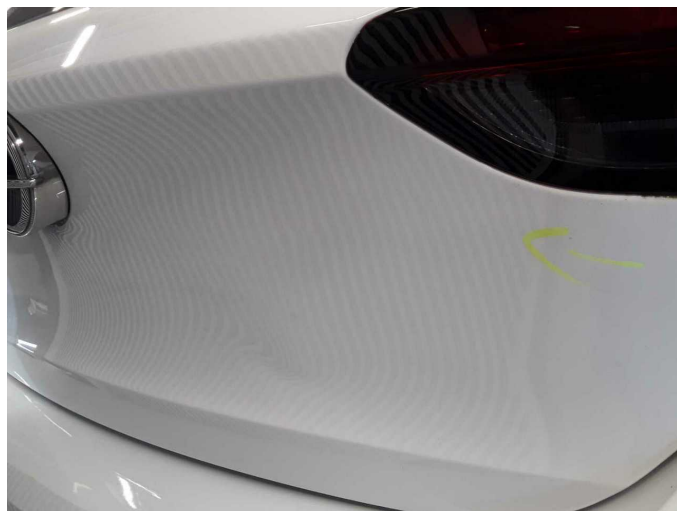
**Damage 2:** Boot lid / rear door: Boot lid - Deformed - Repair and paint

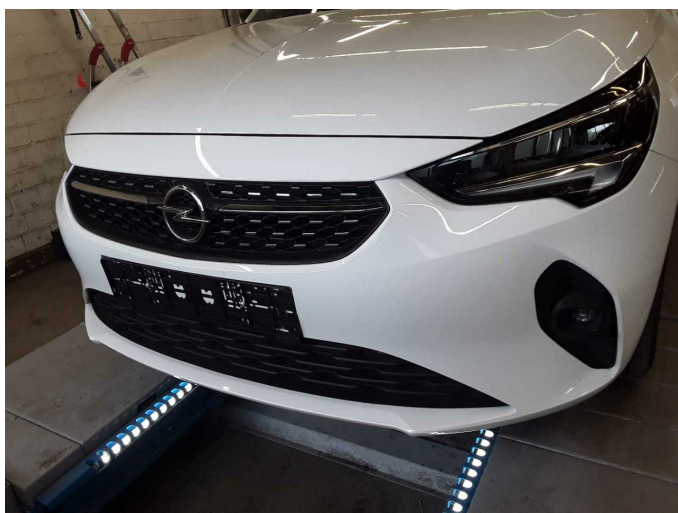
| No. | Component group | Description |
|---|---|---|
| 1 | Front bumper | Front bumper - Stone chips - No deduction |

**Wear and tear 1:** Front bumper: Front bumper - Stone chips - No deduction

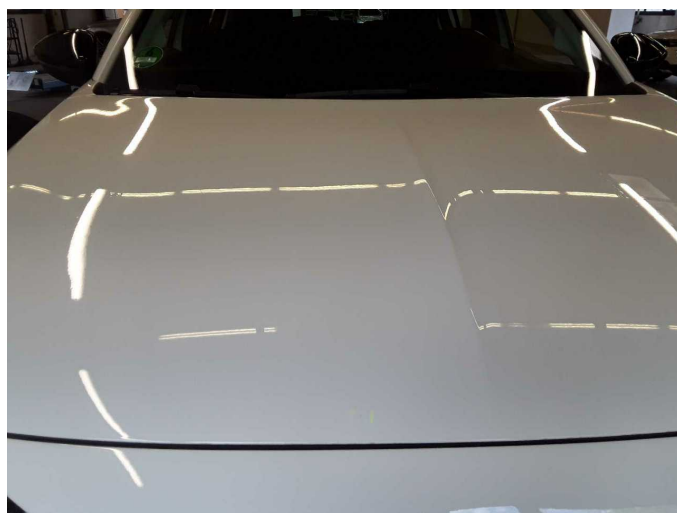
| No. | Component group | Description |
|---|---|---|
| 2 | Bonnet | Bonnet - Stone chips - No deduction |

**Wear and tear 2:** Bonnet: Bonnet - Stone chips - No deduction

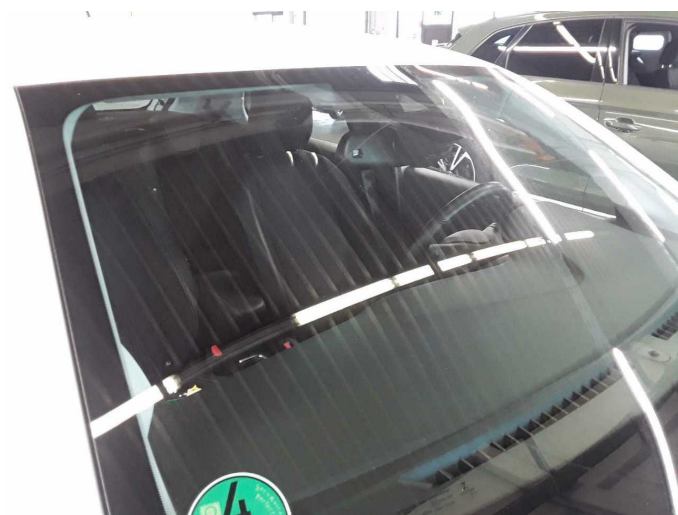
| No. | Component group | Description |
|---|---|---|
| 3 | Vehicle glazing | Windscreen - Stone chips - No deduction |

**Wear and tear 3:** Vehicle glazing: Windscreen - Stone chips - No deduction
