Expertise

Protocol number: 46401181  
Order No. / Reference: 26622536  
Inspection date: 8 Jul 2026

Model: Mondeo Turnier 2.0 EcoBlue Aut. Titanium

VIN: WF0FXXWPCFNS68549

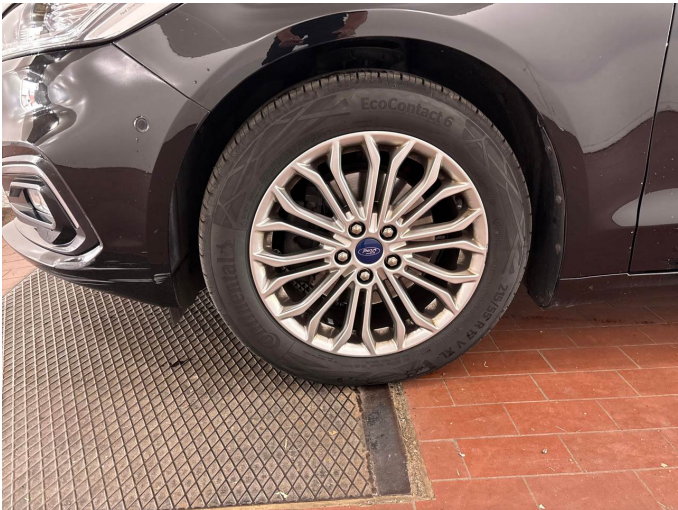
Figure 12: Mounted tyres

| # | Tyre size | Type of tyre | Manufacturer | Tread depth |
|---|---|---|---|---|
| 1) | 215/55 R17 98V | Summer tyres on Light alloy | Continental | 7mm / 7mm |
| 2) | 215/55 R17 98V | Summer tyres on Light alloy | Continental | 5mm / 5mm |

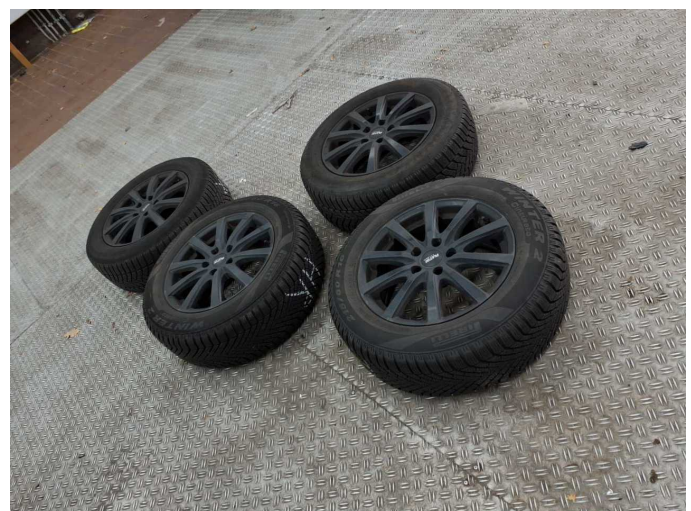
Figure 18: Additional tyres

| # | Tyre size | Type of tyre | Manufacturer | Tread depth |
|---|---|---|---|---|
| 1) | 215/60 R16 99H | Winter tyres on Light alloy | Pirelli | 8mm / 8mm |
| 2) | 215/60 R16 99H | Winter tyres on Light alloy | Pirelli | 8mm / 8mm |

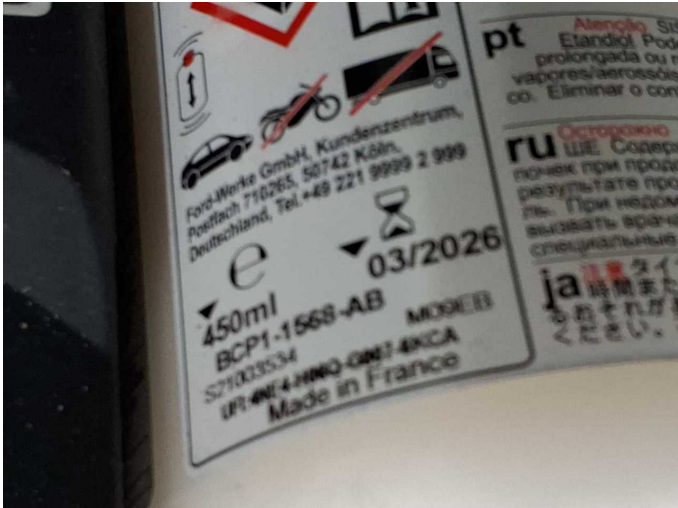
| No. | Component group | Description |
|---|---|---|
| 2 | Equipment | Tirefit filler - Expired - Replace |

Damage 2: Equipment: Tirefit filler - Expired - Replace

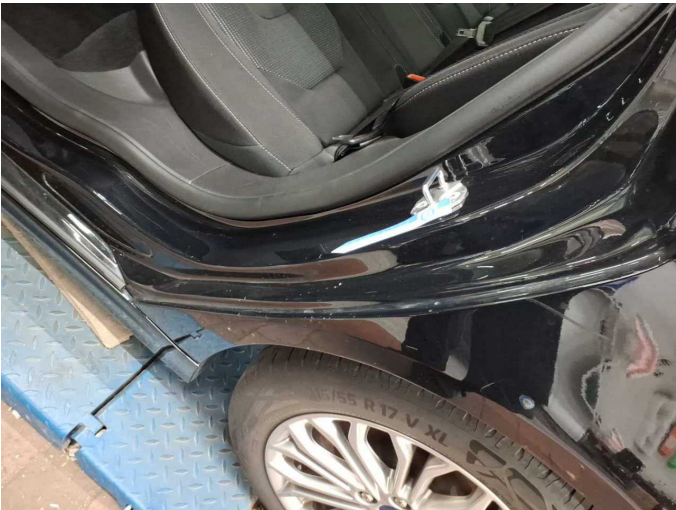
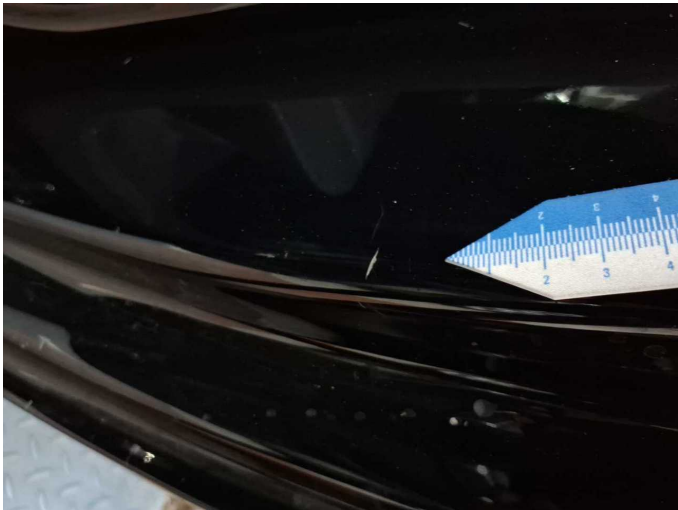
| No. | Component group | Description |
|---|---|---|
| 3 | Side panel - rear left side | Sill - Scratch(es) - Smart repair |

Damage 3: Side panel - rear left side: Sill - Scratch(es) - Smart repair

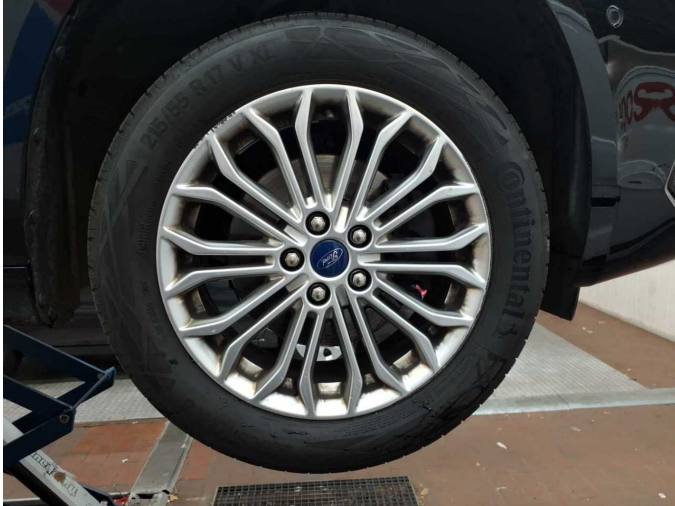
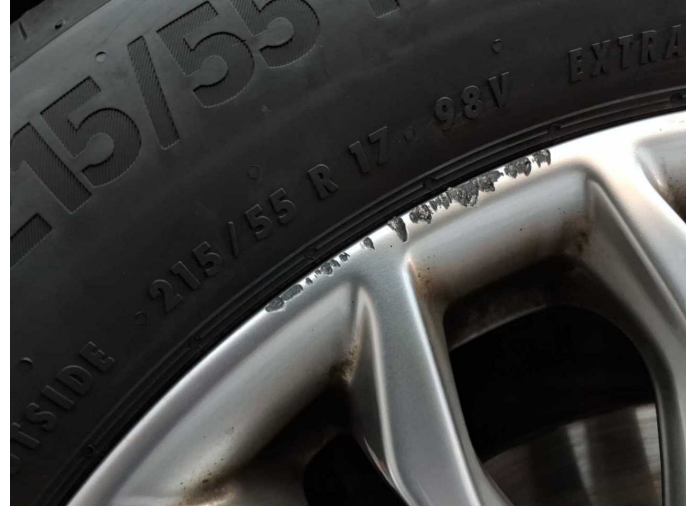
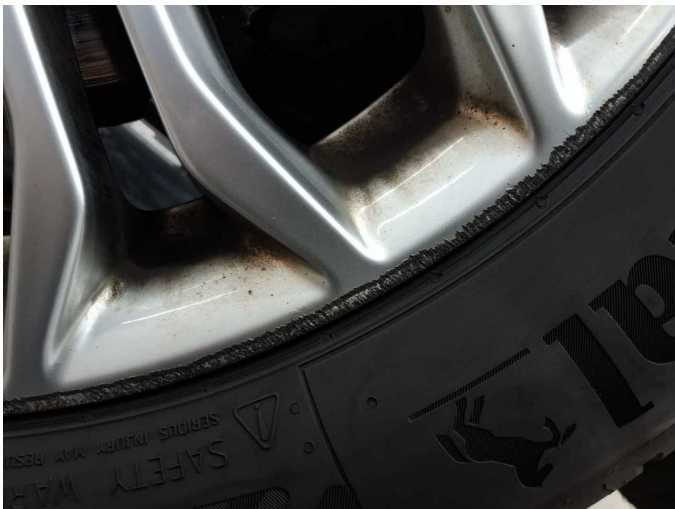
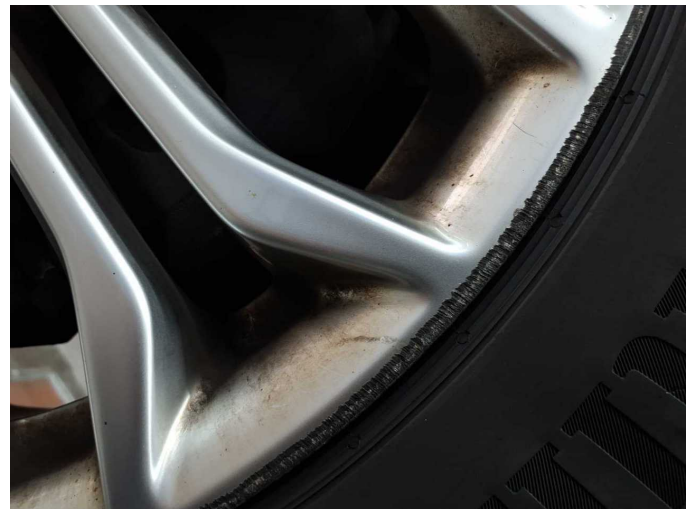
| No. | Component group | Description |
|---|---|---|
| 4 | Wheel / tyres | Alloy rim - front right side - Scratched - Loss in value |

**Damage 4:** Wheel / tyres: Alloy rim - front right side - Scratched - Loss in value

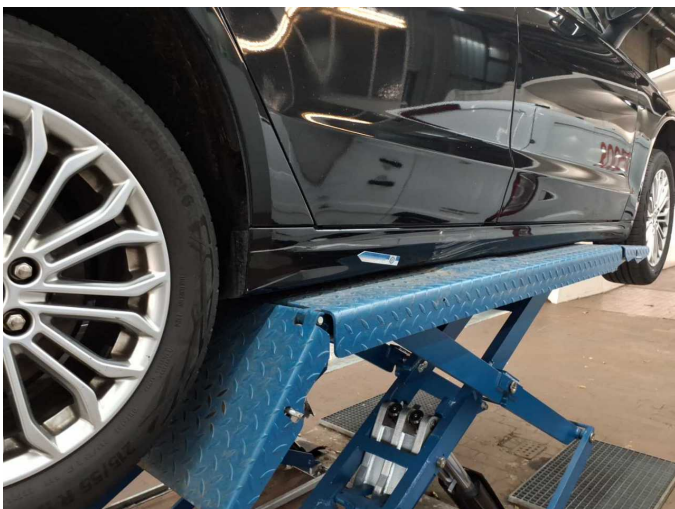
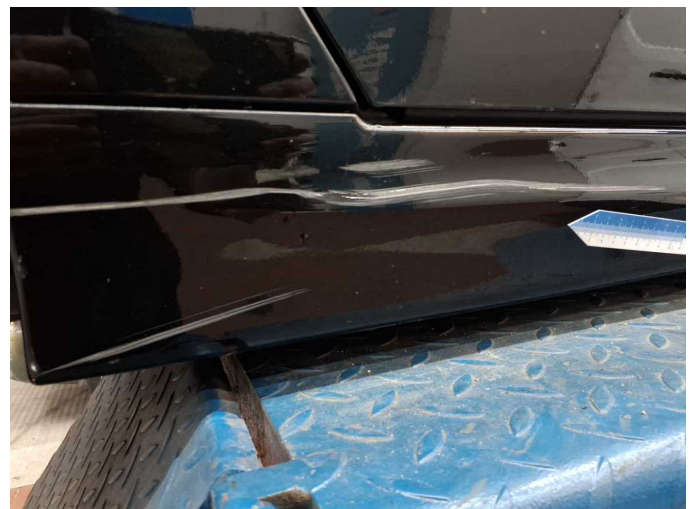
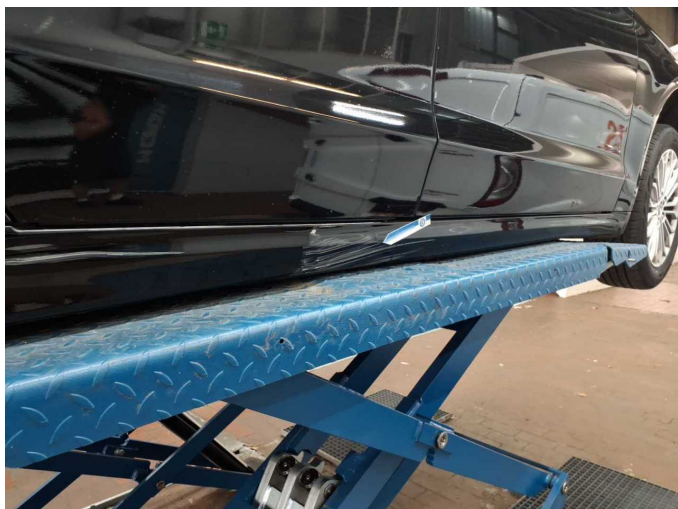
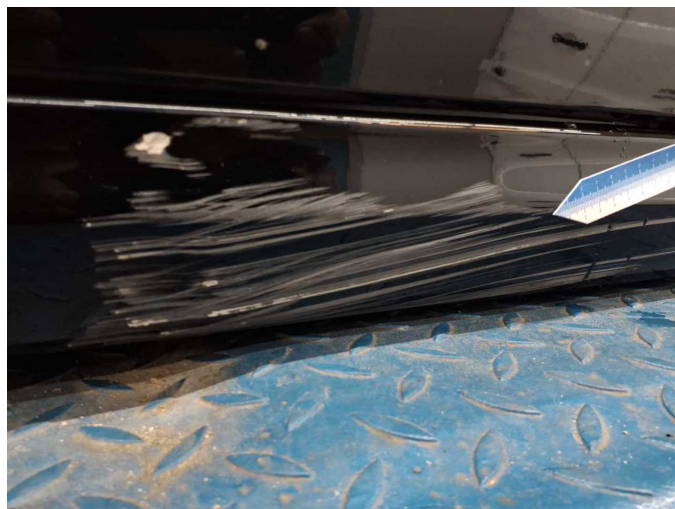
| No. | Component group | Description |
|---|---|---|
| 6 | Sill - right side | Trim - Scratched - Repair and paint |

**Damage 6:** Sill - right side: Trim - Scratched - Repair and paint

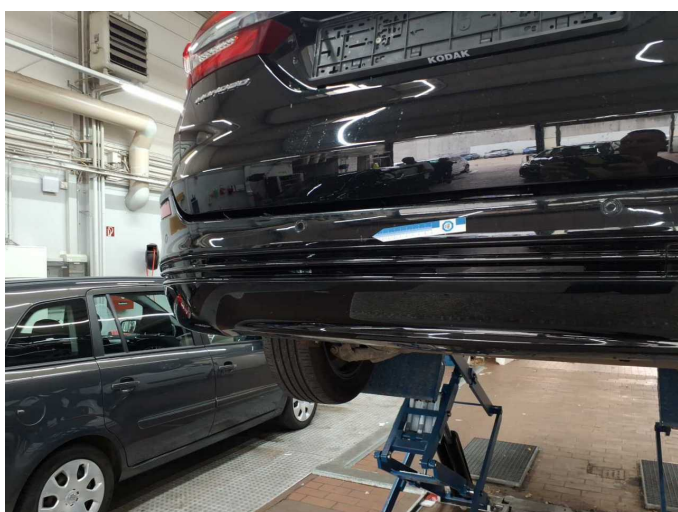
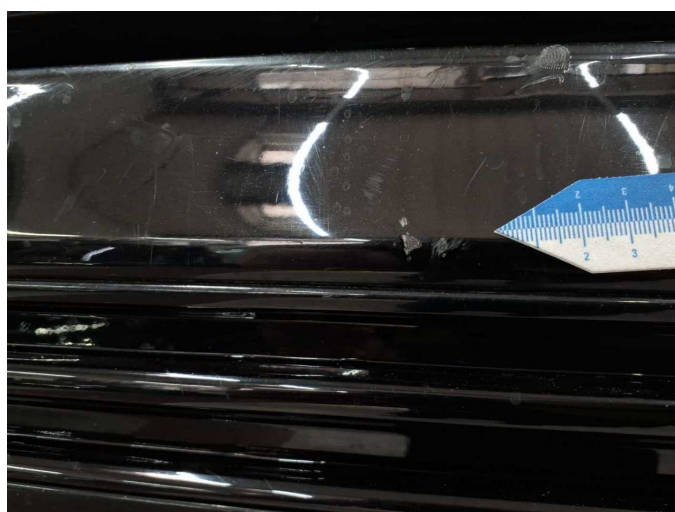
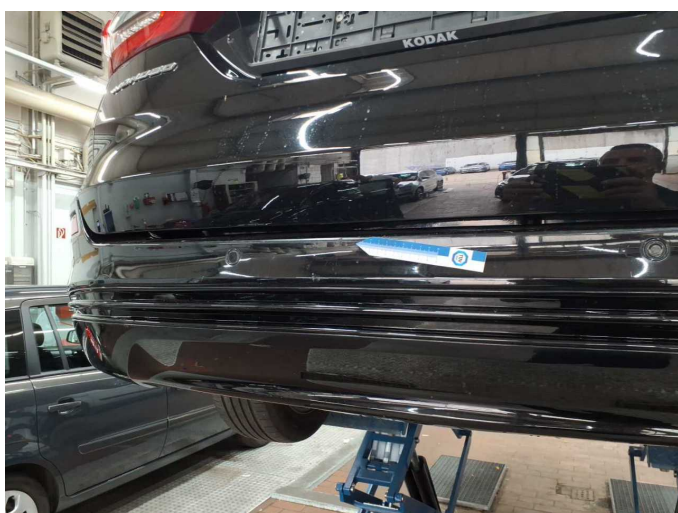
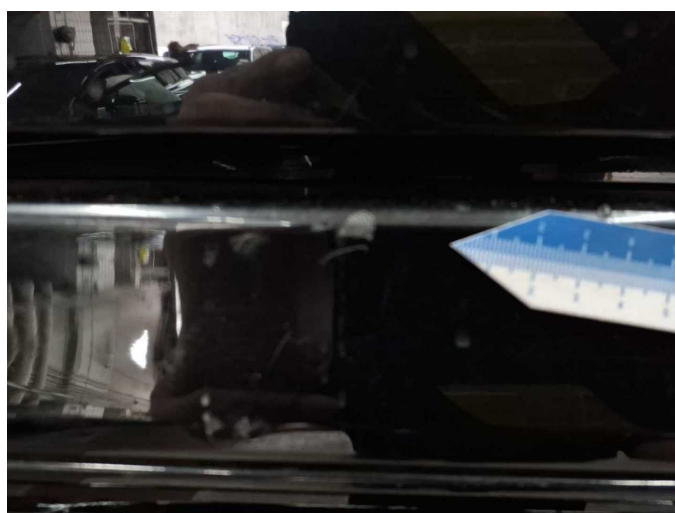
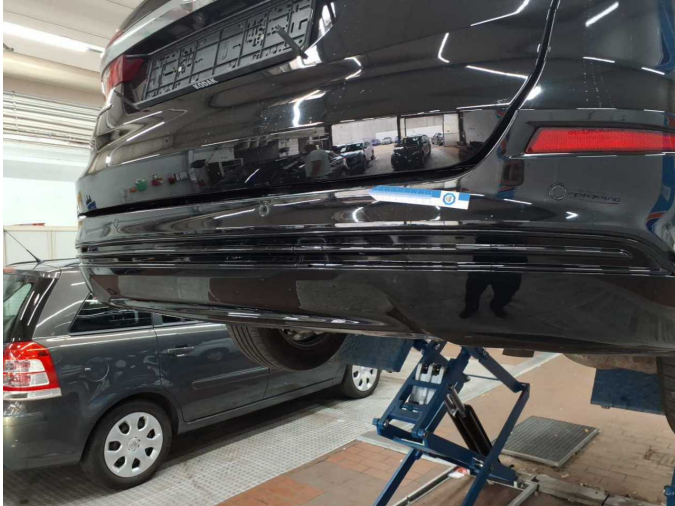
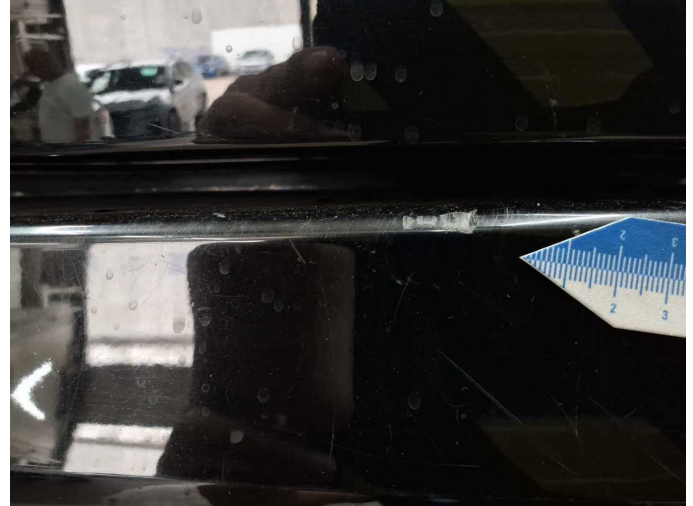
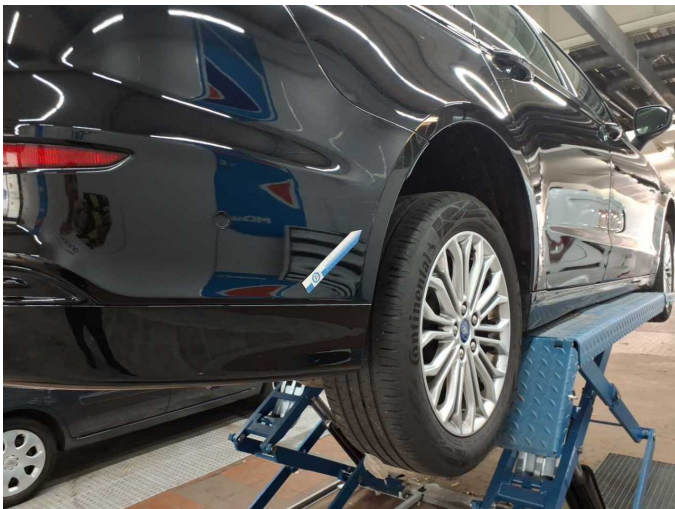
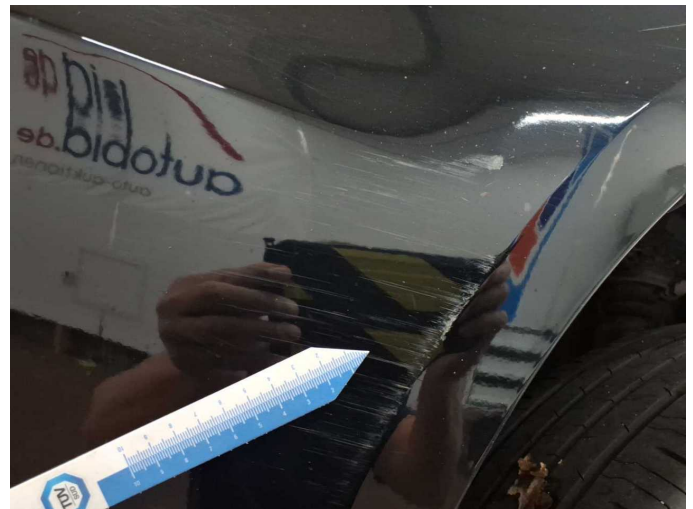
| No. | Component group | Description |
|---|---|---|
| 7 | Rear bumper | Rear bumper - Scratched - Paint |

**Damage 7:** Rear bumper: Rear bumper - Scratched - Paint

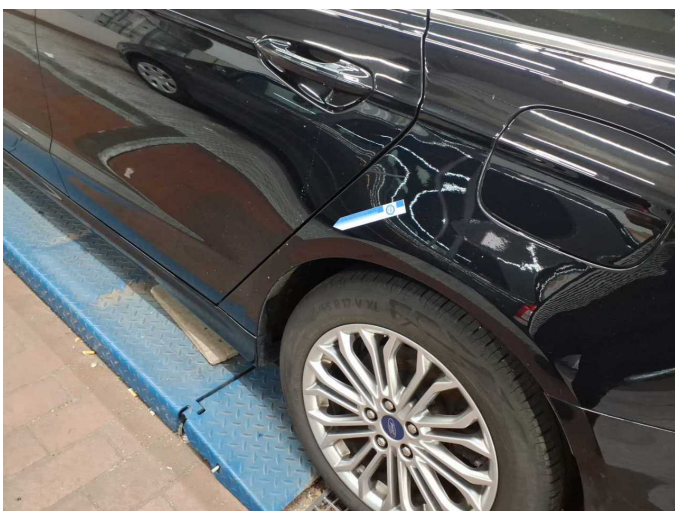
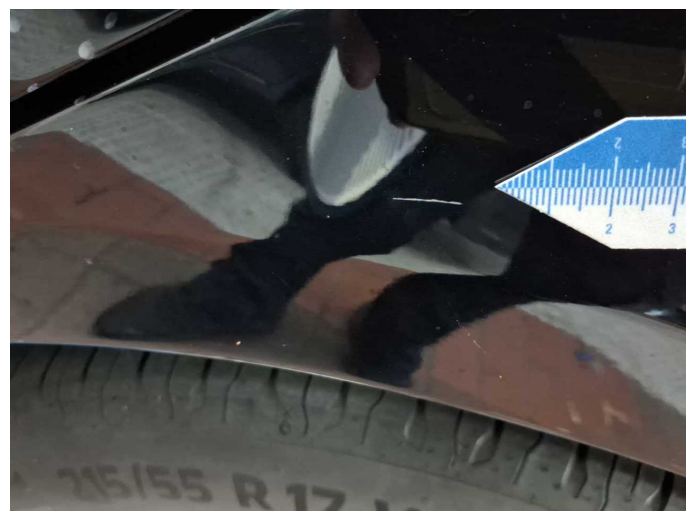
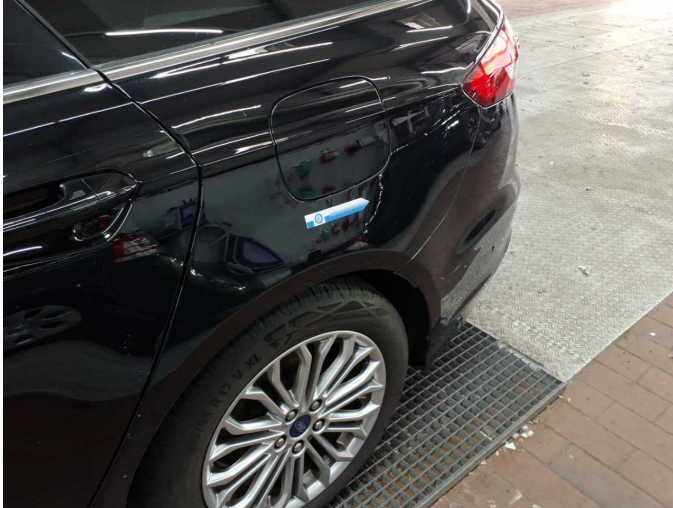
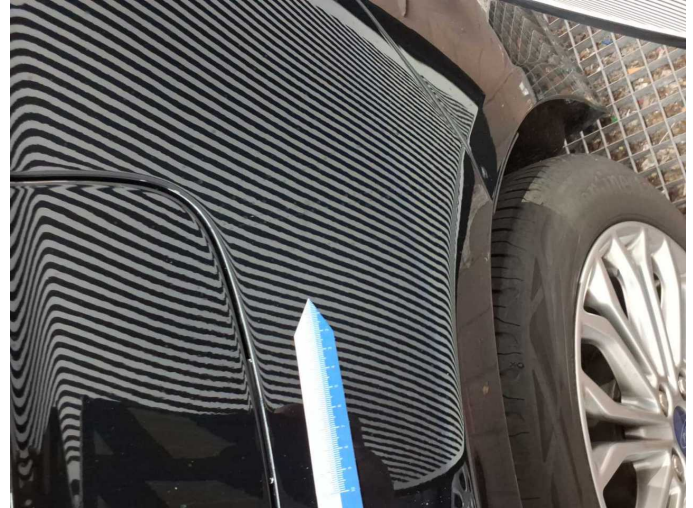
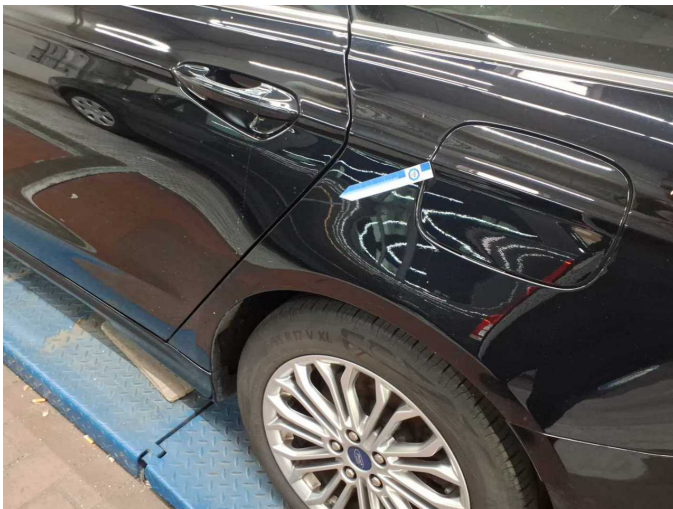
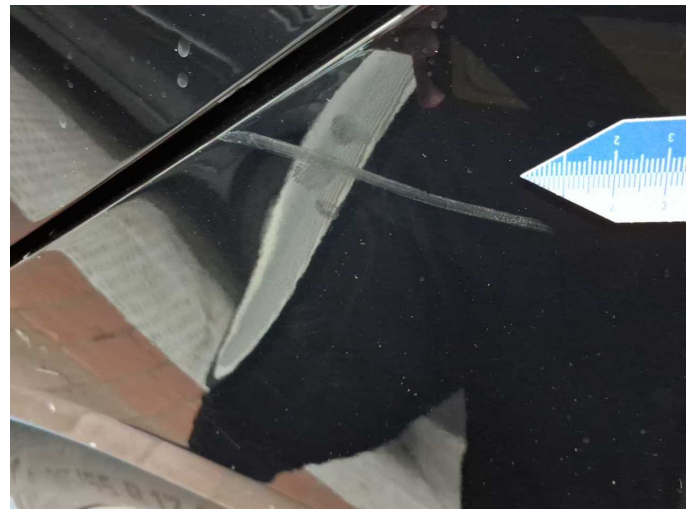
| No. | Component group | Description |
|---|---|---|
| 8 | Side panel - rear left side | Side panel - Dent / paintcoat damage - Paint |

**Damage 8:** Side panel - rear left side: Side panel - Dent / paintcoat damage - Paint

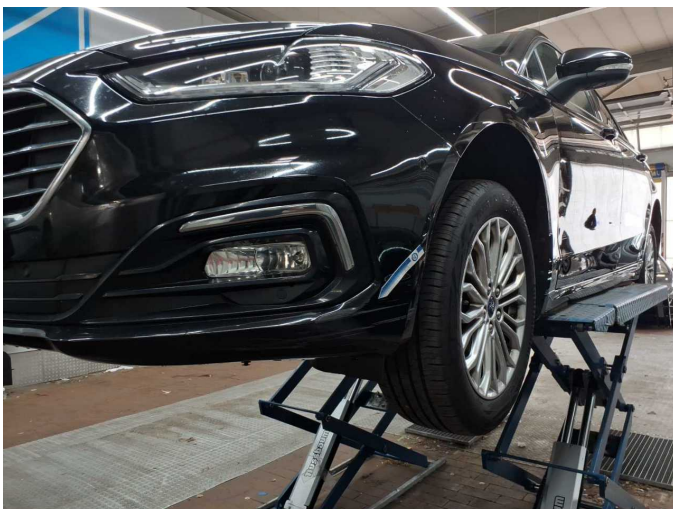
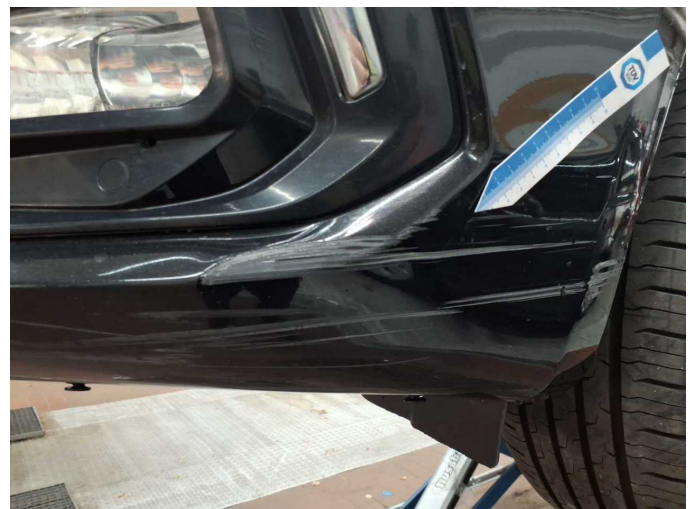
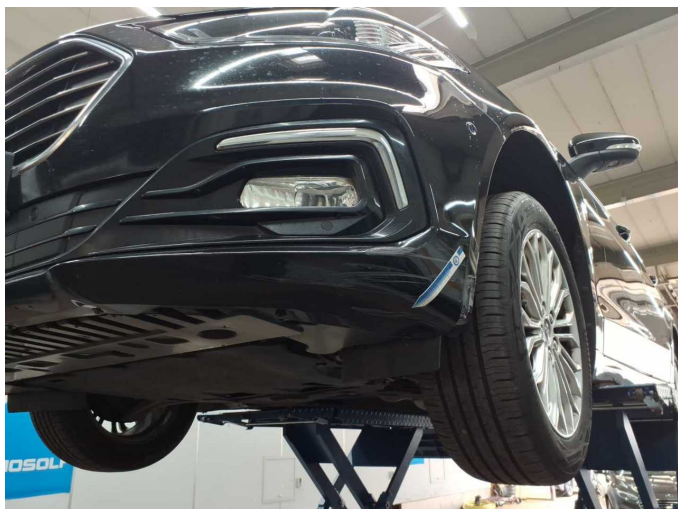
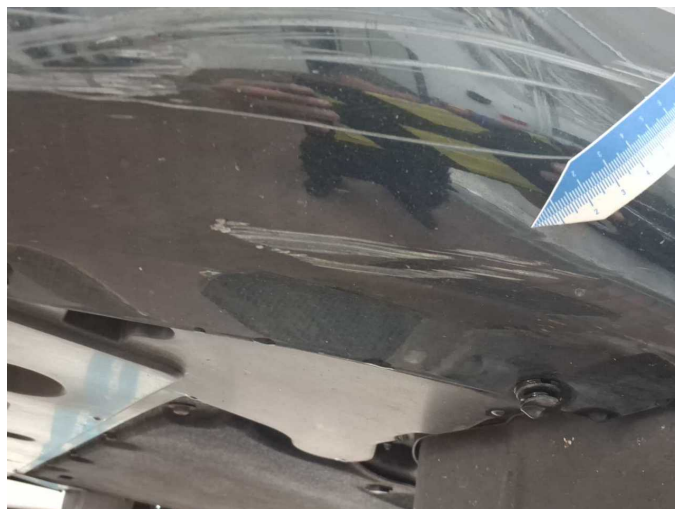
| No. | Component group | Description |
|---|---|---|
| 9 | Front bumper | Front bumper - Scratched - Paint |

**Damage 9:** Front bumper: Front bumper - Scratched - Paint

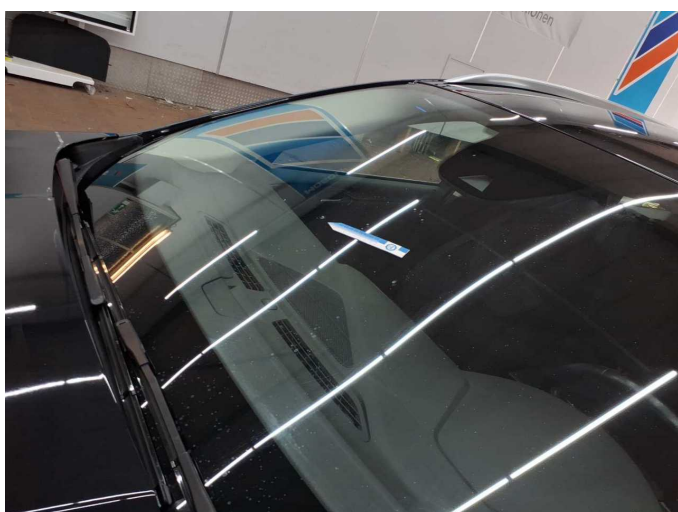
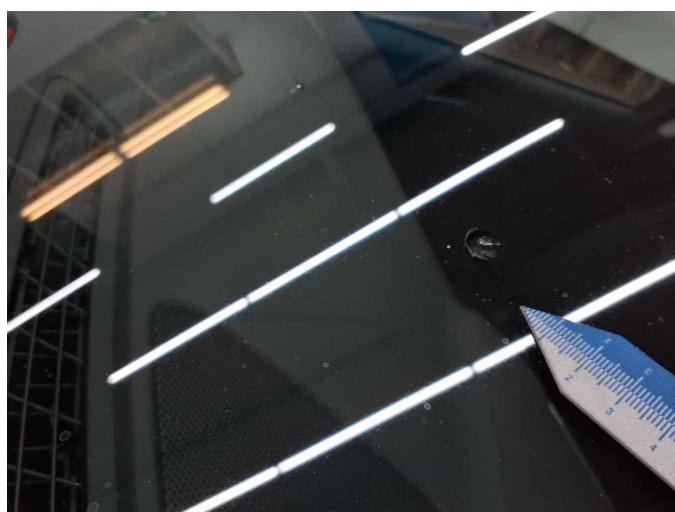
| No. | Component group | Description |
|---|---|---|
| 10 | Vehicle glazing | Windscreen - Broken / torn - Replace |

**Damage 10:** Vehicle glazing: Windscreen - Broken / torn - Replace

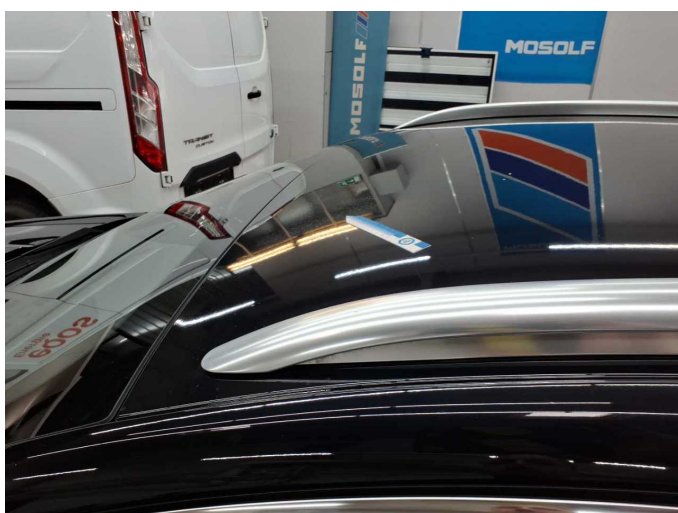
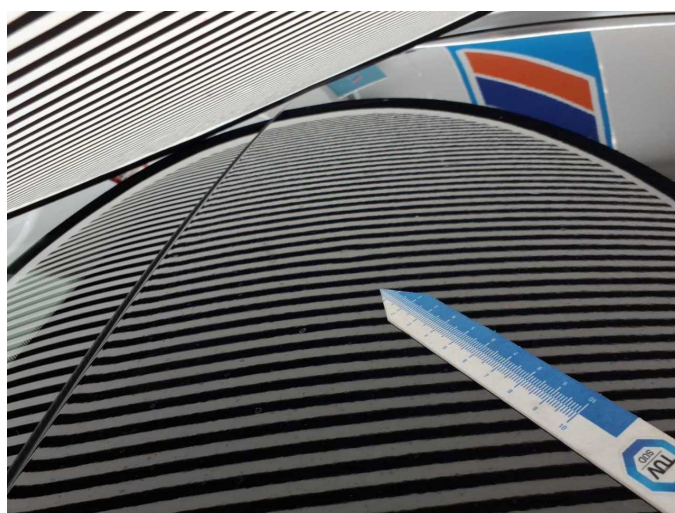
| No. | Component group | Description |
|---|---|---|
| 3 | Roof | Roof - dent(s) - No deduction |

**Wear and tear 3:** Roof: Roof - dent(s) - No deduction

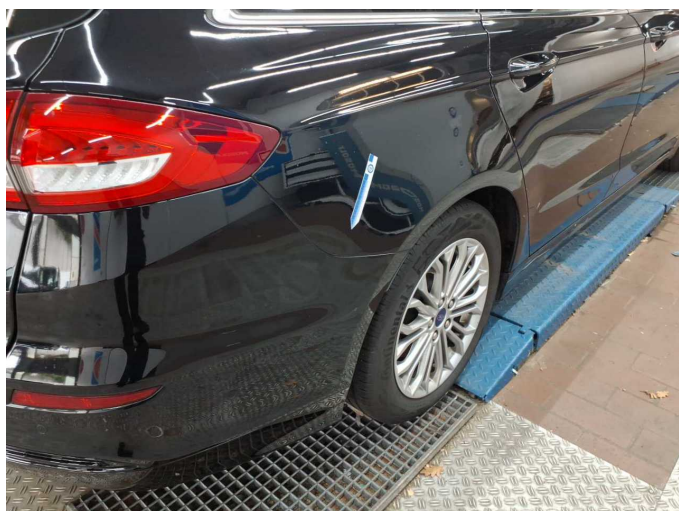
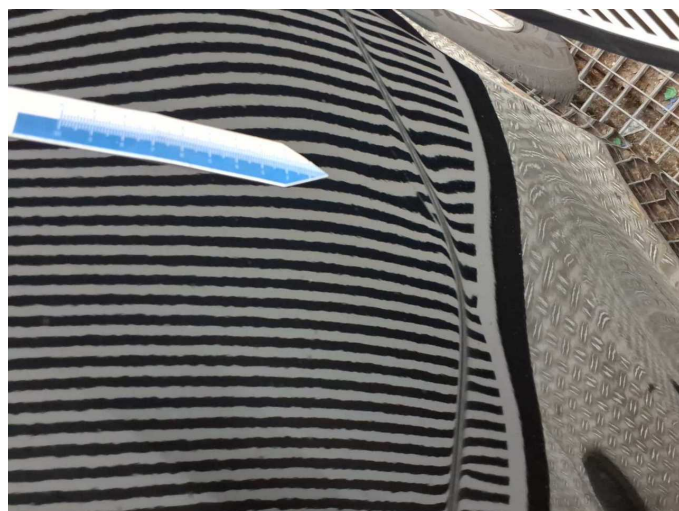
| No. | Component group | Description |
|---|---|---|
| 4 | Side panel - rear right side | Side panel - dent(s) - No deduction |

**Wear and tear 4:** Side panel - rear right side: Side panel - dent(s) - No deduction
