Expertise

Protocol number: 46637404  
Order No. / Reference: 26681265  
Inspection date: 22 Jul 2026

Manufacturer: Opel

Model: Grandland X 1.5 D Start/Stop Automatik Business Edition

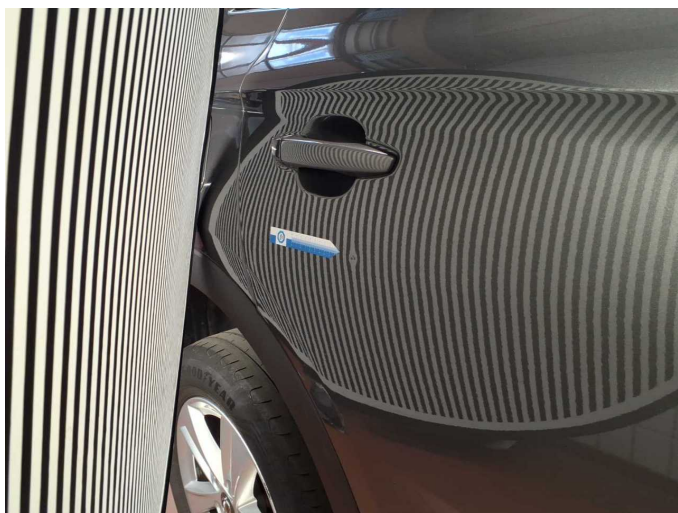
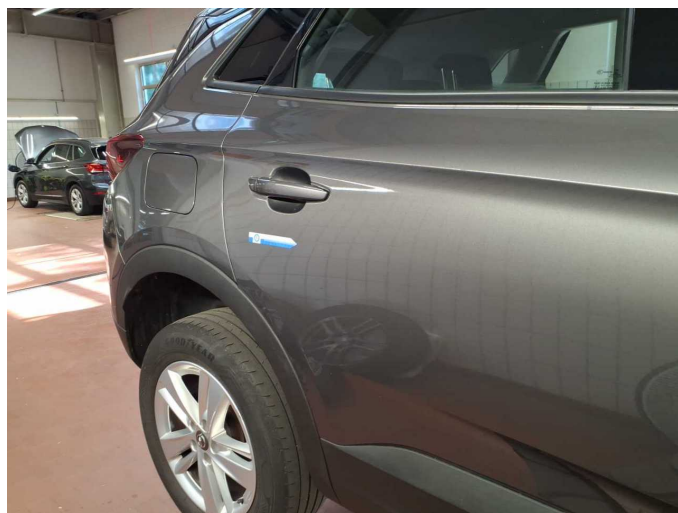
Damage 1: Door - rear right side: Door - dent(s) - Smooth repair work

| No. | Component group | Description |
|---|---|---|
| 1 | Door - rear right side | Door - dent(s) - Smooth repair work |

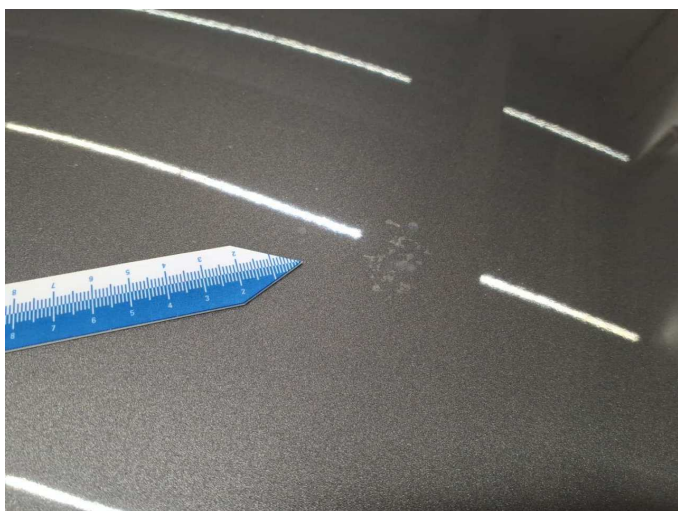
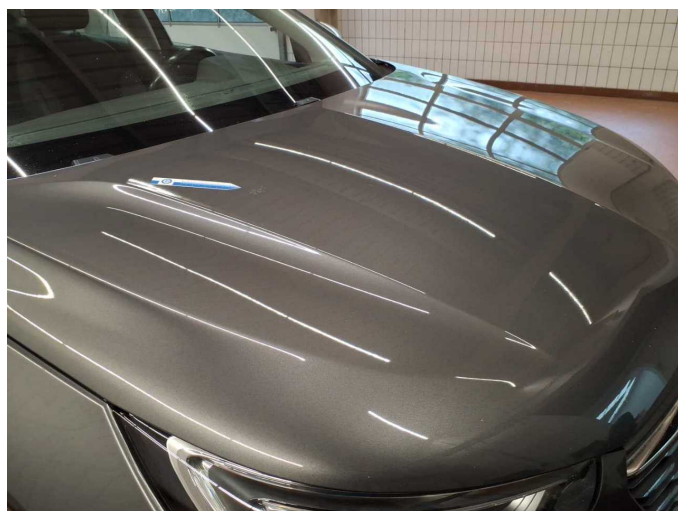
Damage 2: Bonnet: Bonnet (schleifen und polieren) - Soiled - Smart repair

| No. | Component group | Description |
|---|---|---|
| 2 | Bonnet | Bonnet (schleifen und polieren) - Soiled - Smart repair |

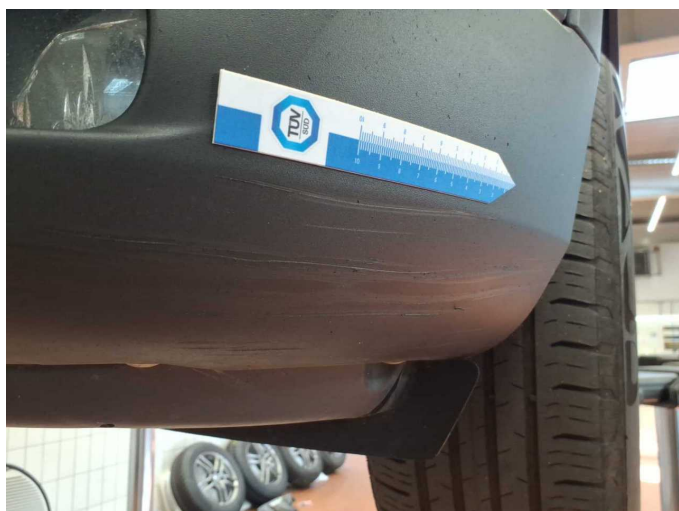
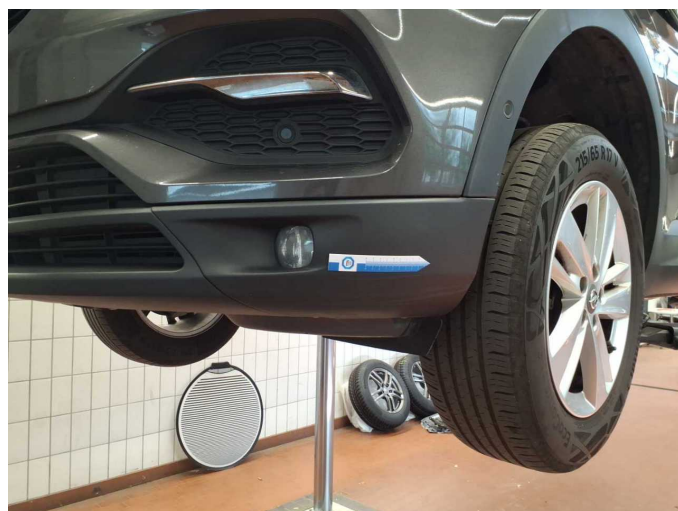
**Damage 3:** Front bumper: Front bumper (unpainted) - Scratched - Replace

| No. | Component group | Description |
|---|---|---|
| 3 | Front bumper | Front bumper (unpainted) - Scratched - Replace |

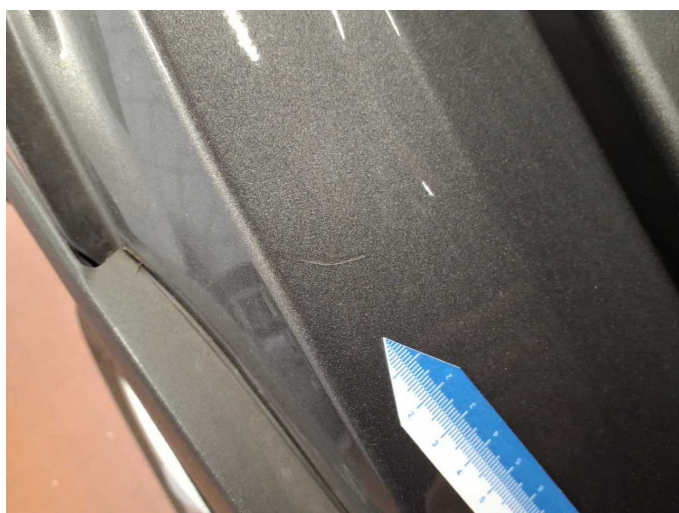
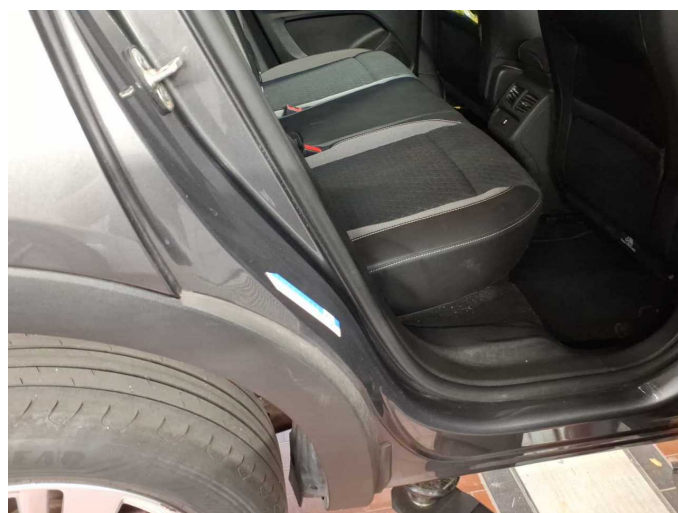
**Damage 4:** Side panel - rear right side: Sill - Scratch(es) - Smart repair

| No. | Component group | Description |
|---|---|---|
| 4 | Side panel - rear right side | Sill - Scratch(es) - Smart repair |

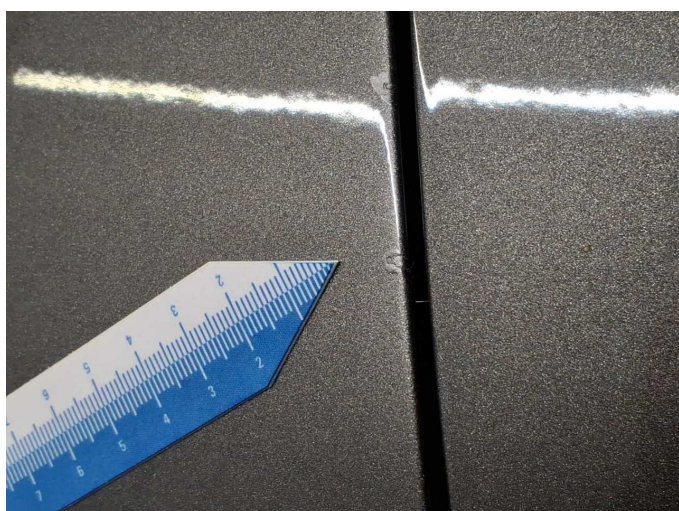
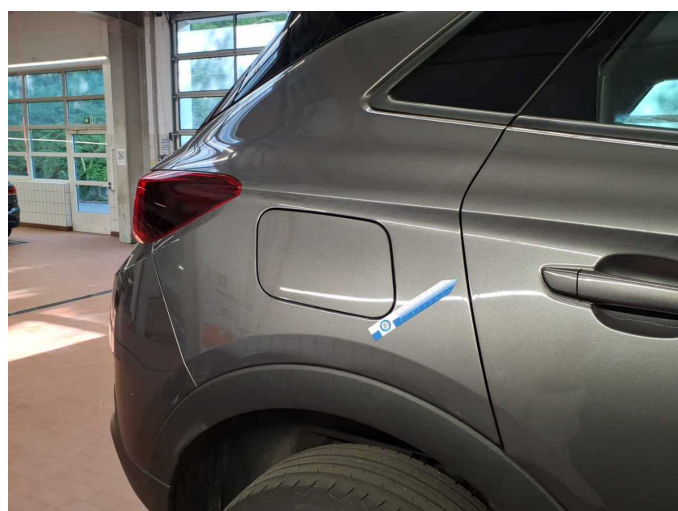
**Damage 5:** Side panel - rear right side: Side panel - Scratch(es) - Smart repair

| No. | Component group | Description |
|---|---|---|
| 5 | Side panel - rear right side | Side panel - Scratch(es) - Smart repair |

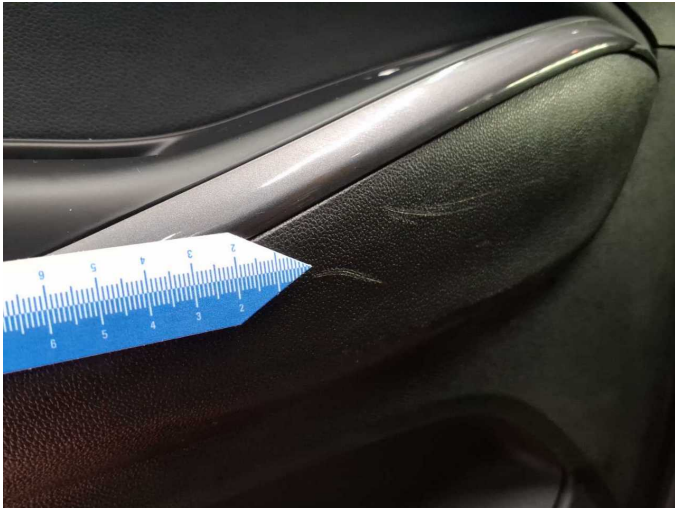
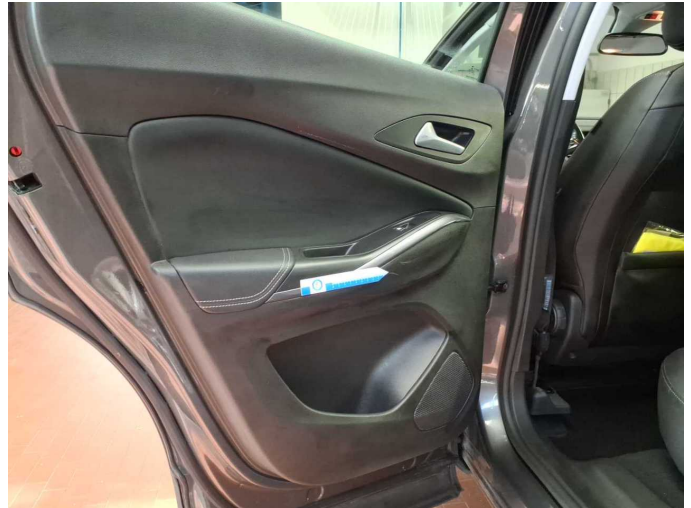
**Damage 6:** Trim / covers: Door trim - rear left side - Scratch(es) - Smart repair

| No. | Component group | Description |
|---|---|---|
| 6 | Trim / covers | Door trim - rear left side - Scratch(es) - Smart repair |

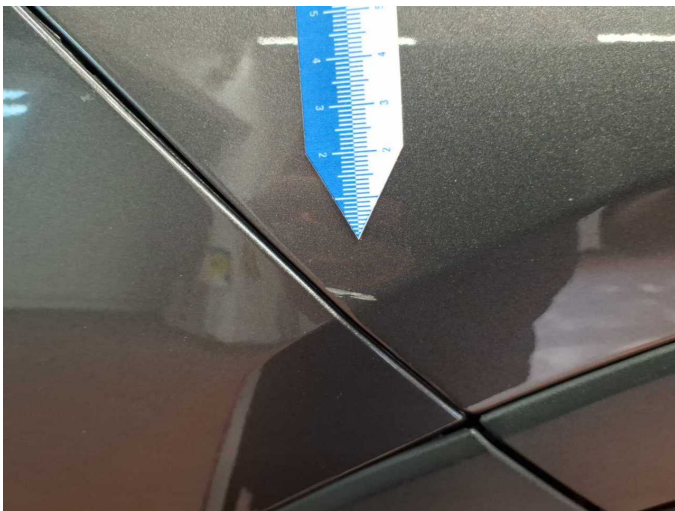
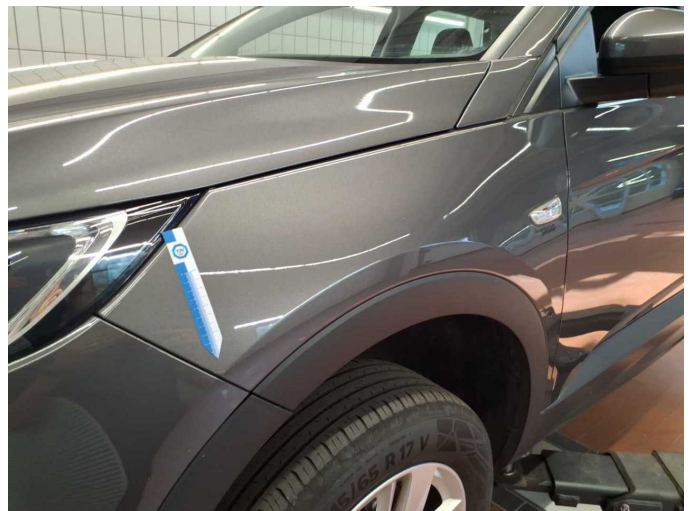
**Damage 7:** Mudguard - left side: Mudguard - left side - Scratch(es) - Smart repair

| No. | Component group | Description |
|---|---|---|
| 7 | Mudguard - left side | Mudguard - left side - Scratch(es) - Smart repair |

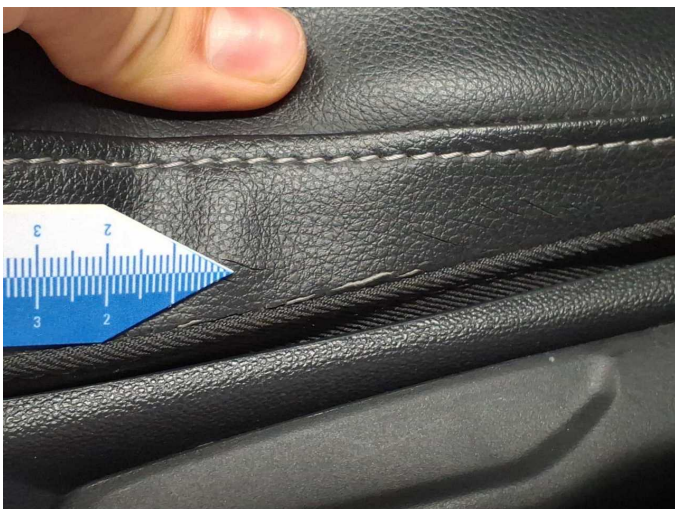
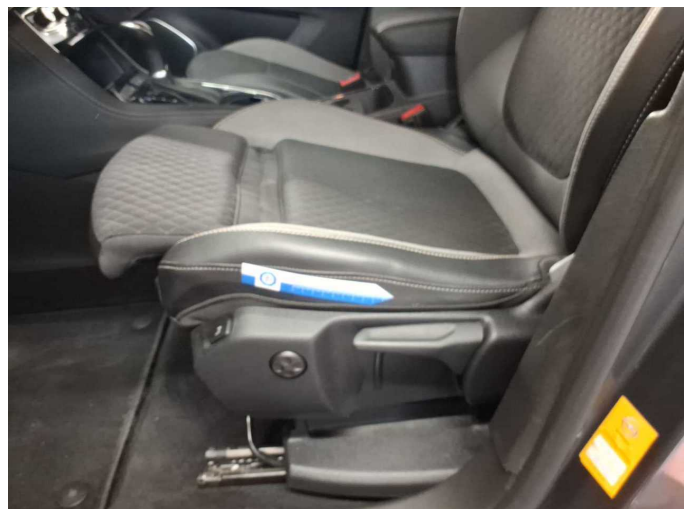
**Damage 8:** Seat - front: Seat cover - left side - Porous / cracked - Loss in value

| No. | Component group | Description |
|---|---|---|
| 8 | Seat - front | Seat cover - left side - Porous / cracked - Loss in value |

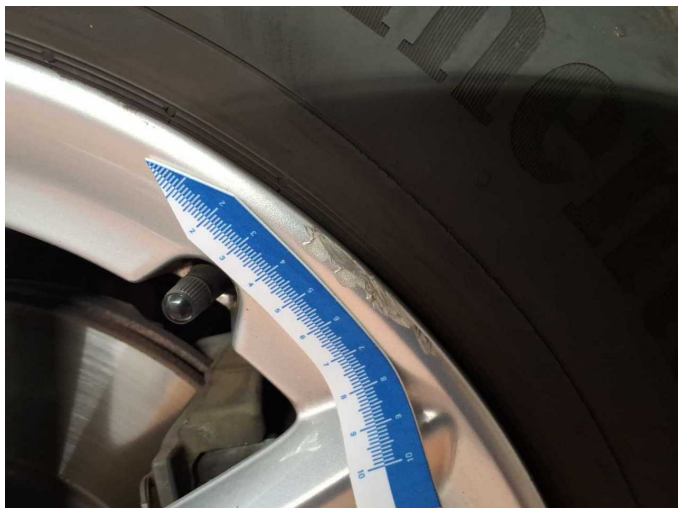
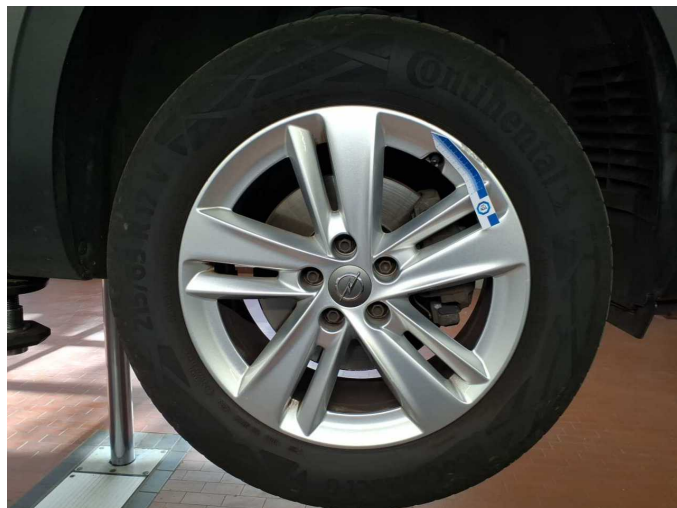
**Damage 9:** Wheel / tyres: Alloy rim - front right side - Scratched - Loss in value

| No. | Component group | Description |
|---|---|---|
| 9 | Wheel / tyres | Alloy rim - front right side - Scratched - Loss in value |

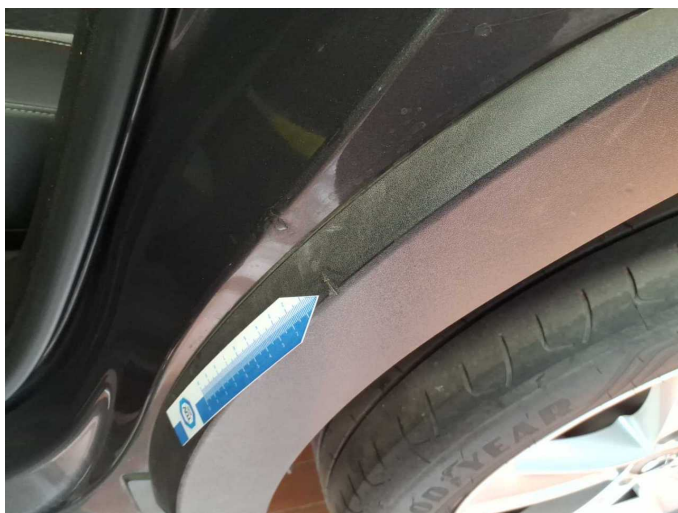
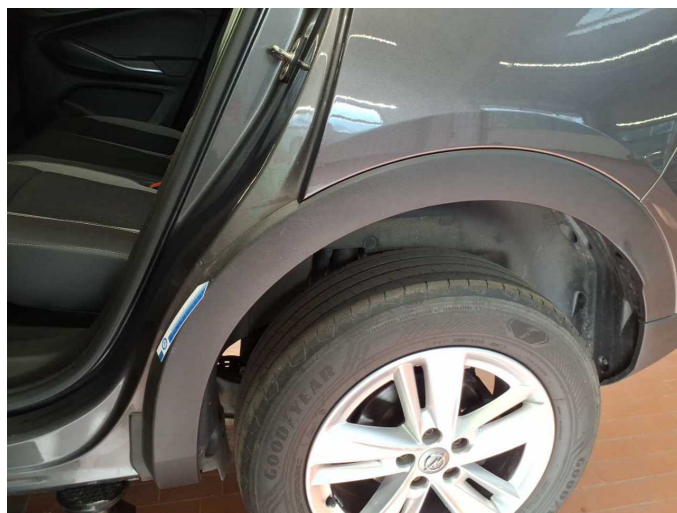
**Damage 10:** Side panel - rear left side: Wheel well extension - Scratch(es) - Replace

| No. | Component group | Description |
|---|---|---|
| 10 | Side panel - rear left side | Wheel well extension - Scratch(es) - Replace |

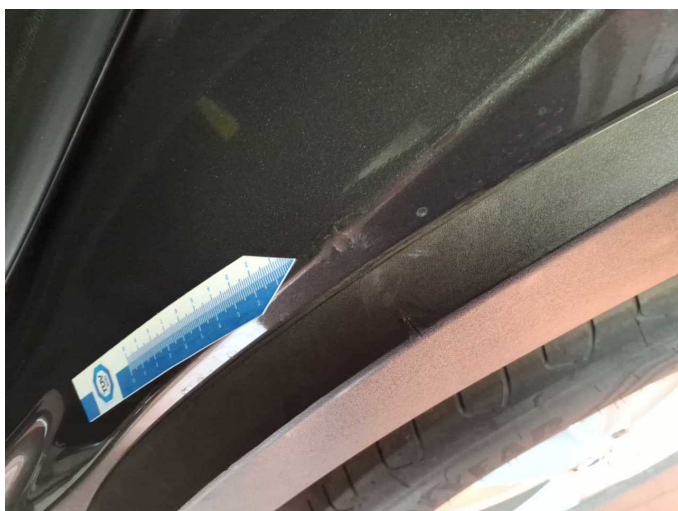
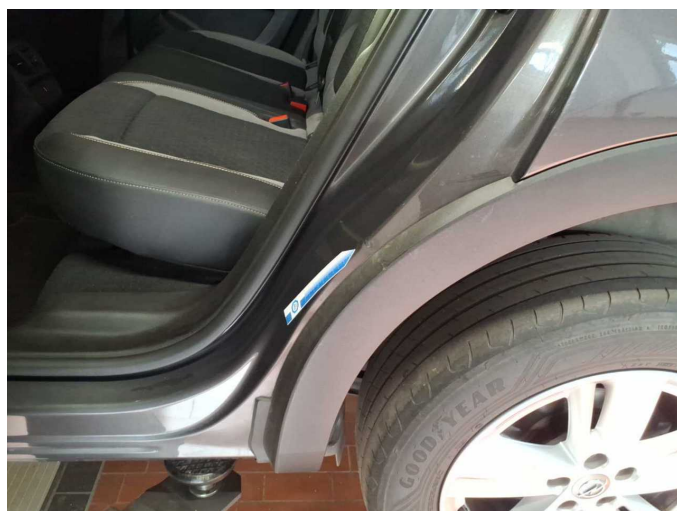
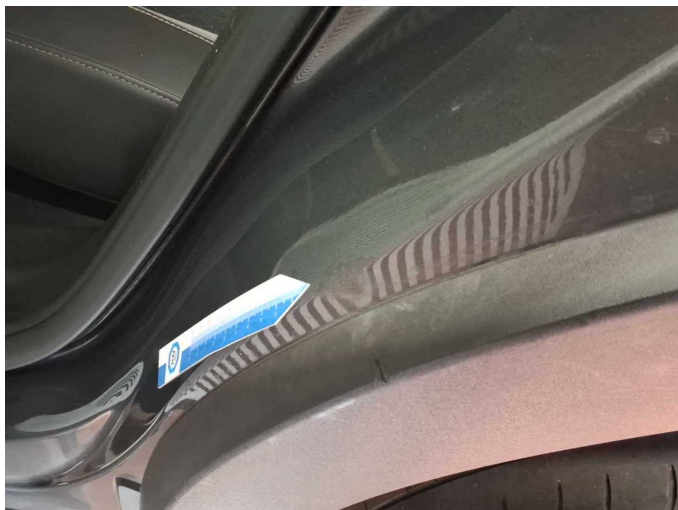
**Damage 11:** Side panel - rear left side: Sill - Dent / paintcoat damage - Smart repair

| No. | Component group | Description |
|---|---|---|
| 11 | Side panel - rear left side | Sill - Dent / paintcoat damage - Smart repair |

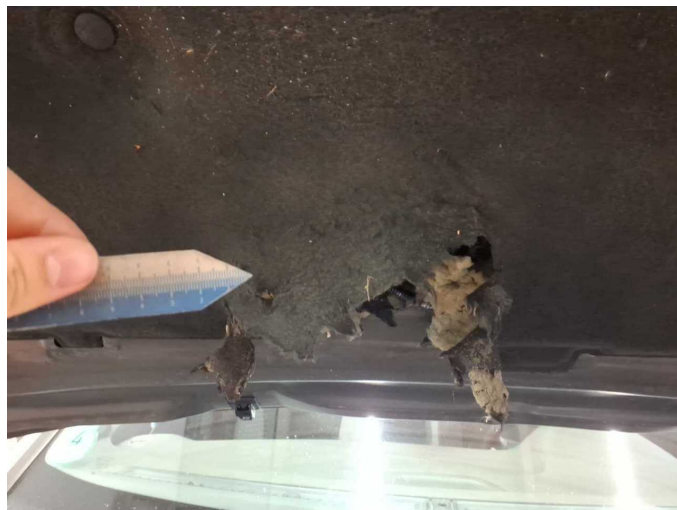
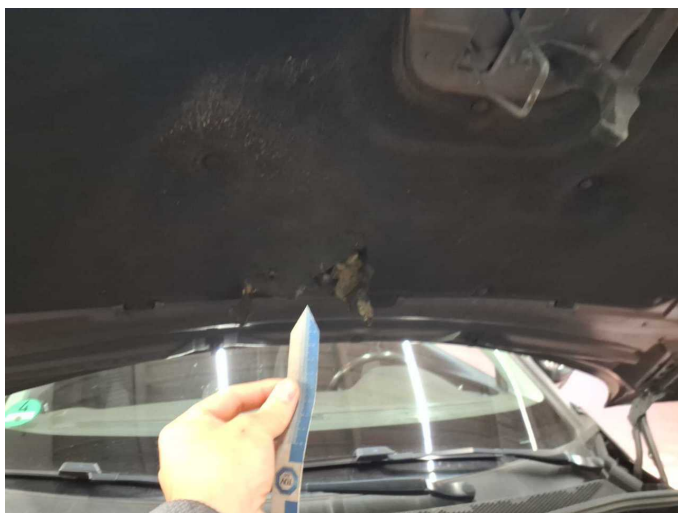
**Damage 12:** Bonnet: Insulation lining - Damage caused by marten / rodent - Replace

| No. | Component group | Description |
|---|---|---|
| 12 | Bonnet | Insulation lining - Damage caused by marten / rodent - Replace |

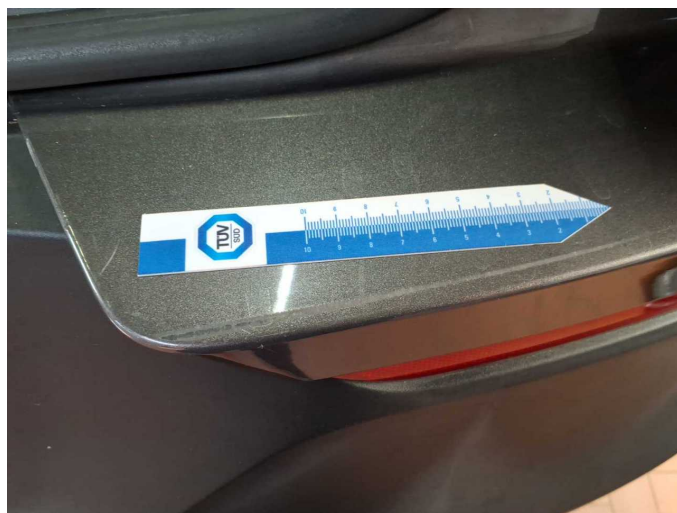
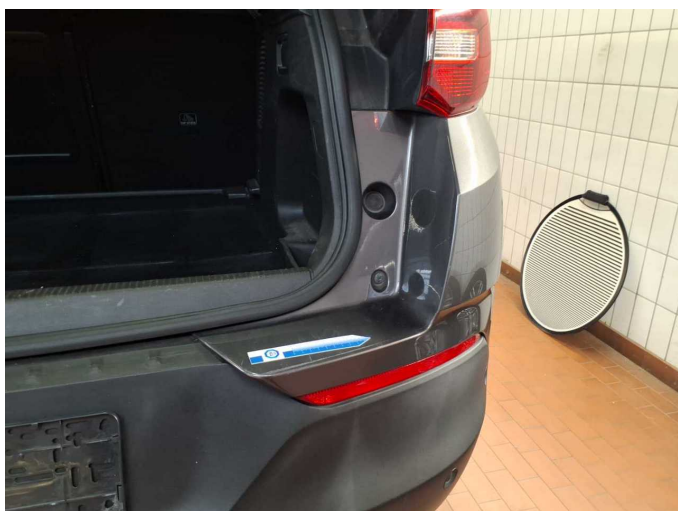
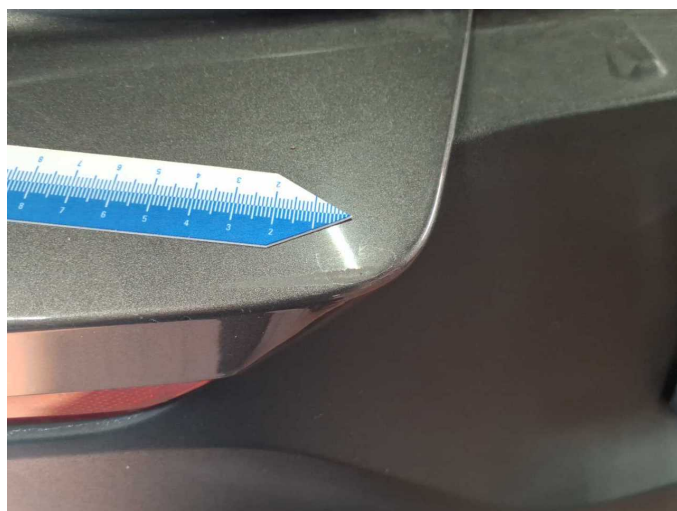
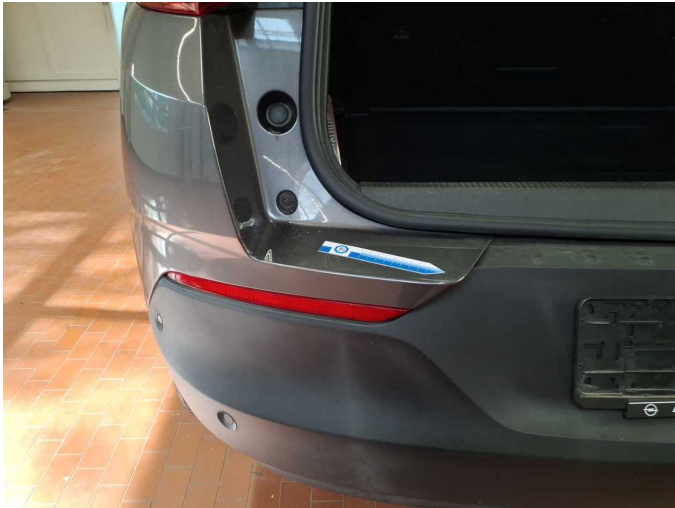
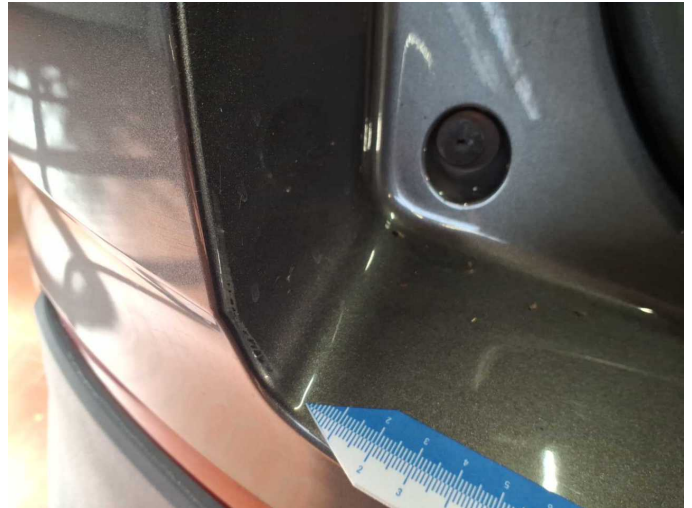
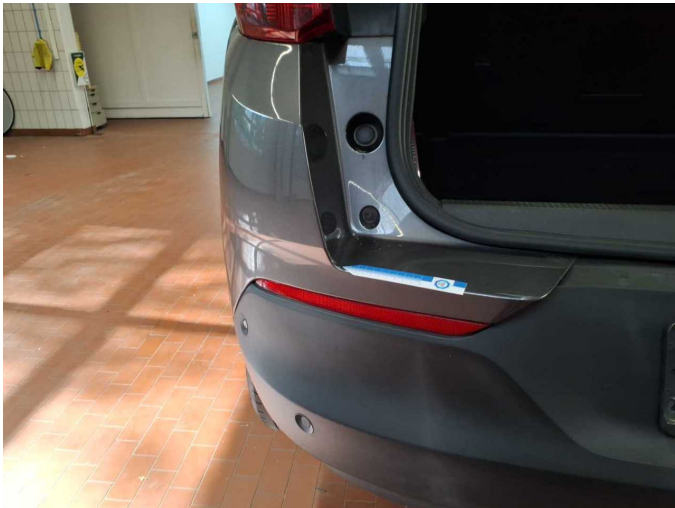
**Damage 13:** Rear bumper: Rear bumper - Scratch(es) - Paint

| No. | Component group | Description |
|---|---|---|
| 13 | Rear bumper | Rear bumper - Scratch(es) - Paint |

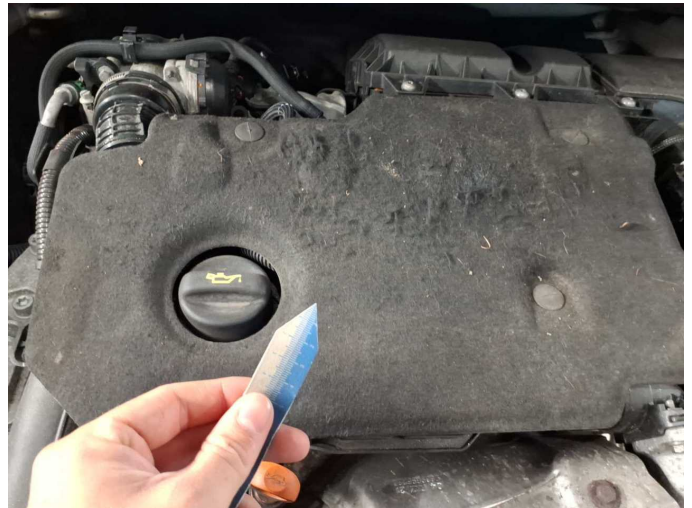
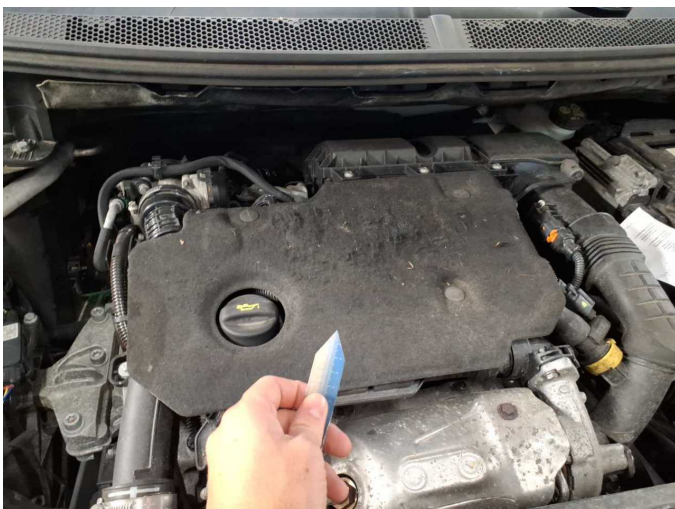
| No. | Component group | Description |
|---|---|---|
| 2 | Engine | Engine cover - Damage caused by marten / rodent - No deduction |

**Wear and tear 2:** Engine: Engine cover - Damage caused by marten / rodent - No deduction

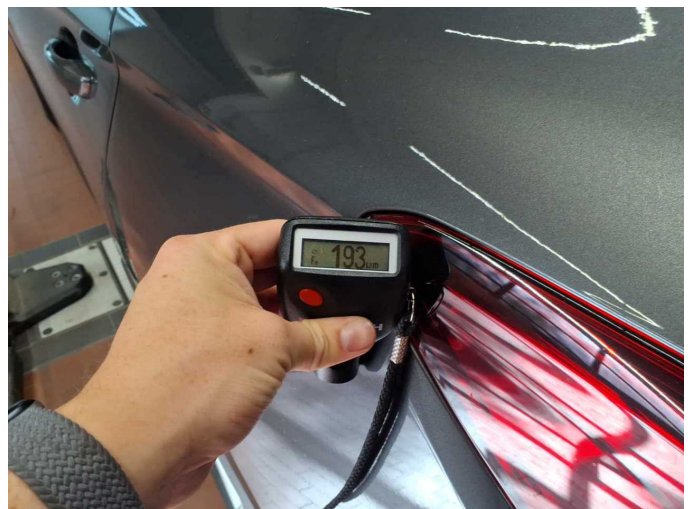
- 1 Side panel - rear left side, Professionally carried out, Invoice of repair done Non-existent
- 2 Door - rear left side, Professionally carried out, Invoice of repair done Non-existent

| Side panel - rear left side | 193 µm | Door - rear left side | 243 µm |

**Repainting 1:** Side panel - rear left side

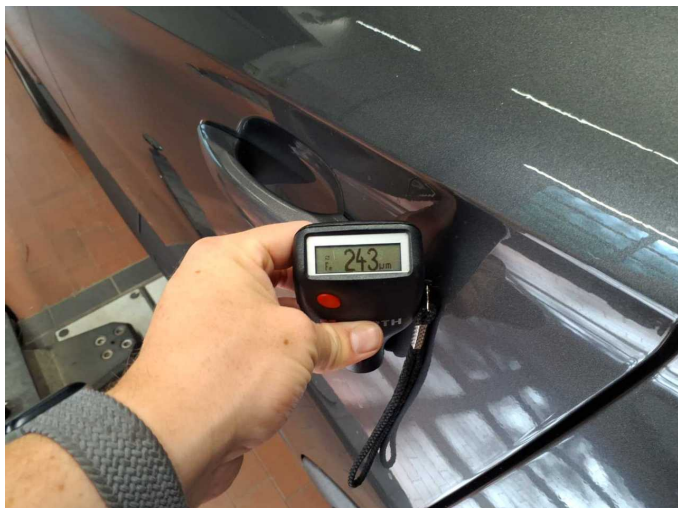
**Repainting 2:** Door - rear left side
