Expertise

Protocol number: 46199417  
Order No. / Reference: 26587951  
Inspection date: 29 Jun 2026

Manufacturer: Skoda  
VIN: TMBLN7NS2N8045709

Model: Kodiahq 2.0 TDI 4x4 DSG Tour

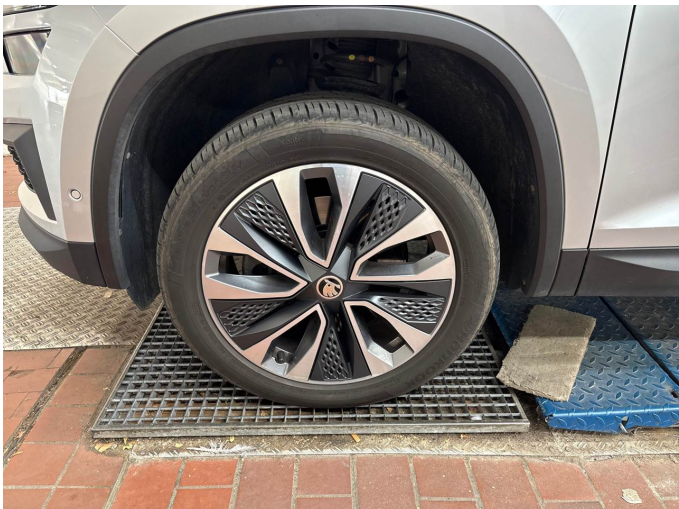
Figure 12: Mounted tyres

| # | Tyre size | Type of tyre | Manufacturer | Tread depth |
|---|---|---|---|---|
| 1) | 235/50 R19 99V | Summer tyres on Light alloy | Hankook | 6mm / 6mm |
| 2) | 235/50 R19 99V | Summer tyres on Light alloy | Hankook | 6mm / 6mm |

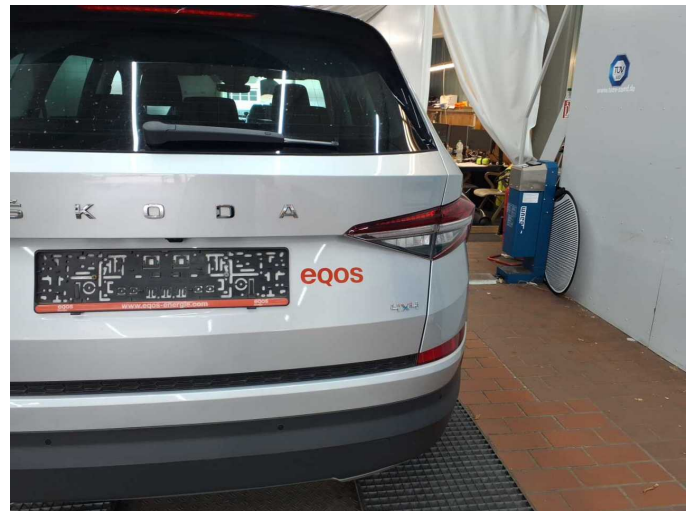
Damage 1: Boot lid / rear door: Boot lid - Glued / labelled - De-glue / neutralise

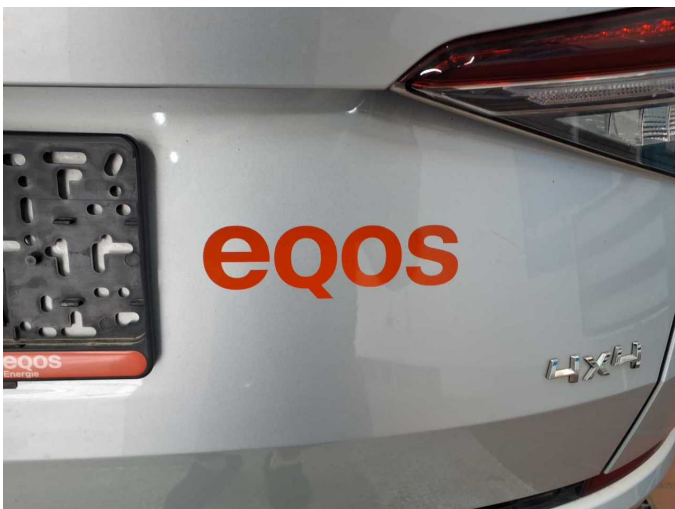
| No. | Component group | Description |
|---|---|---|
| 1 | Boot lid / rear door | Boot lid - Glued / labelled - De-glue / neutralise |

Damage 1: Boot lid / rear door: Boot lid - Glued / labelled - De-glue / neutralise

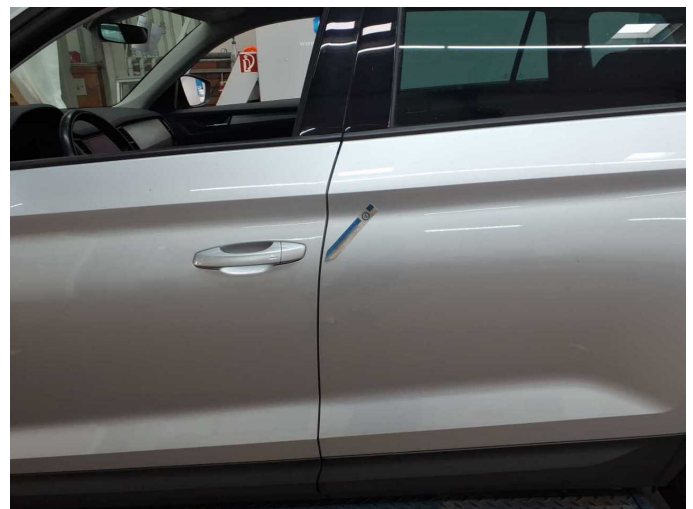
Damage 2: Door - rear left side: Door - Scratch(es) - Smart repair

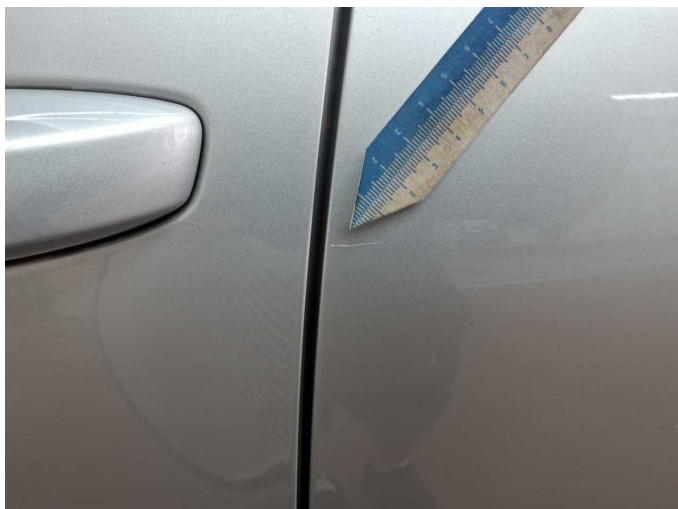
| No. | Component group | Description |
|---|---|---|
| 2 | Door - rear left side | Door - Scratch(es) - Smart repair |

**Damage 2:** Door - rear left side: Door - Scratch(es) - Smart repair

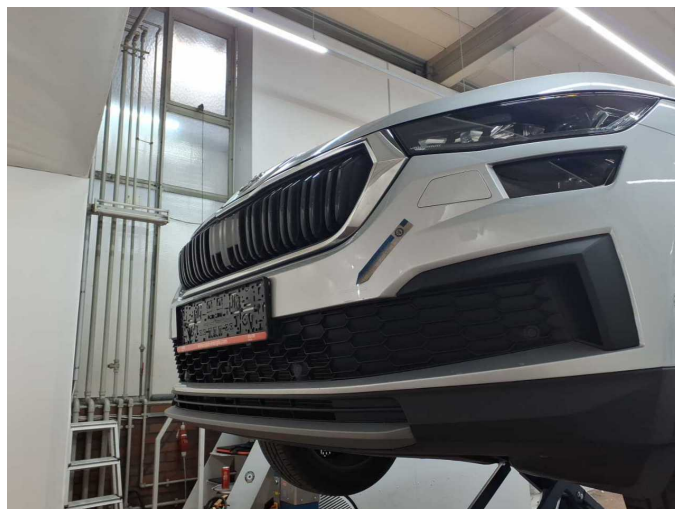
**Damage 3:** Front bumper: Front bumper - Scratch(es) - Smart repair

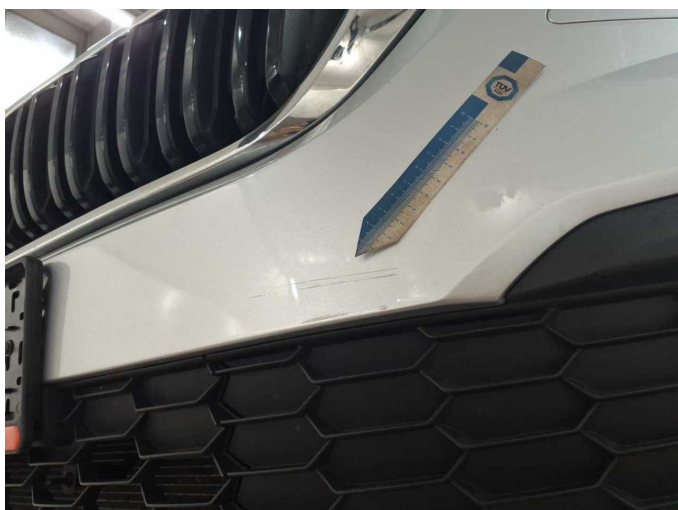
| No. | Component group | Description |
|---|---|---|
| 3 | Front bumper | Front bumper - Scratch(es) - Smart repair |

**Damage 3:** Front bumper: Front bumper - Scratch(es) - Smart repair

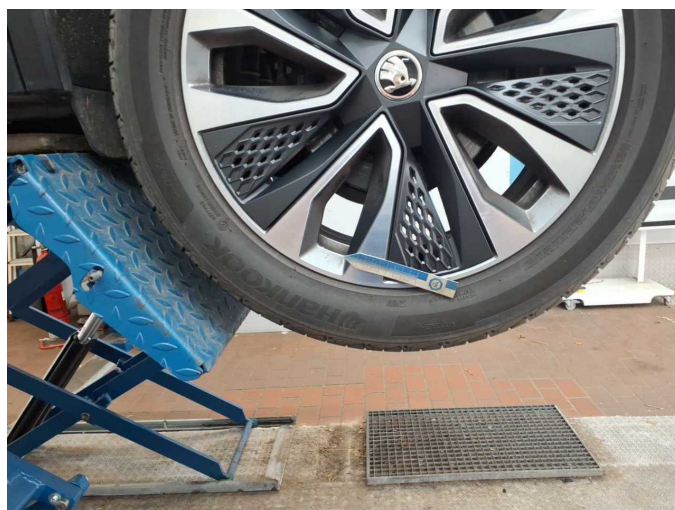
**Damage 4:** Wheel / tyres: Alloy rim - rear left side - Corrosion - Loss in value

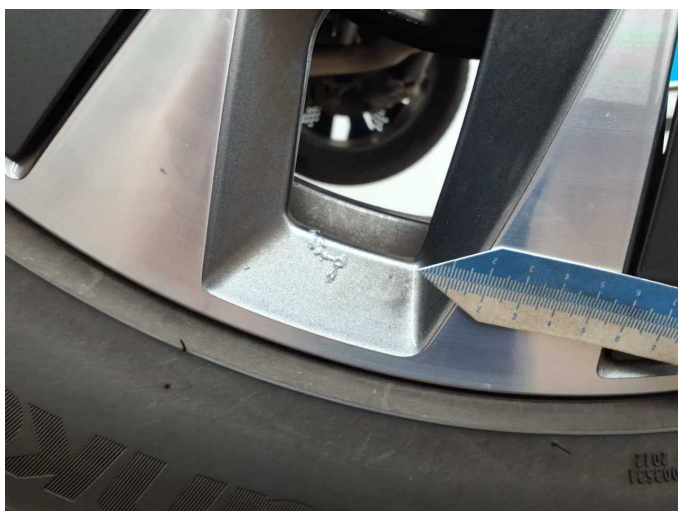
| No. | Component group | Description |
|---|---|---|
| 4 | Wheel / tyres | Alloy rim - rear left side - Corrosion - Loss in value |

**Damage 4:** Wheel / tyres: Alloy rim - rear left side - Corrosion - Loss in value

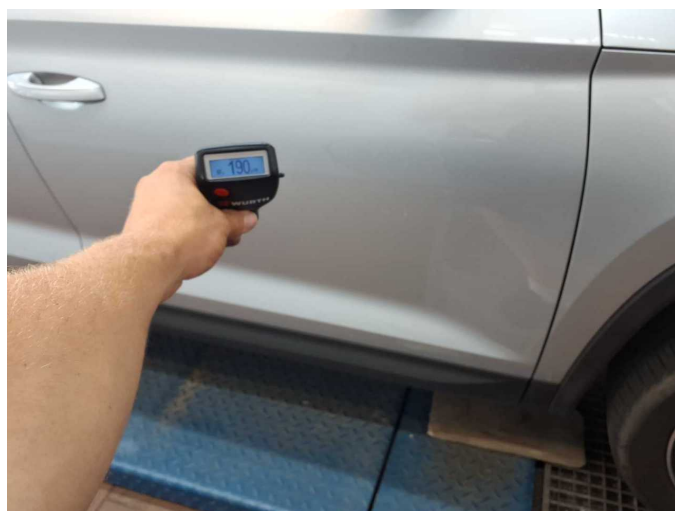
| 1 | Door - front right side, Professionally carried out, Invoice of repair done Non-existent |

| Door - front right side | 190 µm |

**Repainting 1:** Door - front right side

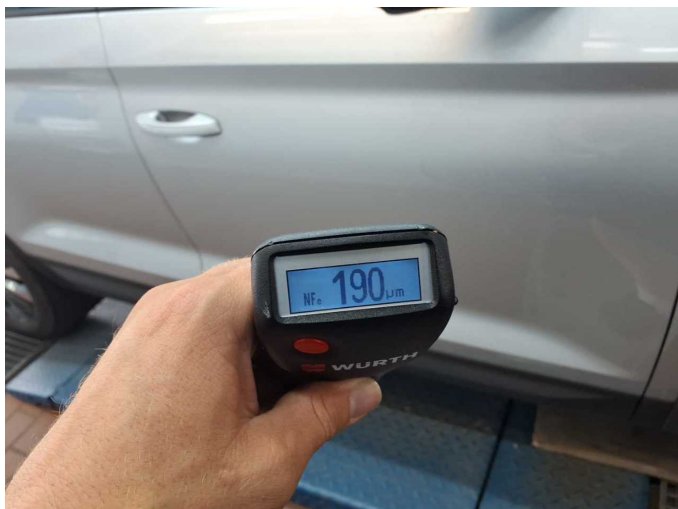
**Repainting 1:** Door - front right side
