Expertise

Protocol number: 46653824  
Order No. / Reference: 26594963  
Inspection date: 16 Jul 2026

Manufacturer: Skoda  
VIN: TMBJC7NY9PF043827

Model: Enyaq iV 80

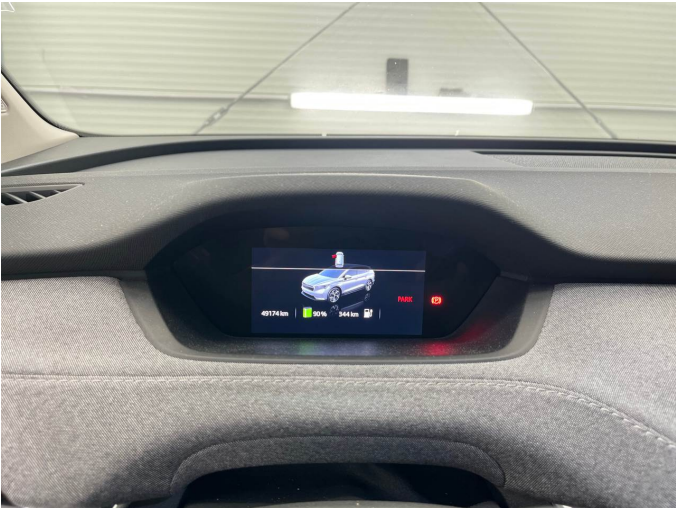
| Vehicle details | |
|---|---|
| Mileage (Read) | 49,174 km |

Figure 7: Instrument cluster

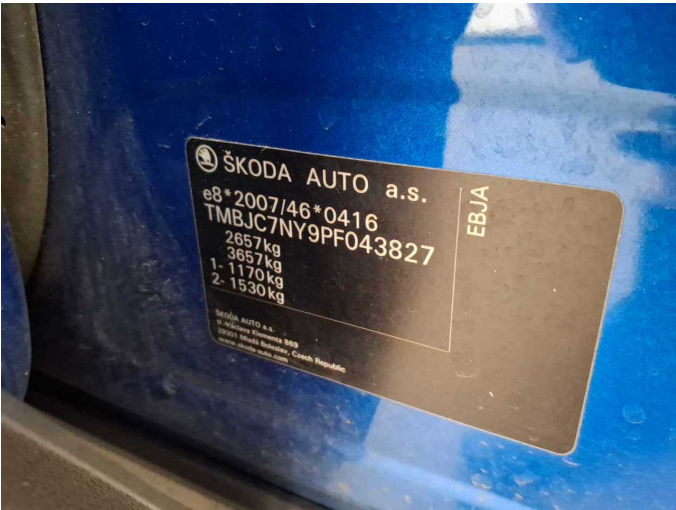
| VIN comparison | The vehicle identification number (VIN) was read from the vehicle and its conformity with the submitted documents was confirmed by the undersigned during the inspection. |

Figure 11: VIN

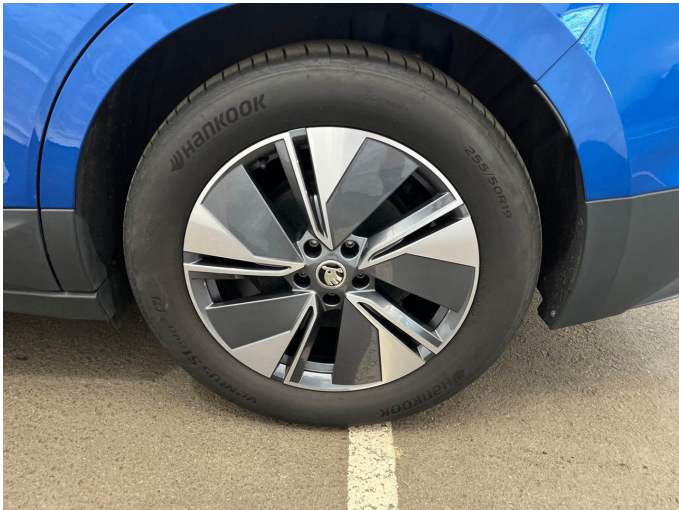
| # | Tyre size | Type of tyre | Manufacturer | Tread depth |
|---|---|---|---|---|
| 1) | 235/55 R19 101T | Summer tyres on Light alloy | Hankook | 5mm / 5mm |
| 2) | 255/50 R19 103T | Summer tyres on Light alloy | Hankook | 5mm / 5mm |

Figure 12: Mounted tyres

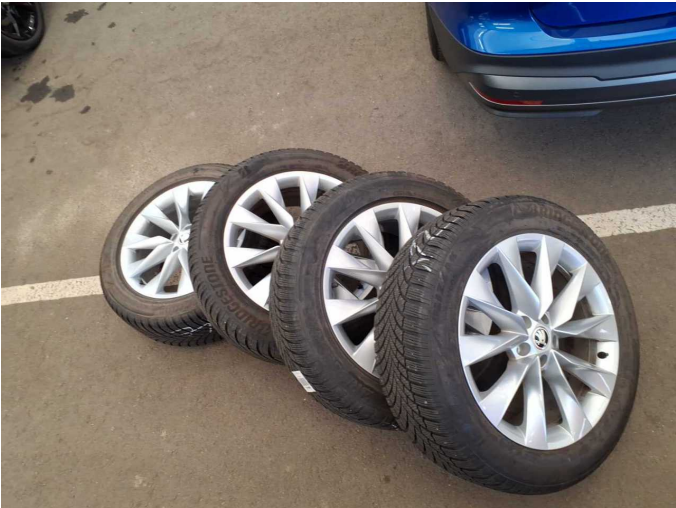
| # | Tyre size | Type of tyre | Manufacturer | Tread depth |
|---|---|---|---|---|
| 1) | 235/55 R19 105V | Winter tyres on Light alloy | Bridgestone | 6mm / 6mm |
| 2) | 255/50 R19 107V | Winter tyres on Light alloy | Bridgestone | 6mm / 6mm |

Figure 15: Additional tyres

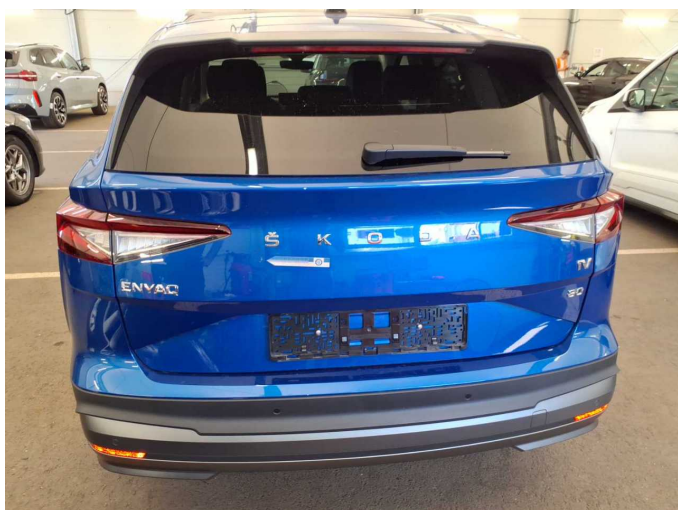
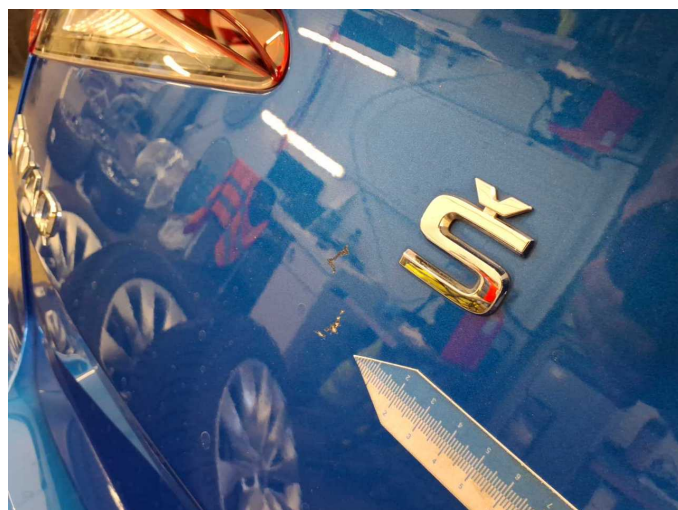
| No. | Component group | Description |
|---|---|---|
| 1 | Boot lid / rear door | Boot lid - Scratch(es) - Paint |

**Damage 1:** Boot lid / rear door: Boot lid - Scratch(es) - Paint

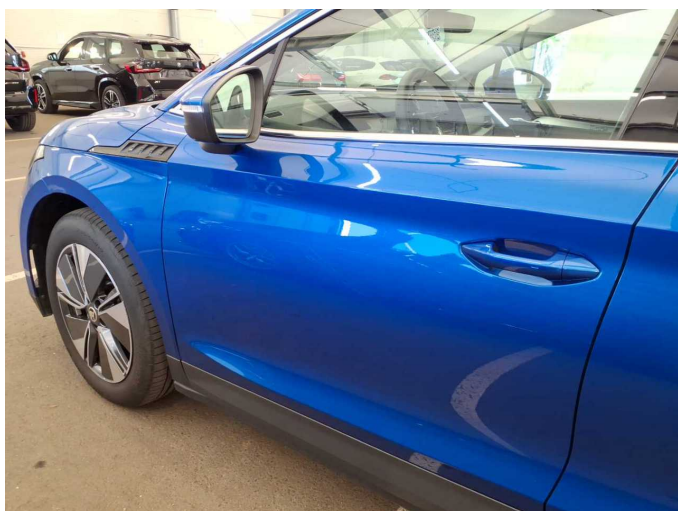
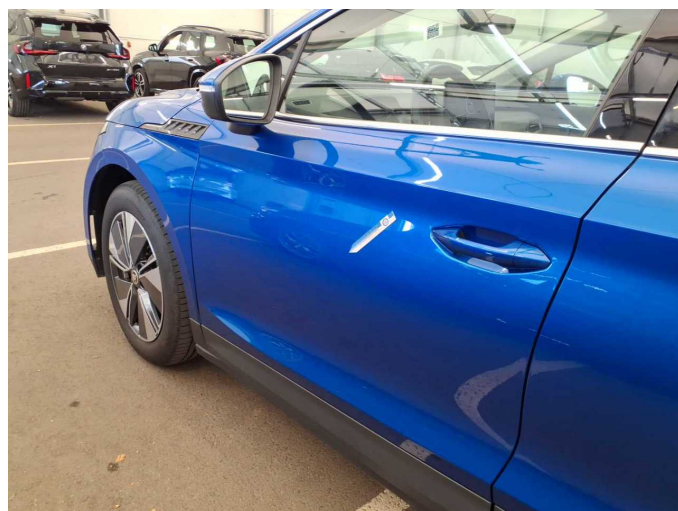
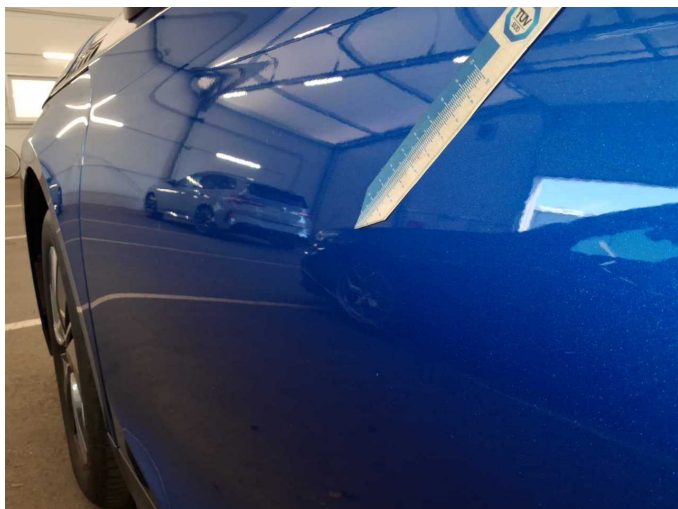
| No. | Component group | Description |
|---|---|---|
| 2 | Door - front left side | Door - Scratch(es) - Paint |

**Damage 2:** Door - front left side: Door - Scratch(es) - Paint

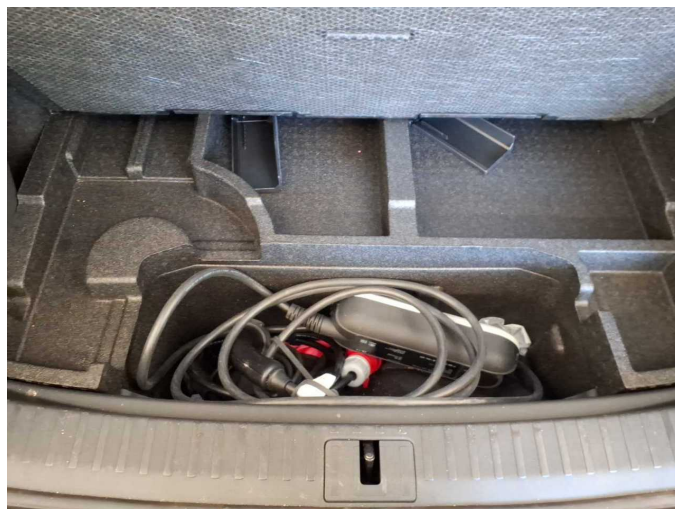
Equipment - Tirefit complete

**Missing part 1:** Equipment: Tirefit complete - Missing - Replace
