Expertise

Protocol number: 46528676  
Order No. / Reference: 26570738  
Inspection date: 8 Jul 2026

Manufacturer: Audi  
VIN: WAUZZZFY5N2051792

Model: Q5 35 TDI S tronic

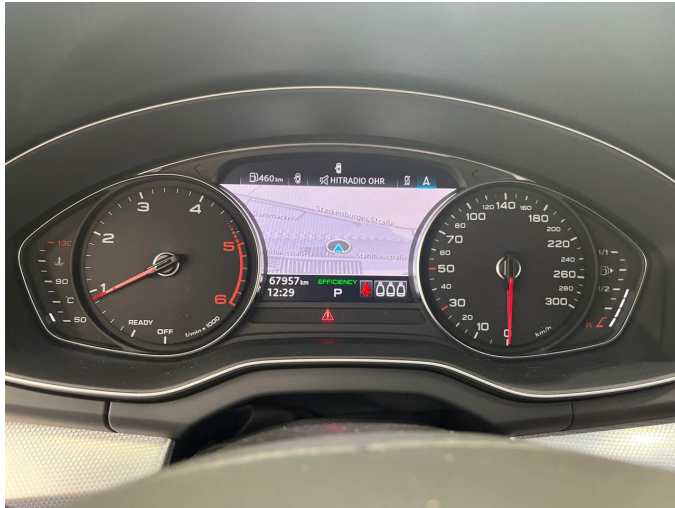
**Figure 7:** Instrument cluster

| Vehicle details | |
|---|---|
| Mileage (Read) | 67,957 km |

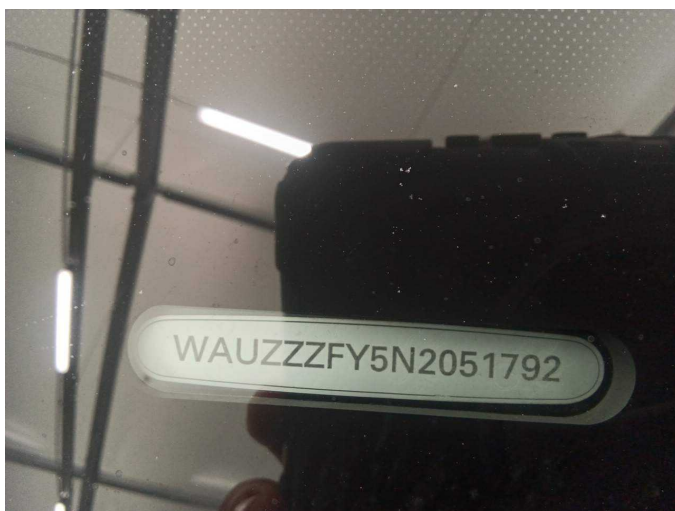
**Figure 11:** VIN

| VIN comparison | The vehicle identification number (VIN) was read from the vehicle and its conformity with the submitted documents was confirmed by the undersigned during the inspection. |

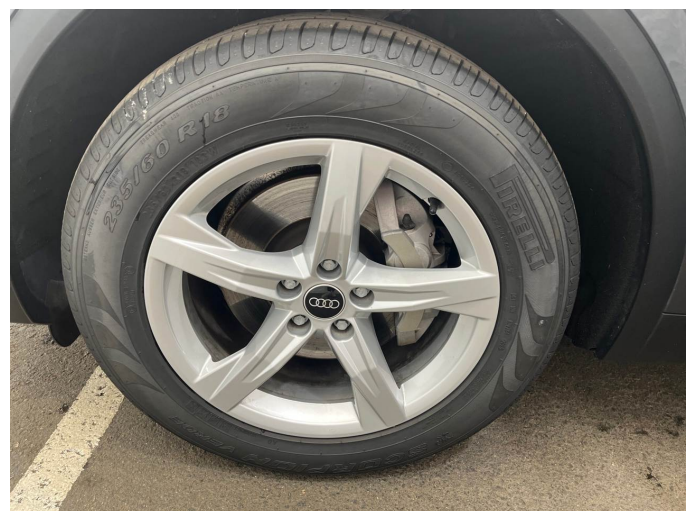
**Figure 12:** Mounted tyres

| # | Tyre size | Type of tyre | Manufacturer | Tread depth |
|---|---|---|---|---|
| 1) | 235/60 R18 103W | Summer tyres on Light alloy | Pirelli | 7mm / 7mm |
| 2) | 235/60 R18 103W | Summer tyres on Light alloy | Pirelli | 7mm / 7mm |

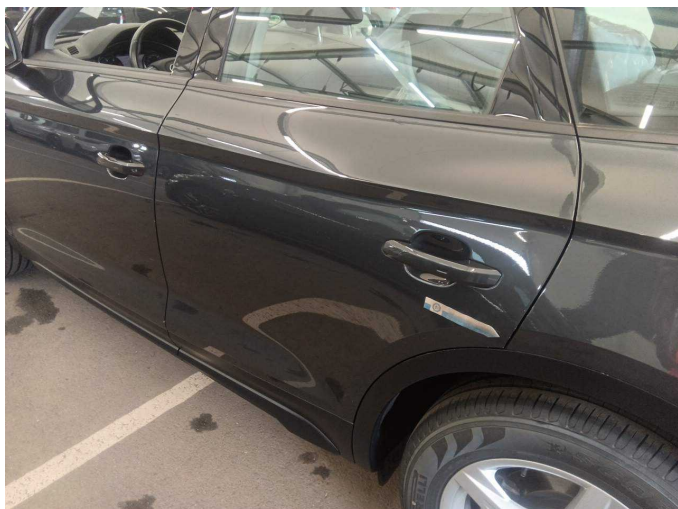
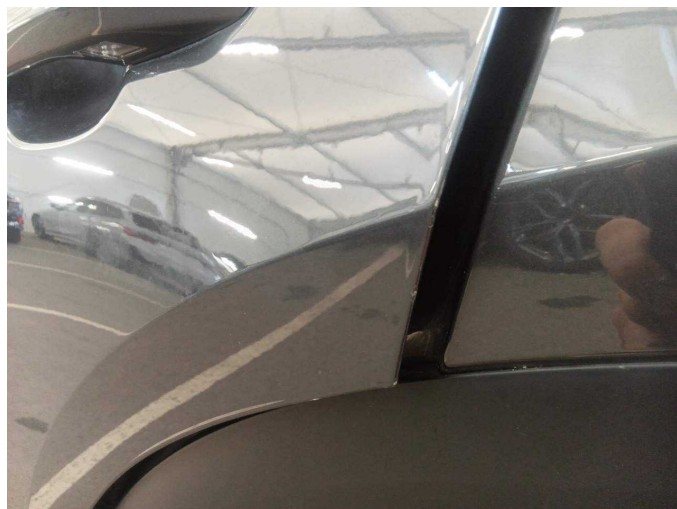
| No. | Component group | Description |
|---|---|---|
| 1 | Door - rear left side | Door edge - Scratch(es) - Smart repair |

**Damage 1:** Door - rear left side: Door edge - Scratch(es) - Smart repair

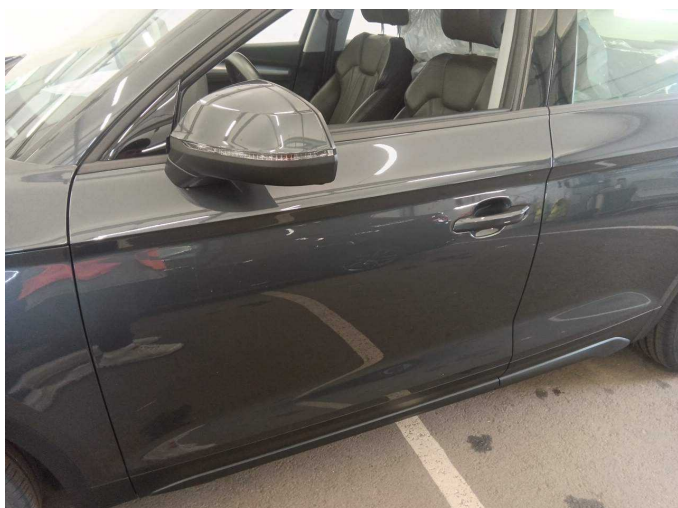
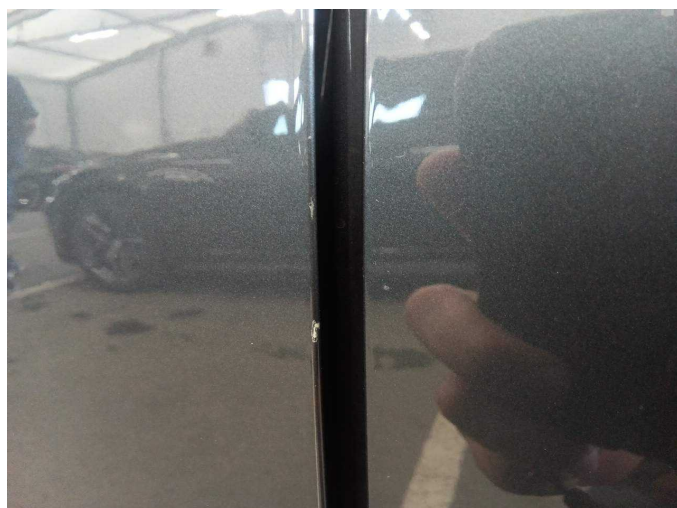
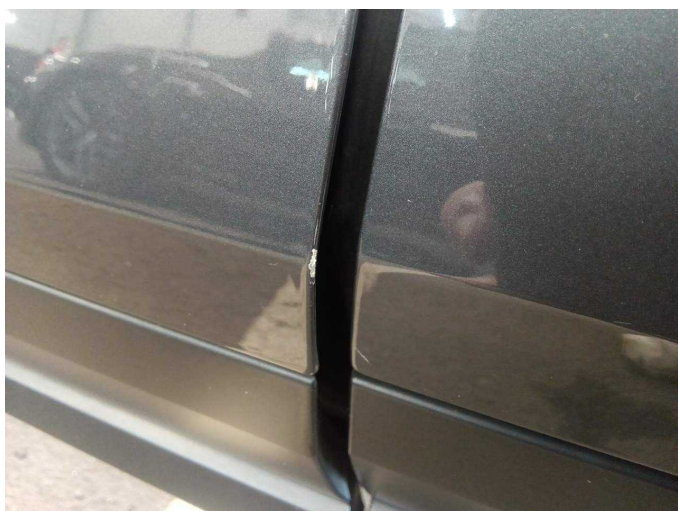
| No. | Component group | Description |
|---|---|---|
| 2 | Door - front left side | Door edge - Scratch(es) - Smart repair |

**Damage 2:** Door - front left side: Door edge - Scratch(es) - Smart repair

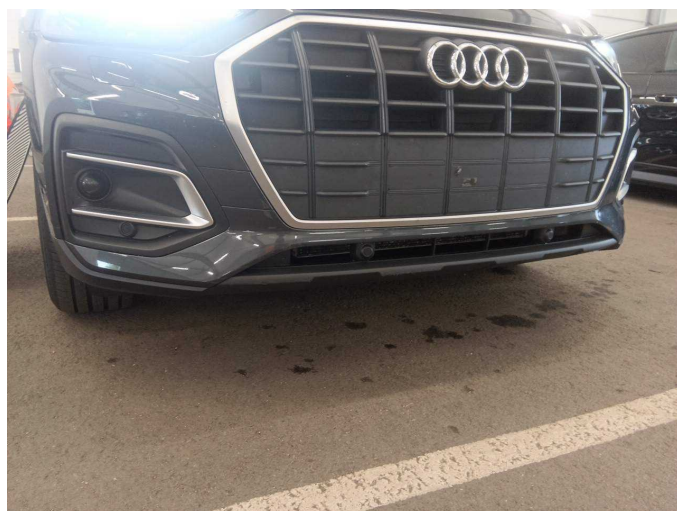
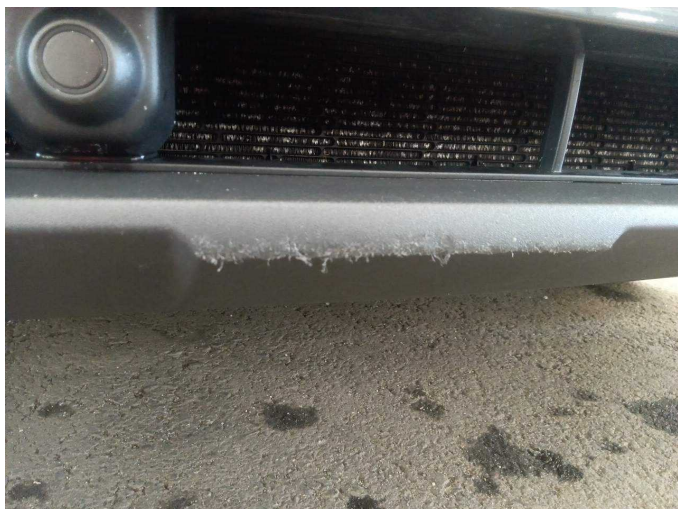
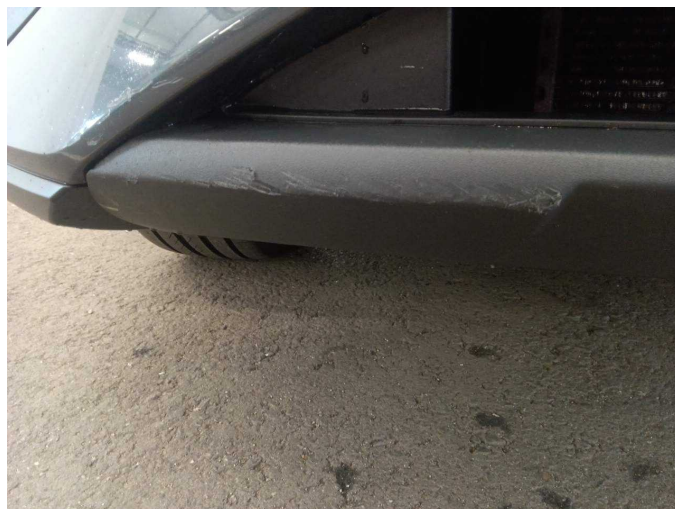
| No. | Component group | Description |
|---|---|---|
| 3 | Front bumper | Spoiler - Scratch(es) - Replace |

**Damage 3:** Front bumper: Spoiler - Scratch(es) - Replace

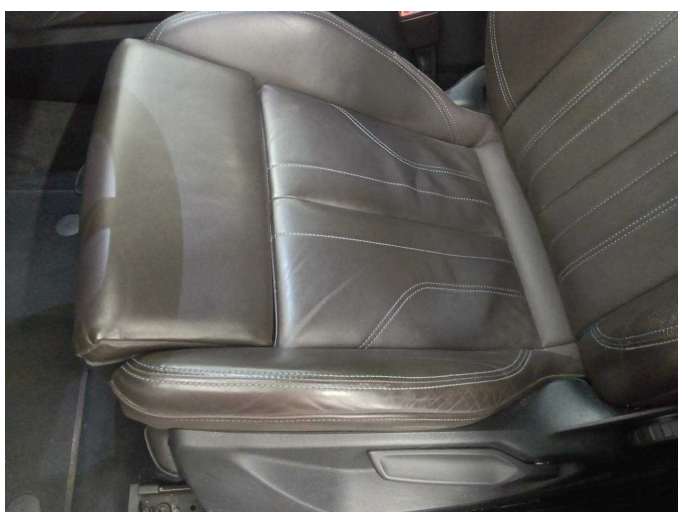
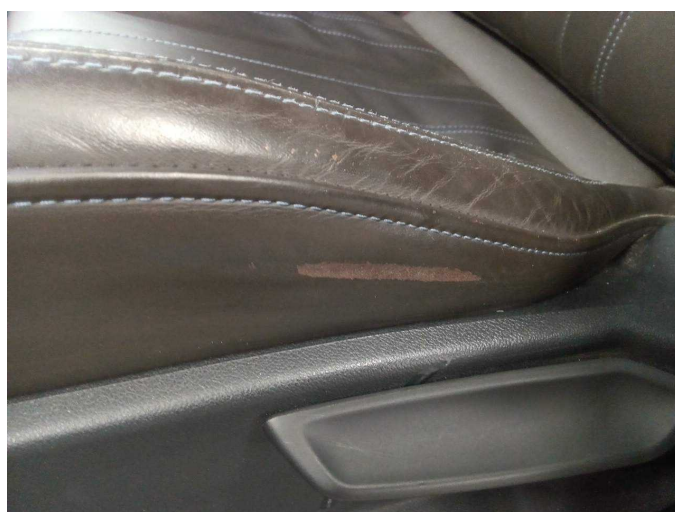
| No. | Component group | Description |
|---|---|---|
| 4 | Seat - front | Seat cover - left side - Worn - Smart repair |

**Damage 4:** Seat - front: Seat cover - left side - Worn - Smart repair

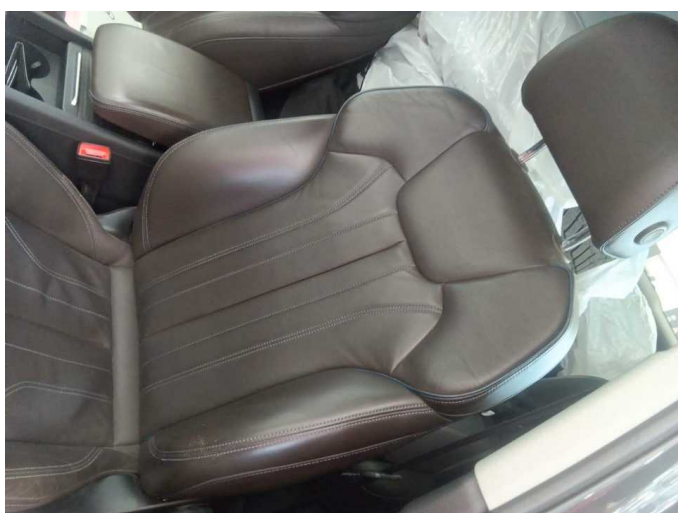
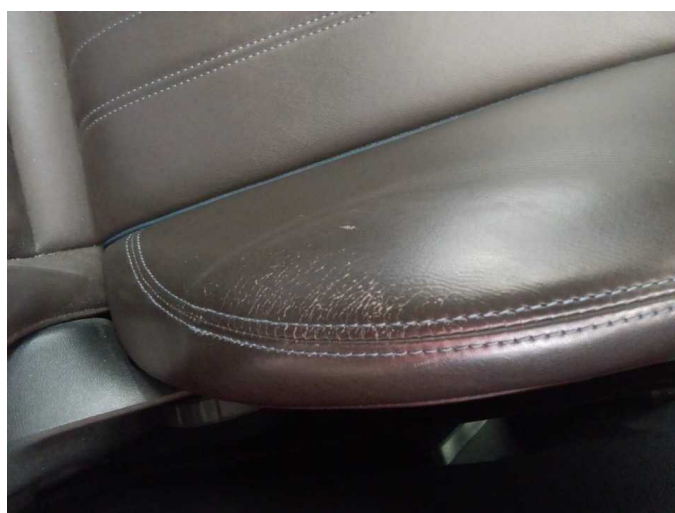
| No. | Component group | Description |
|---|---|---|
| 5 | Seat - front | Backrest - left side - Worn - Smart repair |

**Damage 5:** Seat - front: Backrest - left side - Worn - Smart repair

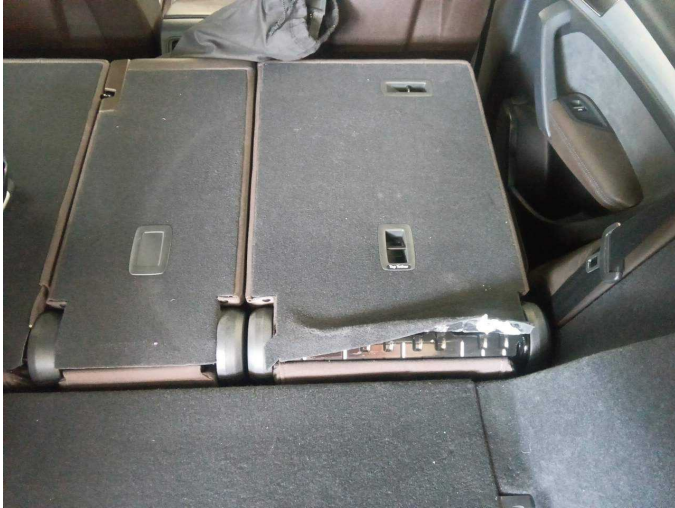
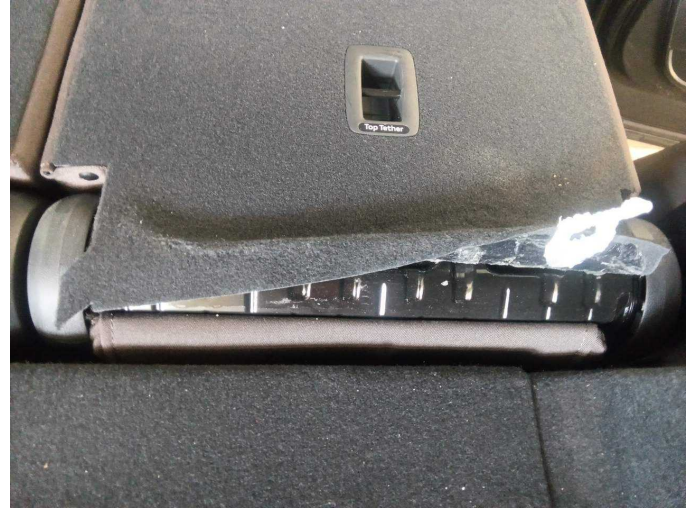
| No. | Component group | Description |
|---|---|---|
| 6 | Seat - rear | Backrest cover (Sitz Rechts, Klebestelle beschädigt, Mehrkosten möglich) - Damaged - Diagnosed and repair if necessary |

**Damage 6:** Seat - rear: Backrest cover (Sitz Rechts, Klebestelle beschädigt, Mehrkosten möglich) - Damaged - Diagnosed and repair if necessary

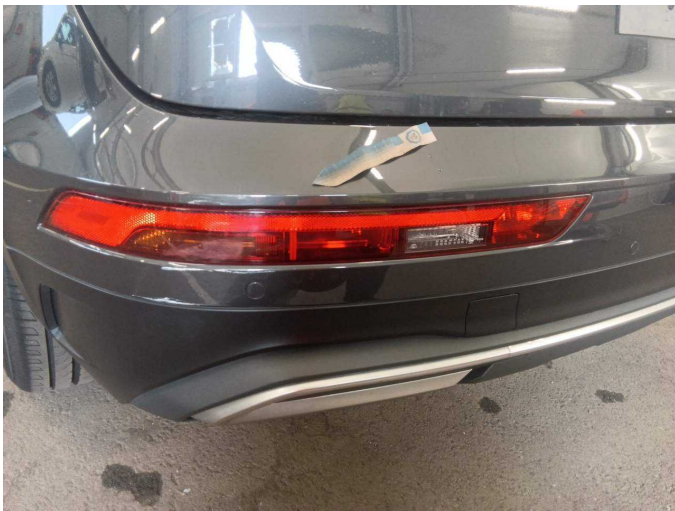
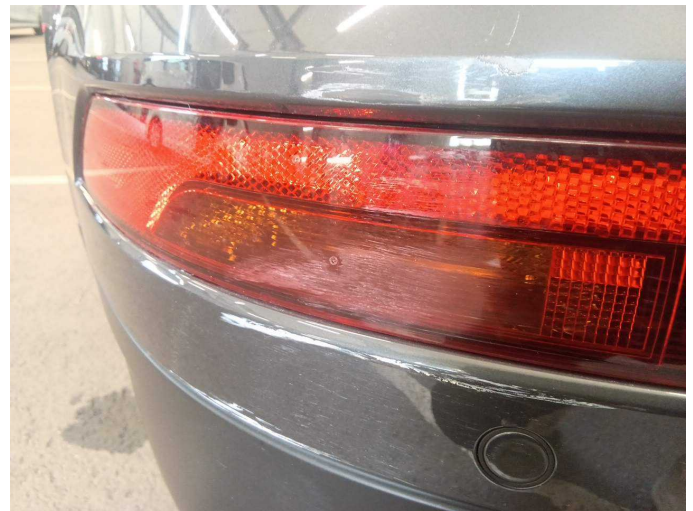
| No. | Component group | Description |
|---|---|---|
| 7 | Rear bumper | Reflector - left side - Scratch(es) - Replace |

**Damage 7:** Rear bumper: Reflector - left side - Scratch(es) - Replace

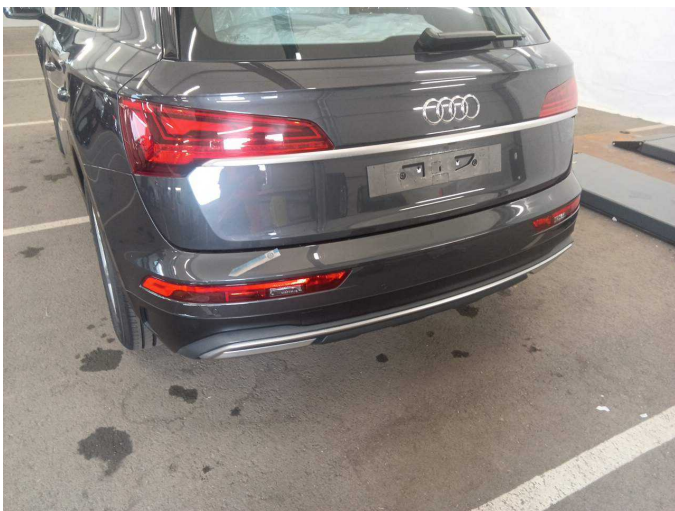
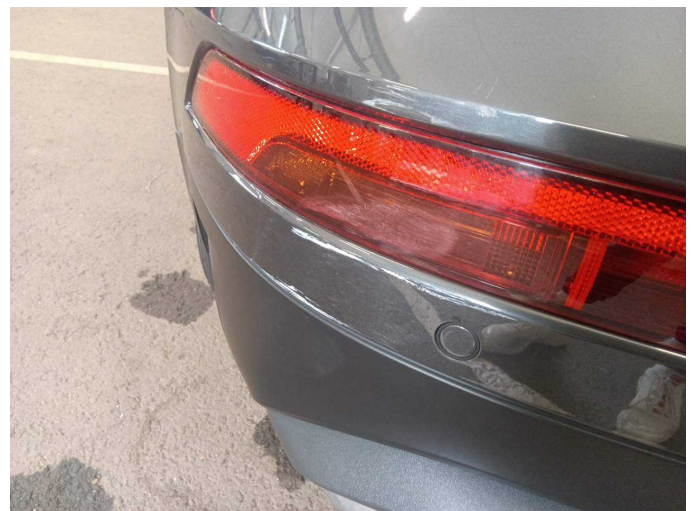
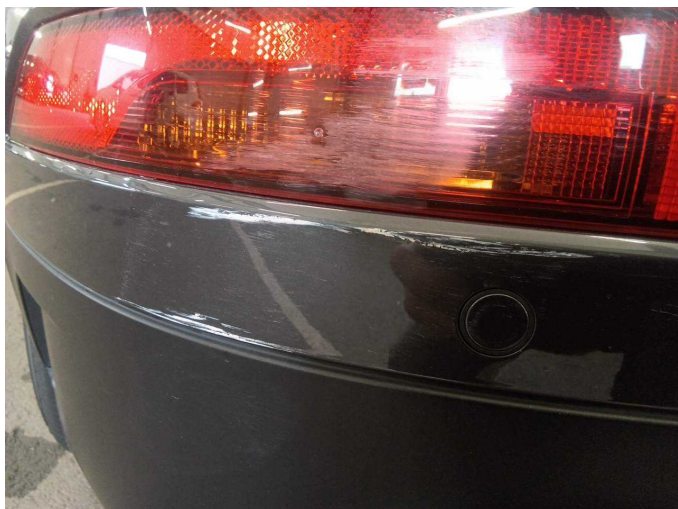
| No. | Component group | Description |
|---|---|---|
| 8 | Rear bumper | Rear bumper - Scratch(es) - Paint |

**Damage 8:** Rear bumper: Rear bumper - Scratch(es) - Paint

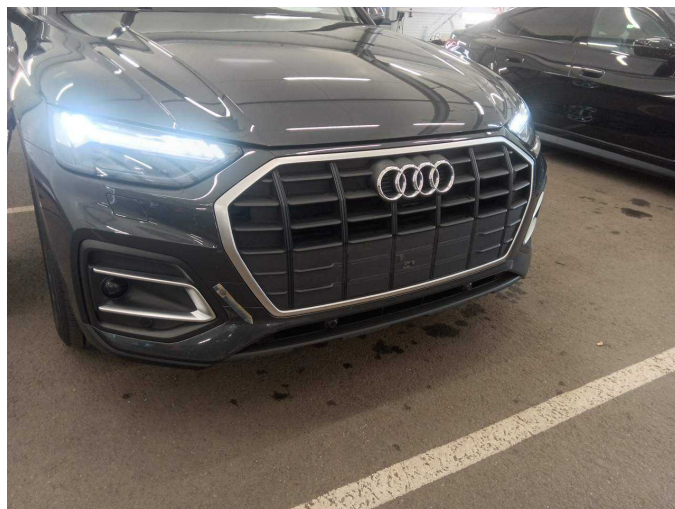
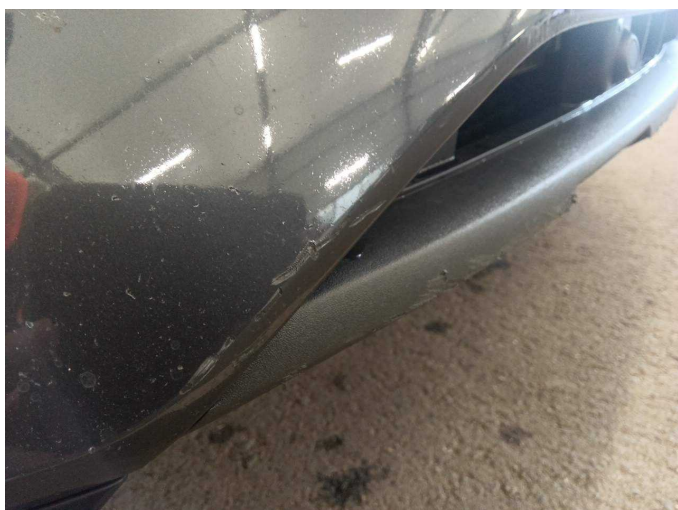
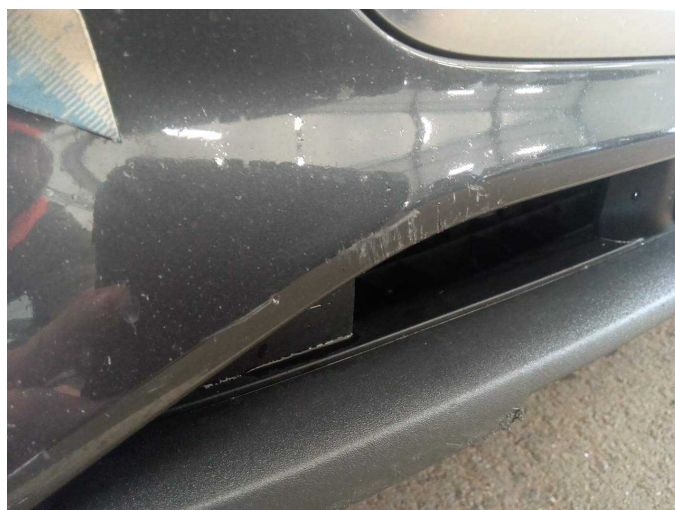
| No. | Component group | Description |
|---|---|---|
| 9 | Front bumper | Front bumper - Scratch(es) - Paint |

**Damage 9:** Front bumper: Front bumper - Scratch(es) - Paint

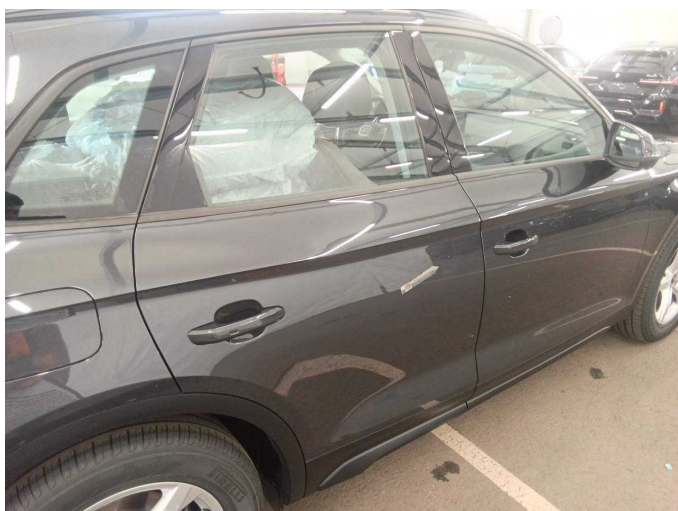
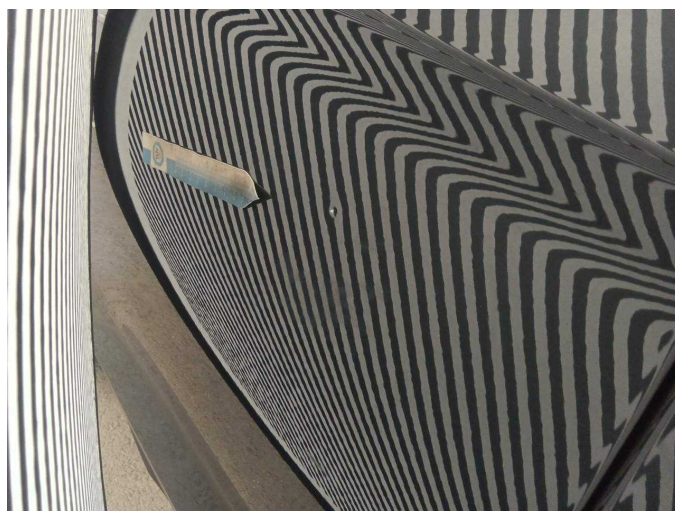
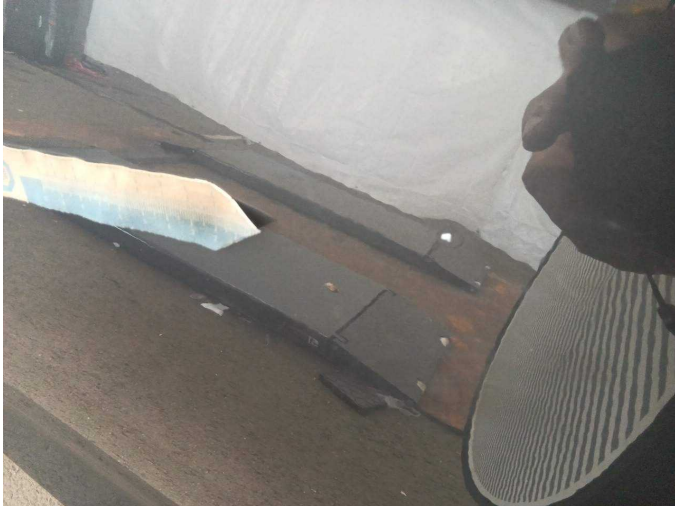
| No. | Component group | Description |
|---|---|---|
| 10 | Door - rear right side | Door - Dent / paintcoat damage - Repair and paint |

**Damage 10:** Door - rear right side: Door - Dent / paintcoat damage - Repair and paint

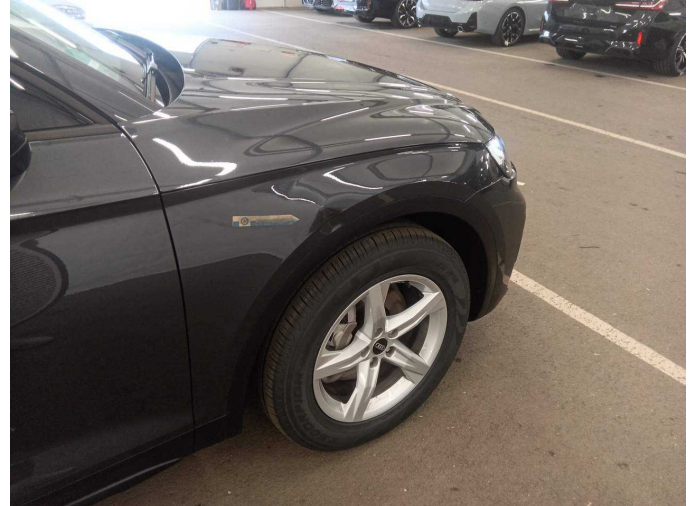
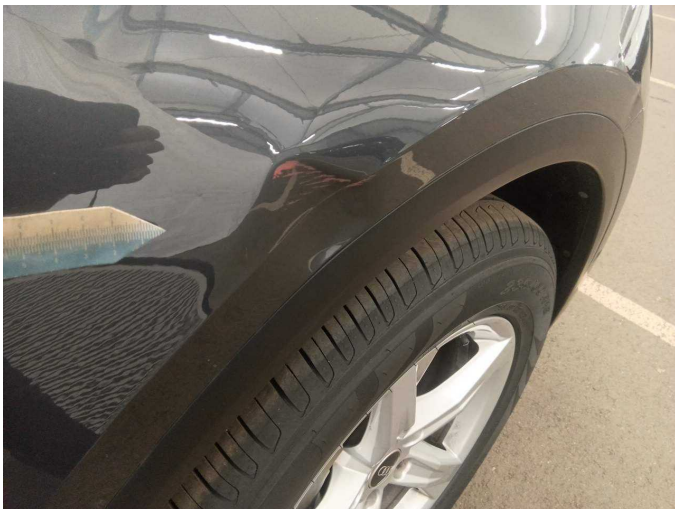
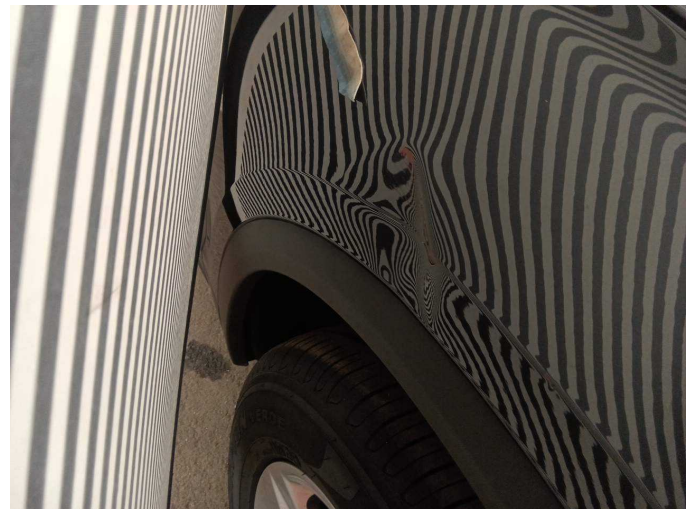
| No. | Component group | Description |
|---|---|---|
| 11 | Mudguard - right side | Mudguard - right side - Deformed - Replace |

**Damage 11:** Mudguard - right side: Mudguard - right side - Deformed - Replace
