Expertise

Protocol number: 46058479  
Order No. / Reference: 26512509  
Inspection date: 18 Jun 2026

Manufacturer: Volkswagen

Model: T-Roc 1.5 TSI OPF Life

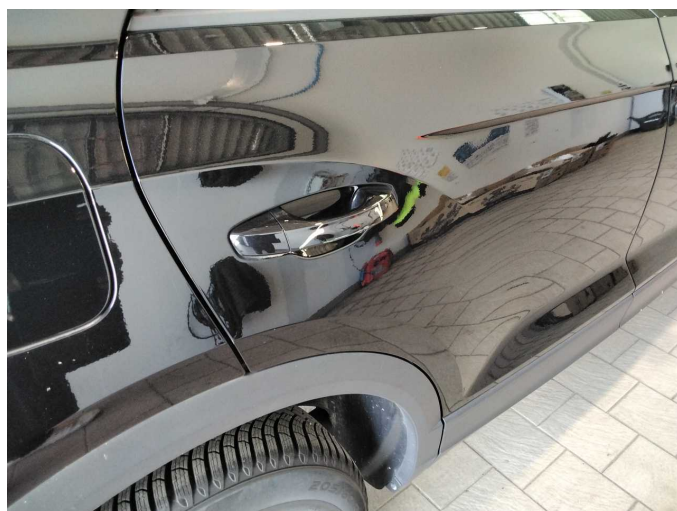
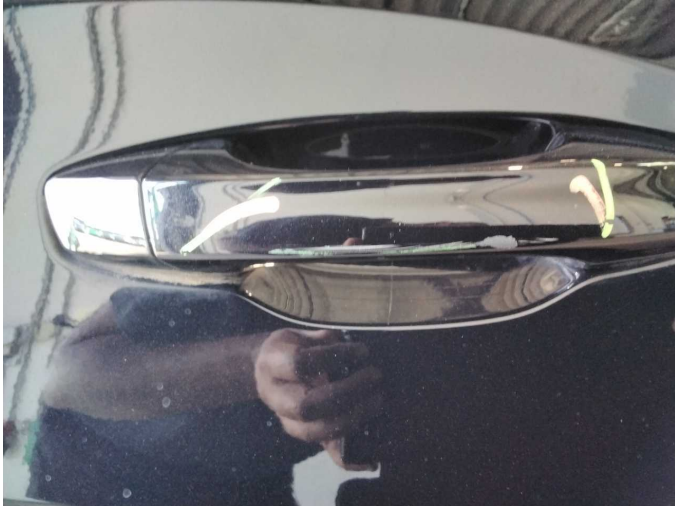
| No. | Component group | Description |
|---|---|---|
| 1 | Door - rear right side | Door handle - outside - Scratch(es) - Smart repair |

Damage 1: Door - rear right side: Door handle - outside - Scratch(es) - Smart repair

**Damage 1:** Door - rear right side: Door handle - outside - Scratch(es) - Smart repair

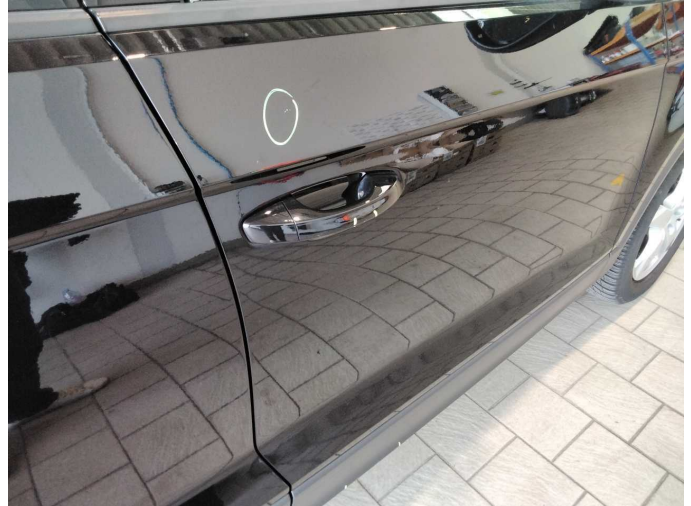
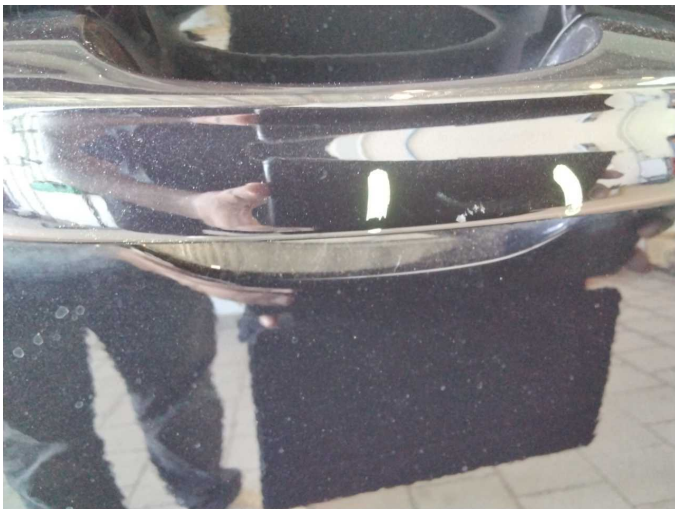
| No. | Component group | Description |
|---|---|---|
| 2 | Door - front right side | Door handle - outside - Scratch(es) - Smart repair |

**Damage 2:** Door - front right side: Door handle - outside - Scratch(es) - Smart repair

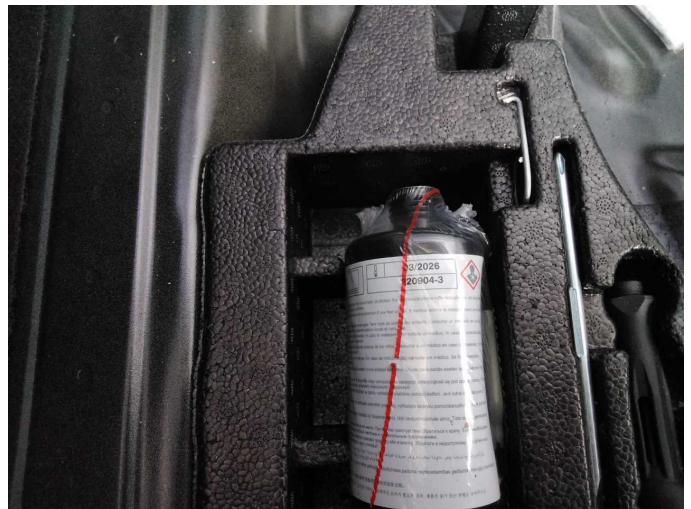
| Typ | Tyre size | Type of tyre | Manufacturer | Tread depth |
|---|---|---|---|---|
| | Tirefit | Expiration date 03/2026 | | |

| No. | Component group | Description |
|---|---|---|
| 3 | Equipment | Tirefit filler - Expired - Replace |

**Damage 3:** Equipment: Tirefit filler - Expired - Replace

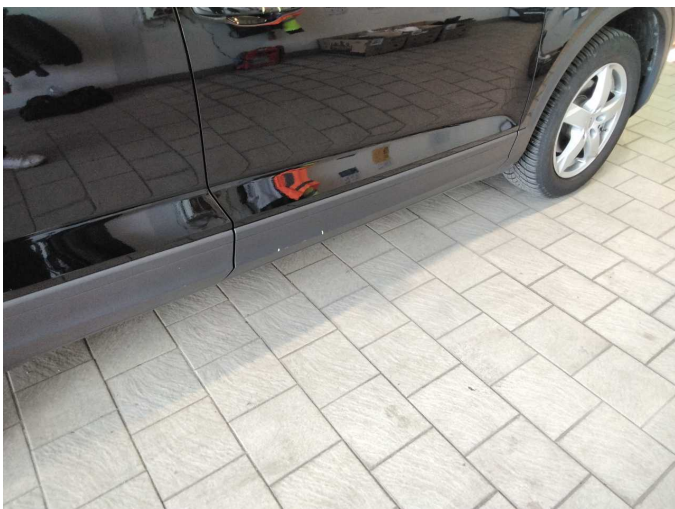
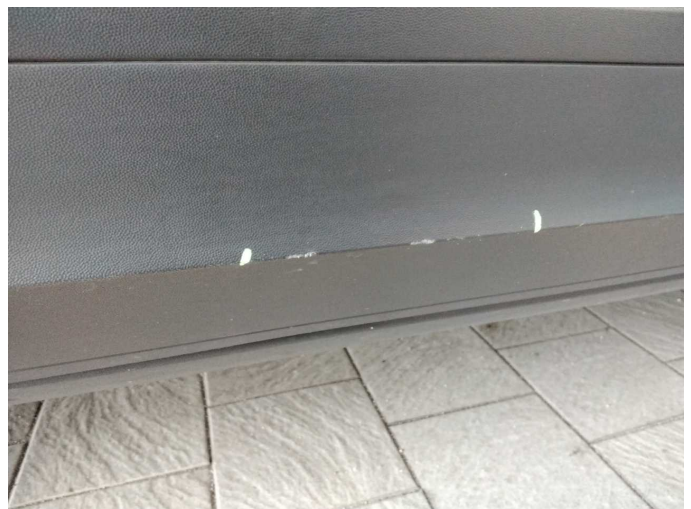
| No. | Component group | Description |
|---|---|---|
| 4 | Door - front right side | Brightware - lower - Scratch(es) - Loss in value |

**Damage 4:** Door - front right side: Brightware - lower - Scratch(es) - Loss in value

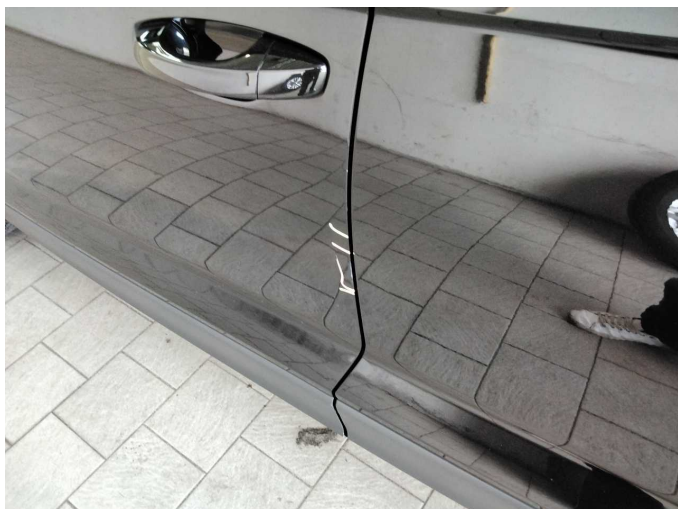
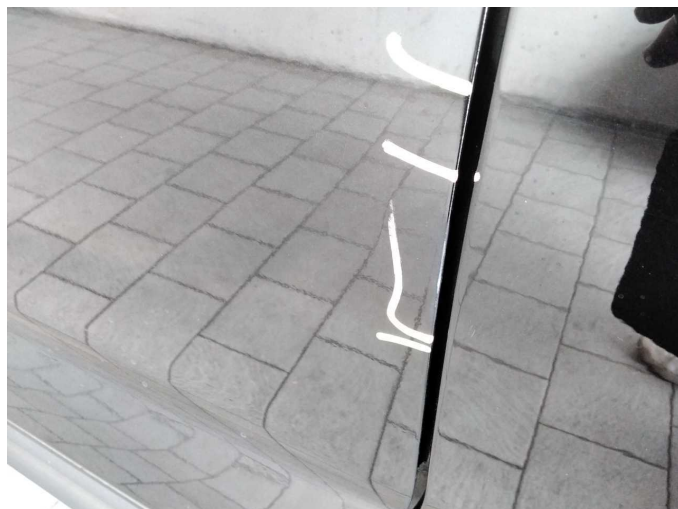
| No. | Component group | Description |
|---|---|---|
| 5 | Door - front left side | Door edge - Scratch(es) - Smart repair |

**Damage 5:** Door - front left side: Door edge - Scratch(es) - Smart repair

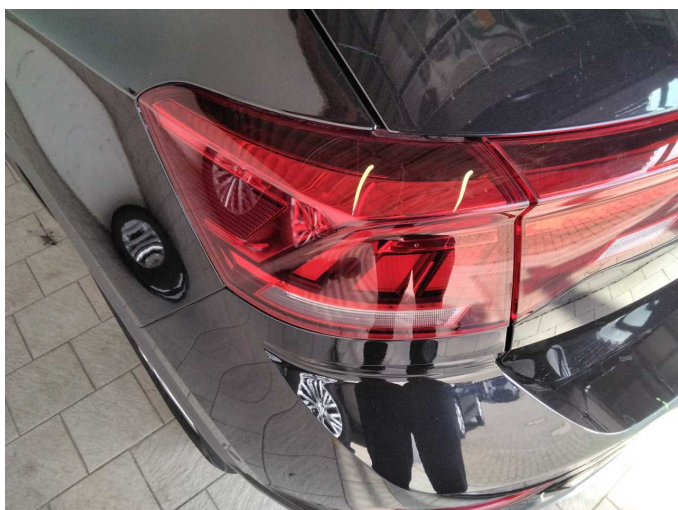
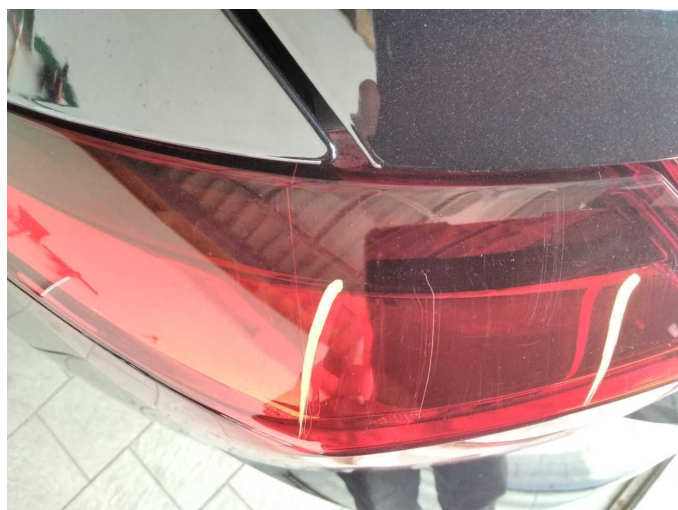
| No. | Component group | Description |
|---|---|---|
| 6 | Tail light | Tail lamp - left side - Scratch(es) - Loss in value |

**Damage 6:** Tail light: Tail lamp - left side - Scratch(es) - Loss in value

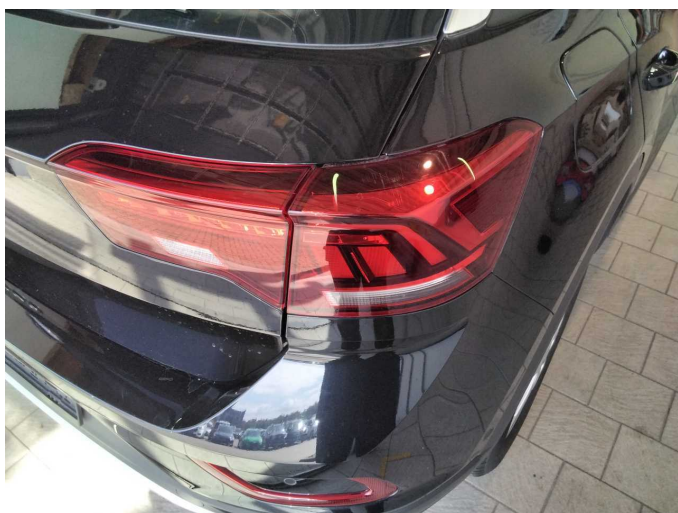
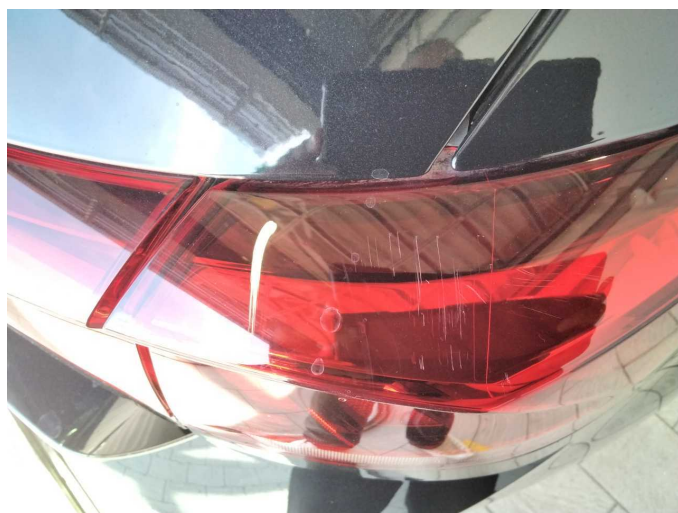
| No. | Component group | Description |
|---|---|---|
| 7 | Tail light | Tail lamp - right side - Scratch(es) - Loss in value |

**Damage 7:** Tail light: Tail lamp - right side - Scratch(es) - Loss in value

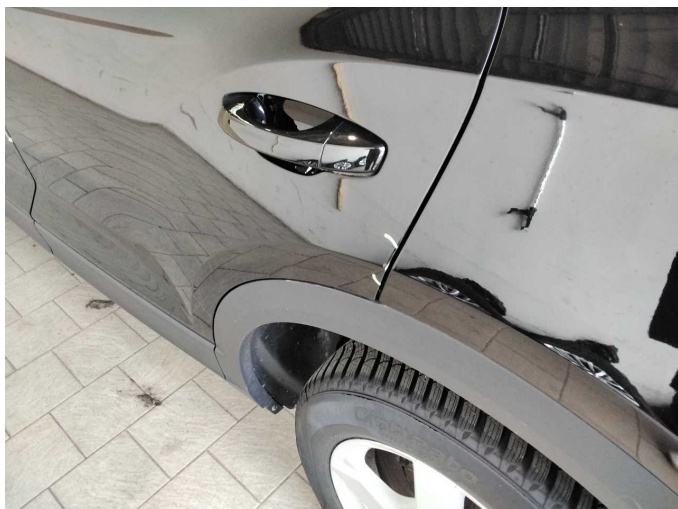
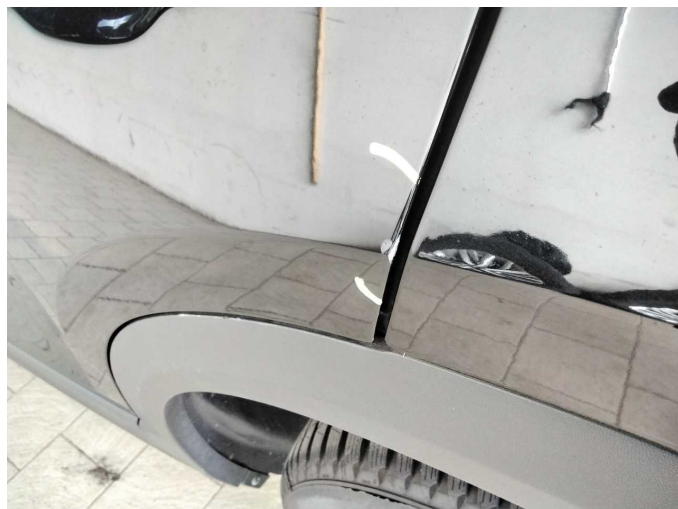
| No. | Component group | Description |
|---|---|---|
| 8 | Door - rear left side | Door edge - Scratch(es) - Smart repair |

**Damage 8:** Door - rear left side: Door edge - Scratch(es) - Smart repair

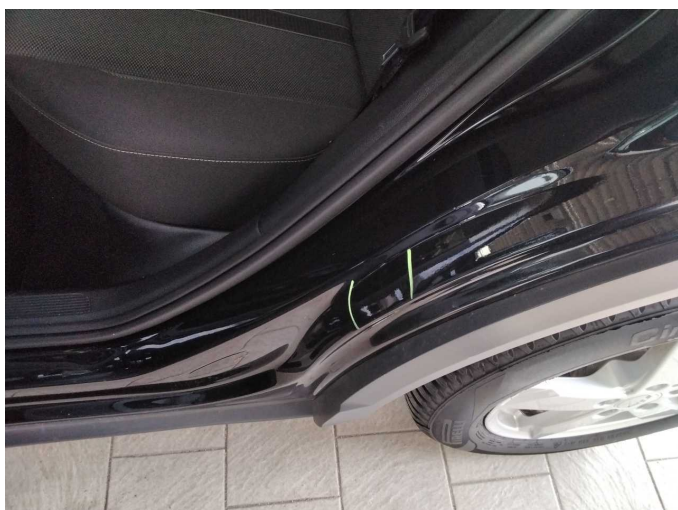
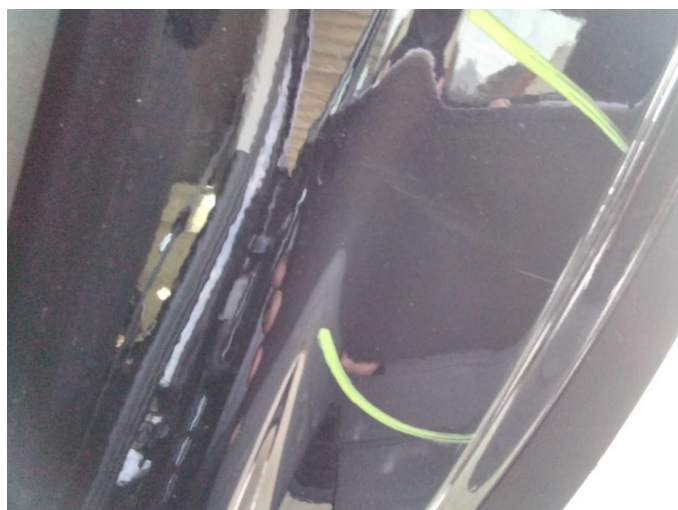
| No. | Component group | Description |
|---|---|---|
| 9 | Body | C-pillar - left side - Scratch(es) - Smart repair |

**Damage 9:** Body: C-pillar - left side - Scratch(es) - Smart repair

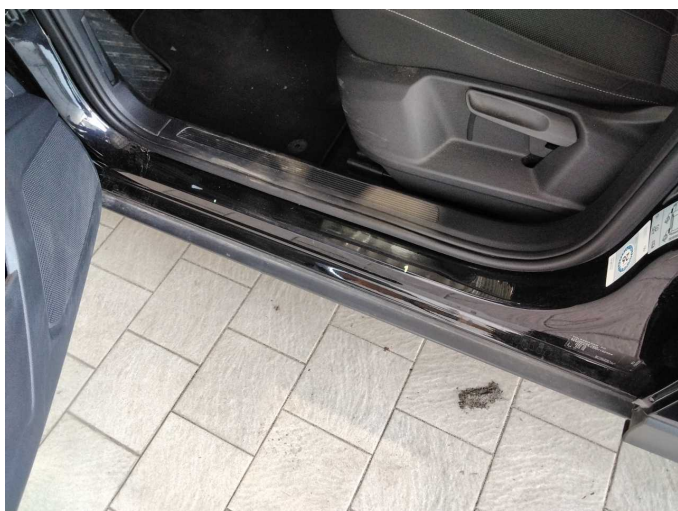
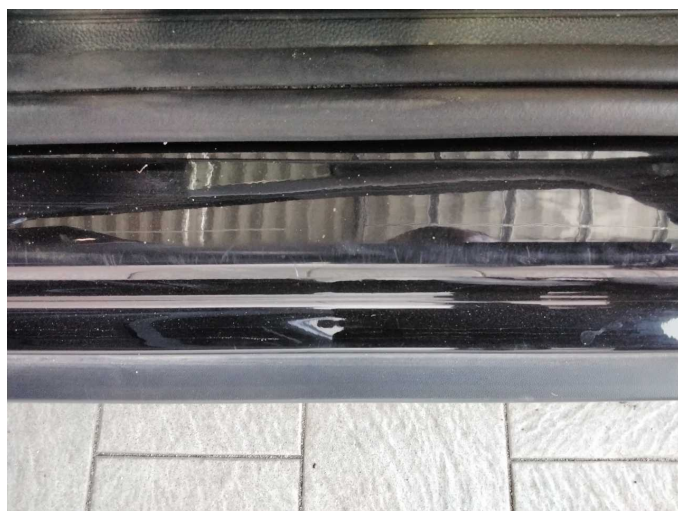
| No. | Component group | Description |
|---|---|---|
| 10 | Sill - left side | Sill - Scratch(es) - Smart repair |

**Damage 10:** Sill - left side: Sill - Scratch(es) - Smart repair

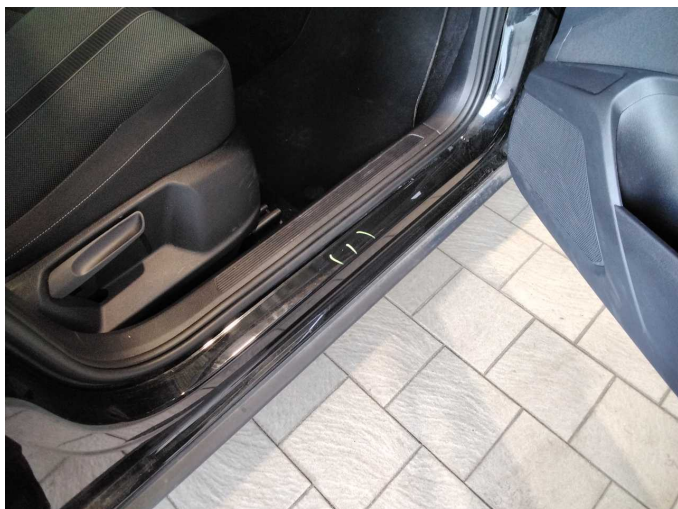
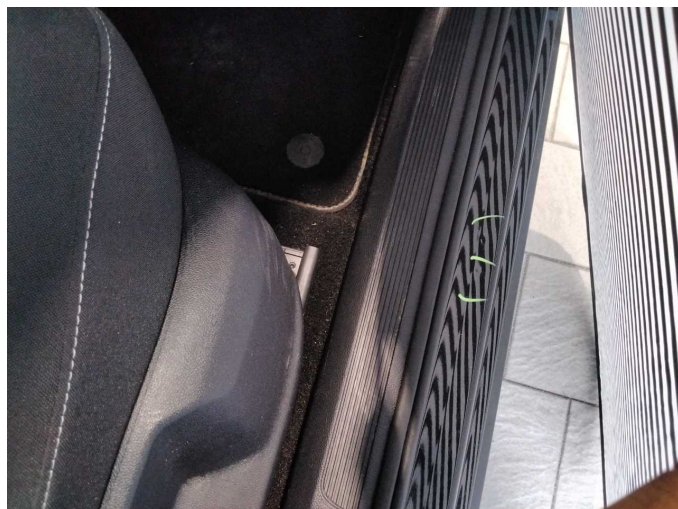
| No. | Component group | Description |
|---|---|---|
| 11 | Sill - right side | Sill - Dent / paintcoat damage - Smart repair |

**Damage 11:** Sill - right side: Sill - Dent / paintcoat damage - Smart repair

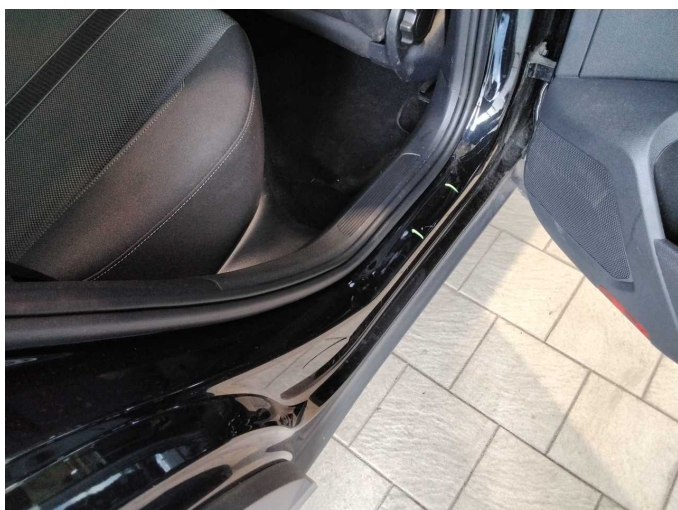
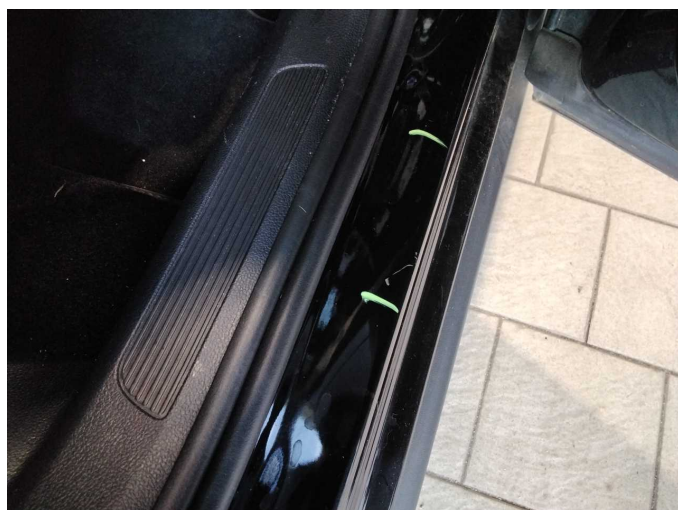
| No. | Component group | Description |
|---|---|---|
| 12 | Side panel - rear right side | Sill - Scratch(es) - Smart repair |

**Damage 12:** Side panel - rear right side: Sill - Scratch(es) - Smart repair

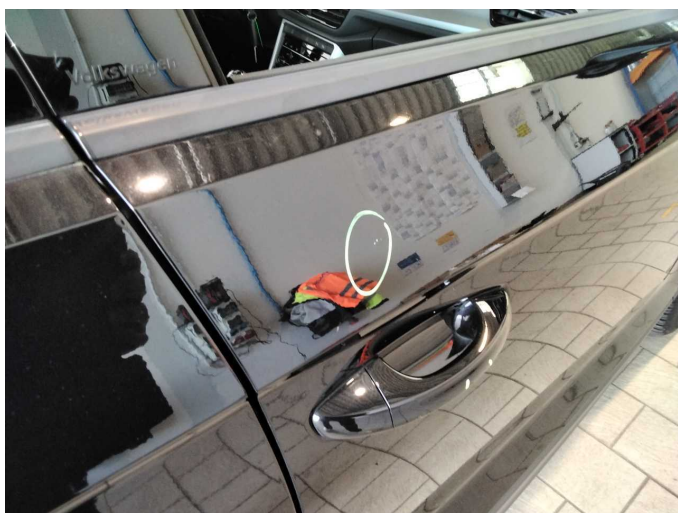
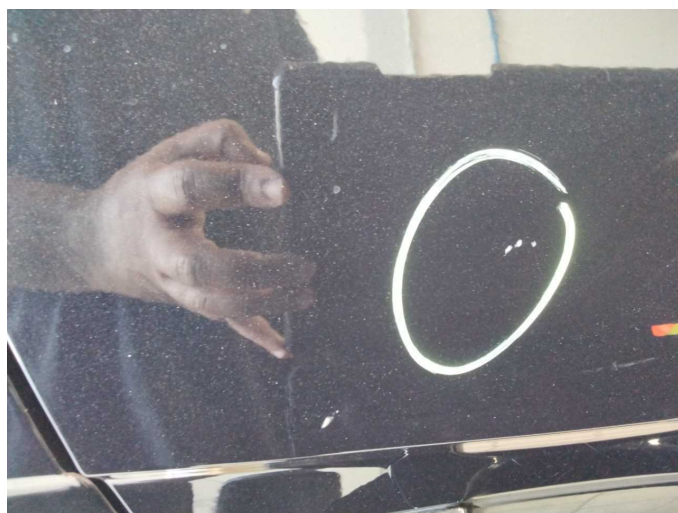
| No. | Component group | Description |
|---|---|---|
| 13 | Door - front right side | Door - Scratch(es) - Smart repair |

**Damage 13:** Door - front right side: Door - Scratch(es) - Smart repair

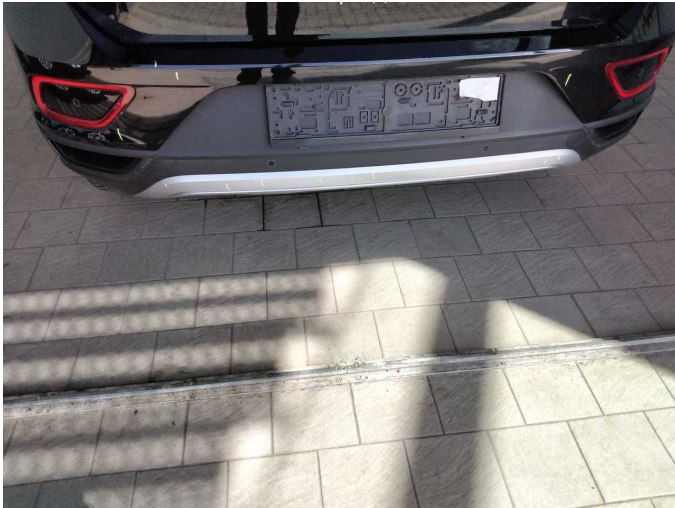
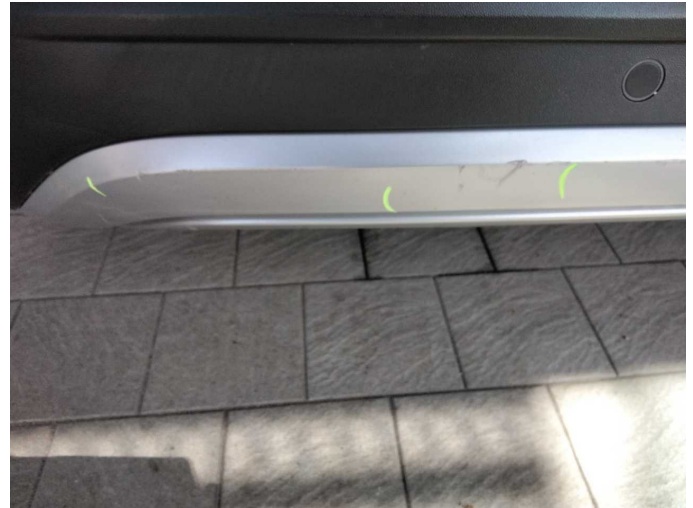
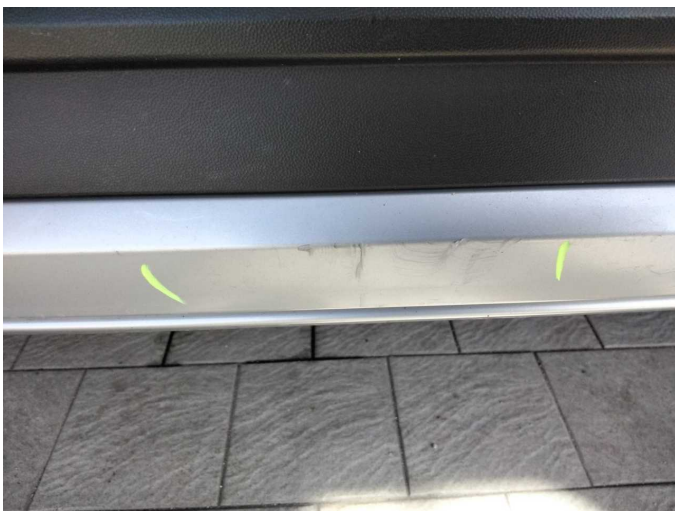
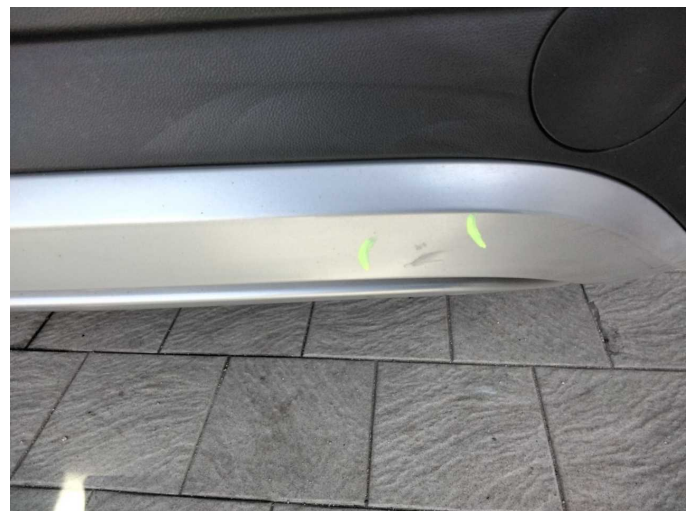
| No. | Component group | Description |
|---|---|---|
| 14 | Rear bumper | Spoiler - Scratch(es) - Replace |

**Damage 14:** Rear bumper: Spoiler - Scratch(es) - Replace

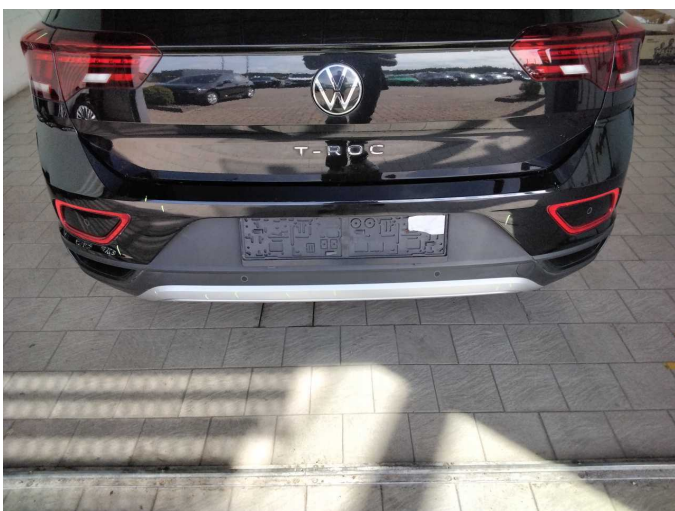
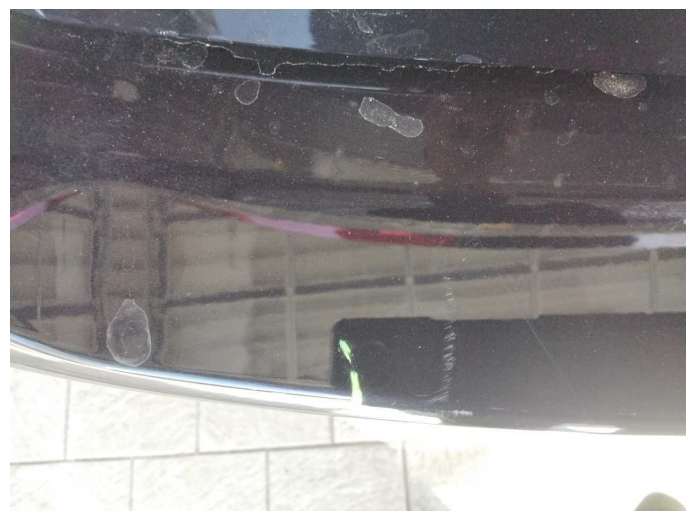
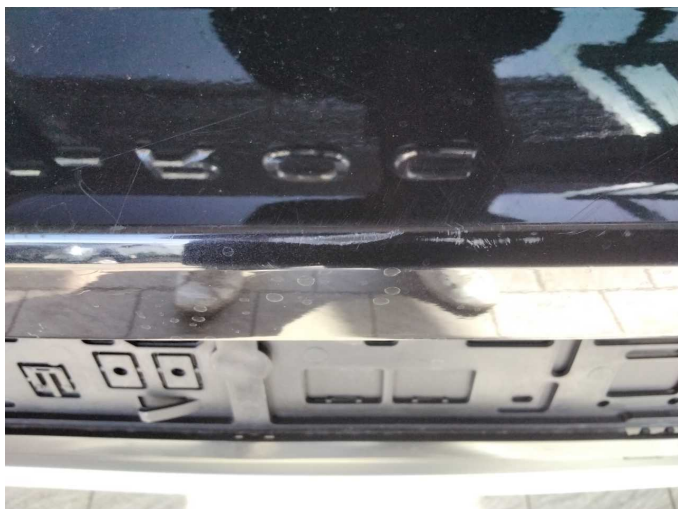
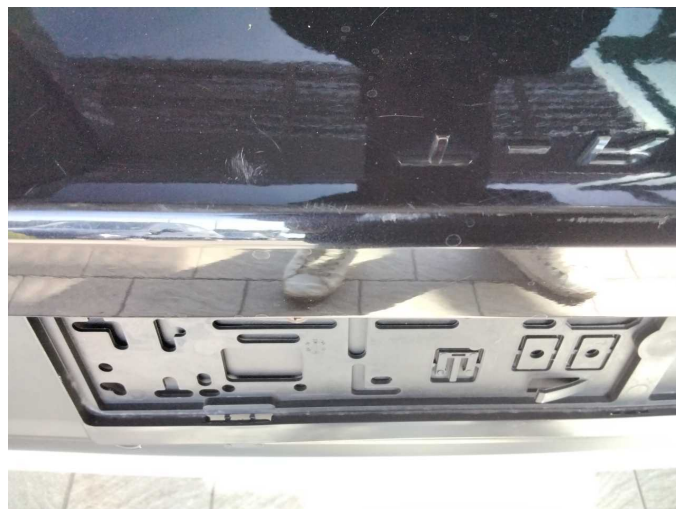
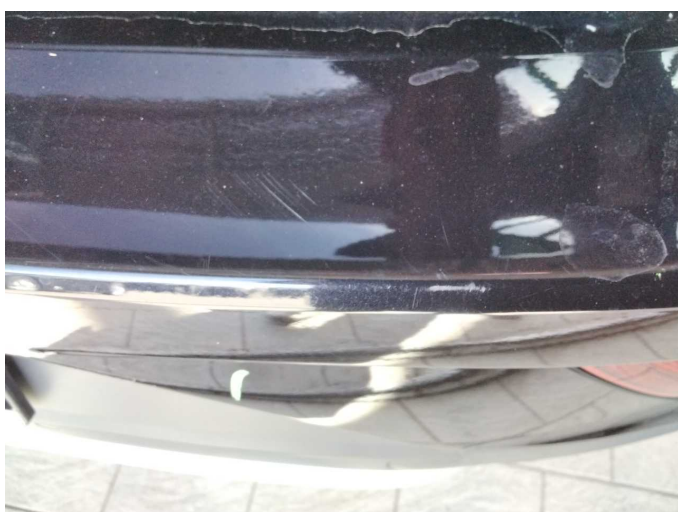
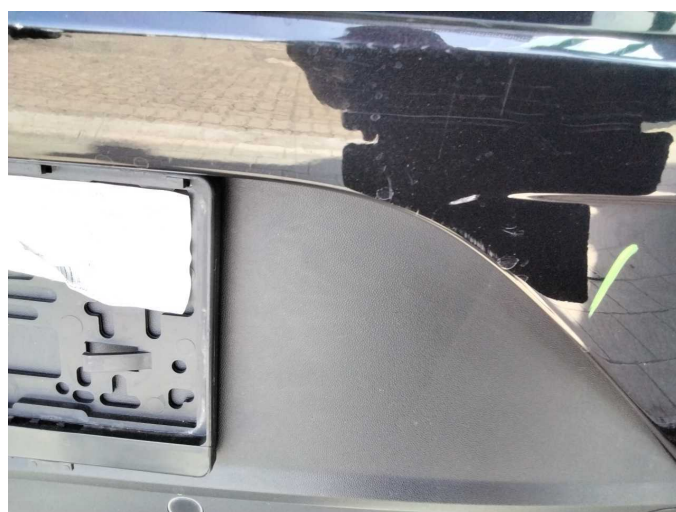
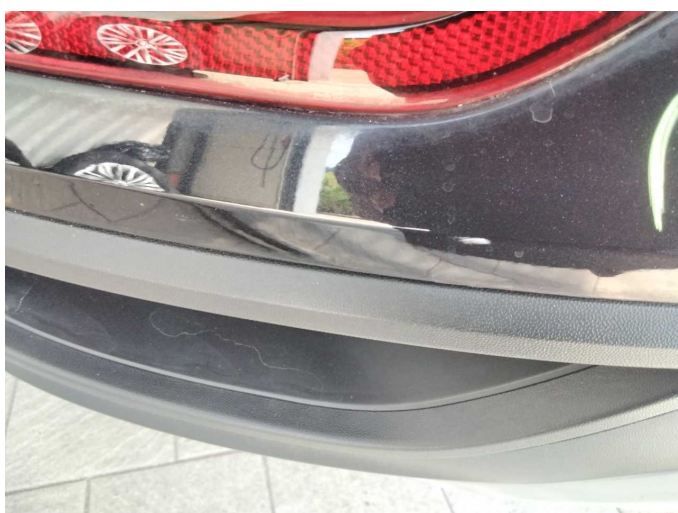
| No. | Component group | Description |
|---|---|---|
| 15 | Rear bumper | Rear bumper - Scratch(es) - Paint |

**Damage 15:** Rear bumper: Rear bumper - Scratch(es) - Paint

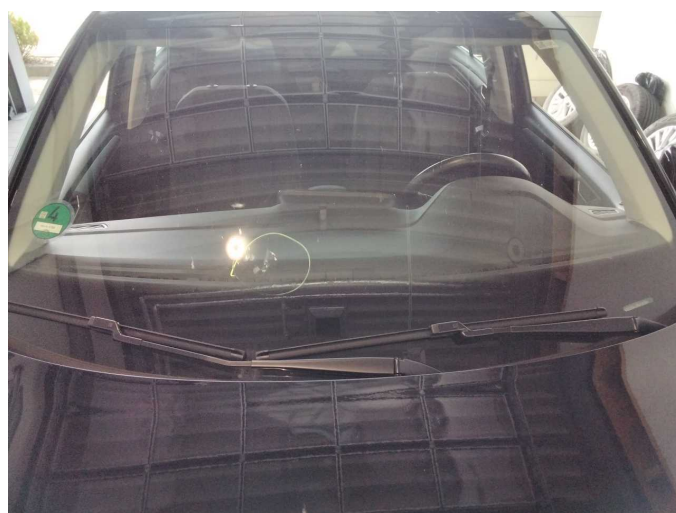
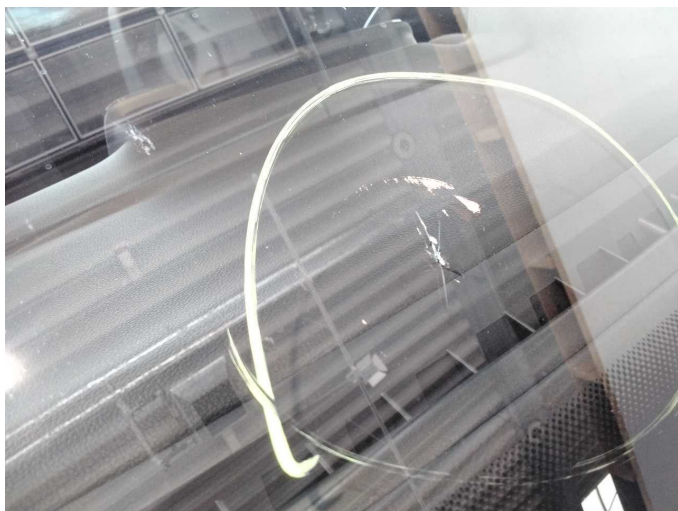
| No. | Component group | Description |
|---|---|---|
| 16 | Vehicle glazing | Windscreen - Broken / torn - Replace |

**Damage 16:** Vehicle glazing: Windscreen - Broken / torn - Replace

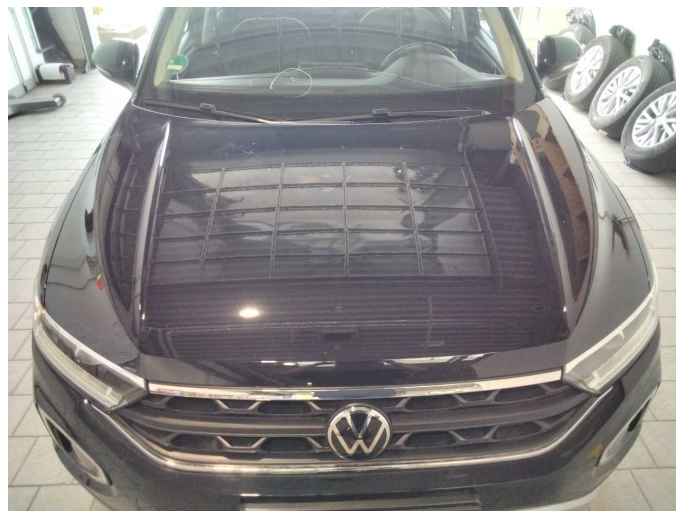
| No. | Component group | Description |
|---|---|---|
| 1 | Bonnet | Bonnet - Stone chips - No deduction |

**Wear and tear 1:** Bonnet: Bonnet - Stone chips - No deduction

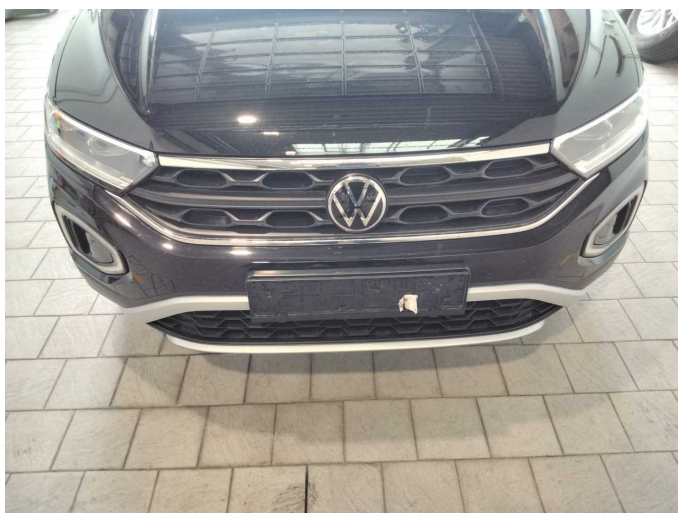
| No. | Component group | Description |
|---|---|---|
| 2 | Front bumper | Front bumper - Stone chips - No deduction |

**Wear and tear 2:** Front bumper: Front bumper - Stone chips - No deduction

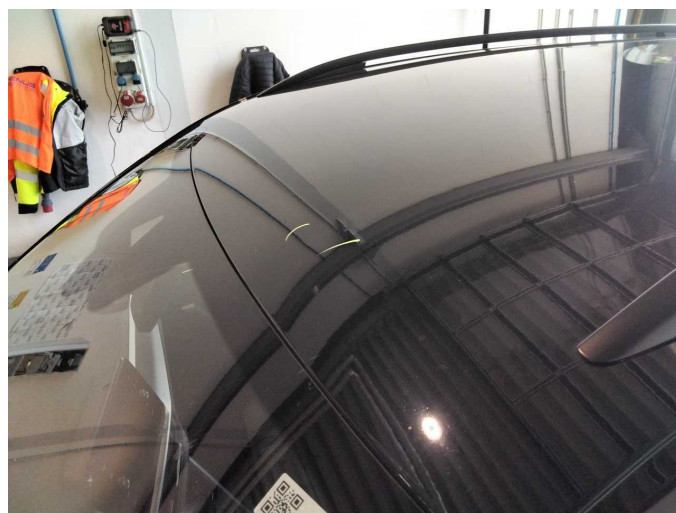
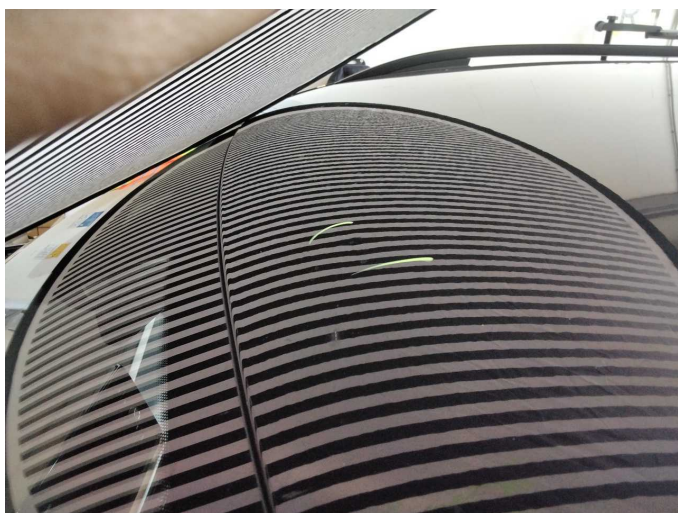
| No. | Component group | Description |
|---|---|---|
| 3 | Roof | Roof - dent(s) - No deduction |

**Wear and tear 3:** Roof: Roof - dent(s) - No deduction

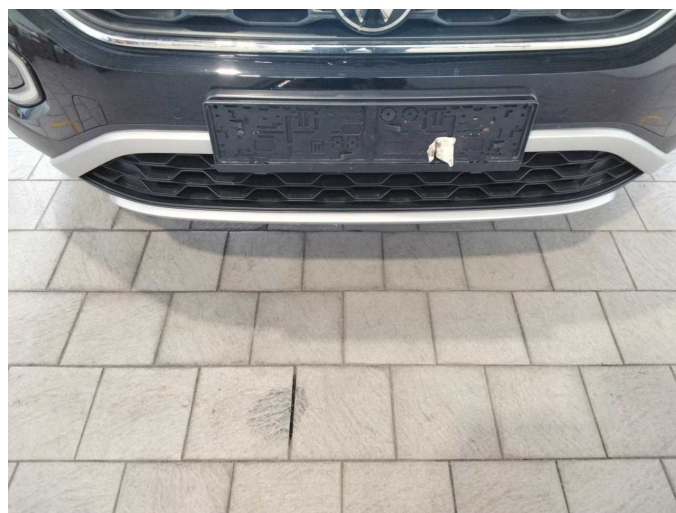
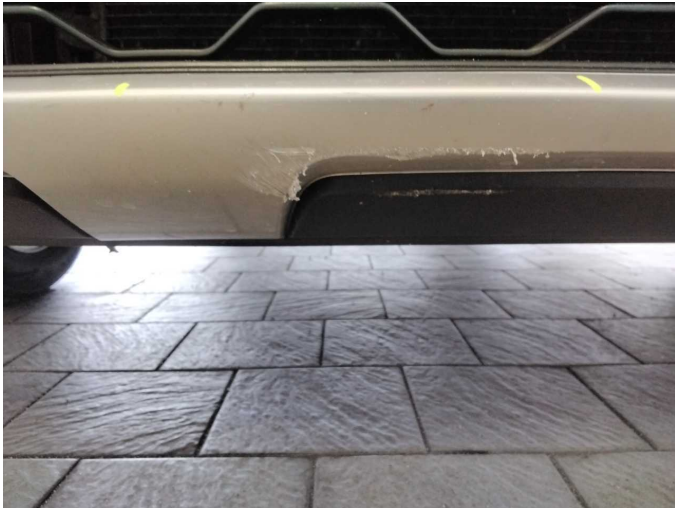
| No. | Component group | Description |
|---|---|---|
| 4 | Front bumper | Spoiler (unterhalb) - Scratch(es) - No deduction |

**Wear and tear 4:** Front bumper: Spoiler (unterhalb) - Scratch(es) - No deduction

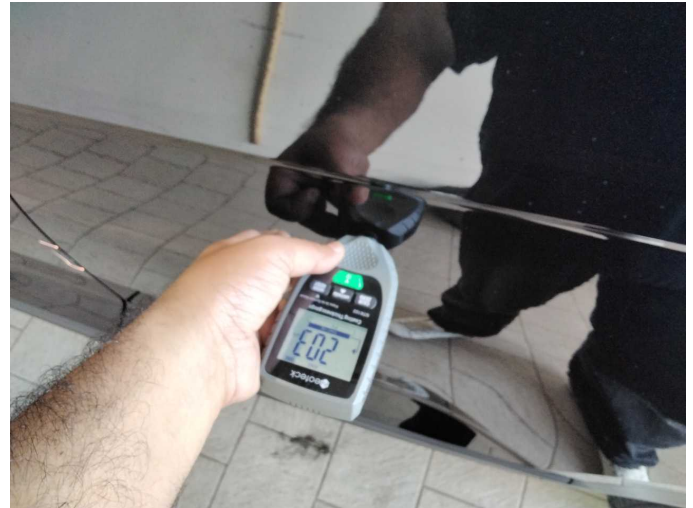
| No. | Repainting |
|---|---|
| 1 | Door - rear left side, Professionally carried out, Invoice of repair done Non-existent |

| Door - rear left side | 203 µm |

**Repainting 1:** Door - rear left side
