Expertise

Protocol number: 46797341  
Order No. / Reference: 26688259  
Inspection date: 27 Jul 2026

Manufacturer: Volkswagen

Model: Tiguan 2.0 TDI SCR 4MOTION DSG R-Line

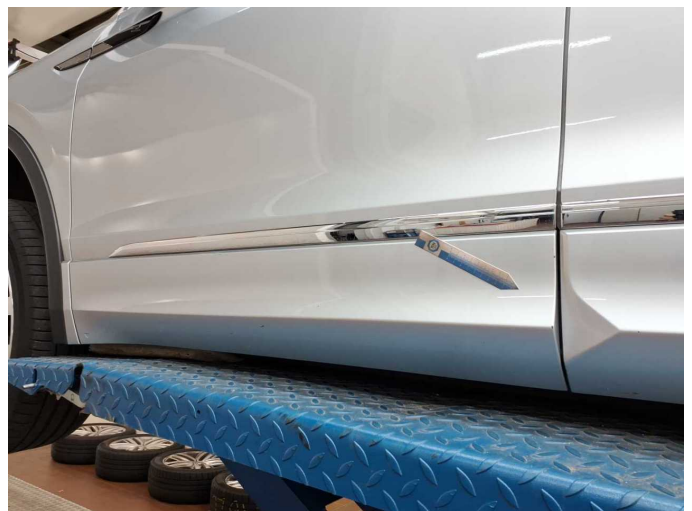
Damage 1: Trim / covers: Door trim - front left side - Scratched - Smart repair

**Damage 1:** Trim / covers: Door trim - front left side - Scratched - Smart repair

| No. | Component group | Description |
|---|---|---|
| 1 | Trim / covers | Door trim - front left side - Scratched - Smart repair |

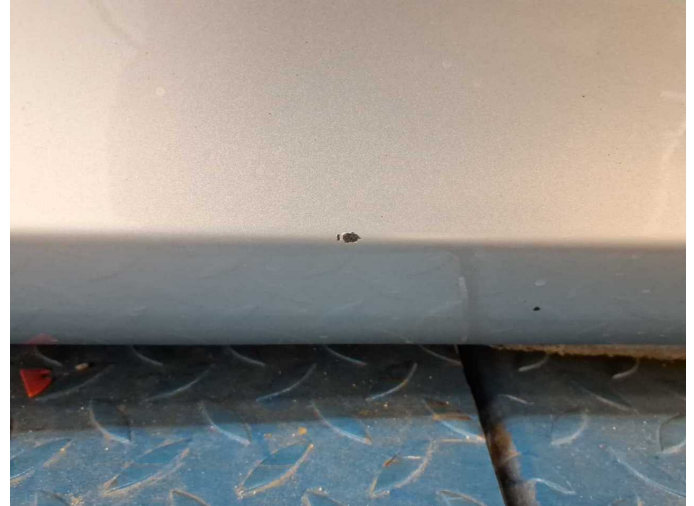
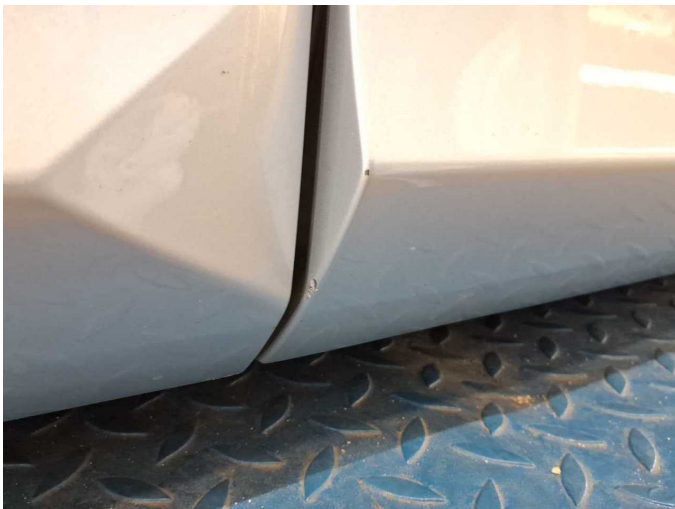
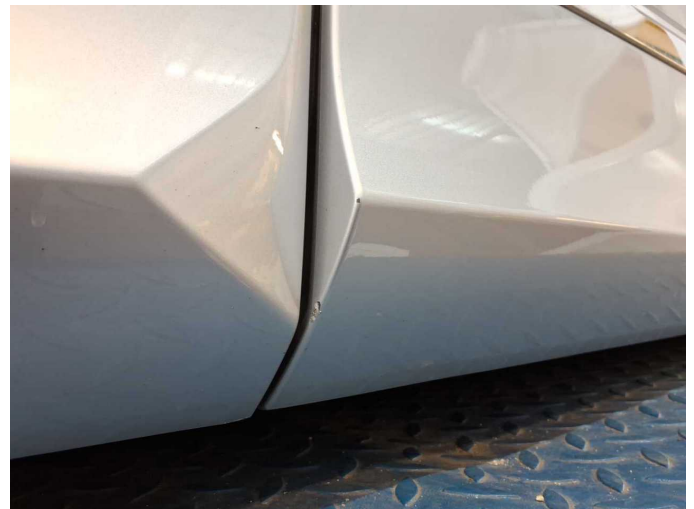
**Damage 2:** Trim / covers: Door trim - front right side - Scratched - Smart repair

| No. | Component group | Description |
|---|---|---|
| 2 | Trim / covers | Door trim - front right side - Scratched - Smart repair |

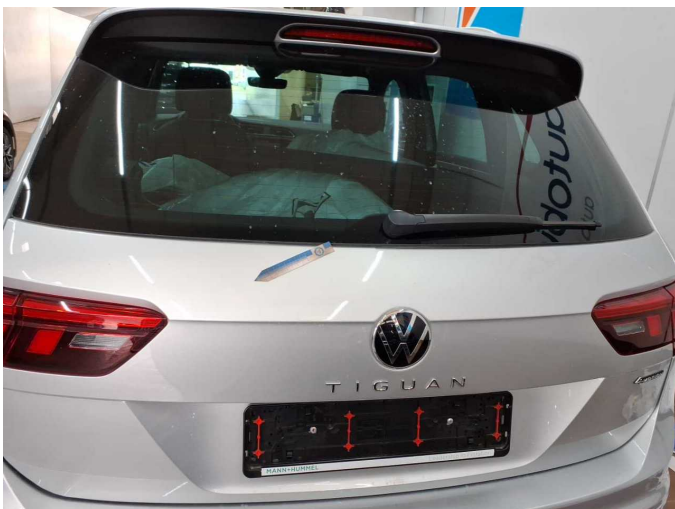
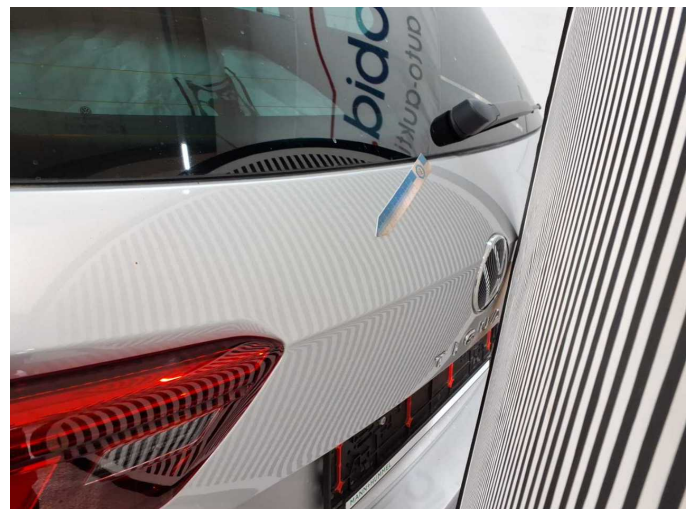
**Damage 3:** Boot lid / rear door: Boot lid - dent(s) - Smooth repair work

| No. | Component group | Description |
|---|---|---|
| 3 | Boot lid / rear door | Boot lid - dent(s) - Smooth repair work |

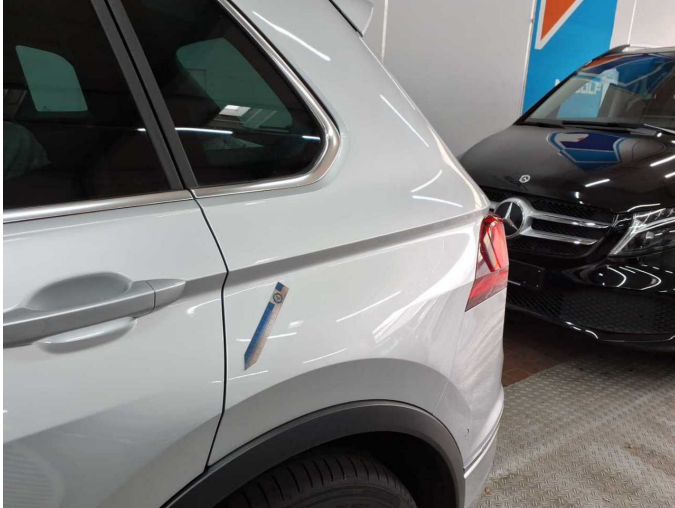
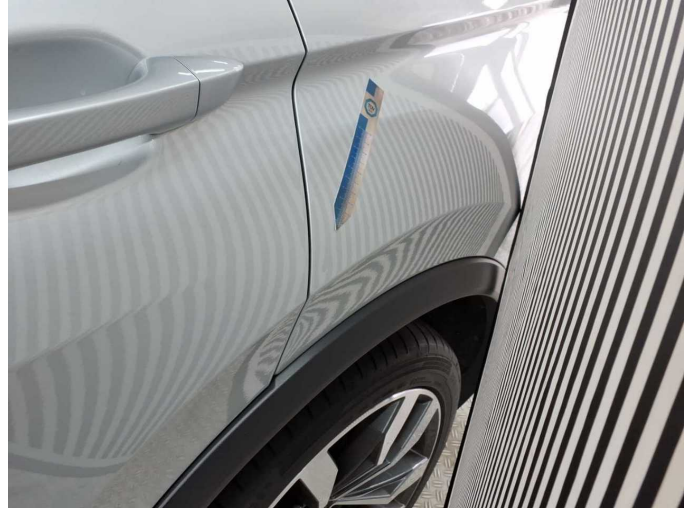
**Damage 4:** Side panel - rear left side: Side panel - dent(s) - Smooth repair work

| No. | Component group | Description |
|---|---|---|
| 4 | Side panel - rear left side | Side panel - dent(s) - Smooth repair work |

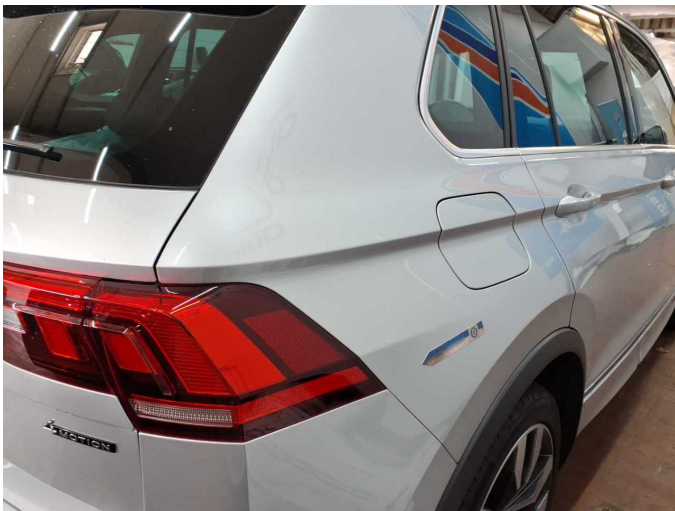
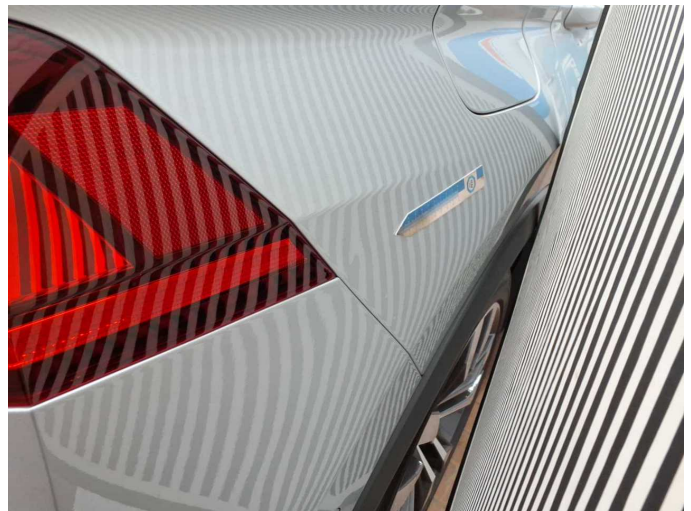
**Damage 5:** Side panel - rear right side: Side panel - dent(s) - Smooth repair work

| No. | Component group | Description |
|---|---|---|
| 5 | Side panel - rear right side | Side panel - dent(s) - Smooth repair work |

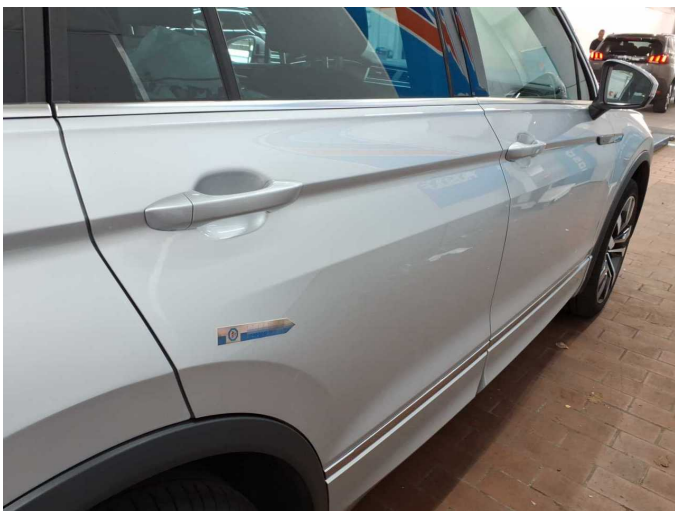
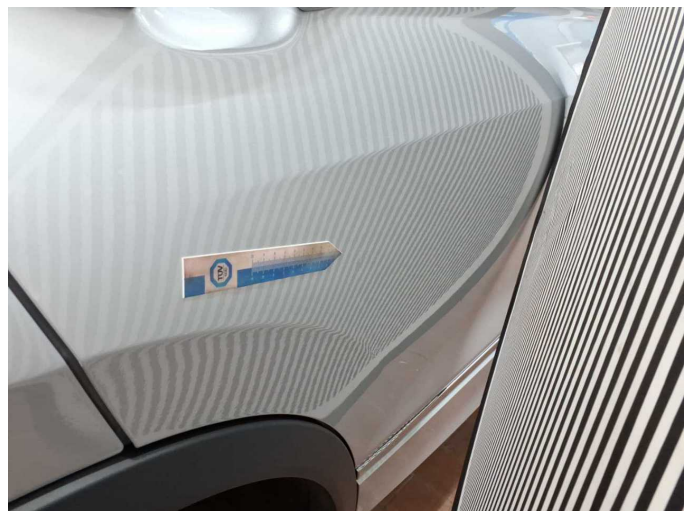
**Damage 6:** Door - rear right side: Door - dent(s) - Smooth repair work

| No. | Component group | Description |
|---|---|---|
| 6 | Door - rear right side | Door - dent(s) - Smooth repair work |

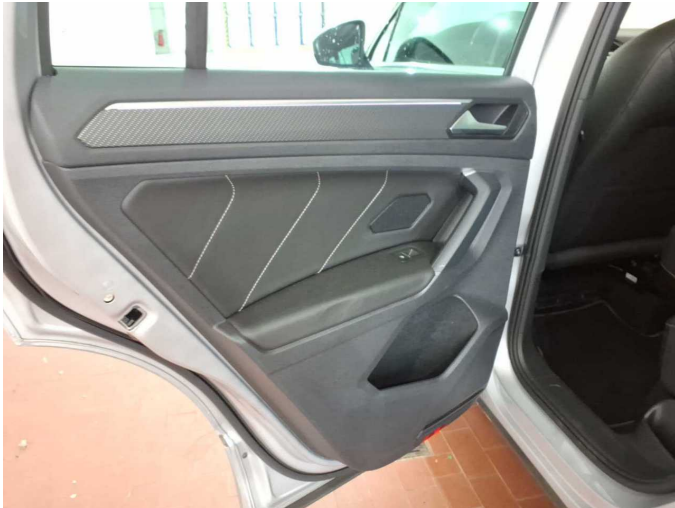
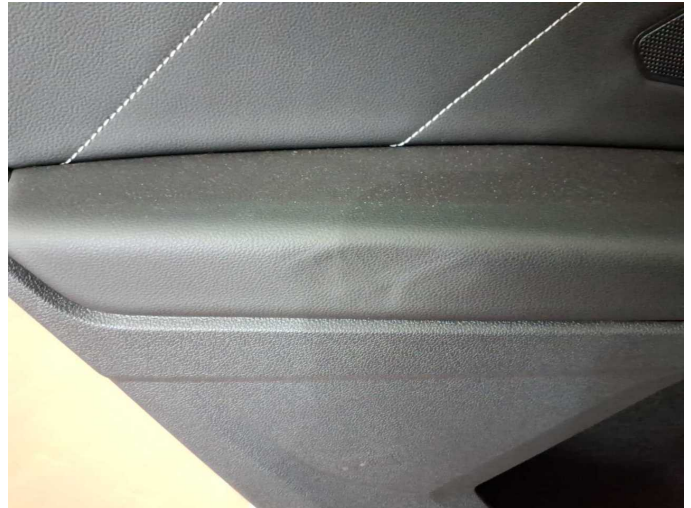
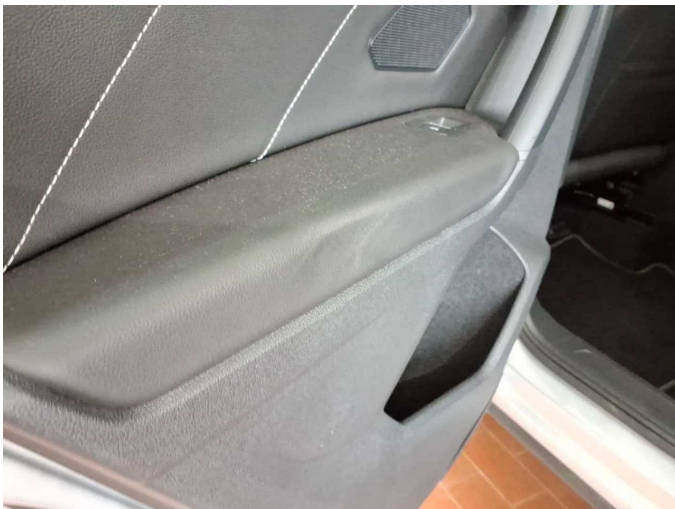
**Damage 7:** Trim / covers: Door trim - rear left side - Damaged - Loss in value

| No. | Component group | Description |
|---|---|---|
| 7 | Trim / covers | Door trim - rear left side - Damaged - Loss in value |

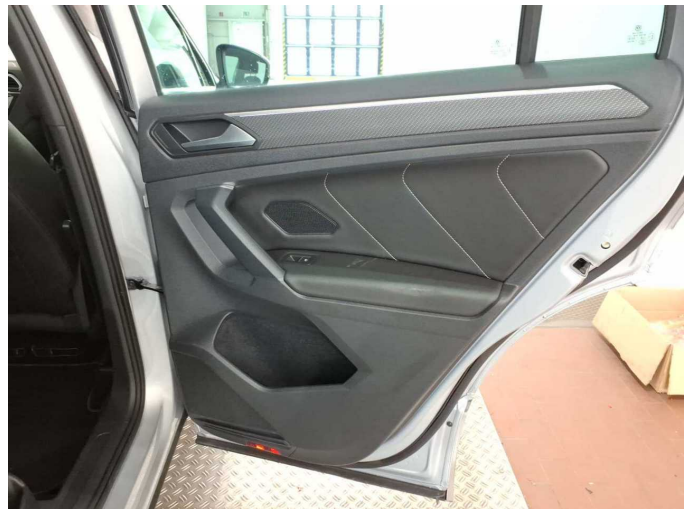
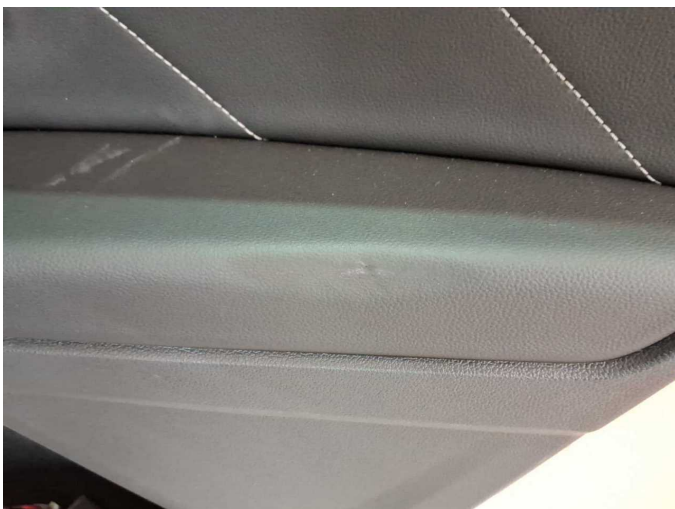
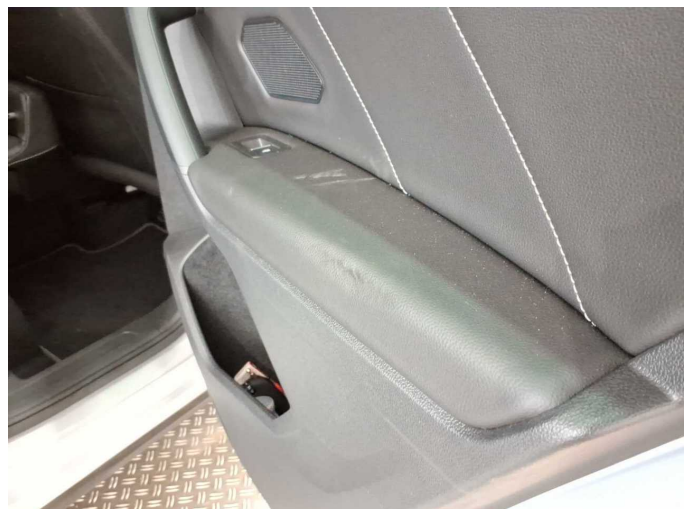
**Damage 8:** Trim / covers: Door trim - rear right side - Damaged - Loss in value

| No. | Component group | Description |
|---|---|---|
| 8 | Trim / covers | Door trim - rear right side - Damaged - Loss in value |

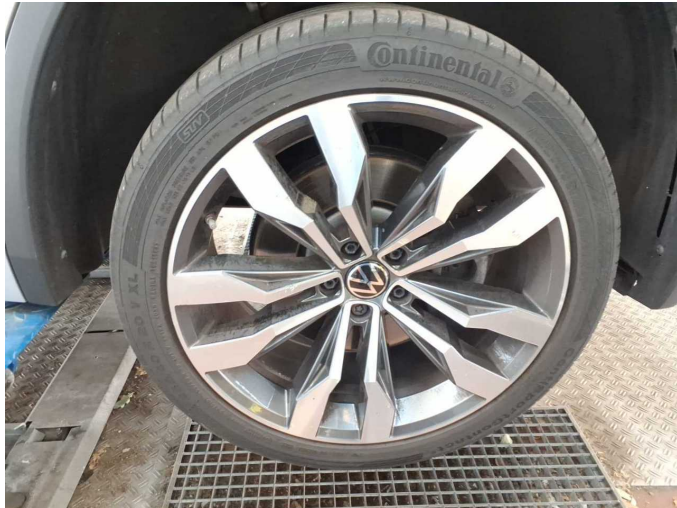
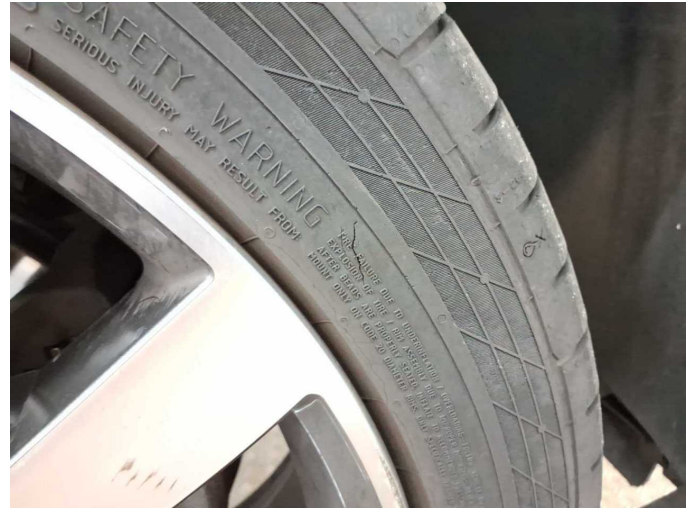
**Damage 9:** Wheel / tyres: Tyre - front right side - Damaged - Replace

| No. | Component group | Description |
|---|---|---|
| 9 | Wheel / tyres | Tyre - front right side - Damaged - Replace |

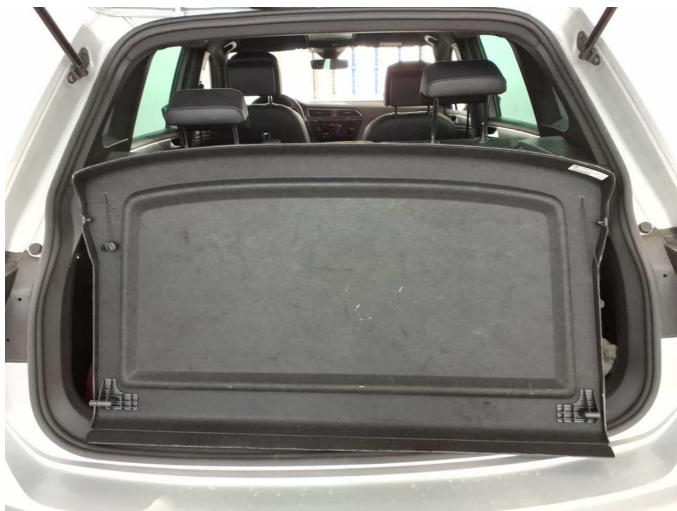
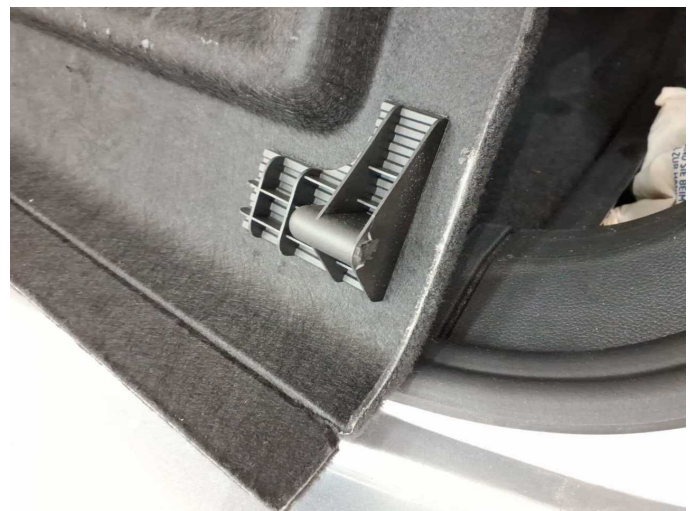
**Damage 10:** Interior: Rear shelf - Broken / torn - Replace

| No. | Component group | Description |
|---|---|---|
| 10 | Interior | Rear shelf - Broken / torn - Replace |

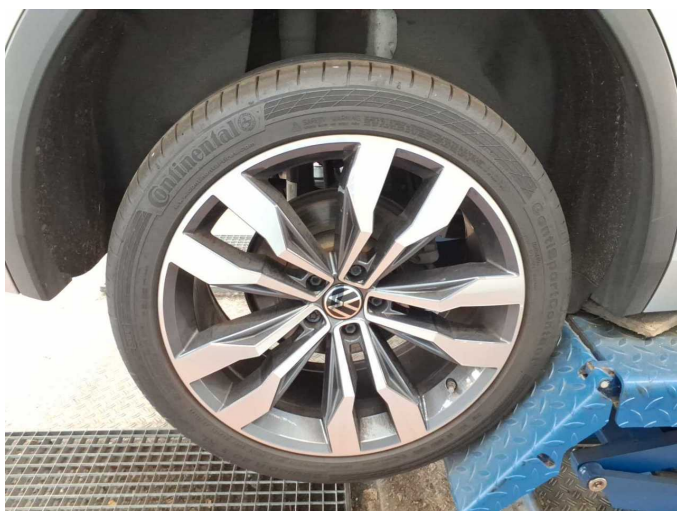
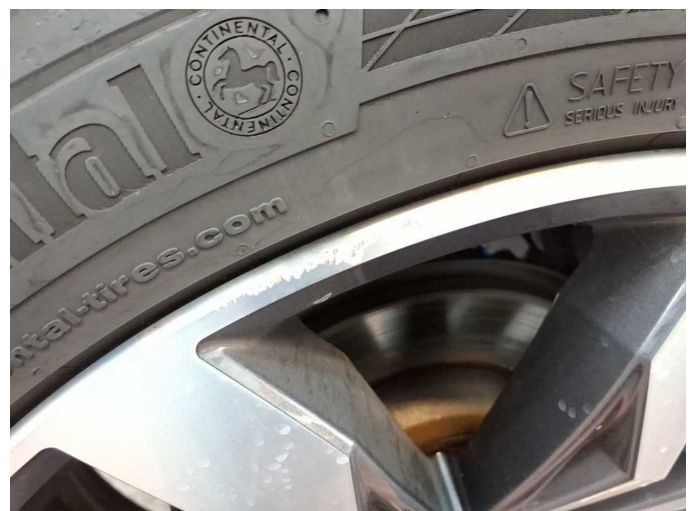
**Damage 11:** Wheel / tyres: Alloy rim - rear right side - Damaged - Loss in value

| No. | Component group | Description |
|---|---|---|
| 11 | Wheel / tyres | Alloy rim - rear right side - Damaged - Loss in value |

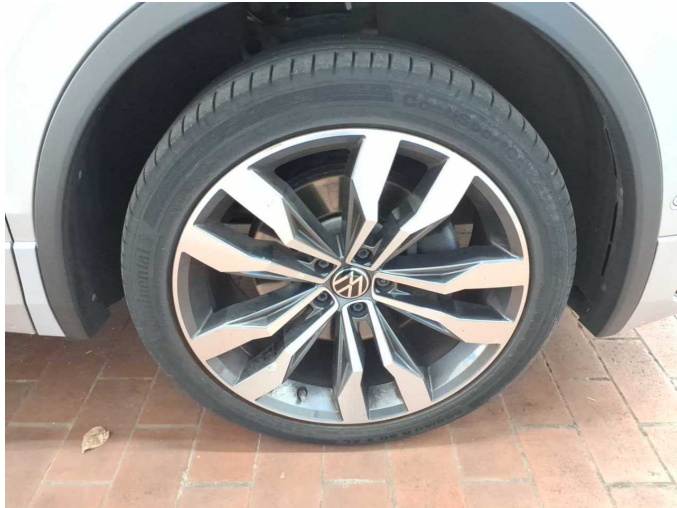
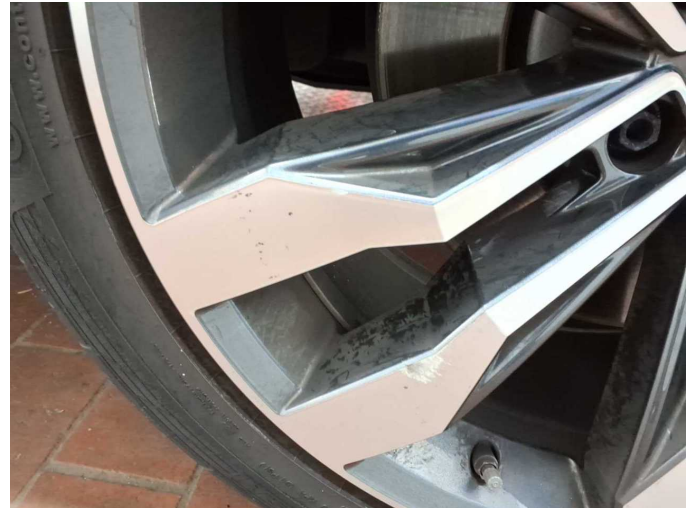
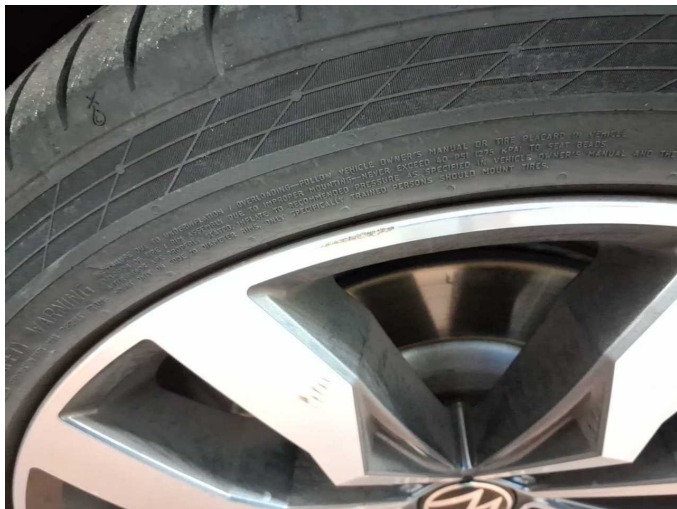
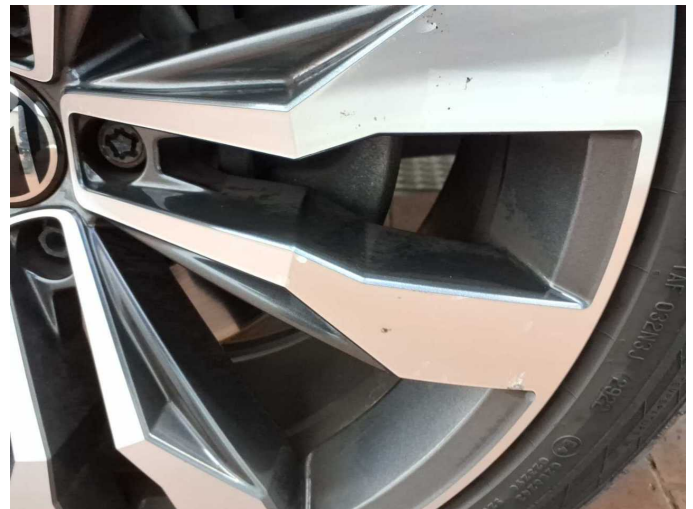
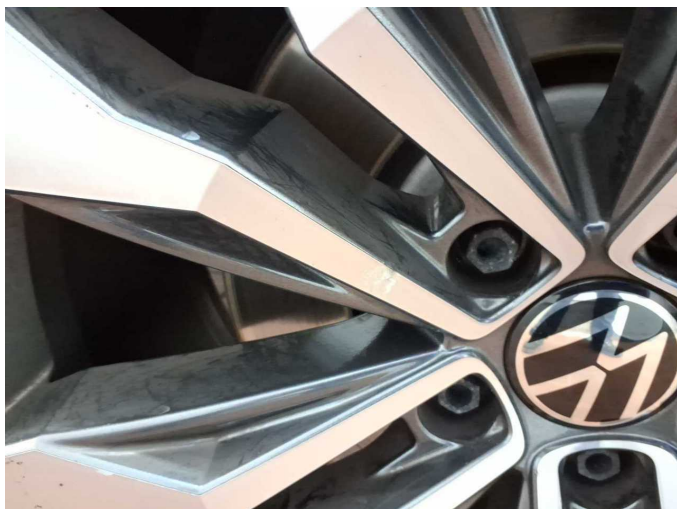
**Damage 12:** Wheel / tyres: Alloy rim - front right side - Scratch(es) - Replace

| No. | Component group | Description |
|---|---|---|
| 12 | Wheel / tyres | Alloy rim - front right side - Scratch(es) - Replace |

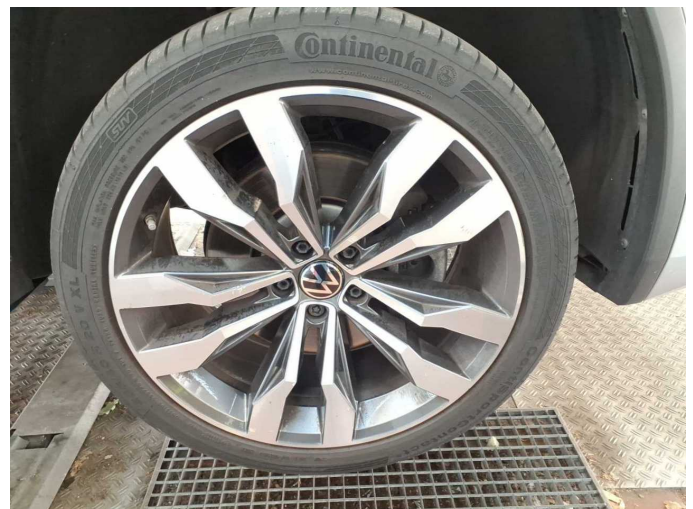
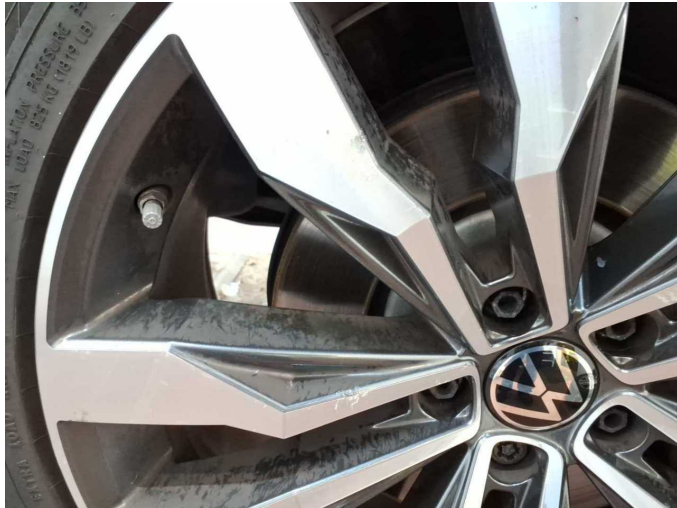
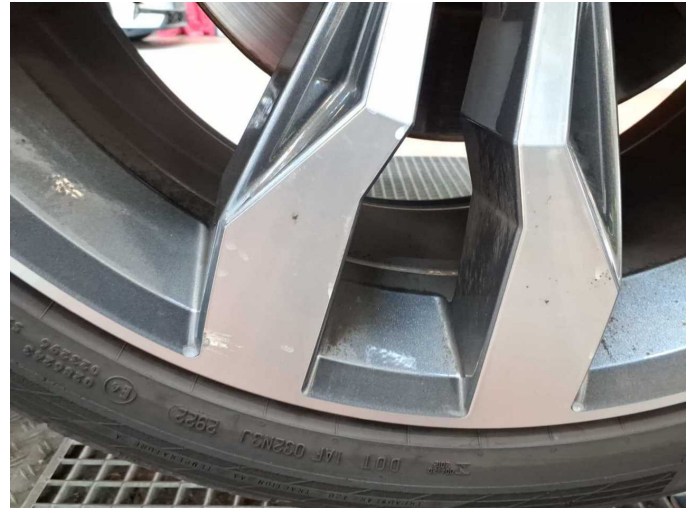
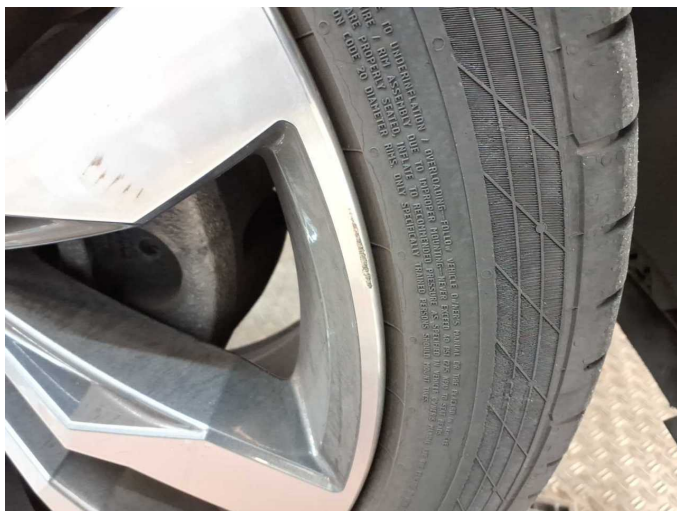
**Damage 13:** Wheel / tyres: Alloy rim - front right side - Damaged - Loss in value

| No. | Component group | Description |
|---|---|---|
| 13 | Wheel / tyres | Alloy rim - front right side - Damaged - Loss in value |

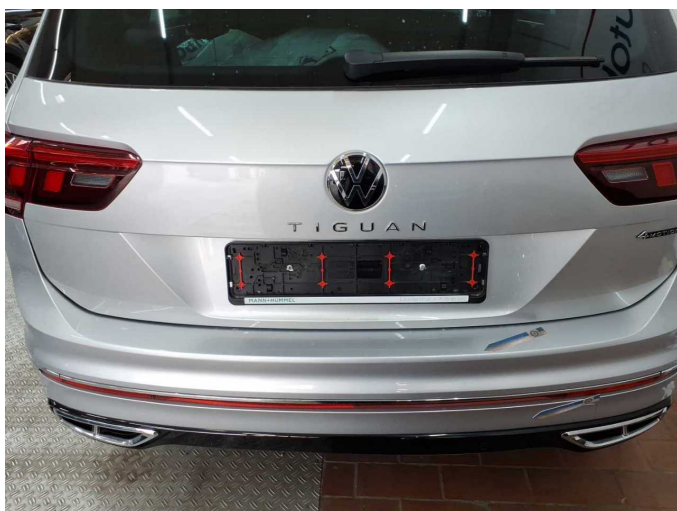
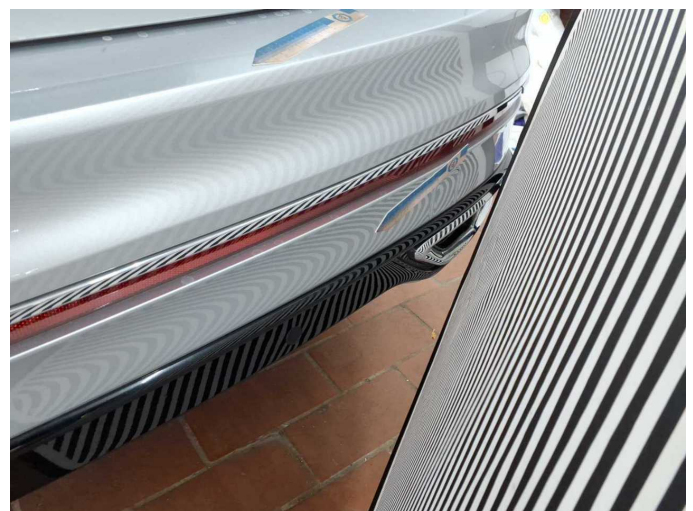
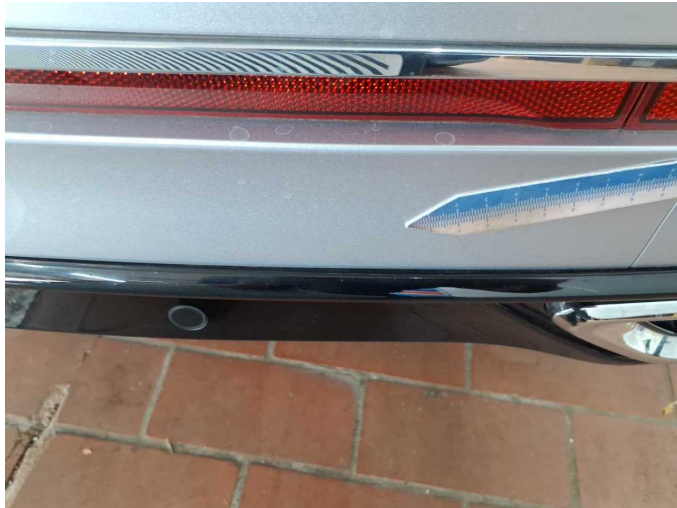
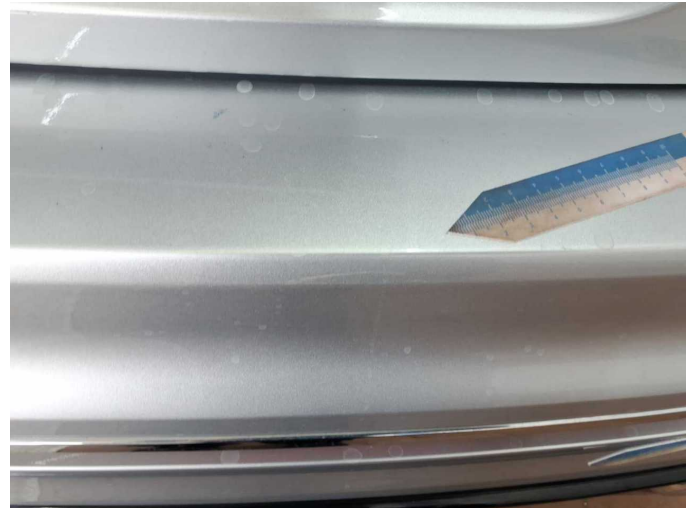
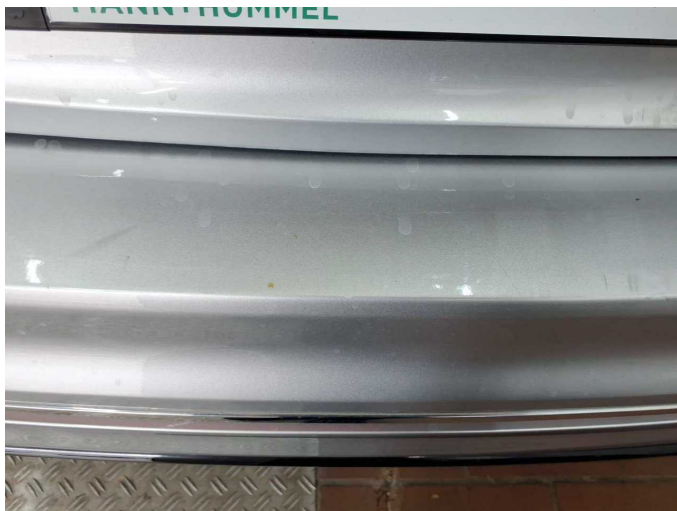
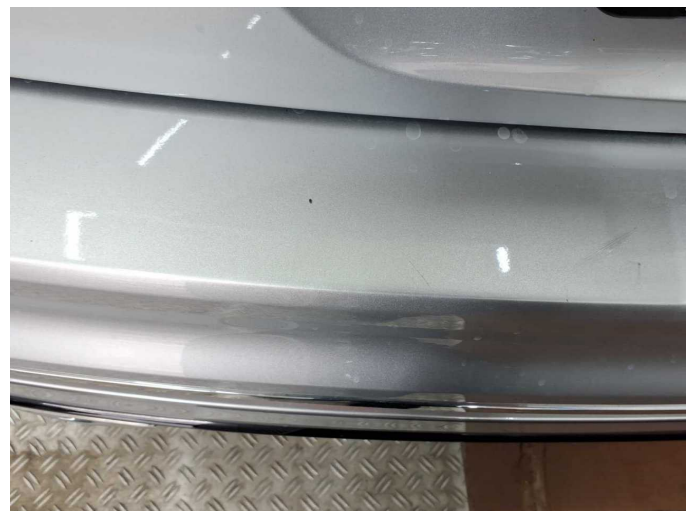
**Damage 15:** Rear bumper: Rear bumper - Dent / paintcoat damage - Paint

| No. | Component group | Description |
|---|---|---|
| 15 | Rear bumper | Rear bumper - Dent / paintcoat damage - Paint |

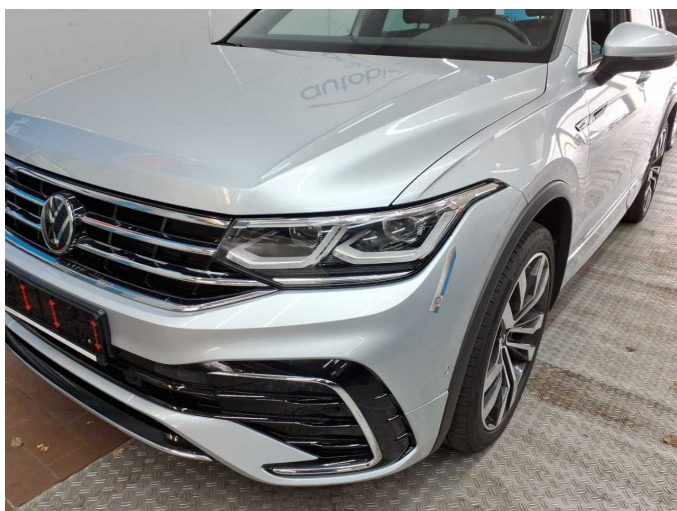
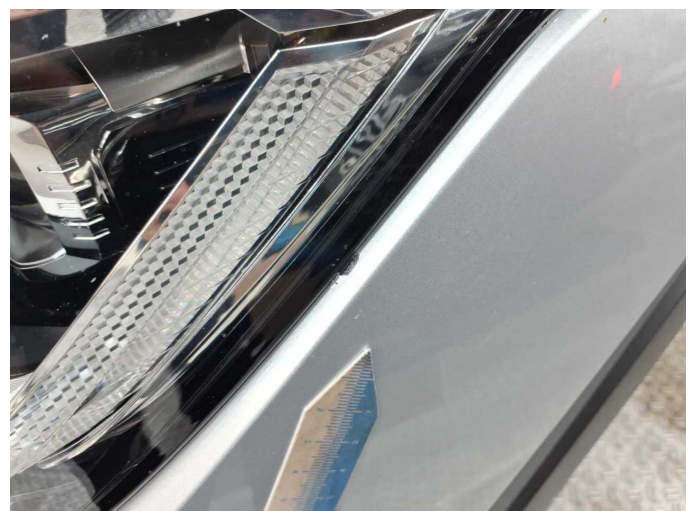
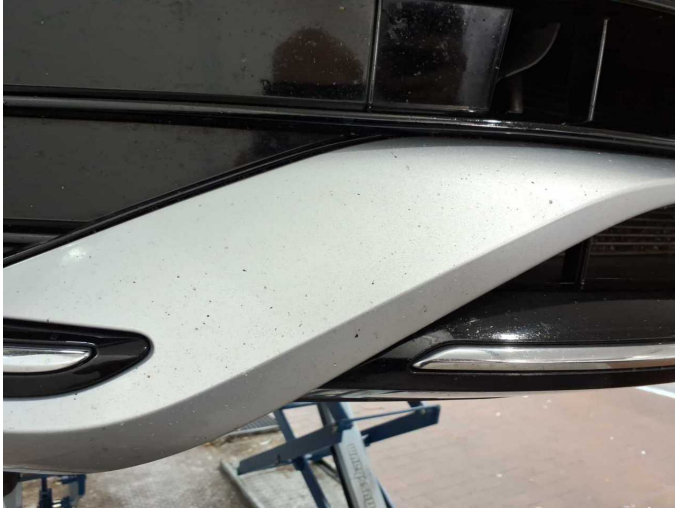
**Damage 16:** Front bumper: Front bumper - Paint defect - Paint

| No. | Component group | Description |
|---|---|---|
| 16 | Front bumper | Front bumper - Paint defect - Paint |

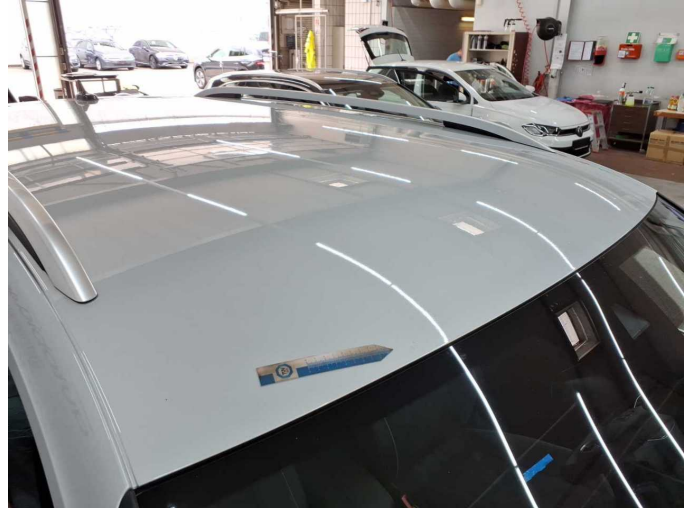
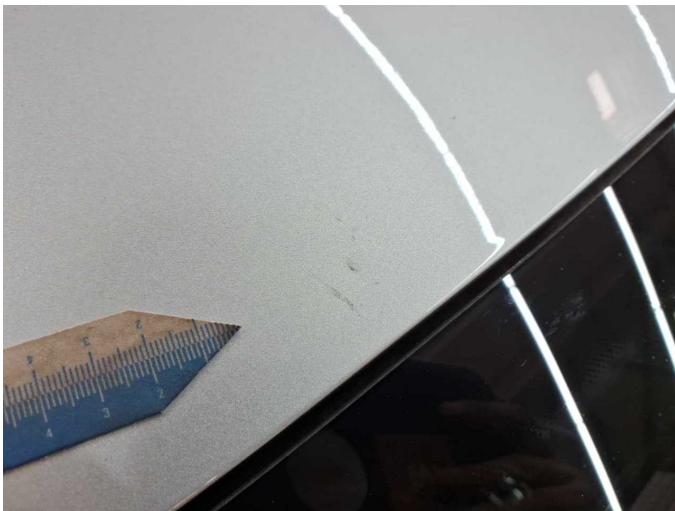
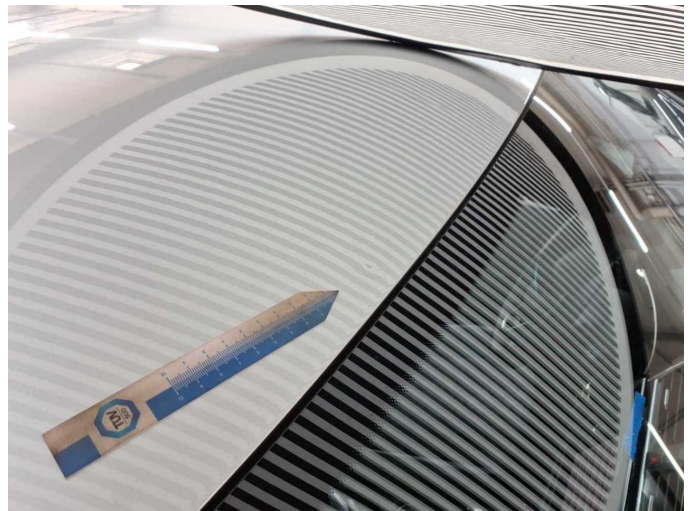
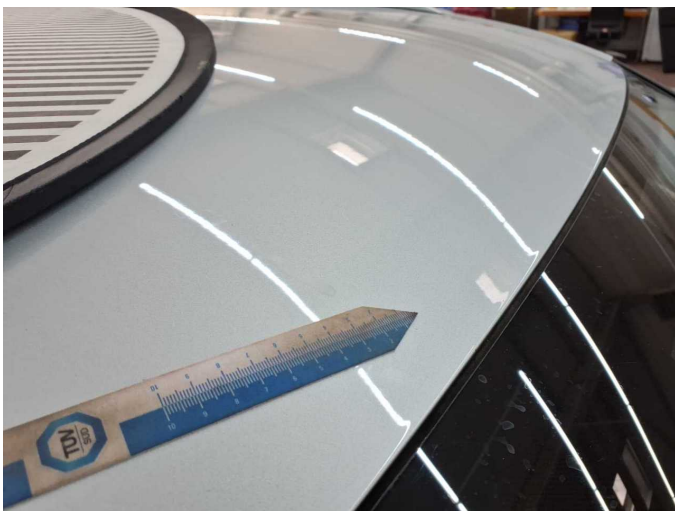
**Damage 17:** Roof: Roof - Dent / paintcoat damage - Paint

| No. | Component group | Description |
|---|---|---|
| 17 | Roof | Roof - Dent / paintcoat damage - Paint |

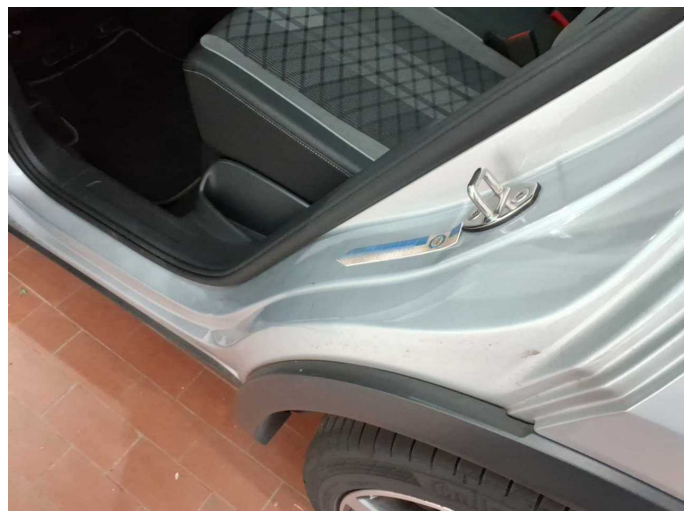
**Wear and tear 3:** Side panel - rear left side: Sill - dent(s) - No deduction

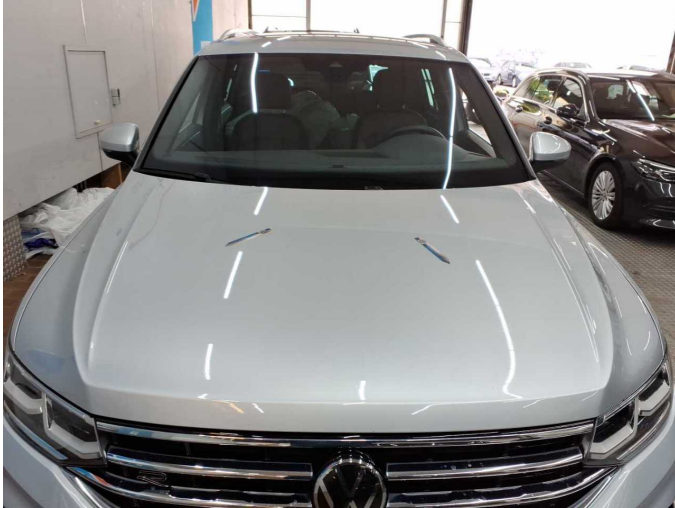
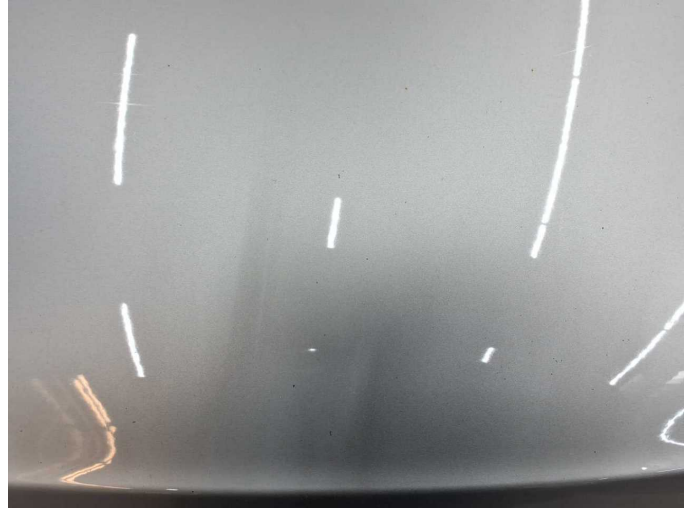
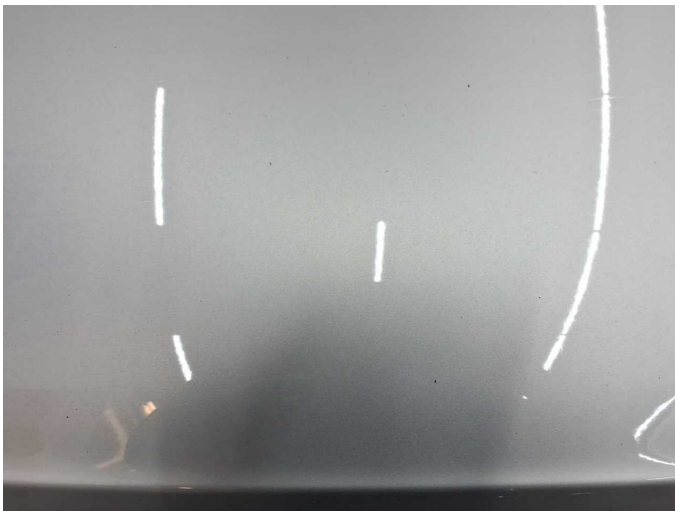
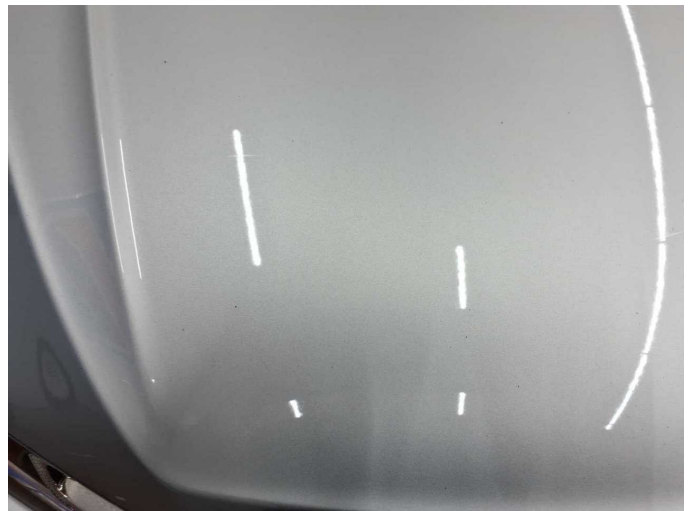
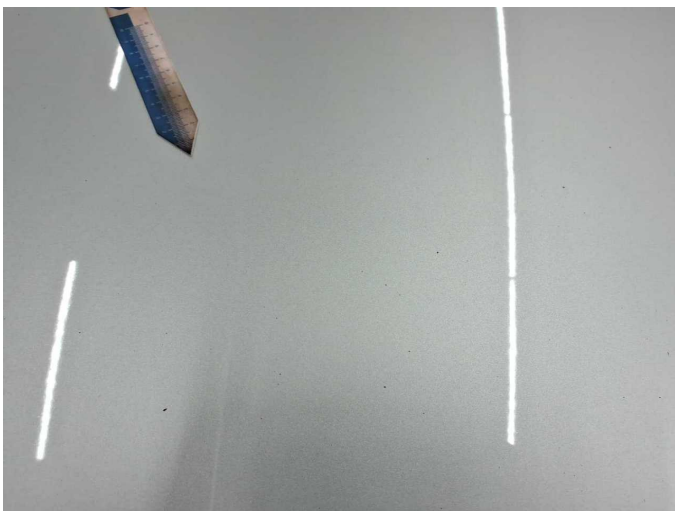
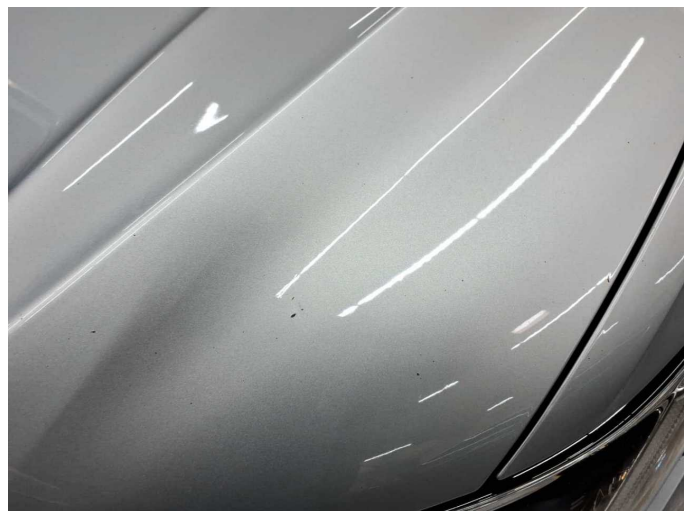
**Wear and tear 4:** Bonnet: Bonnet - Stone chips - No deduction

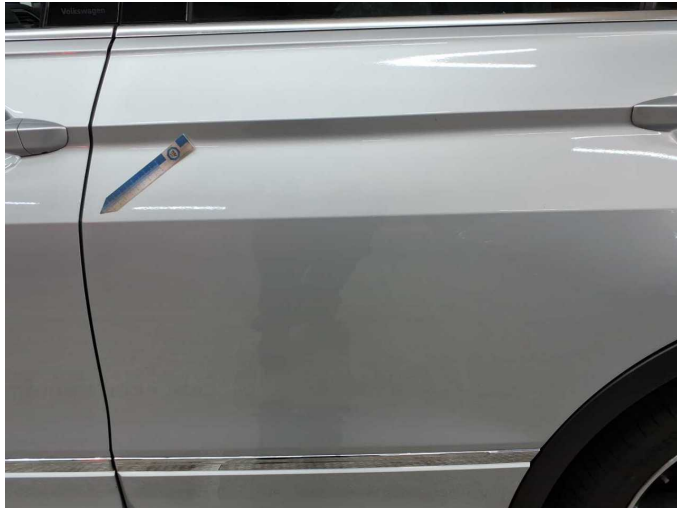
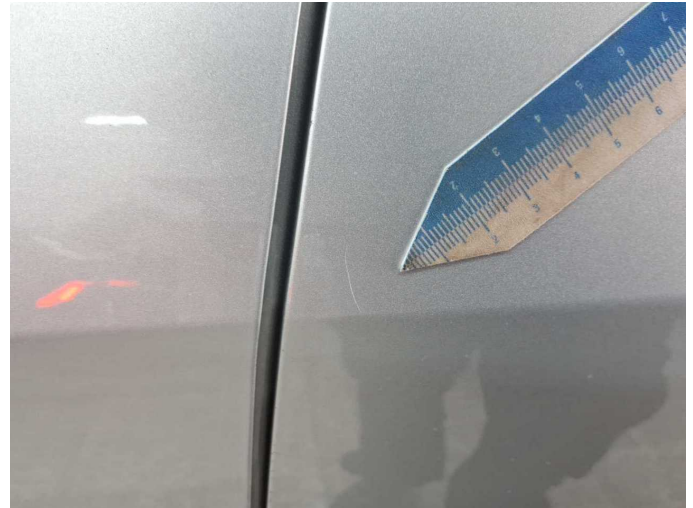
**Wear and tear 5:** Door - rear left side: Door - Scratch(es) - No deduction

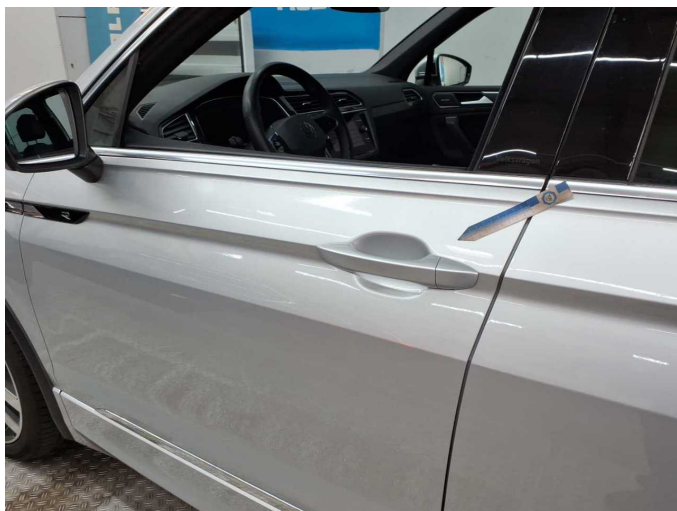
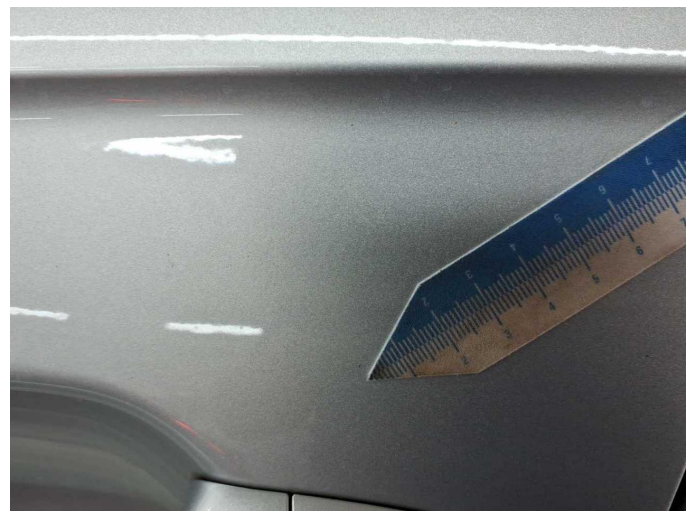
**Wear and tear 6:** Door - front left side: Door - Scratch(es) - No deduction

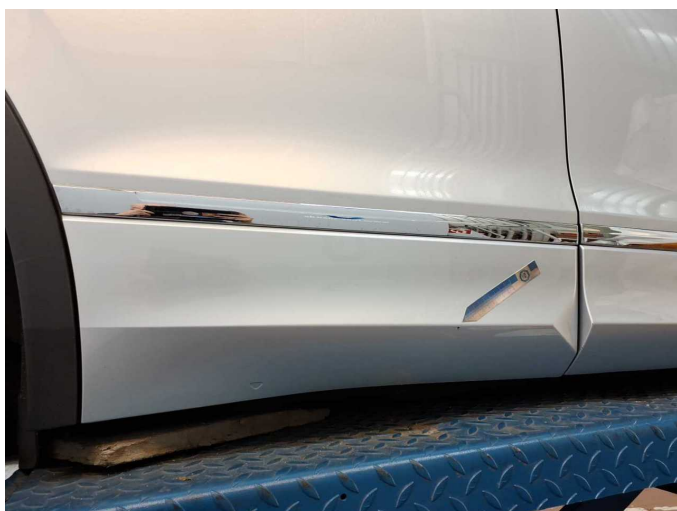
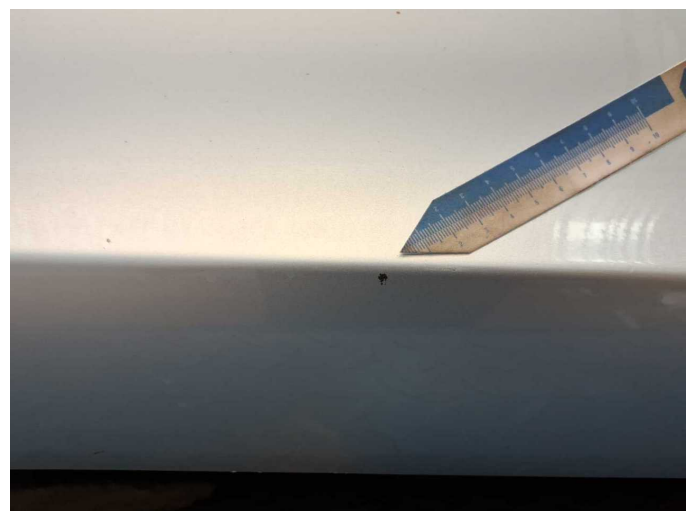
**Wear and tear 7:** Trim / covers: Door trim - rear right side - Scratched - No deduction
