Expertise

Protocol number: 46797341  
Order No. / Reference: 26688259  
Inspection date: 27 Jul 2026

Manufacturer: Volkswagen

Model: Tiguan 2.0 TDI SCR 4MOTION DSG R-Line

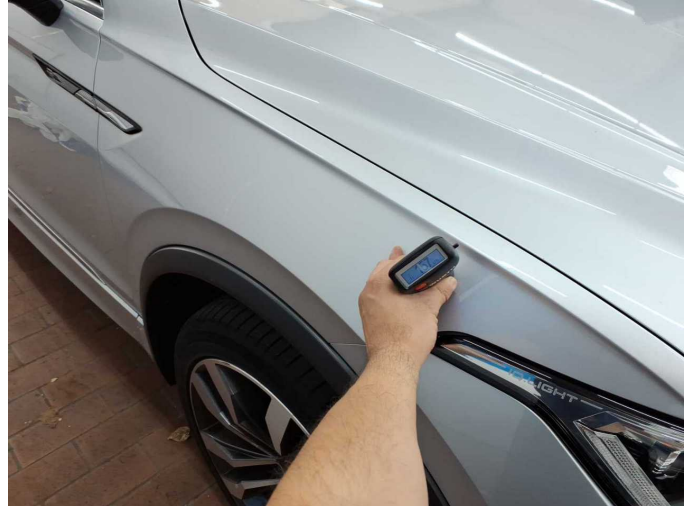
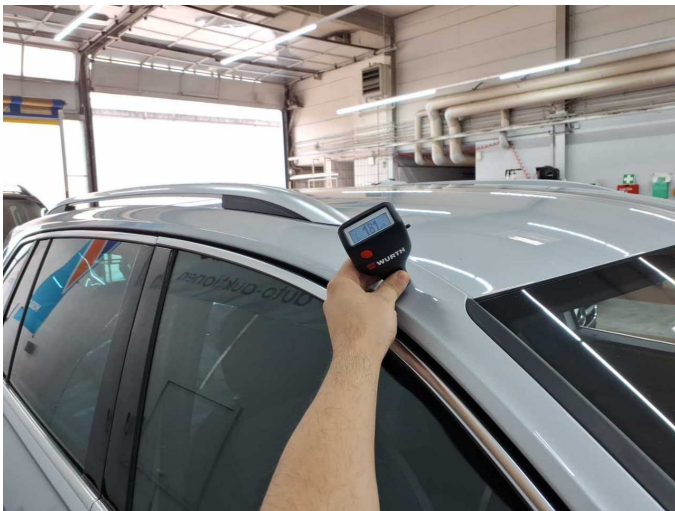
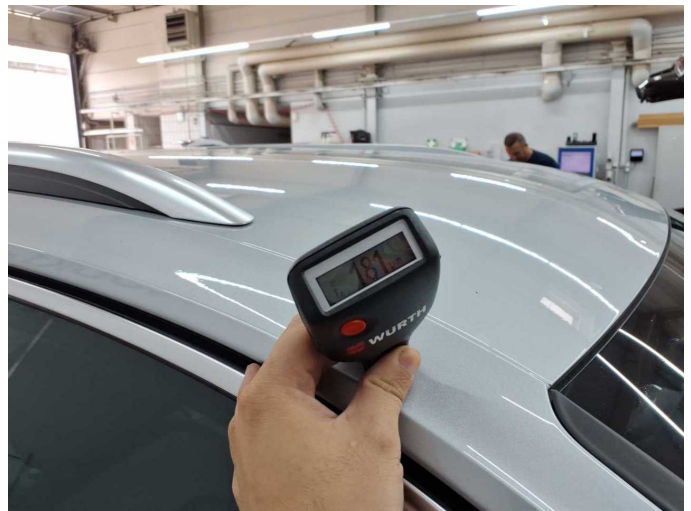
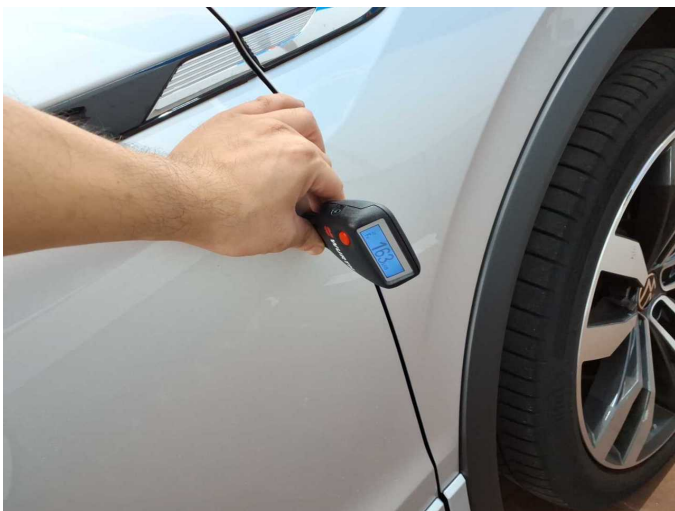
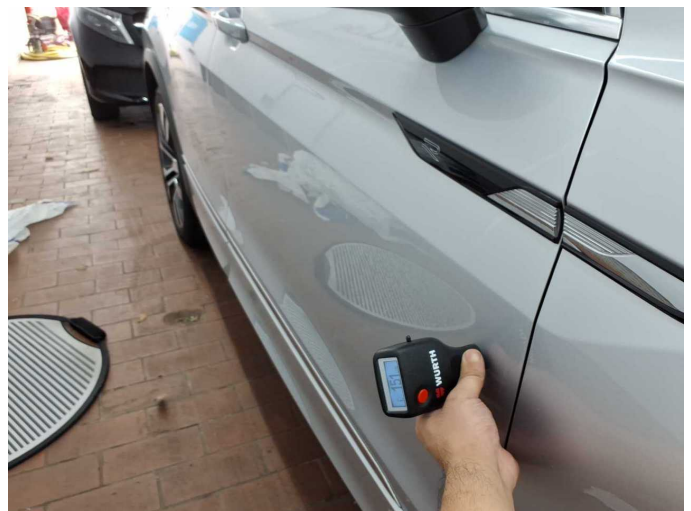
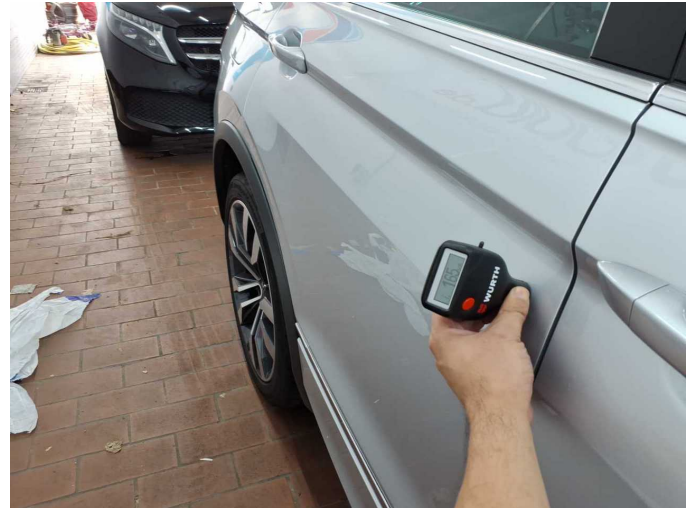
**Previous damage 2: Side right**
