Expertise

Protocol number: 46558011  
Order No. / Reference: 26534766  
Inspection date: 16 Jul 2026

Manufacturer: Opel

Model: Zafira Life 2.0 D M Aut. Elegance

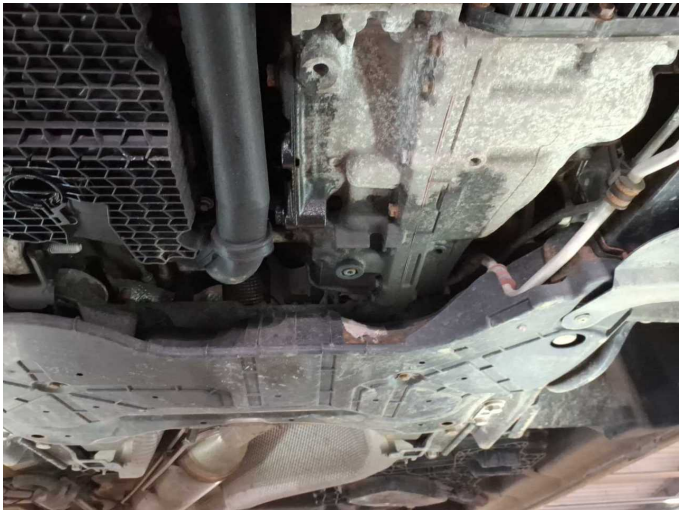
Damage 1: Gearbox: Gearbox - Leaking - Perform diagnosis

| No. | Component group | Description |
|---|---|---|
| 1 | Gearbox | Gearbox - Leaking - Perform diagnosis |

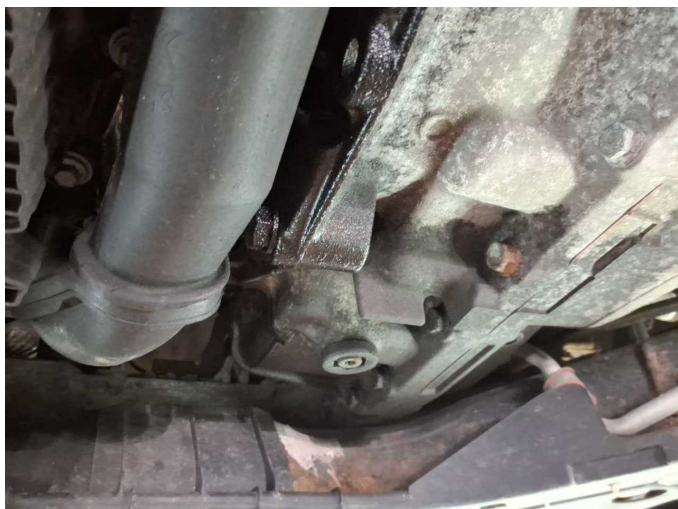
**Damage 1:** Gearbox: Gearbox - Leaking - Perform diagnosis

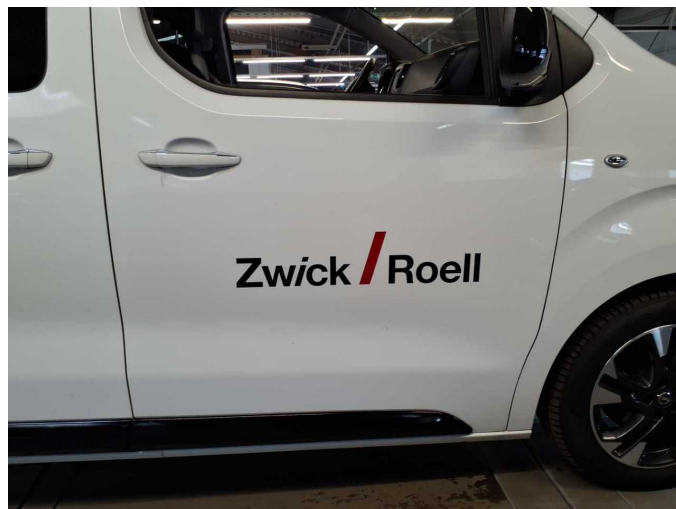
**Damage 2:** Body: Body - Glued / labelled - De-glue / neutralise

| No. | Component group | Description |
|---|---|---|
| 2 | Body | Body - Glued / labelled - De-glue / neutralise |

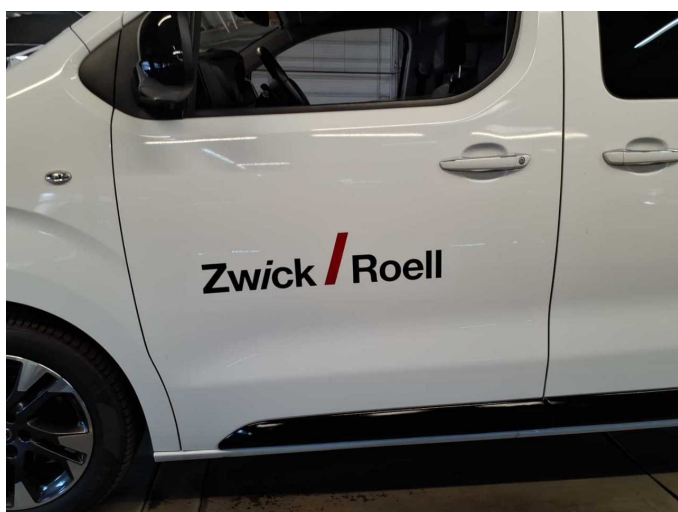
**Damage 2:** Body: Body - Glued / labelled - De-glue / neutralise

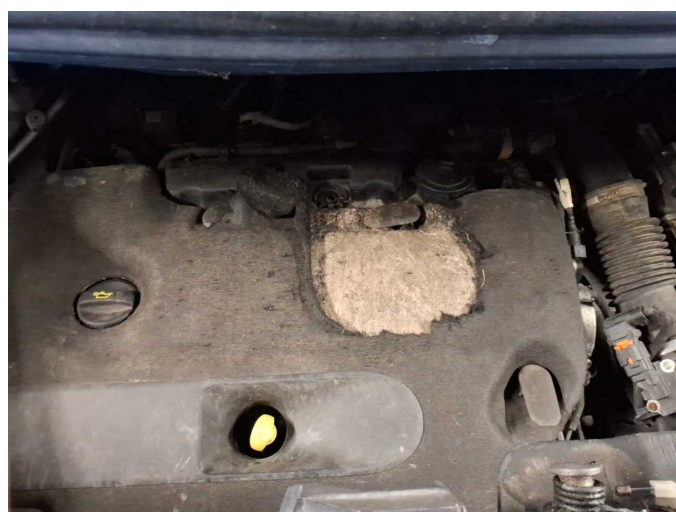
**Damage 3:** Engine: Engine cover - Damaged - Replace

| No. | Component group | Description |
|---|---|---|
| 3 | Engine | Engine cover - Damaged - Replace |

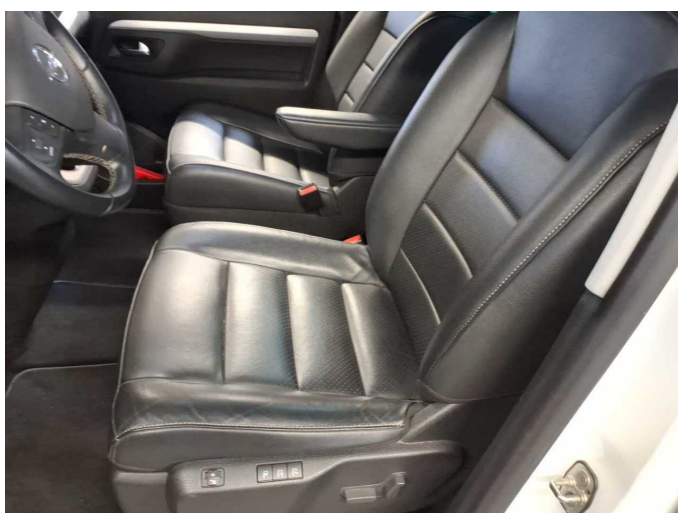
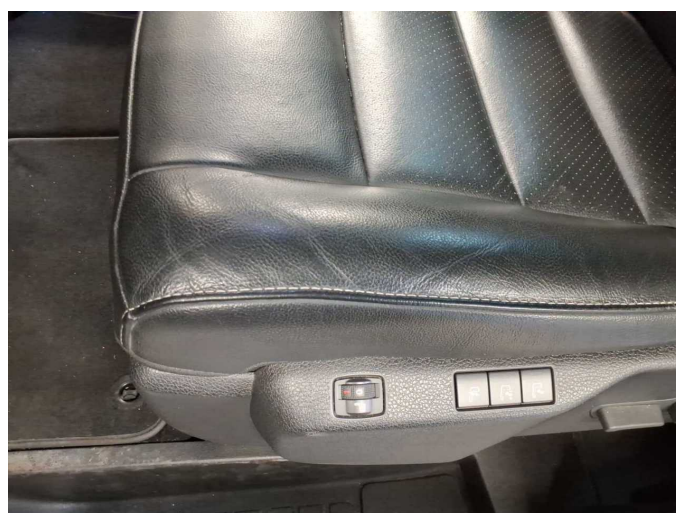
| No. | Component group | Description |
|---|---|---|
| 1 | Seat - front | Seat cover - left side - Abrasion - No deduction |

**Wear and tear 1:** Seat - front: Seat cover - left side - Abrasion - No deduction
