Expertise

Protocol number: 46163697  
Order No. / Reference: 26407639  
Inspection date: 23 Jun 2026

Model: GLE 350 e 4Matic 9G-TRONIC

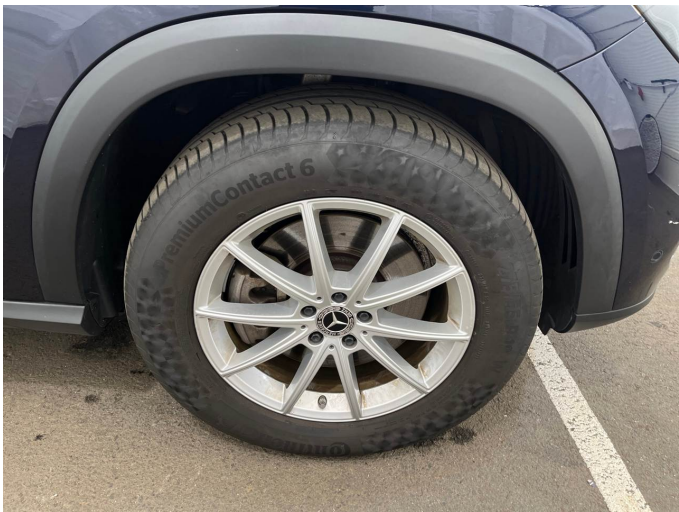
| # | Tyre size | Type of tyre | Manufacturer | Tread depth |
|---|---|---|---|---|
| 1) | 275/55 R19 111W | Summer tyres on Light alloy | Continental | 6mm / 6mm |
| 2) | 275/55 R19 111W | Summer tyres on Light alloy | Continental | 6mm / 6mm |

Figure 12: Mounted tyres

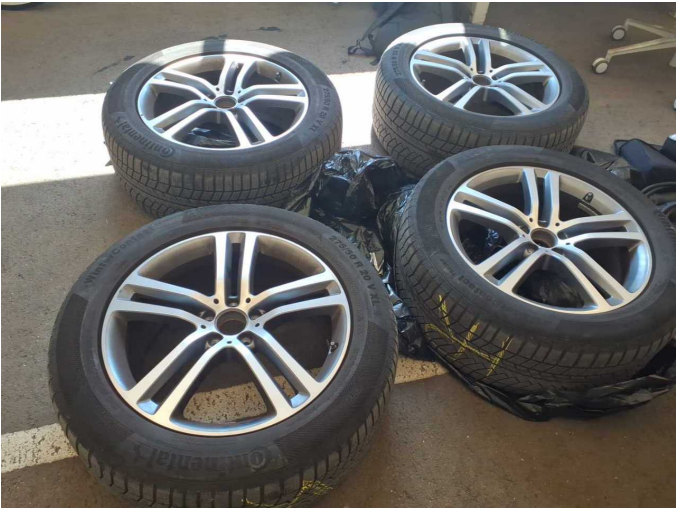
| # | Tyre size | Type of tyre | Manufacturer | Tread depth |
|---|---|---|---|---|
| 1) | 275/50 R20 113V | Winter tyres on Light alloy | Continental | 3mm / 3mm |
| 2) | 275/50 R20 113V | Winter tyres on Light alloy | Continental | 5mm / 5mm |

Figure 15: Additional tyres

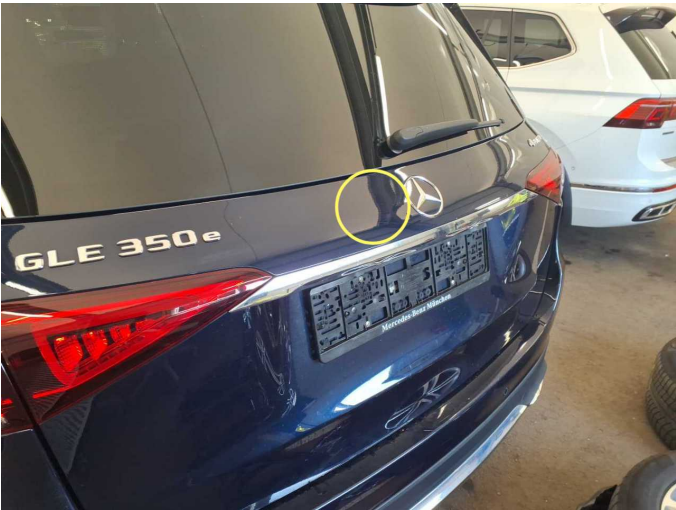
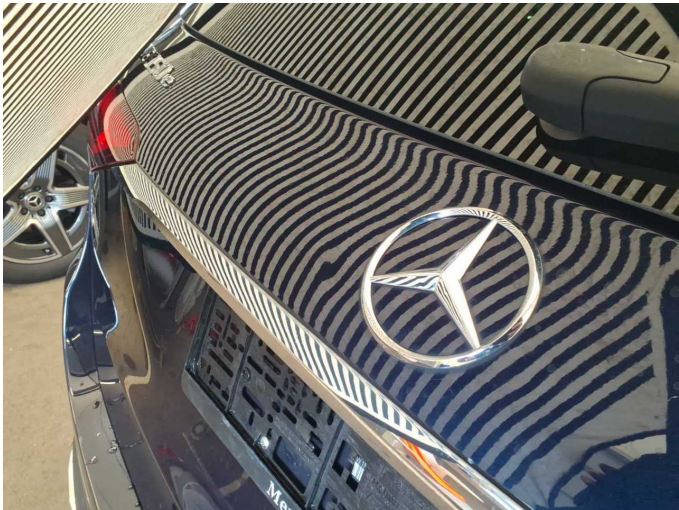
| No. | Component group | Description |
|---|---|---|
| 1 | Boot lid / rear door | Boot lid - dent(s) - Smooth repair work |

Damage 1: Boot lid / rear door: Boot lid - dent(s) - Smooth repair work

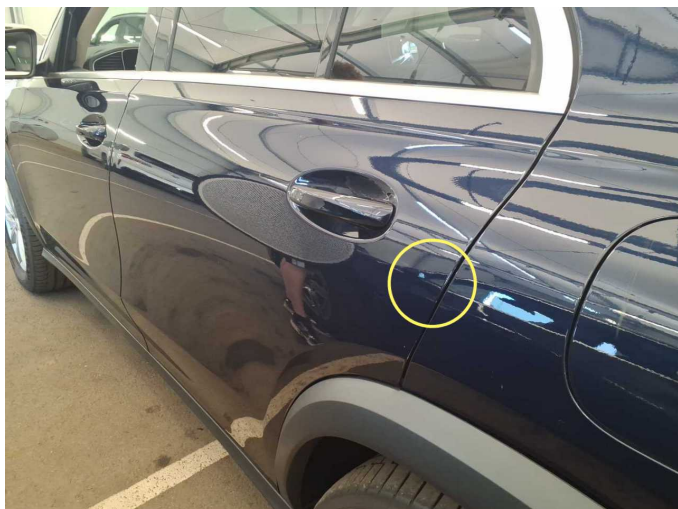
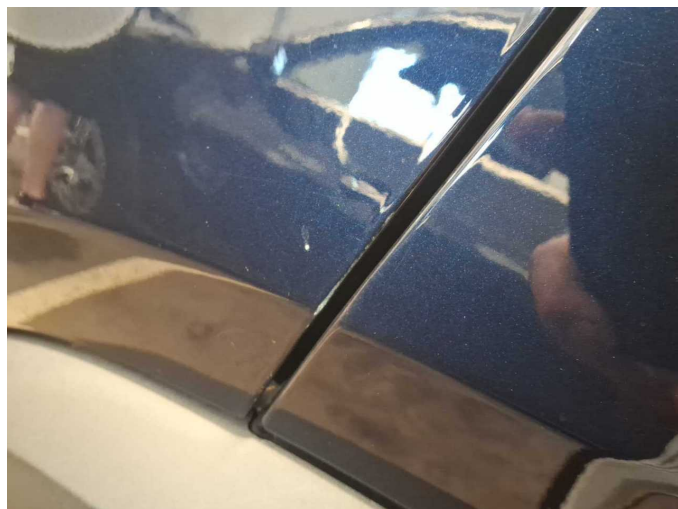
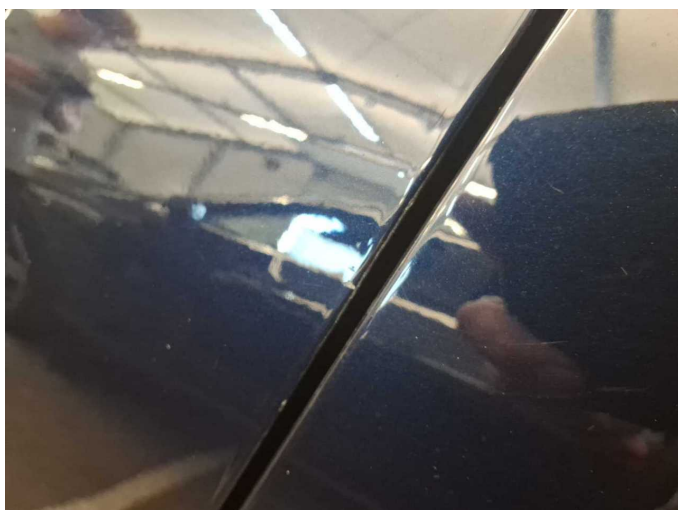
| No. | Component group | Description |
|---|---|---|
| 2 | Door - rear left side | Door edge - Scratch(es) - Smart repair |

**Damage 2:** Door - rear left side: Door edge - Scratch(es) - Smart repair

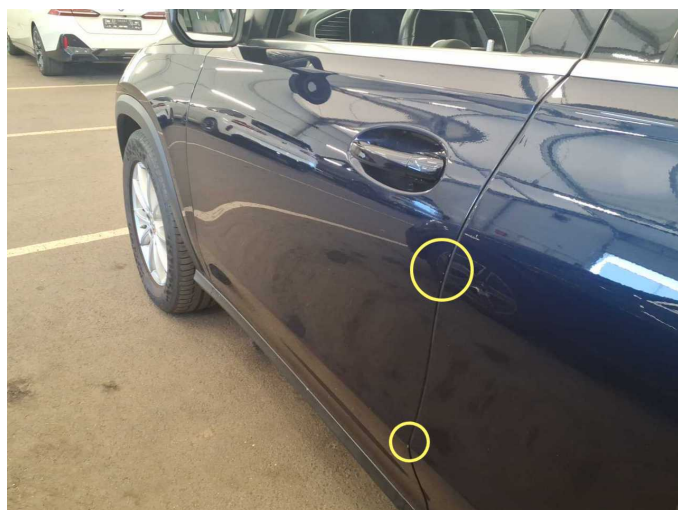
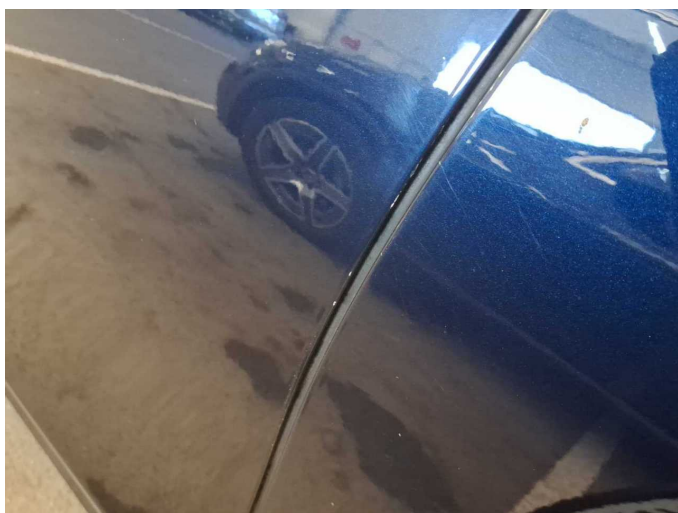
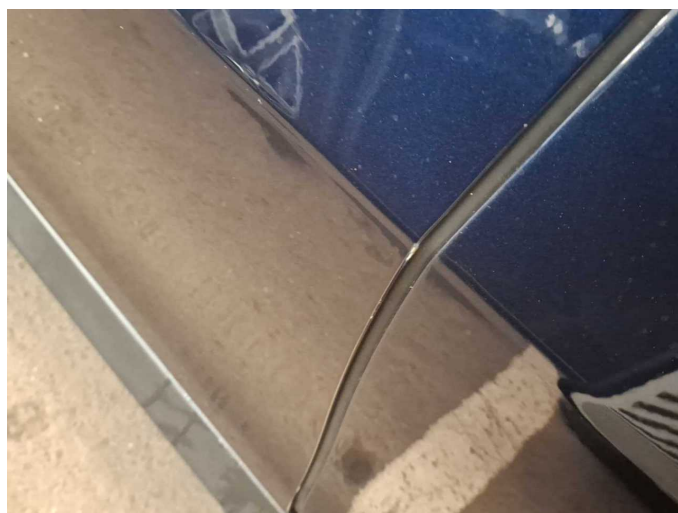
| No. | Component group | Description |
|---|---|---|
| 3 | Door - front left side | Door edge - Scratch(es) - Smart repair |

**Damage 3:** Door - front left side: Door edge - Scratch(es) - Smart repair

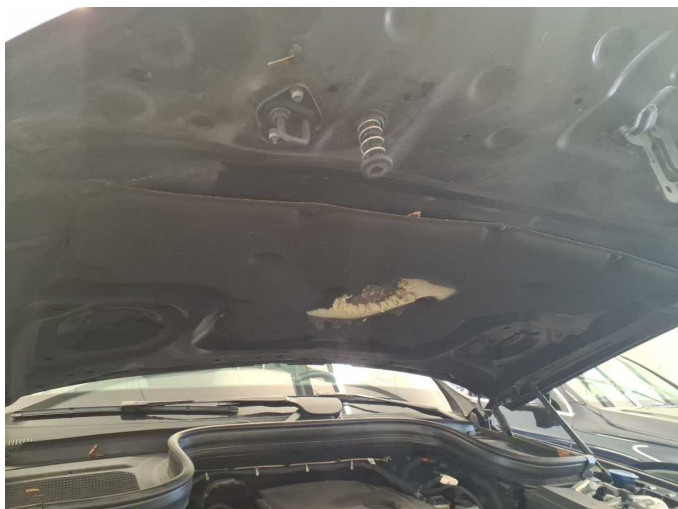
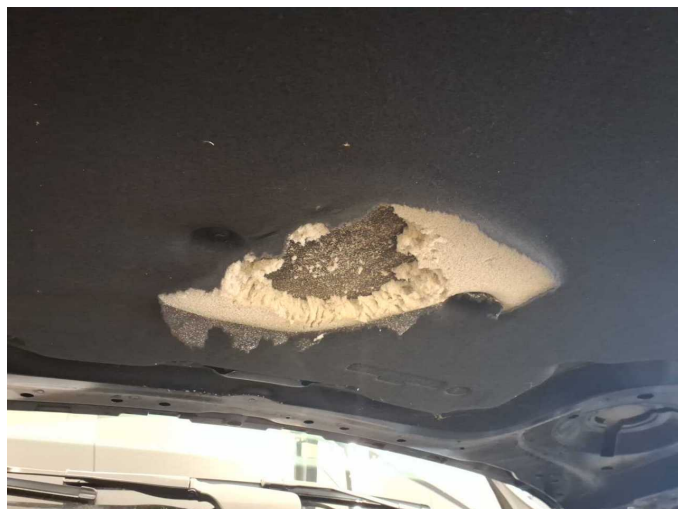
| No. | Component group | Description |
|---|---|---|
| 4 | Bonnet | Insulation lining - Damage caused by marten / rodent - Replace |

**Damage 4:** Bonnet: Insulation lining - Damage caused by marten / rodent - Replace

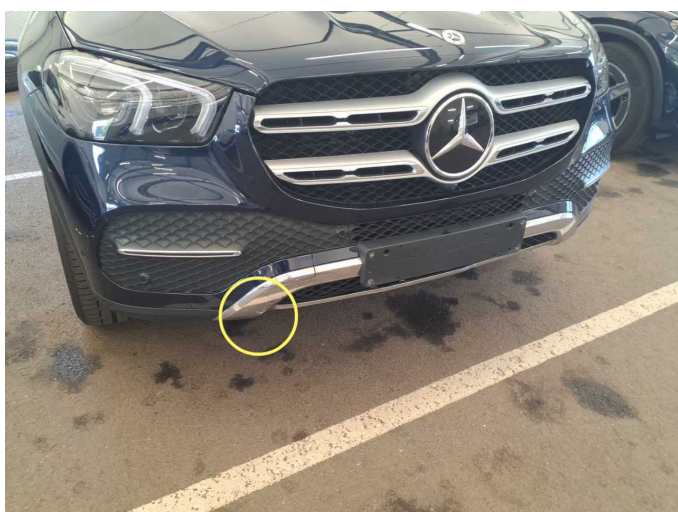
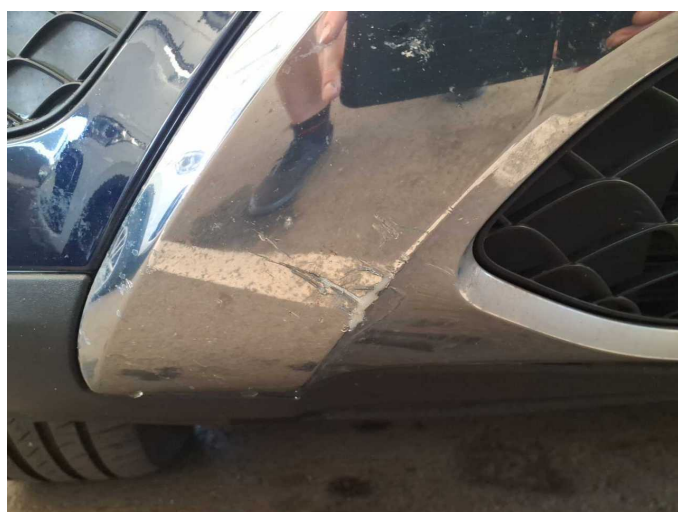
| No. | Component group | Description |
|---|---|---|
| 5 | Front bumper | Spoiler - Scratched - Replace |

**Damage 5:** Front bumper: Spoiler - Scratched - Replace

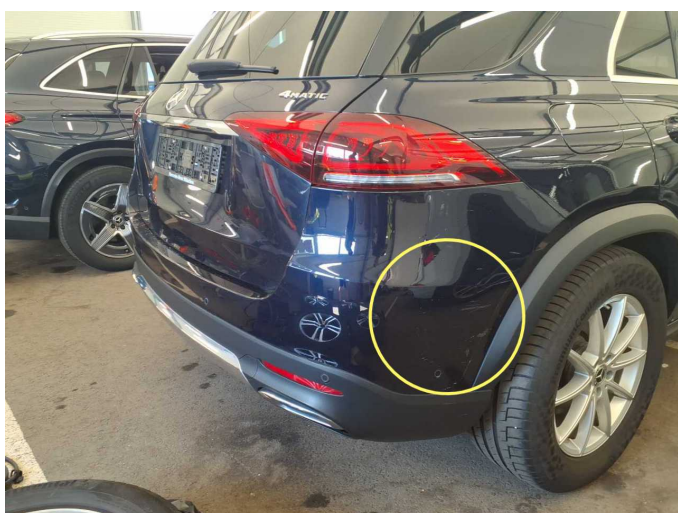
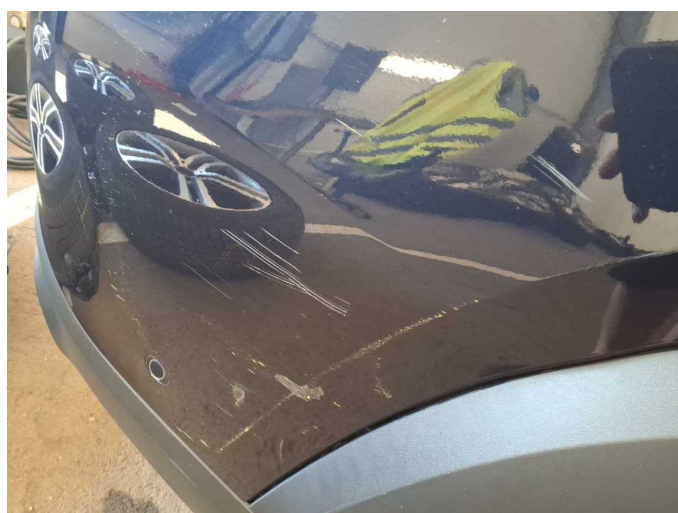
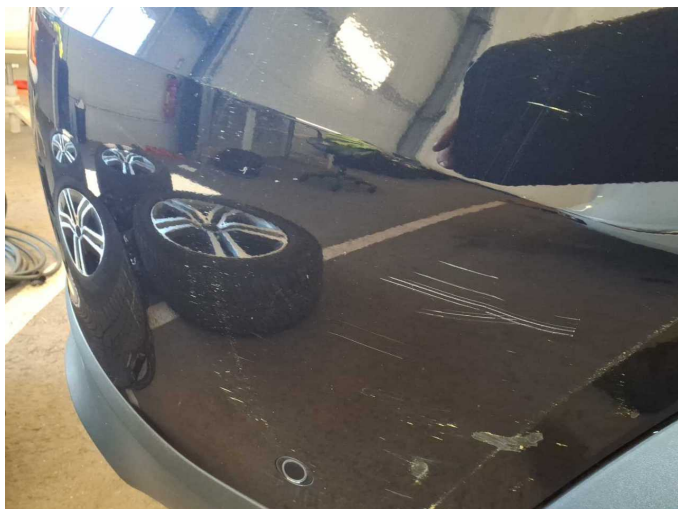
| No. | Component group | Description |
|---|---|---|
| 6 | Rear bumper | Rear bumper - Scratched - Repair and paint |

**Damage 6:** Rear bumper: Rear bumper - Scratched - Repair and paint

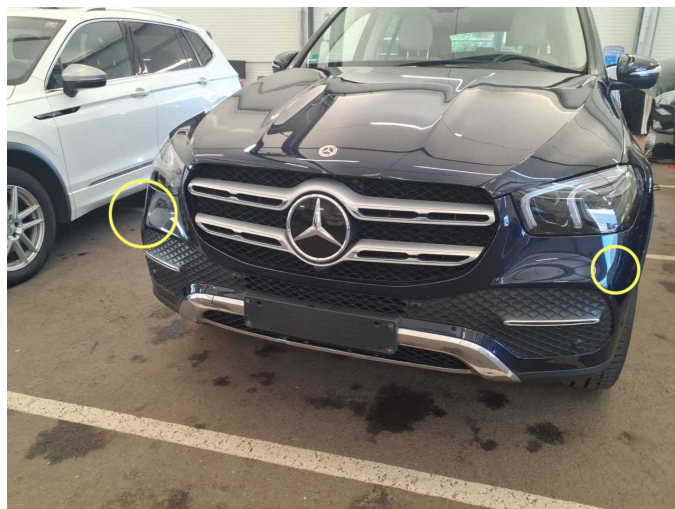
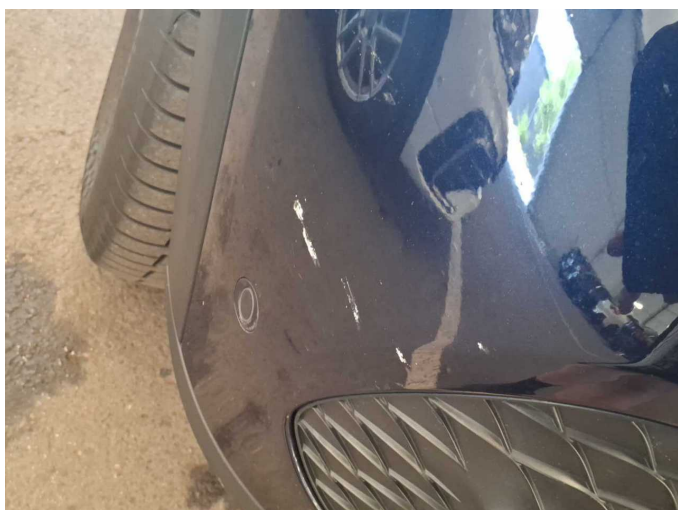
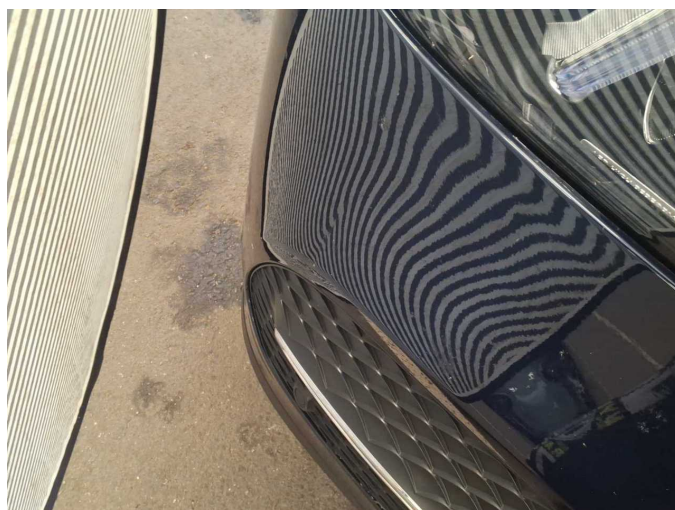
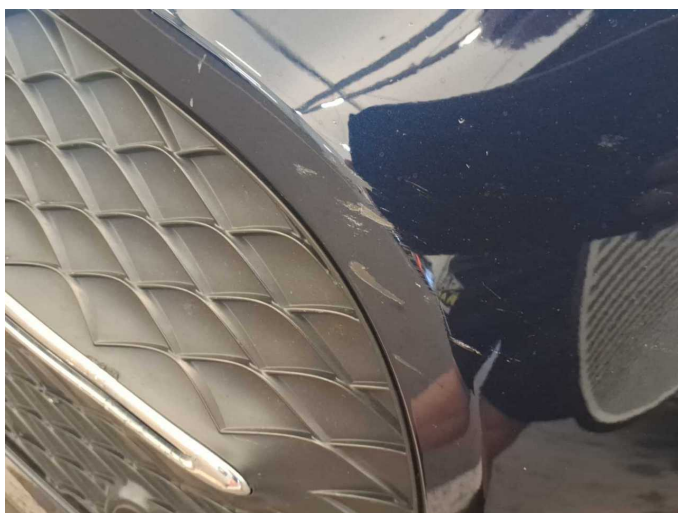
| No. | Component group | Description |
|---|---|---|
| 7 | Front bumper | Front bumper - Dent / paintcoat damage - Repair and paint |

**Damage 7:** Front bumper: Front bumper - Dent / paintcoat damage - Repair and paint
