Expertise

Protocol number: 46230075  
Order No. / Reference: 26584151  
Inspection date: 26 Jun 2026

Manufacturer: Volkswagen

Model: Golf Variant 2.0 TSI OPF DSG R-Line

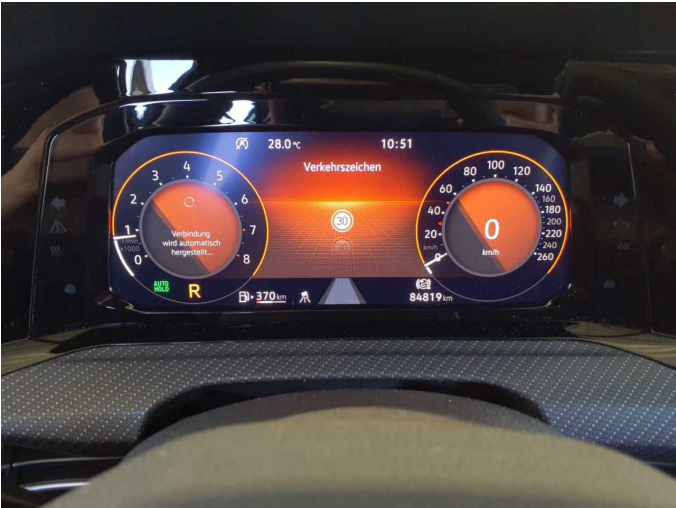
Figure 7: Instrument cluster

| Vehicle details | |
|---|---|
| Mileage (Read) | 84,819 km |

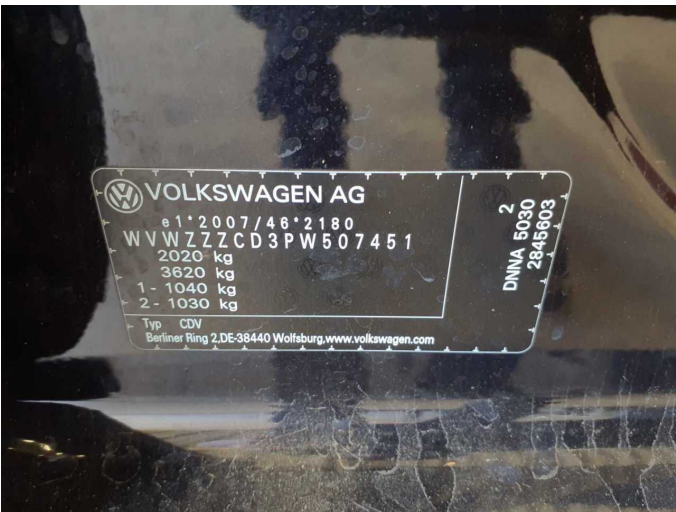
Figure 11: VIN

| VIN comparison | The vehicle identification number (VIN) was read from the vehicle and its conformity with the submitted documents was confirmed by the undersigned during the inspection. |

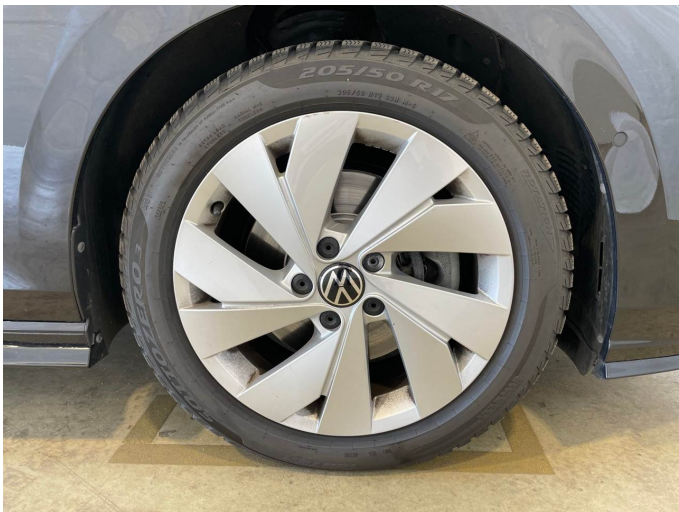
Figure 12: Mounted tyres

| Tyres | | | | |
|---|---|---|---|---|
| 1) | 205/50 R17 93H | Winter tyres on Light alloy | Pirelli | 5mm / 5mm |
| 2) | 205/50 R17 93H | Winter tyres on Light alloy | Bridgestone | 5mm / 5mm |

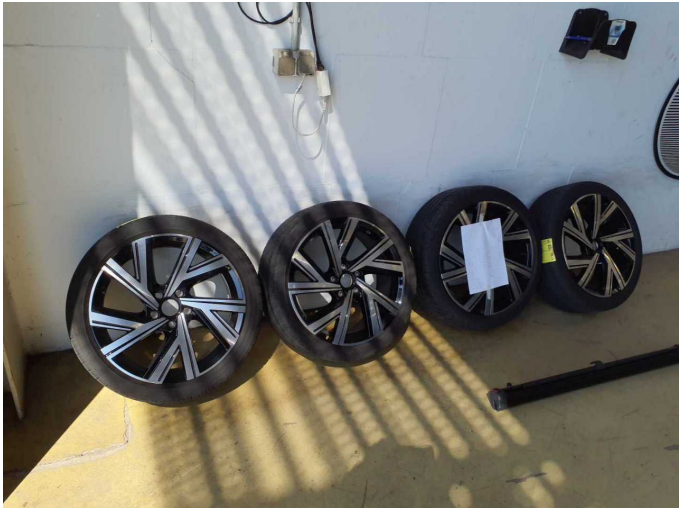
Figure 14: Additional tyres

| Tyres | | | | |
|---|---|---|---|---|
| 1) | 225/40 R18 92Y | Summer tyres on Light alloy | Bridgestone | 5mm / 4mm |
| 2) | 225/40 R18 92Y | Summer tyres on Light alloy | Bridgestone | 5mm / 6mm |

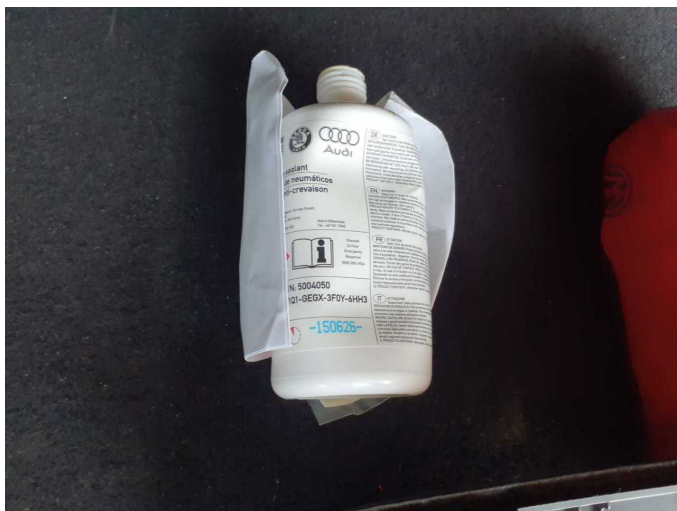
| No. | Component group | Description |
|---|---|---|
| 1 | Equipment | Tirefit filler - Expired - Replace |

Damage 1: Equipment: Tirefit filler - Expired - Replace

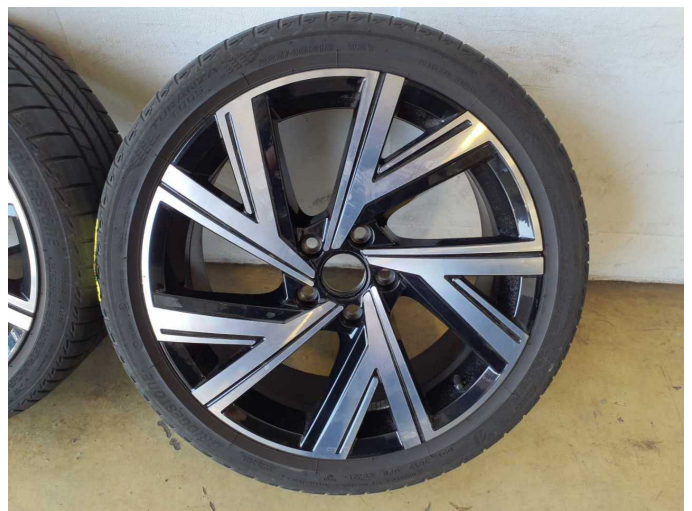
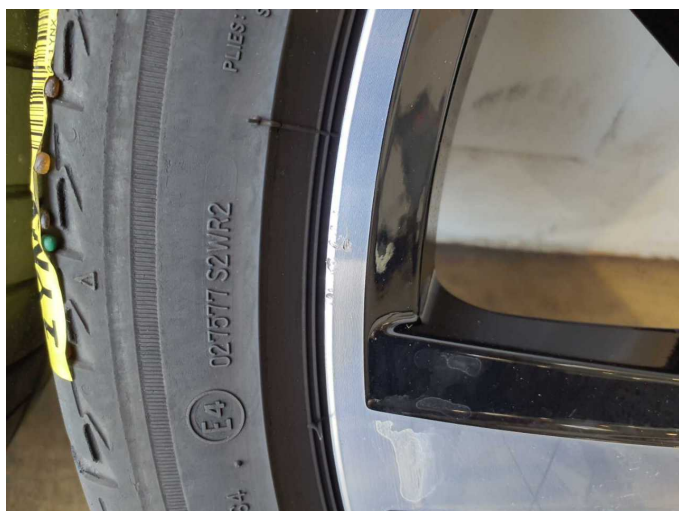
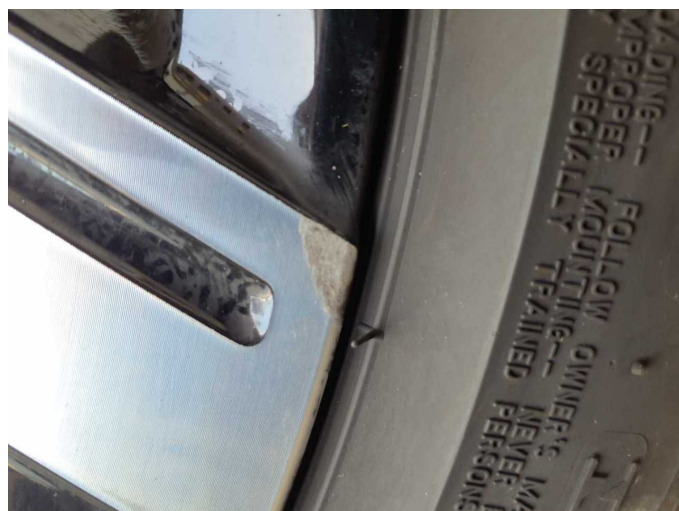
| No. | Component group | Description |
|---|---|---|
| 2 | 2nd wheel set | 1 alloy rim - Scratch(es) - Loss in value |

Damage 2: 2nd wheel set: 1 alloy rim - Scratch(es) - Loss in value

**Damage 2:** 2nd wheel set: 1 alloy rim - Scratch(es) - Loss in value

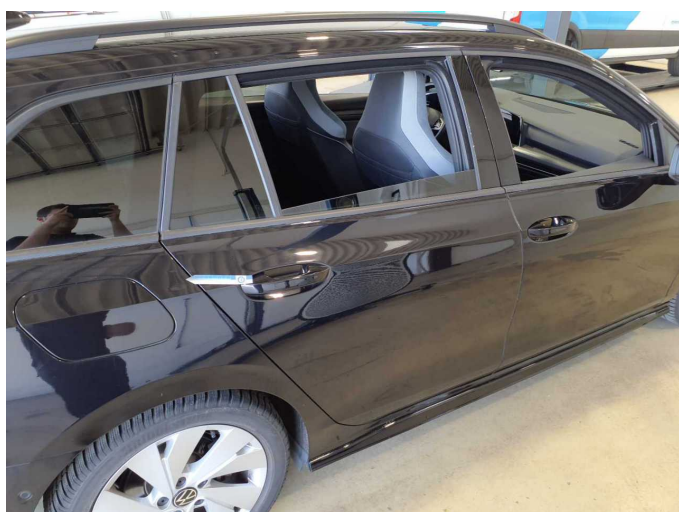
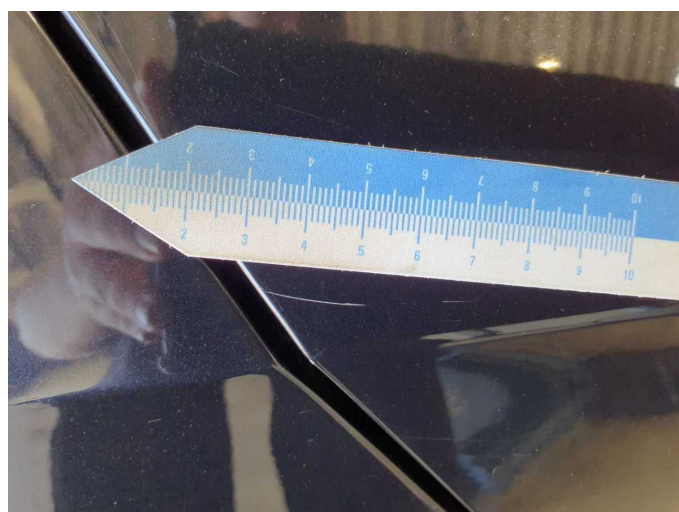
| No. | Component group | Description |
|---|---|---|
| 3 | Door - rear right side | Door - Scratch(es) - Smart repair |

**Damage 3:** Door - rear right side: Door - Scratch(es) - Smart repair

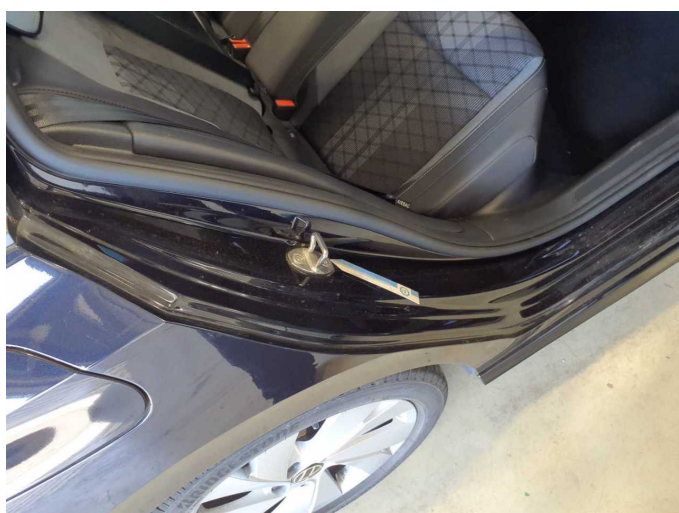
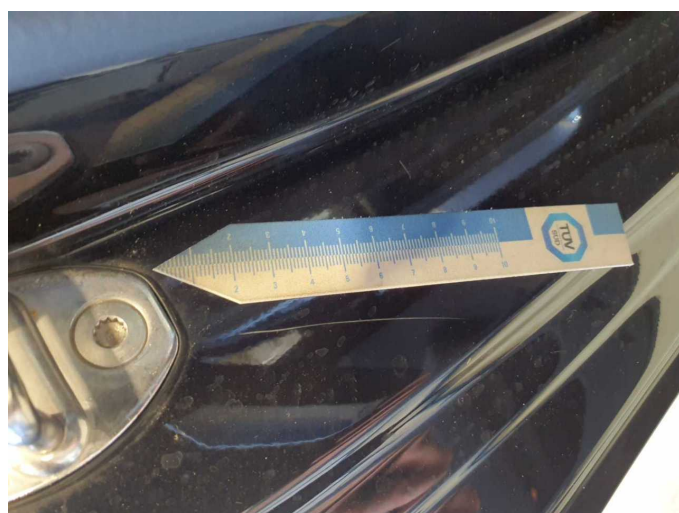
| No. | Component group | Description |
|---|---|---|
| 4 | Side panel - rear right side | Sill - Scratch(es) - Smart repair |

**Damage 4:** Side panel - rear right side: Sill - Scratch(es) - Smart repair

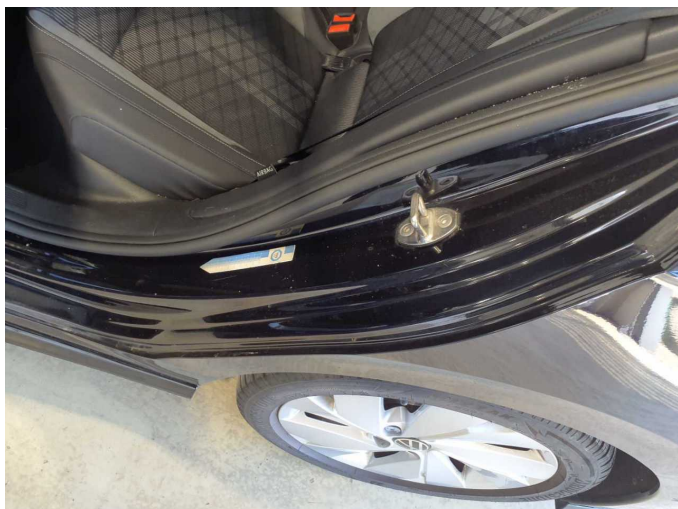
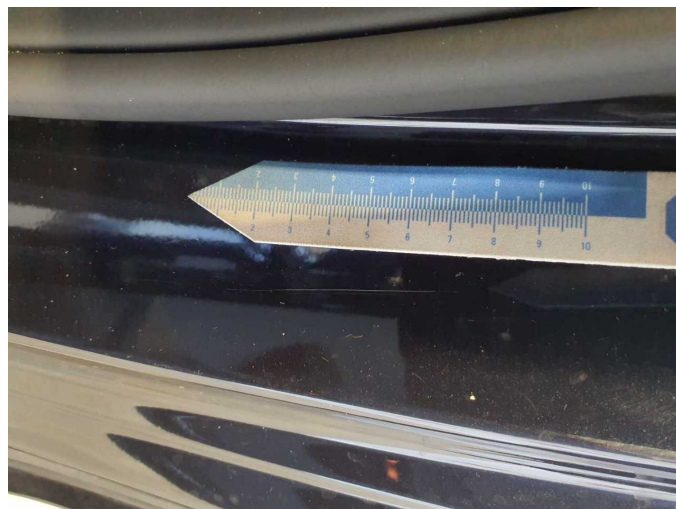
| No. | Component group | Description |
|---|---|---|
| 5 | Side panel - rear left side | Sill - Scratch(es) - Smart repair |

**Damage 5:** Side panel - rear left side: Sill - Scratch(es) - Smart repair

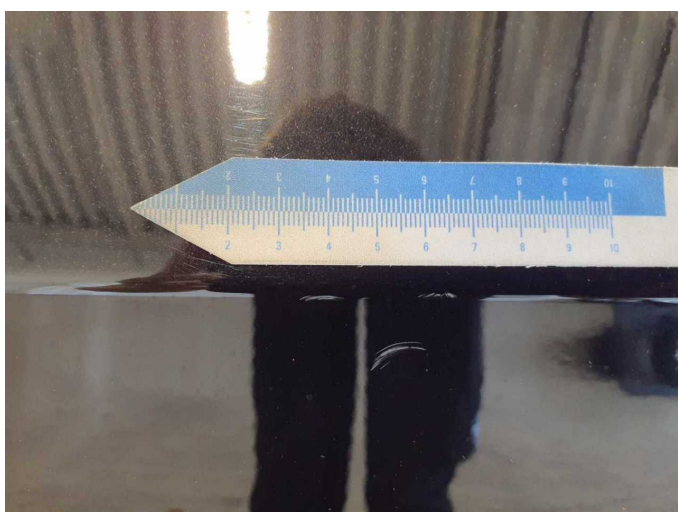
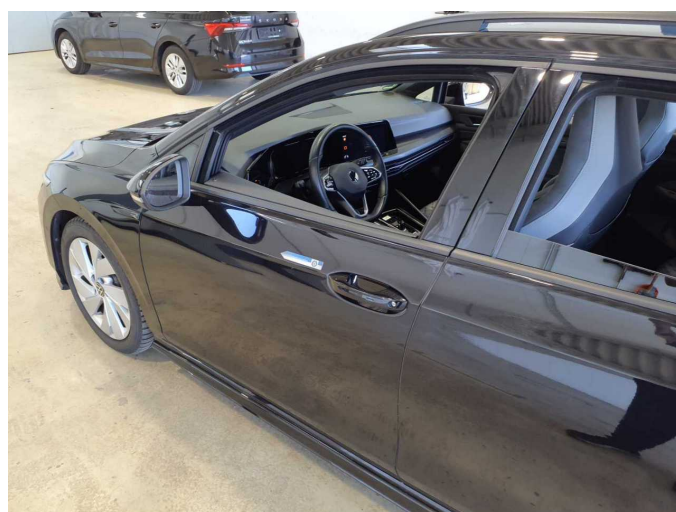
| No. | Component group | Description |
|---|---|---|
| 6 | Door - front left side | Door - Scratch(es) - Smart repair |

**Damage 6:** Door - front left side: Door - Scratch(es) - Smart repair

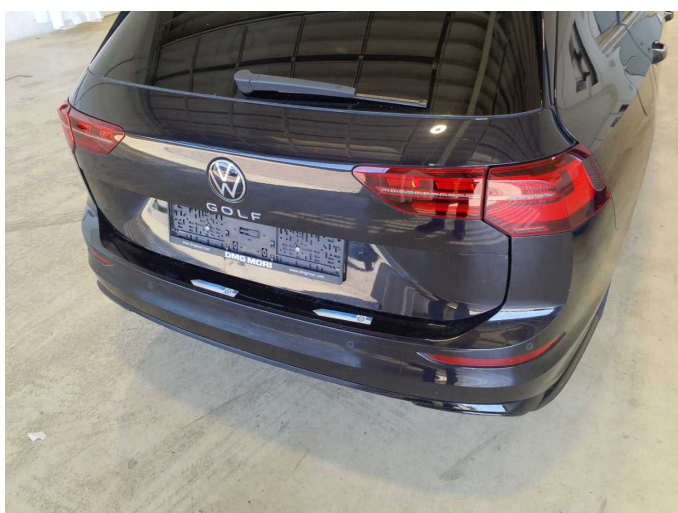
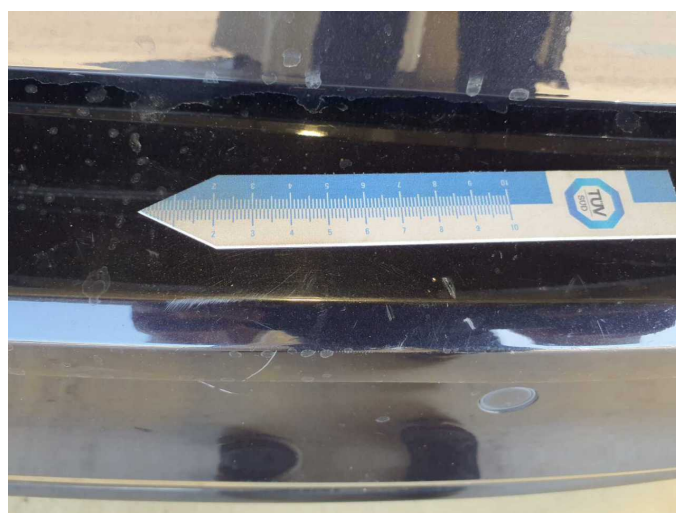
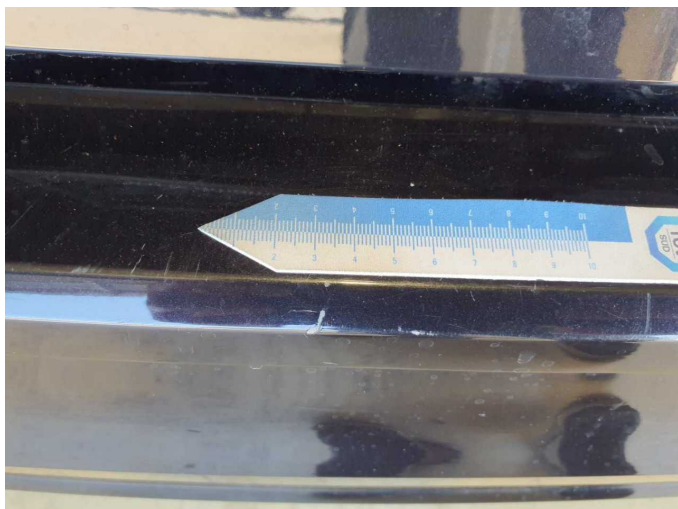
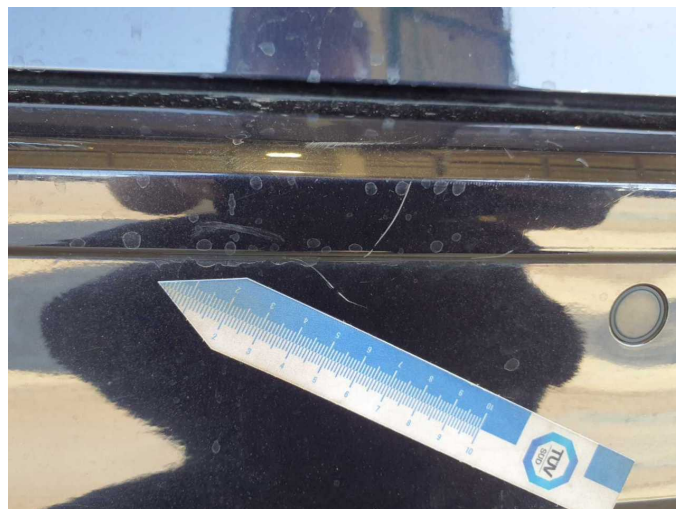
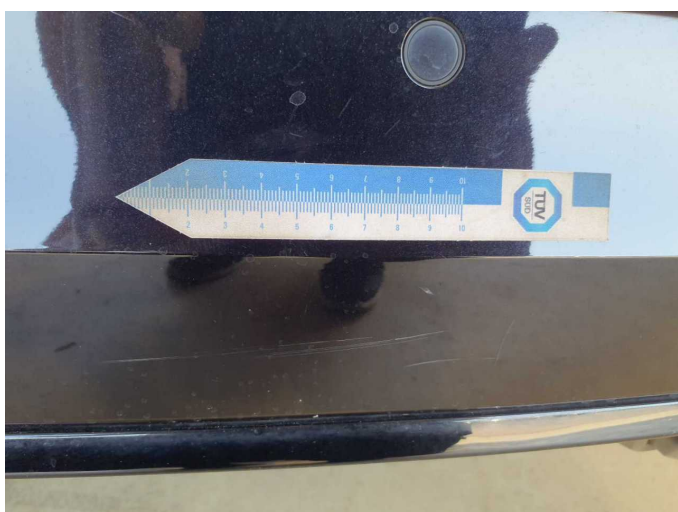
| No. | Component group | Description |
|---|---|---|
| 7 | Rear bumper | Rear bumper - Scratch(es) - Paint |

**Damage 7:** Rear bumper: Rear bumper - Scratch(es) - Paint

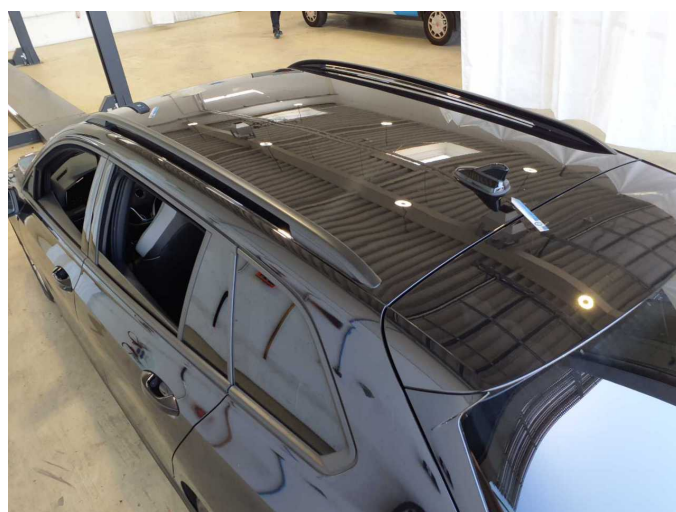
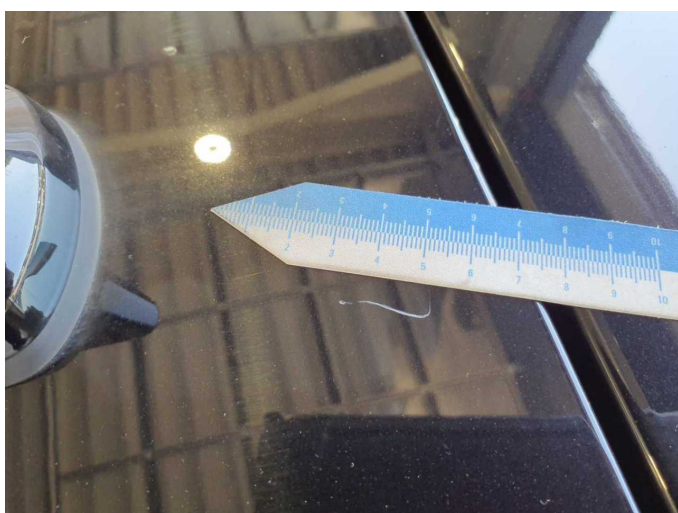
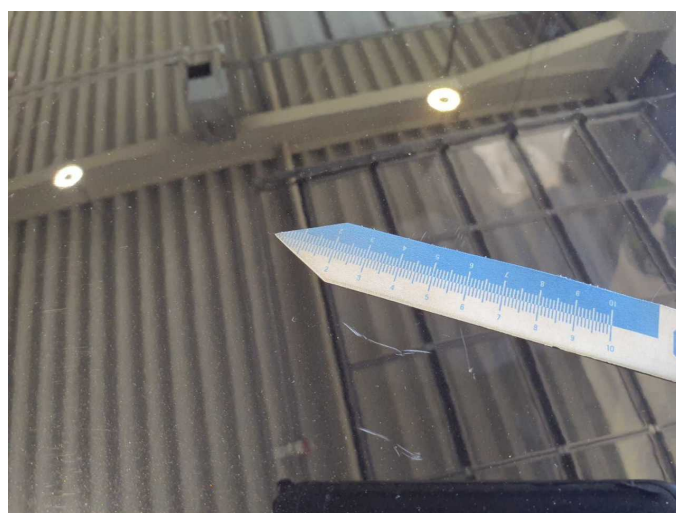
| No. | Component group | Description |
|---|---|---|
| 8 | Roof | Roof - Scratch(es) - Paint |

**Damage 8:** Roof: Roof - Scratch(es) - Paint
