Expertise

Protocol number: 46899689  
Order No. / Reference: 26611649  
Inspection date: 10 Jul 2026

Model: 3008 BlueHDi 130 Stop & Start EAT8 Allure Pack

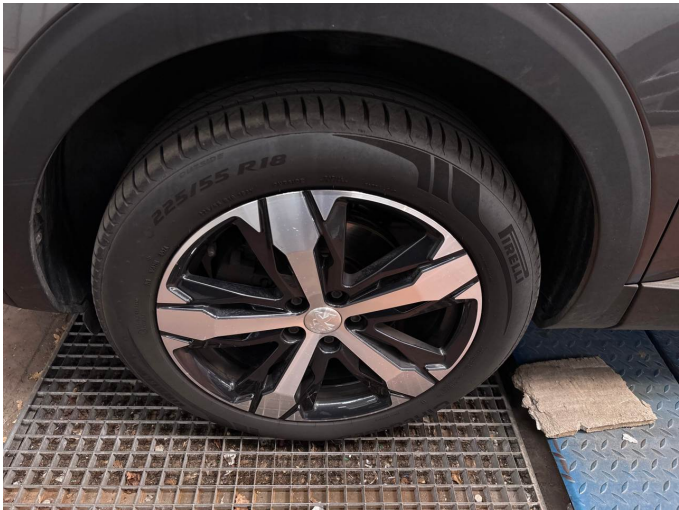
Figure 12: Mounted tyres

| # | Tyre size | Type of tyre | Manufacturer | Tread depth |
|---|---|---|---|---|
| 1) | 225/55 R18 102Y | Summer tyres on Light alloy | Pirelli | 3mm / 3mm |

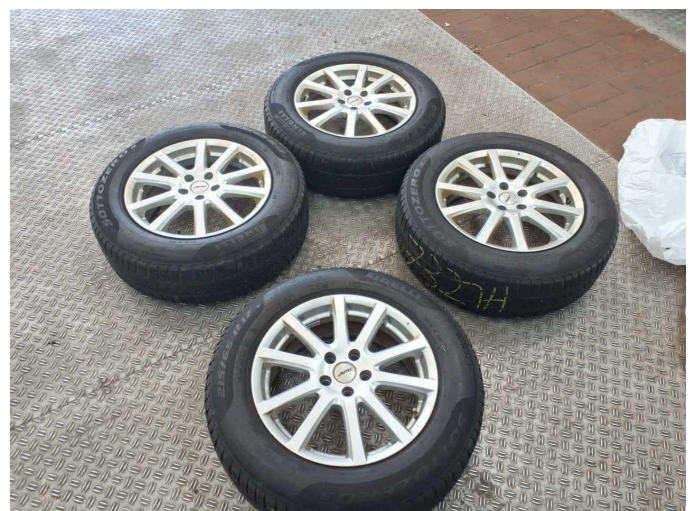
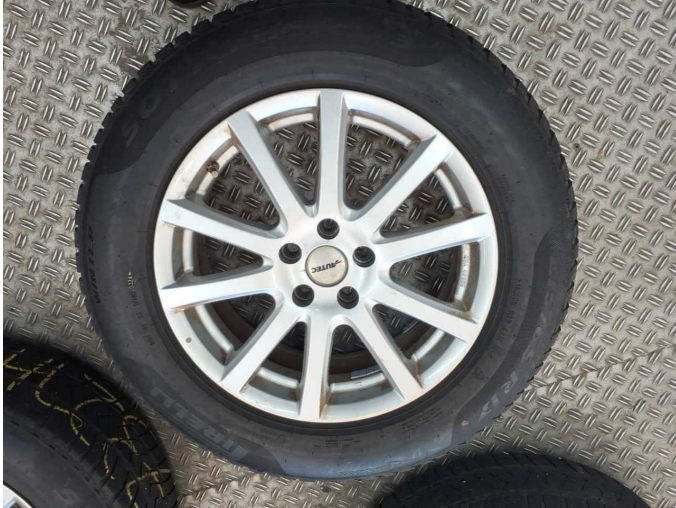
Figure 18: Additional tyres

| # | Tyre size | Type of tyre | Manufacturer | Tread depth |
|---|---|---|---|---|
| 1) | 215/65 R17 99H | Winter tyres on Light alloy | Pirelli | 4mm / 4mm |

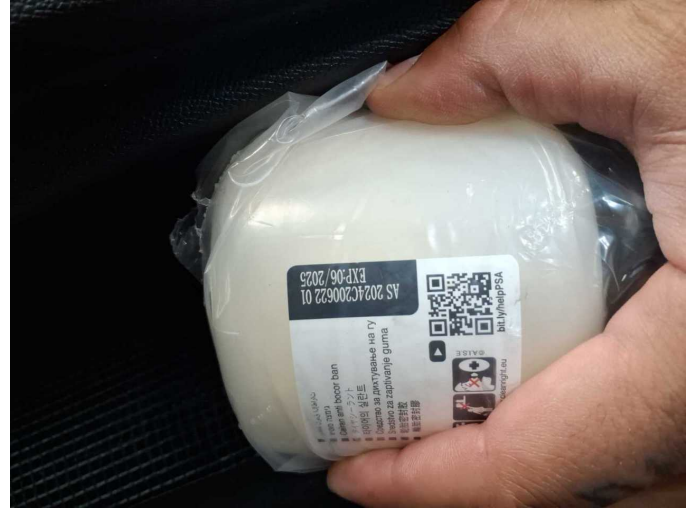
**Damage 1:** Equipment: Tirefit filler - Expired - Replace

| No. | Component group | Description |
|---|---|---|
| 1 | Equipment | Tirefit filler - Expired - Replace |

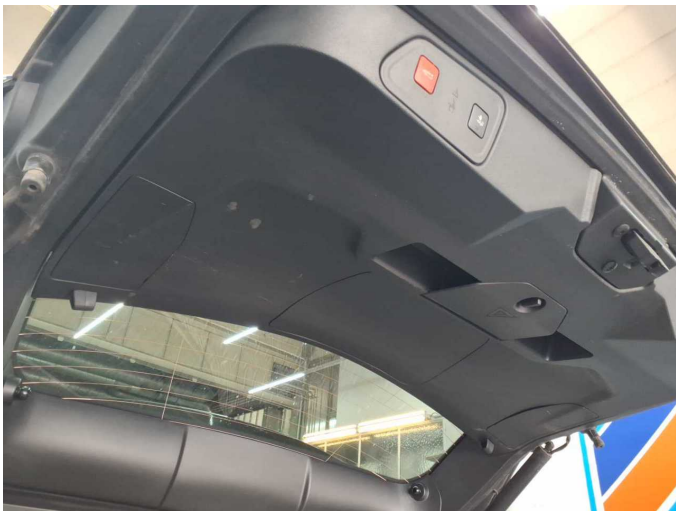
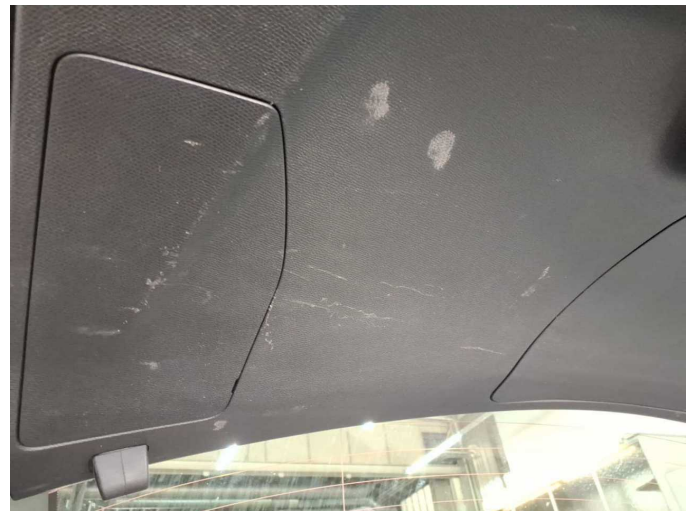
**Damage 2:** Trim / covers: Boot lining - Scratch(es) - Loss in value

| No. | Component group | Description |
|---|---|---|
| 2 | Trim / covers | Boot lining - Scratch(es) - Loss in value |

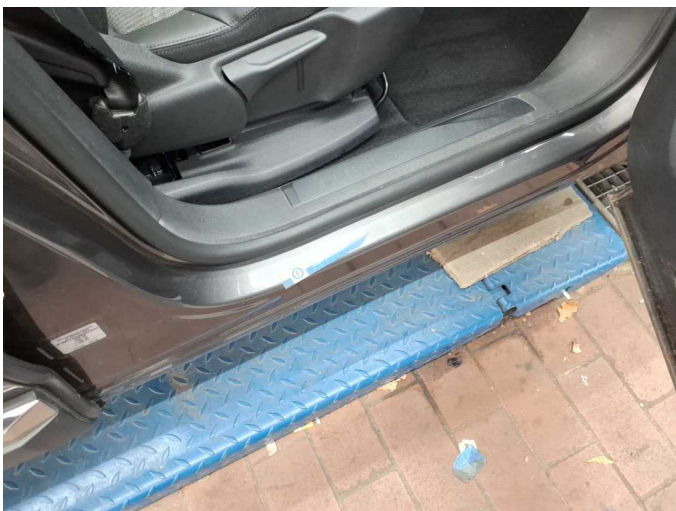
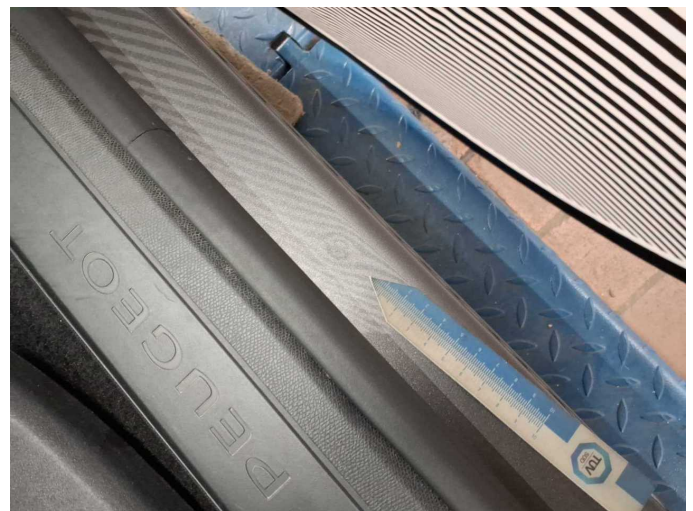
**Damage 3:** Sill - right side: Sill - dent(s) - Smooth repair work

| No. | Component group | Description |
|---|---|---|
| 3 | Sill - right side | Sill - dent(s) - Smooth repair work |

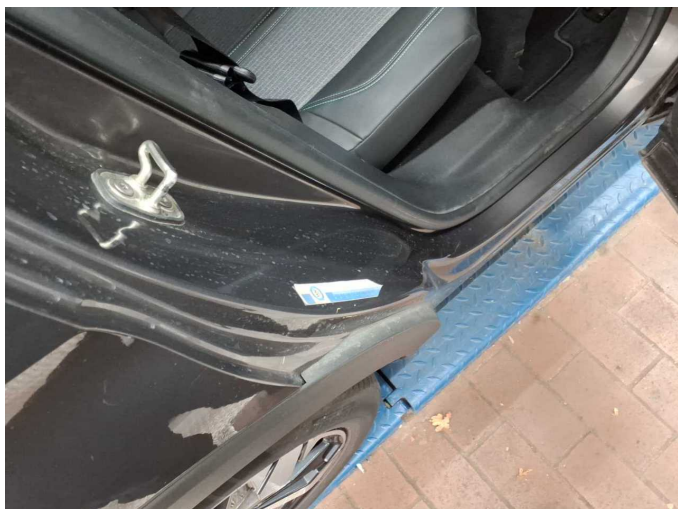
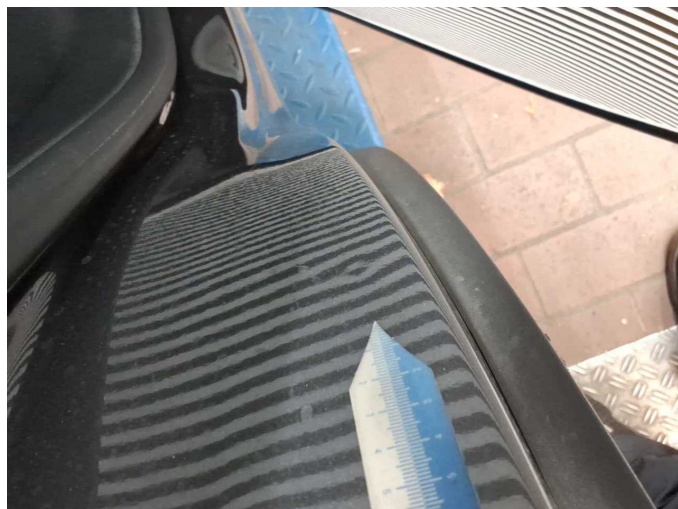
**Damage 4:** Side panel - rear right side: Sill - dent(s) - Smooth repair work

| No. | Component group | Description |
|---|---|---|
| 4 | Side panel - rear right side | Sill - dent(s) - Smooth repair work |

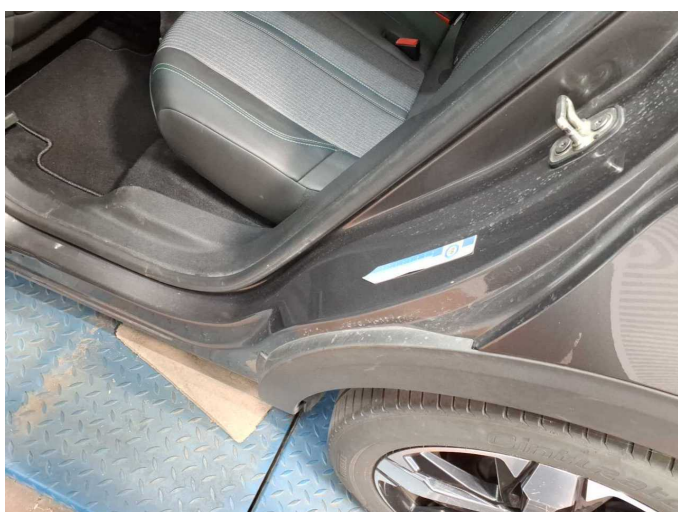
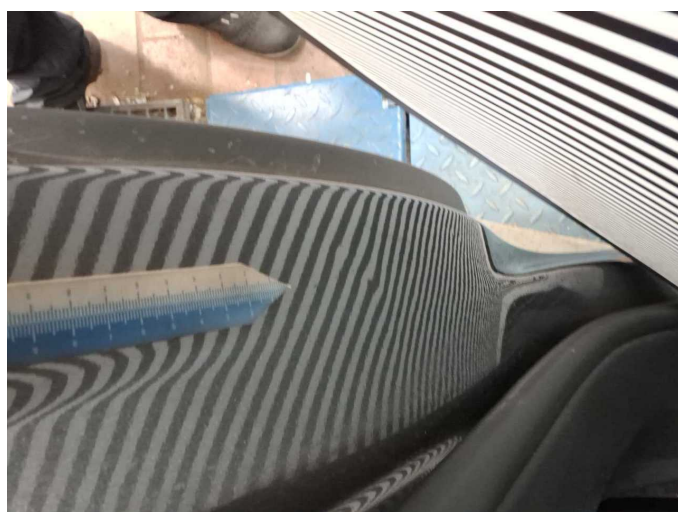
**Damage 5:** Side panel - rear left side: Sill - dent(s) - Smooth repair work

| No. | Component group | Description |
|---|---|---|
| 5 | Side panel - rear left side | Sill - dent(s) - Smooth repair work |

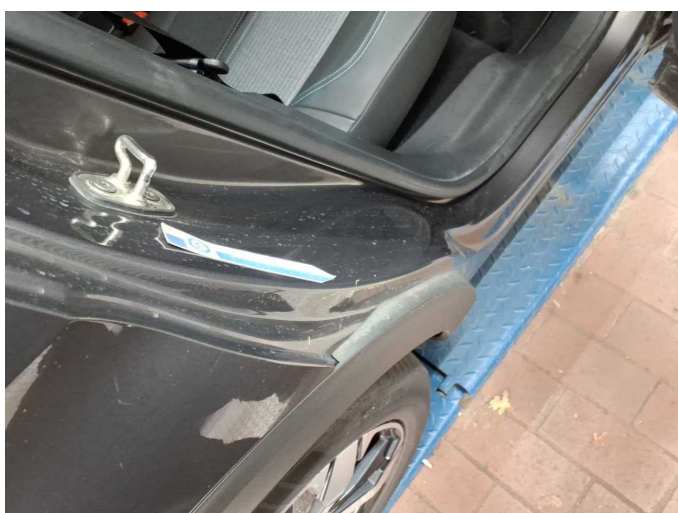
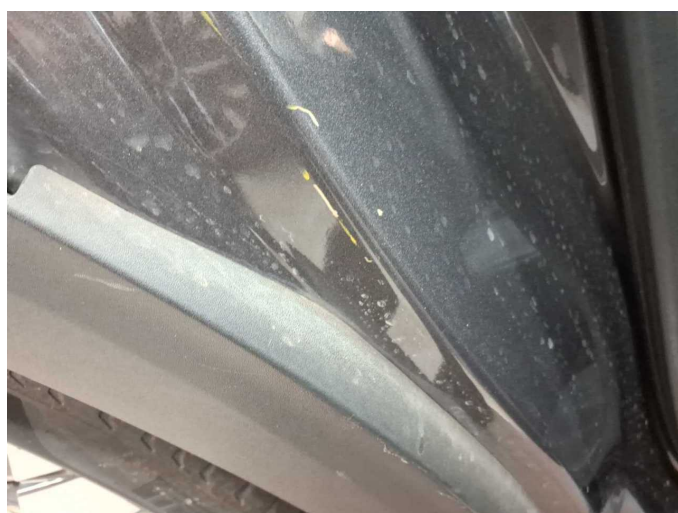
**Damage 6:** Side panel - rear right side: Sill - Scratch(es) - Smart repair

| No. | Component group | Description |
|---|---|---|
| 6 | Side panel - rear right side | Sill - Scratch(es) - Smart repair |

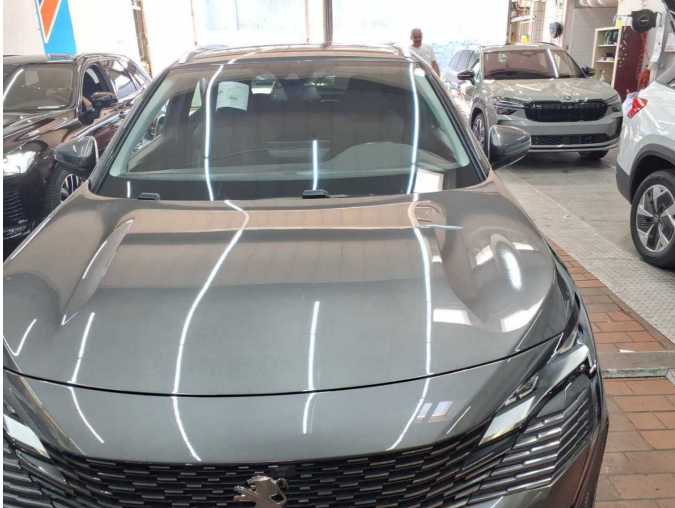
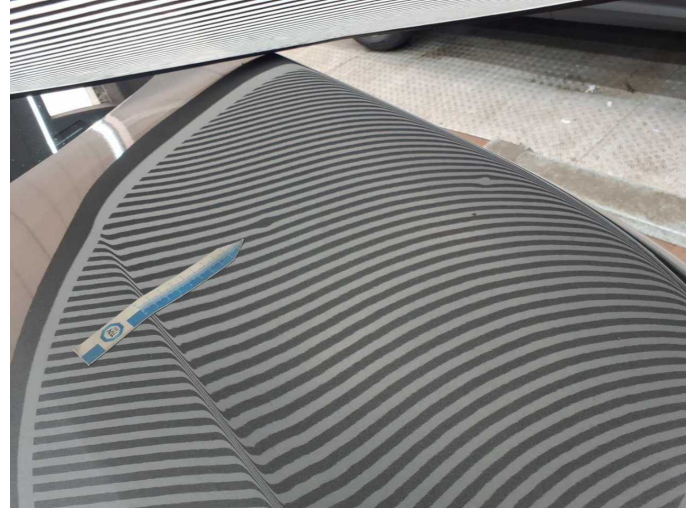
**Damage 7: Bonnet: Bonnet - dent(s) - Smooth repair work**

| No. | Component group | Description |
|---|---|---|
| 7 | Bonnet | Bonnet - dent(s) - Smooth repair work |

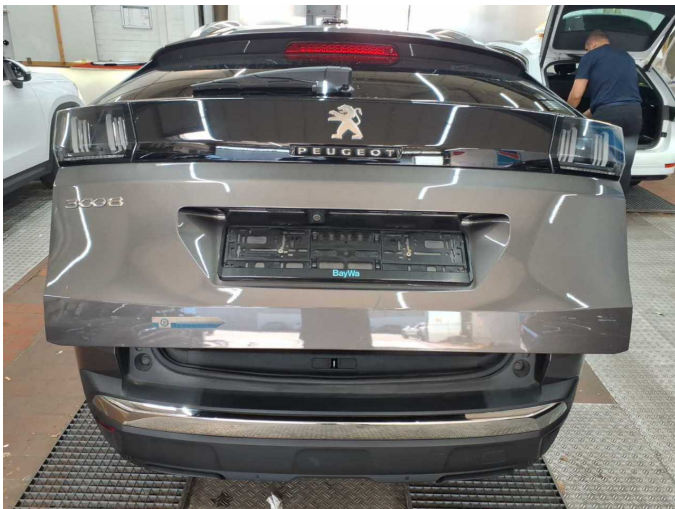
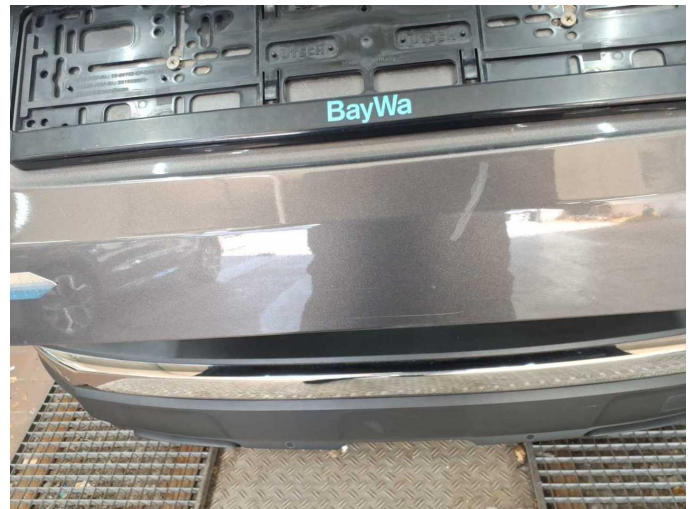
**Damage 8: Boot lid / rear door: Boot lid - Scratch(es) - Smart repair**

| No. | Component group | Description |
|---|---|---|
| 8 | Boot lid / rear door | Boot lid - Scratch(es) - Smart repair |

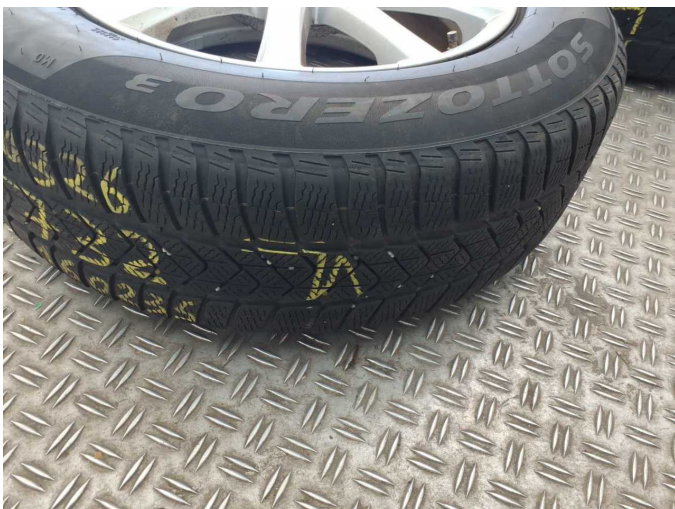
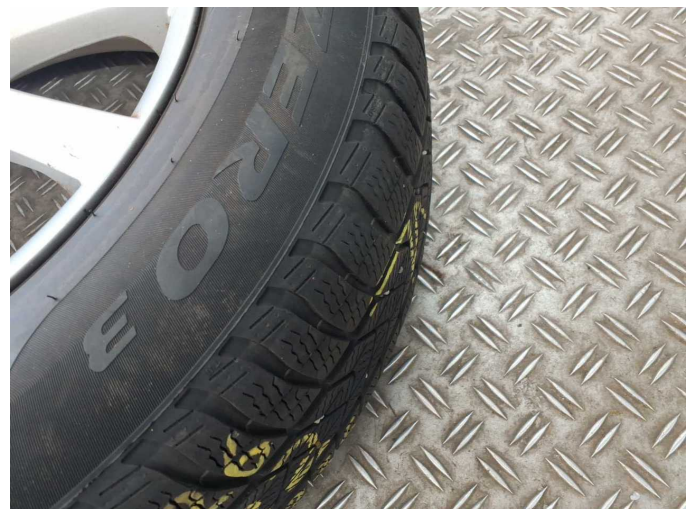
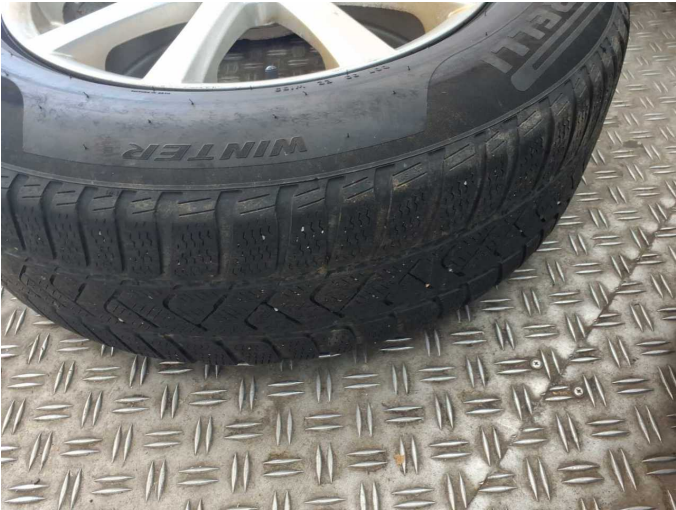
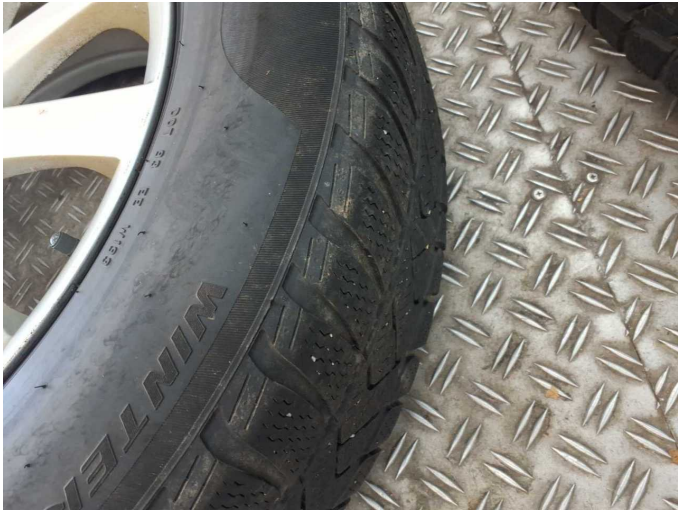
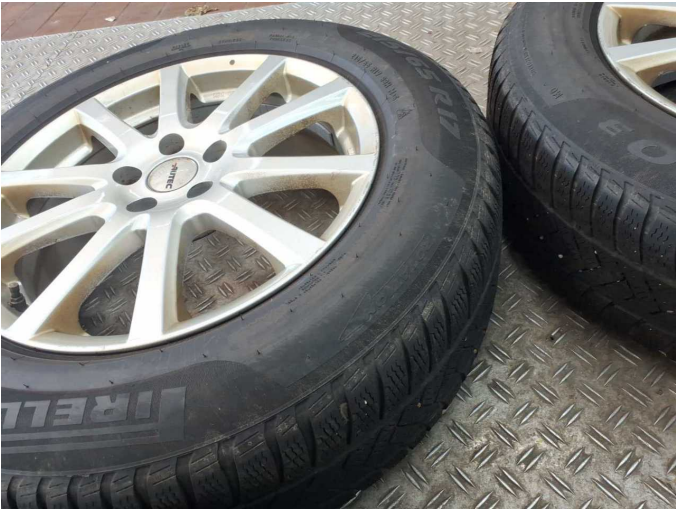
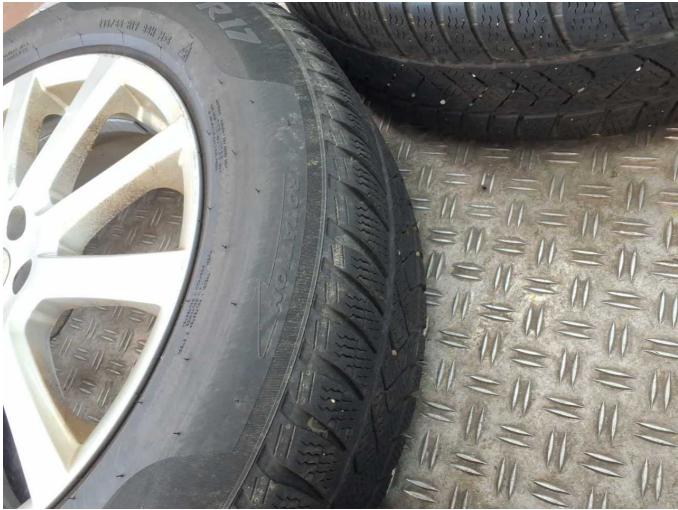
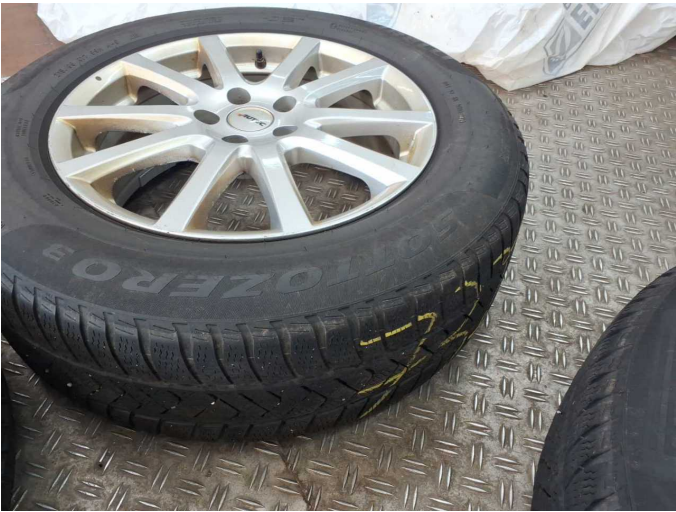
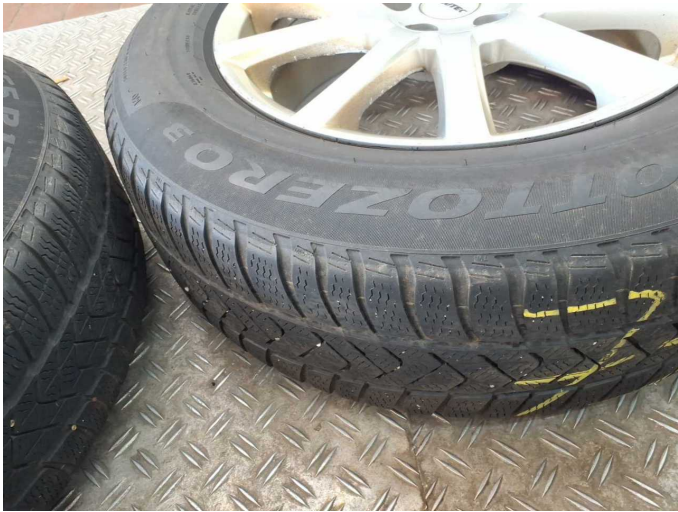
| No. | Component group | Description |
|---|---|---|
| 1 | 2nd wheel set | 2nd wheel set (4mm) - Abrasion - No deduction |

**Wear and tear 1: 2nd wheel set: 2nd wheel set (4mm) - Abrasion - No deduction**

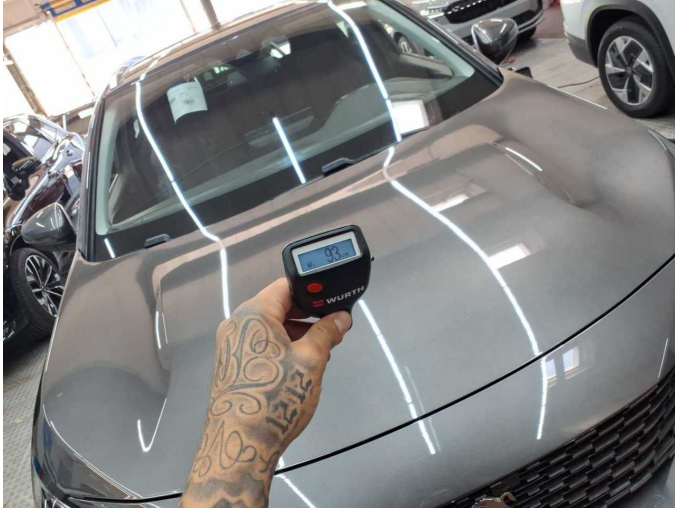
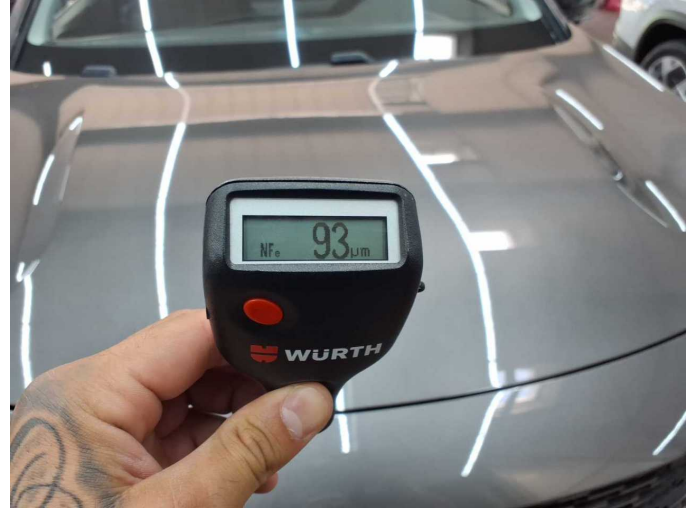
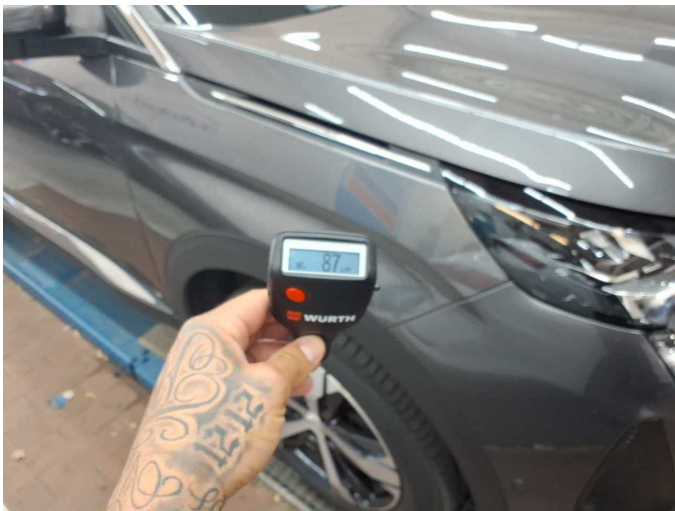
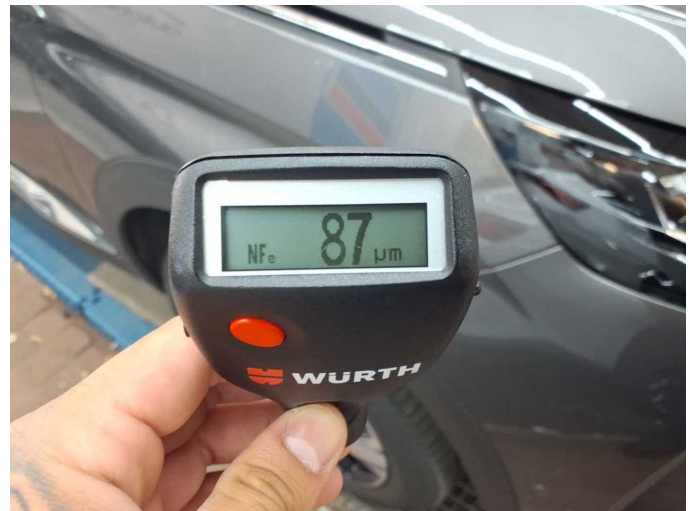
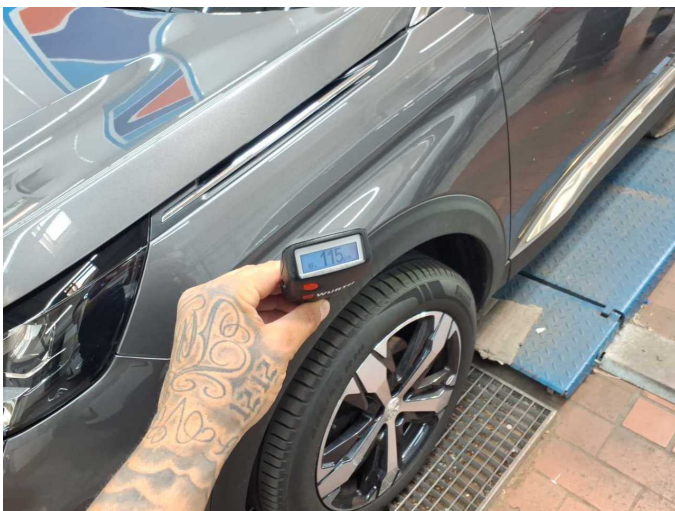
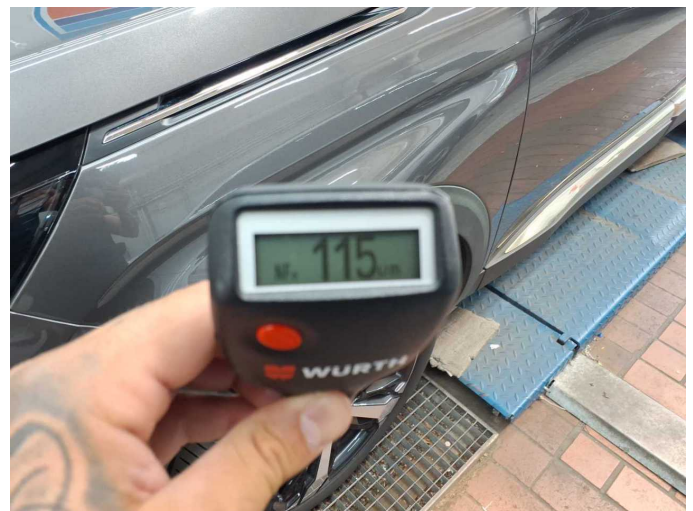
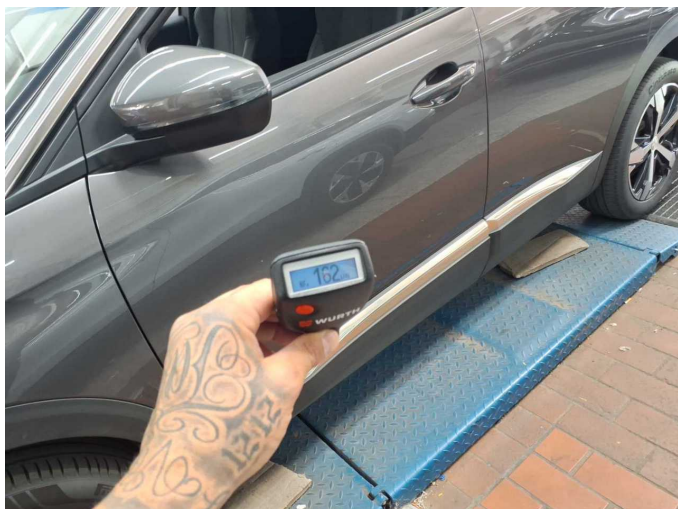
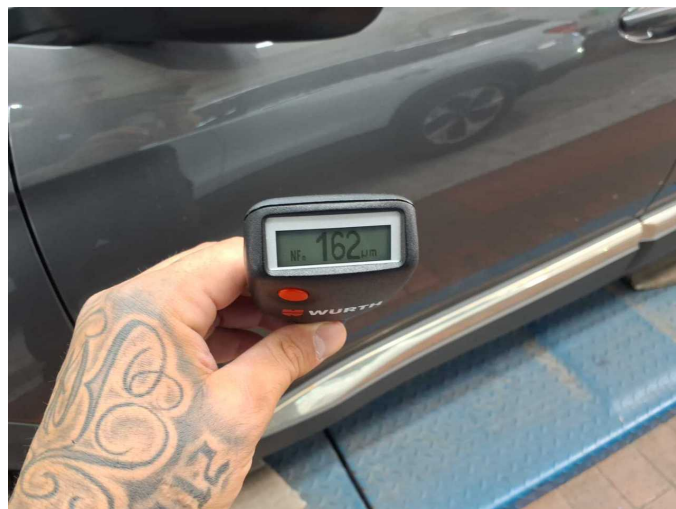
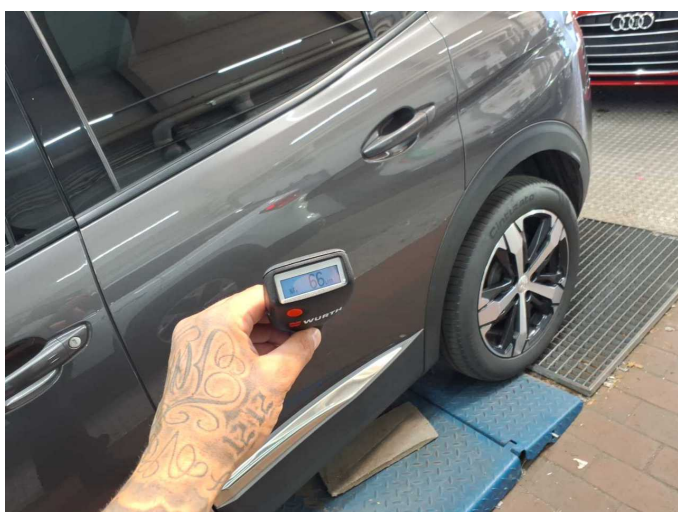
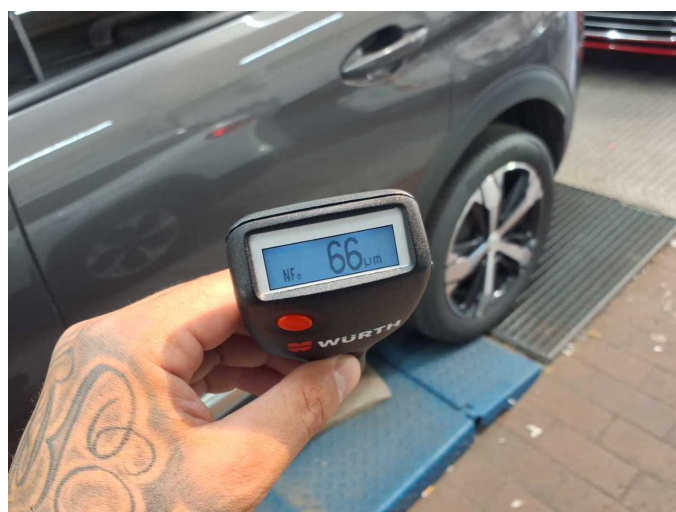
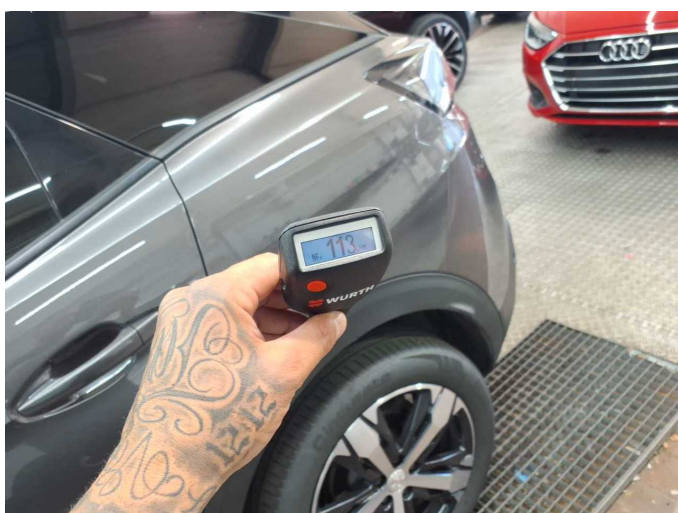
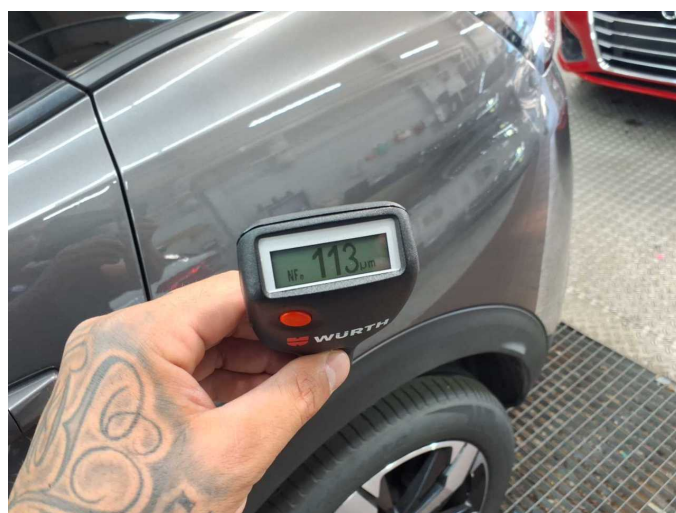
| No. | Previous damage | Extent of damage (Net) |
|---|---|---|
| 2 | Front, Side - left, Provided by user / customer, from 30 Oct 2025 | 8.746,76 € |

According to available information previous damages were repaired at the vehicle. Traces of repairs, which allow conclusions about the area of repair, were not recognizable during the inspection.

**Previous damage 2: Front, Side - left**

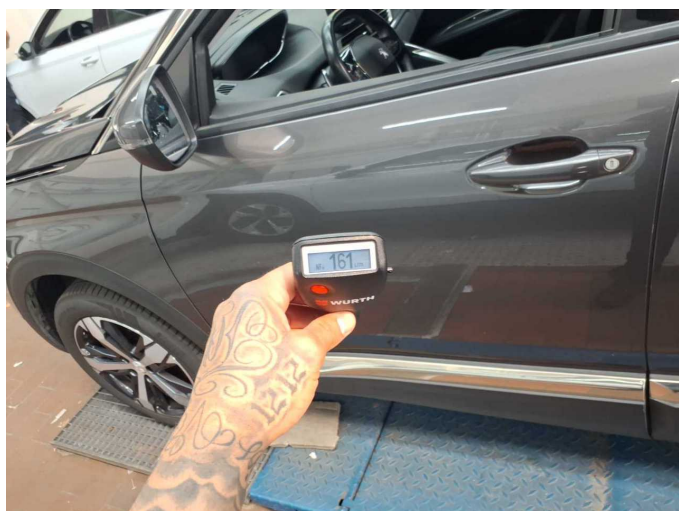
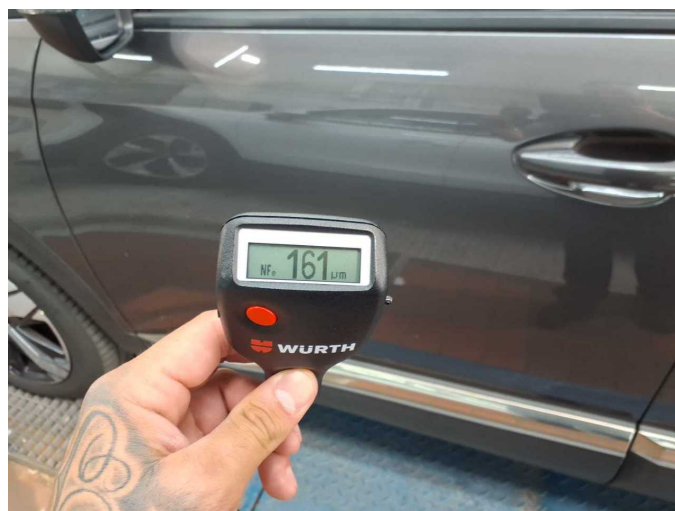
| No. | Repainting |
|---|---|
| 1 | Door - front left side, Professionally carried out |

| Door - front left side | 161 µm |

**Repainting 1:** Door - front left side
