Expertise

Protocol number: 45599365
Order No. / Reference: 26256579
Inspection date: 22 May 2026

Model: Touareg 3.0 V6 TDI 4Motion DPF Aut. R-Line

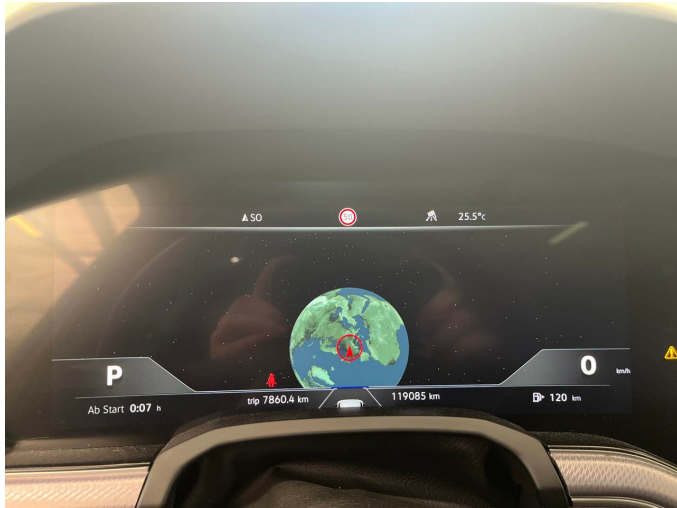
Figure 7: Instrument cluster

Mileage (Read) 119,085 km

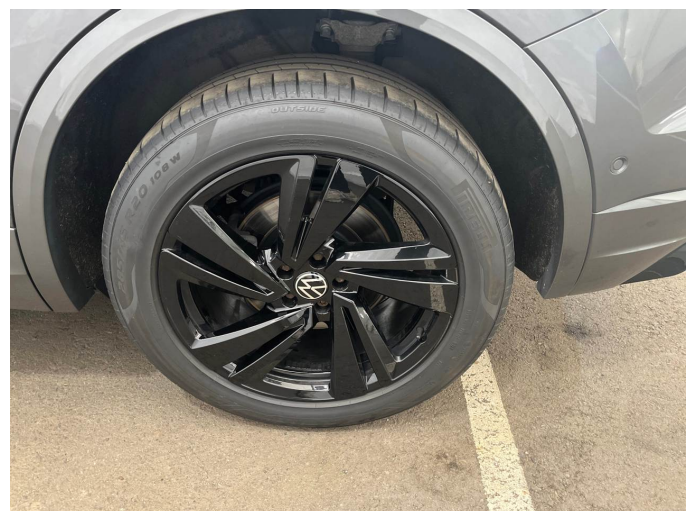
#	Tyre size	Type of tyre	Manufacturer	Tread depth
1)	285/45 R20 108W	Summer tyres on Light alloy	Pirelli	6mm / 6mm
2)	285/45 R20 108W	Summer tyres on Light alloy	Pirelli	6mm / 6mm

Figure 12: Mounted tyres

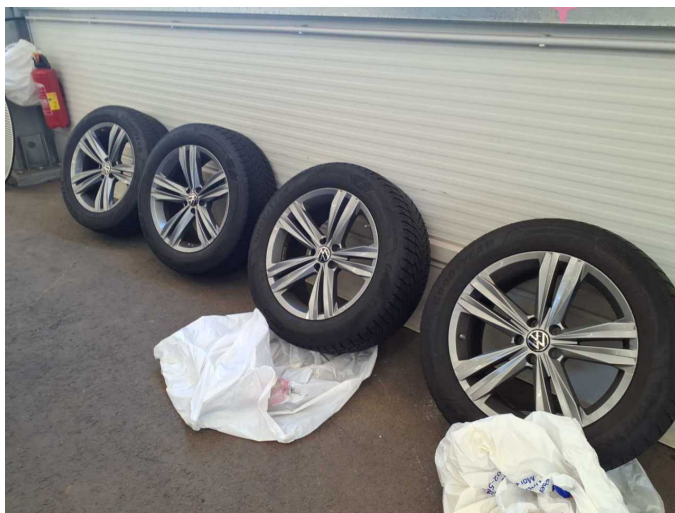
#	Tyre size	Type of tyre	Manufacturer	Tread depth
1)	225/55 R19 111V	Winter tyres on Light alloy	Goodyear	5mm / 5mm
2)	225/55 R19 111V	Winter tyres on Light alloy	Goodyear	5mm / 5mm

Figure 15: Additional tyres

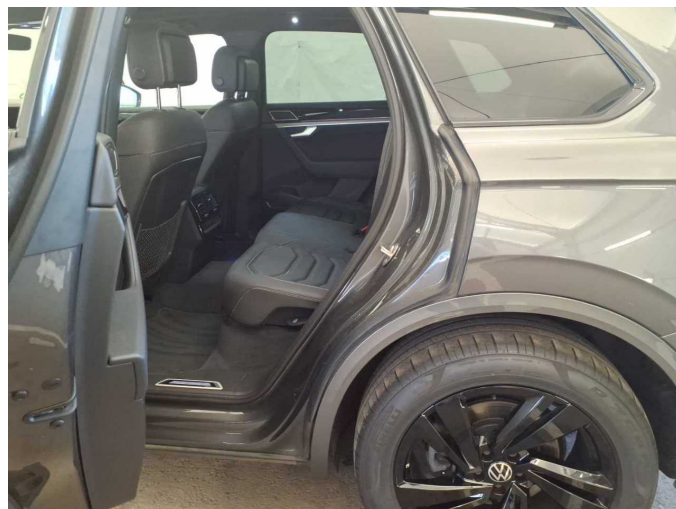
Damage 2: Side panel - rear left side: Sill - Scratch(es) - Smart repair
