Expertise

Manufacturer: Volkswagen

Model: Tiguan 2.0 TDI SCR DSG Life

VIN: WVGZZZCT5TW000063

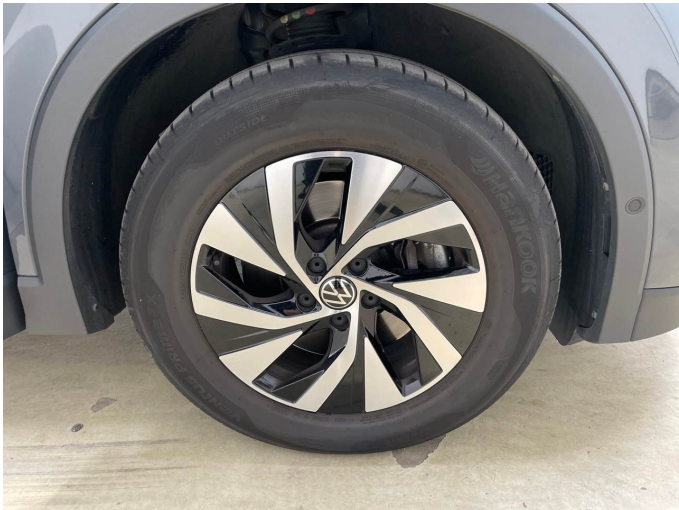
Figure 12: Mounted tyres

| # | Tyre size | Type of tyre | Manufacturer | Tread depth |
|---|---|---|---|---|
| 1) | 215/65 R17 99V | Summer tyres on Light alloy | Hankook | 5mm / 5mm |
| 2) | 215/65 R17 99V | Summer tyres on Light alloy | Hankook | 5mm / 5mm |

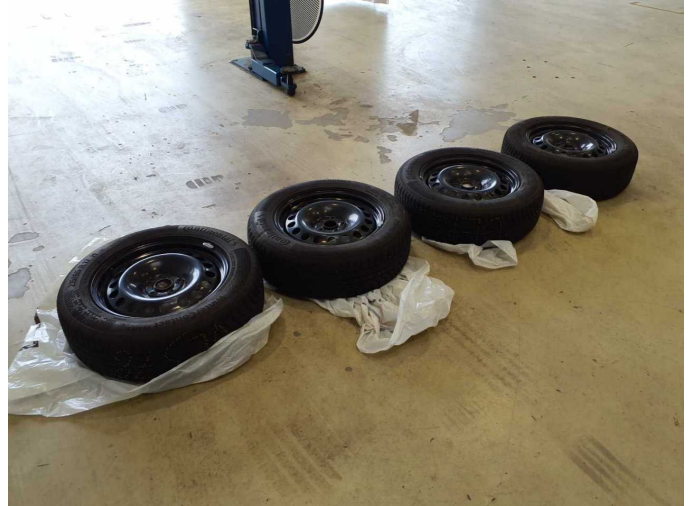
Figure 14: Additional tyres

| # | Tyre size | Type of tyre | Manufacturer | Tread depth |
|---|---|---|---|---|
| 1) | 215/65 R17 99H | Winter tyres on Steel | Continental | 6mm / 6mm |

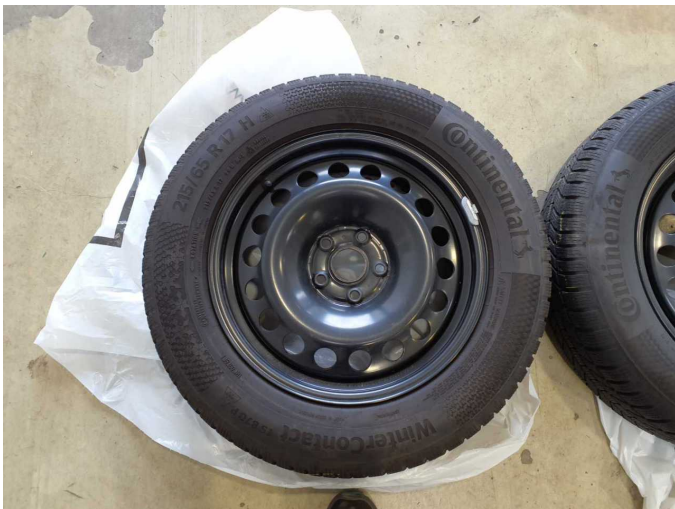
Figure 15: Additional tyres

| # | Tyre size | Type of tyre | Manufacturer | Tread depth |
|---|---|---|---|---|
| 2) | 215/65 R17 99H | Winter tyres on Steel | Continental | 6mm / 6mm |

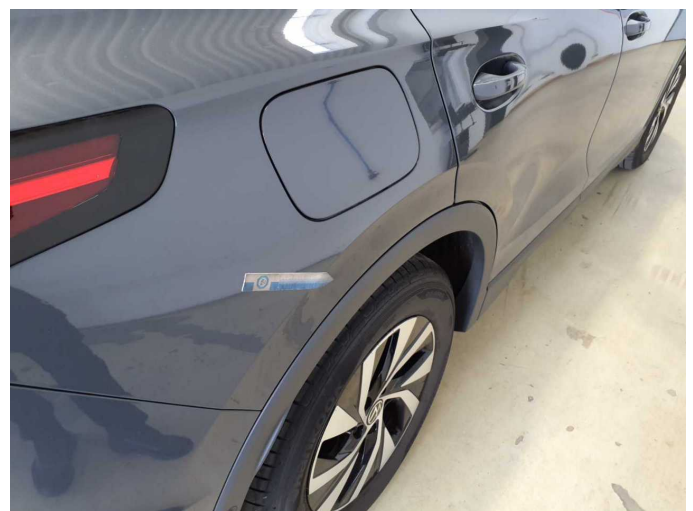
Damage 1: Side panel - rear right side: Side panel - dent(s) - Smooth repair work

| No. | Component group | Description |
|---|---|---|
| 1 | Side panel - rear right side | Side panel - dent(s) - Smooth repair work |

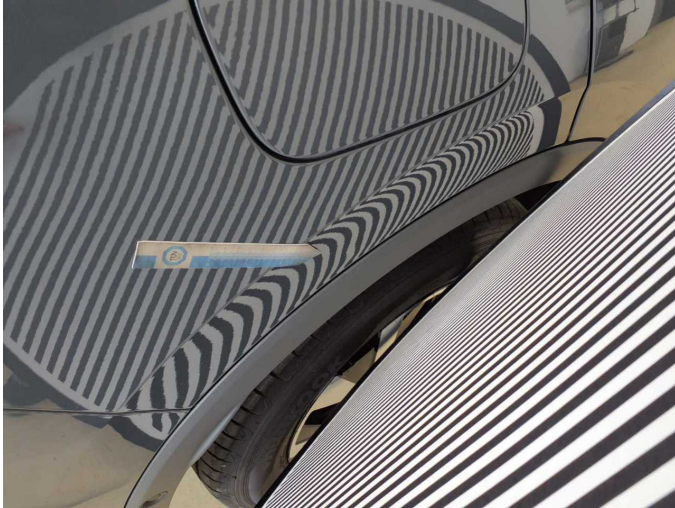
**Damage 1:** Side panel - rear right side: Side panel - dent(s) - Smooth repair work

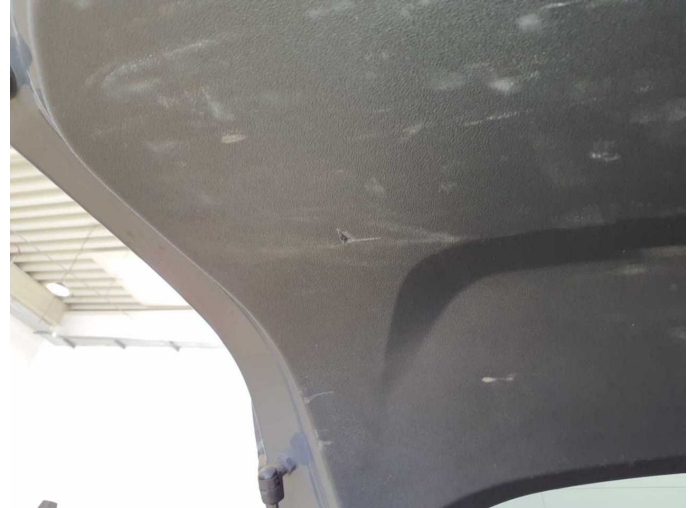
**Damage 2:** Trim / covers: Boot lid - interior trim - Scratch(es) - Replace

| No. | Component group | Description |
|---|---|---|
| 2 | Trim / covers | Boot lid - interior trim - Scratch(es) - Replace |

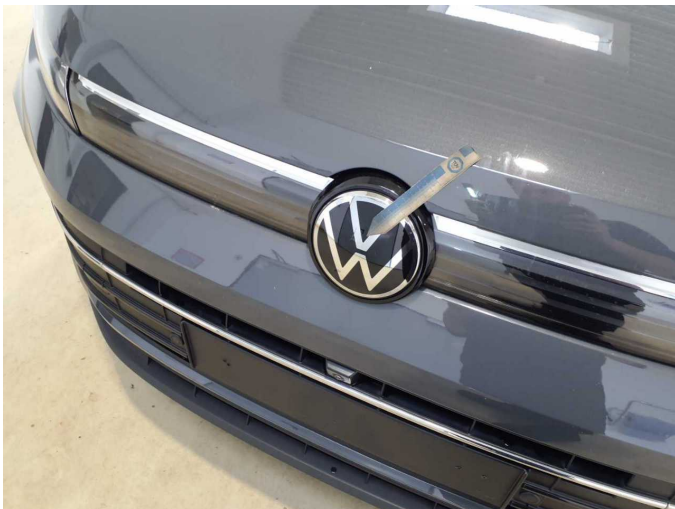
**Damage 3:** Front structure: Emblem - Stone chips - Replace

| No. | Component group | Description |
|---|---|---|
| 3 | Front structure | Emblem - Stone chips - Replace |

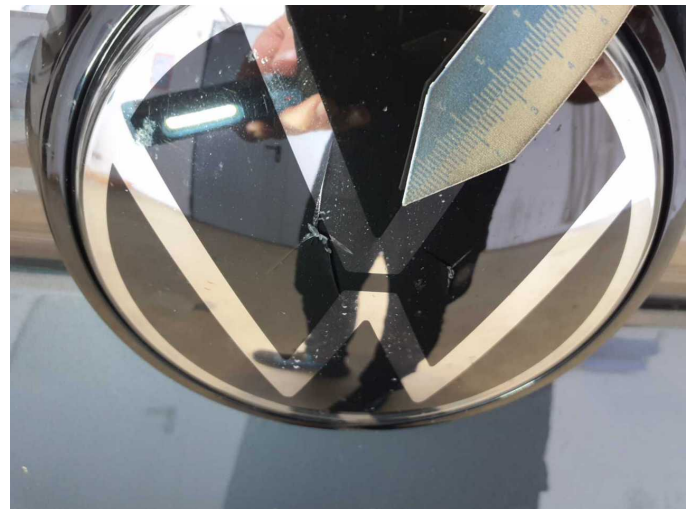
**Damage 3:** Front structure: Emblem - Stone chips - Replace
