## Expertise

Protocol number: 45930317  
Order No. / Reference: 26412453  
Inspection date: 12 Jun 2026

Model: Focus Turnier 1.5 EcoBlue Start-Stopp-System Aut. TITANIUM

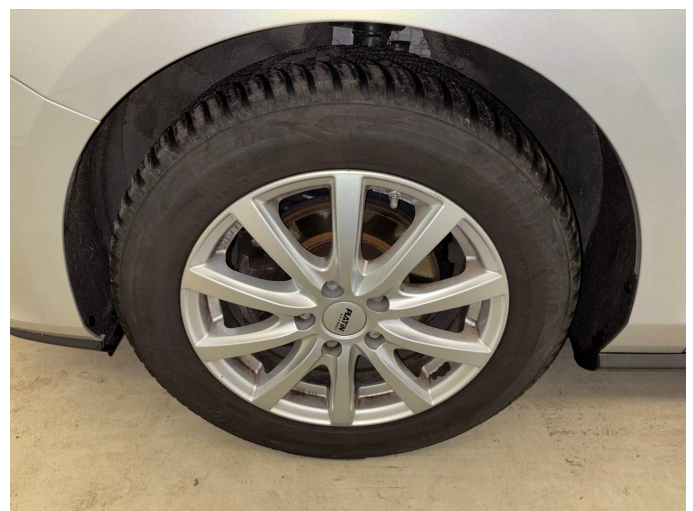
#	Tyre size	Type of tyre	Manufacturer	Tread depth
1)	205/60 R16 92H	Winter tyres on Light alloy	Bridgestone	5mm / 5mm
2)	205/60 R16 92H	Winter tyres on Light alloy	Bridgestone	5mm / 5mm

Figure 12: Mounted tyres

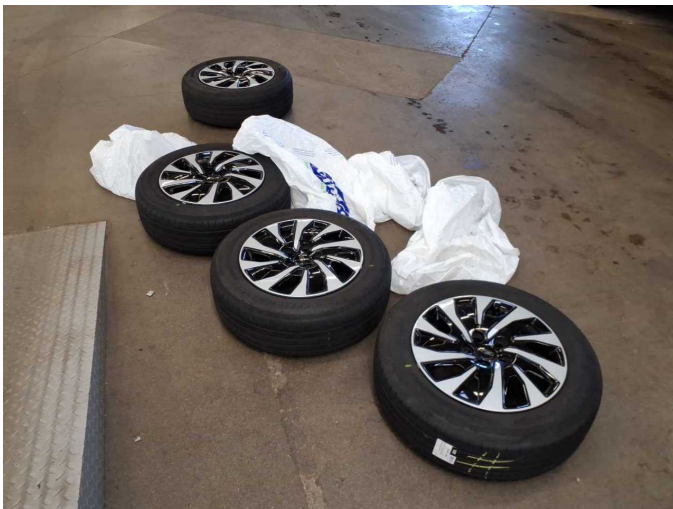
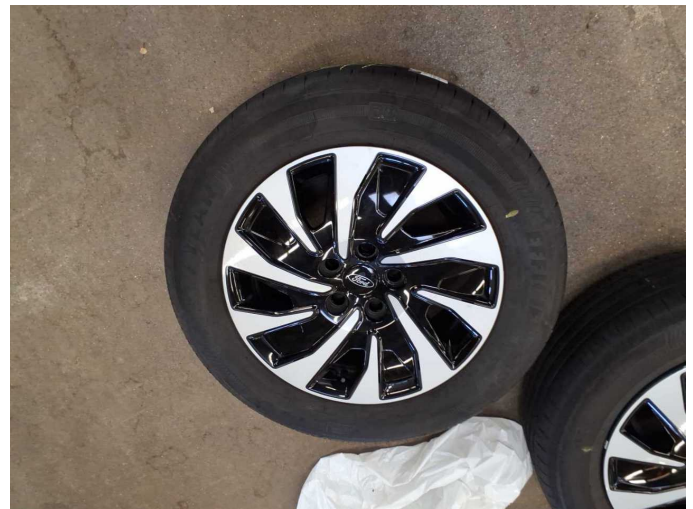
#	Tyre size	Type of tyre	Manufacturer	Tread depth
1)	205/60 R16 92V	Summer tyres on Steel rim with wheel cover	Goodyear	6mm / 6mm
2)	205/60 R16 92V	Summer tyres on Steel rim with wheel cover	Goodyear	6mm / 6mm

Figure 15: Additional tyres

Figure 16: Additional tyres

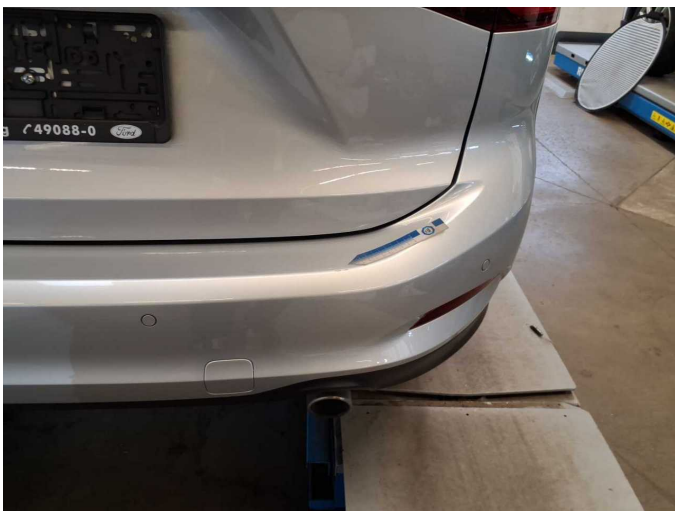
Damage 3: Rear bumper: Rear bumper - Scratch(es) - Smart repair

No.	Component group	Description
1	Misc.	Main inspection - No evidence - No deduction
2	Trim / covers	Floor mats - Holes - Replace
3	Rear bumper	Rear bumper - Scratch(es) - Smart repair

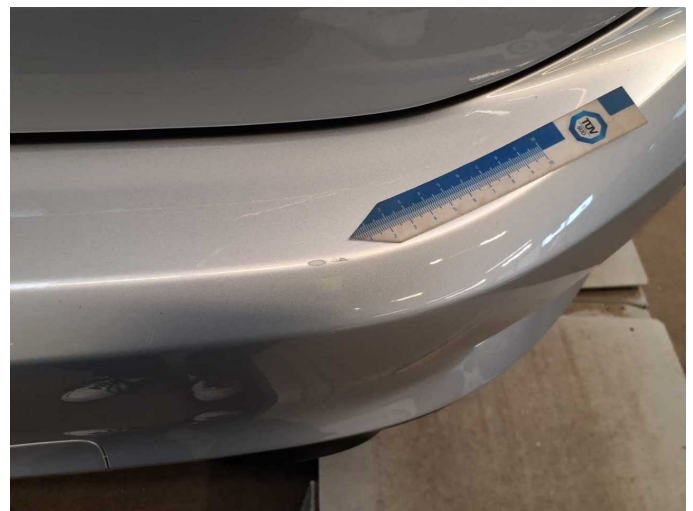
Damage 3: Rear bumper: Rear bumper - Scratch(es) - Smart repair
