Expertise

Protocol number: 46494232  
Order No. / Reference: 26639391  
Inspection date: 10 Jul 2026

Manufacturer: Mercedes-Benz  
VIN: W1N1671171A372548

Model: GLE 350 de 4Matic 9G-TRONIC

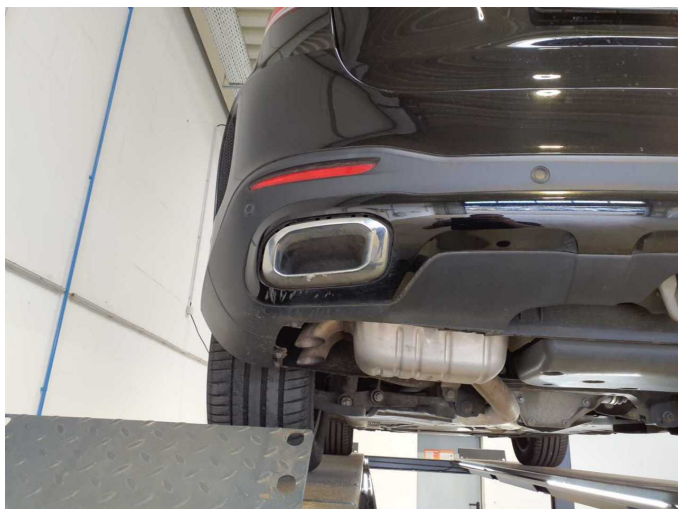
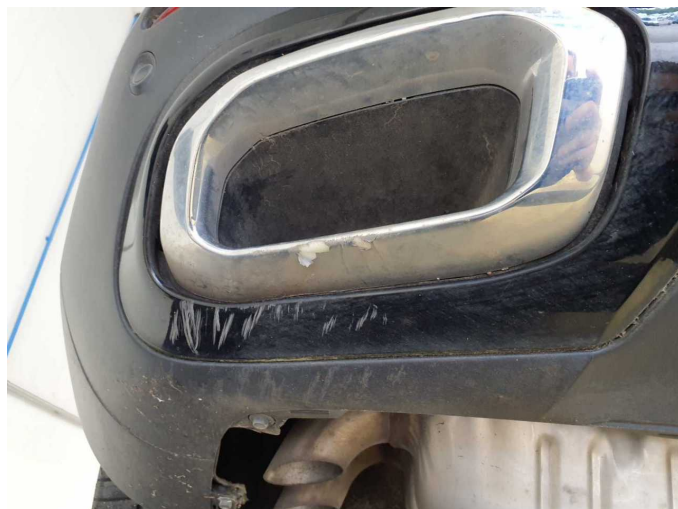
| No. | Component group | Description |
|---|---|---|
| 1 | Trim / covers | Trim / covers - Scratch(es) - Replace |

**Damage 1:** Trim / covers: Trim / covers - Scratch(es) - Replace

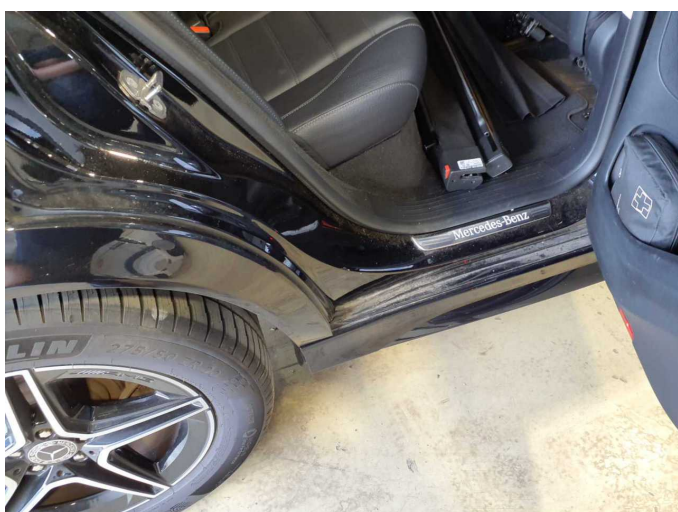
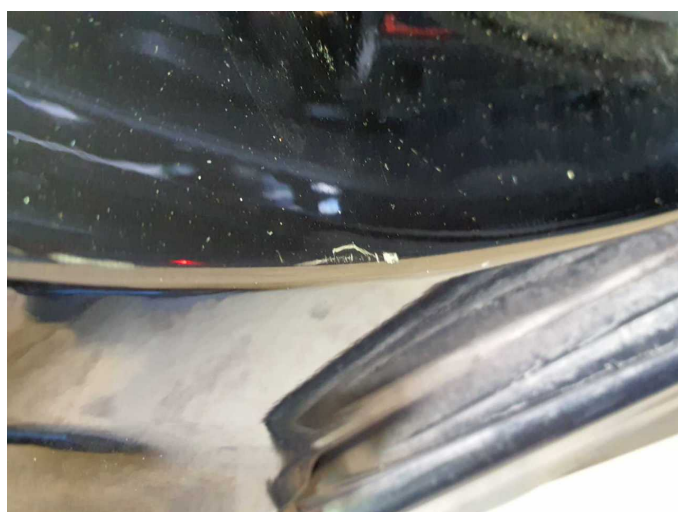
| No. | Component group | Description |
|---|---|---|
| 2 | Side panel - rear right side | Side panel - Scratch(es) - Smart repair |

**Damage 2:** Side panel - rear right side: Side panel - Scratch(es) - Smart repair

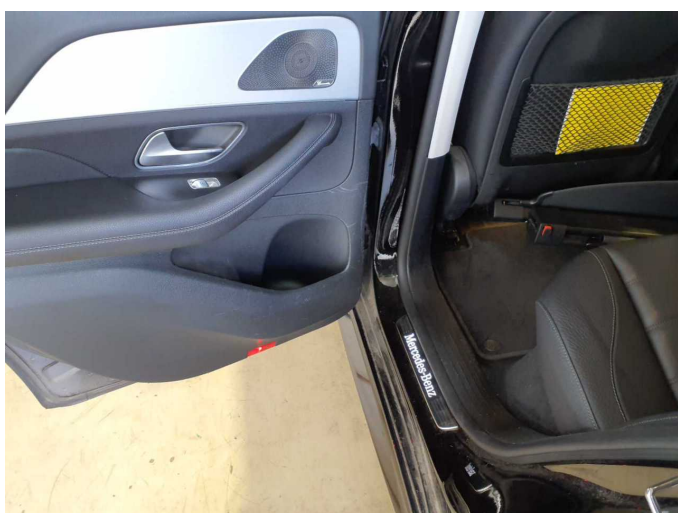
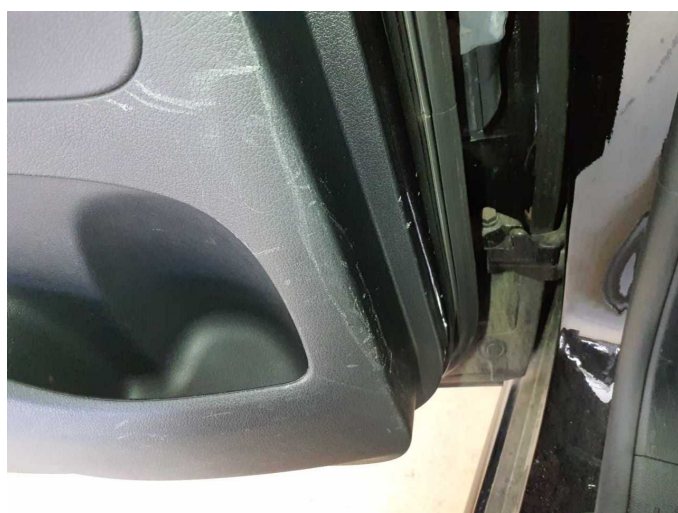
| No. | Component group | Description |
|---|---|---|
| 3 | Trim / covers | Door trim - rear left side - Scratch(es) - Smart repair |

**Damage 3:** Trim / covers: Door trim - rear left side - Scratch(es) - Smart repair

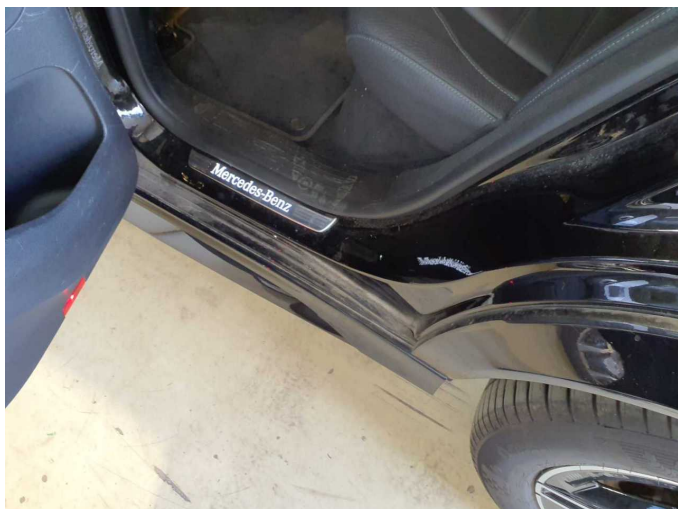
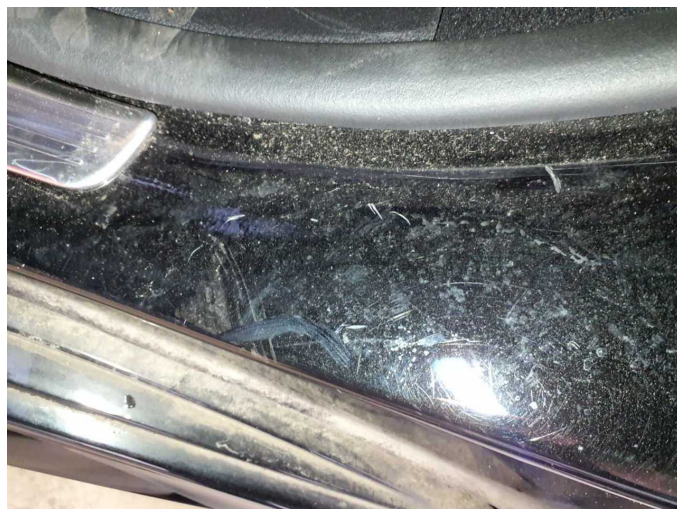
| No. | Component group | Description |
|---|---|---|
| 4 | Side panel - rear left side | Sill - Scratch(es) - Smart repair |

**Damage 4:** Side panel - rear left side: Sill - Scratch(es) - Smart repair

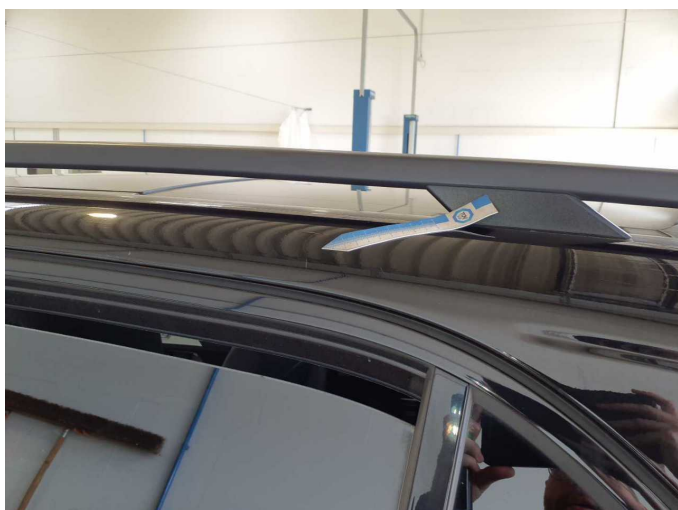
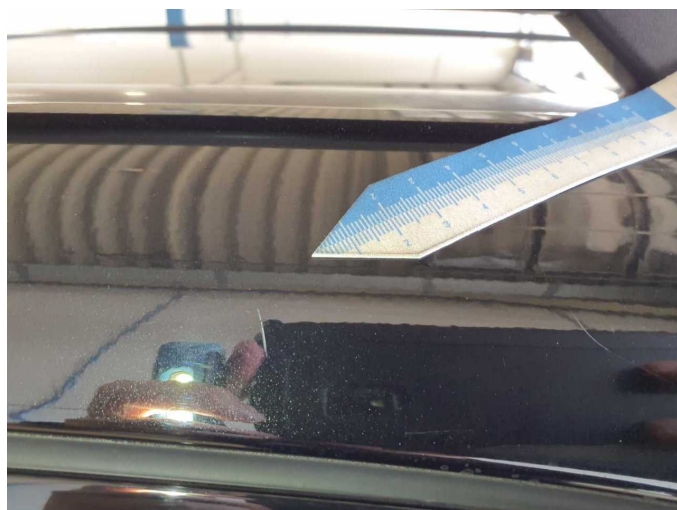
| No. | Component group | Description |
|---|---|---|
| 5 | Roof | Roof rail - left side - Scratch(es) - Smart repair |

**Damage 5:** Roof: Roof rail - left side - Scratch(es) - Smart repair

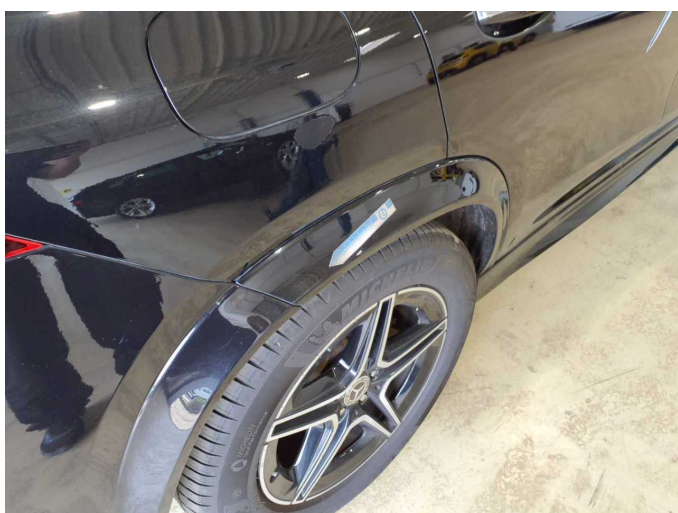
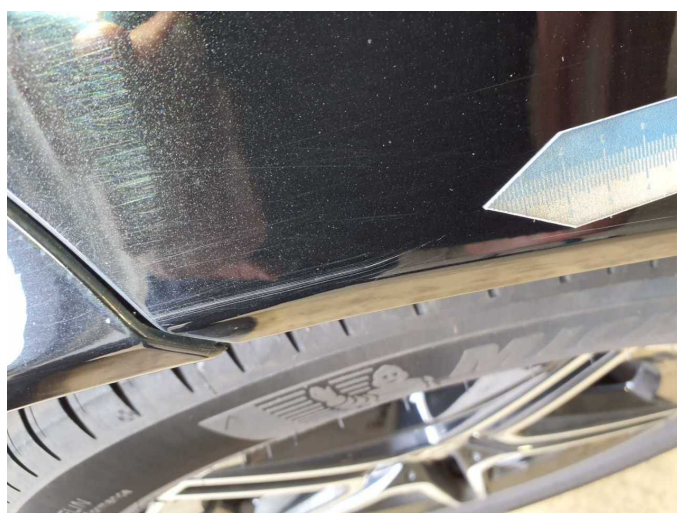
| No. | Component group | Description |
|---|---|---|
| 6 | Side panel - rear right side | Wheel arch - Scratch(es) - Smart repair |

**Damage 6:** Side panel - rear right side: Wheel arch - Scratch(es) - Smart repair

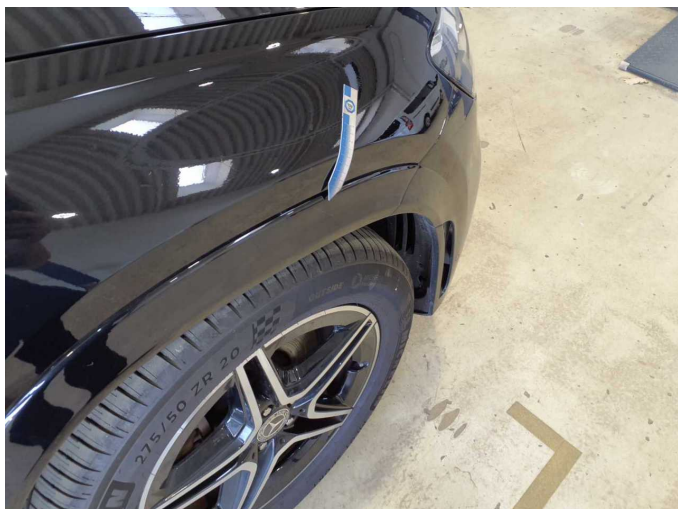
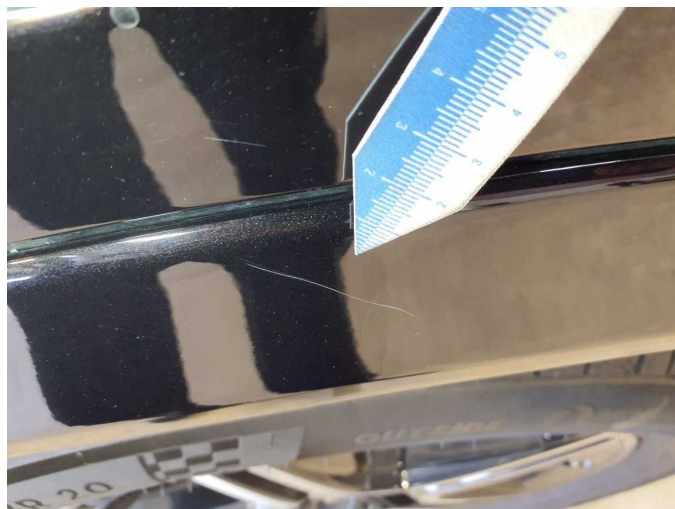
| No. | Component group | Description |
|---|---|---|
| 7 | Mudguard - right side | Mudguard - right side (Radlauf) - Scratch(es) - Smart repair |

**Damage 7:** Mudguard - right side: Mudguard - right side (Radlauf) - Scratch(es) - Smart repair

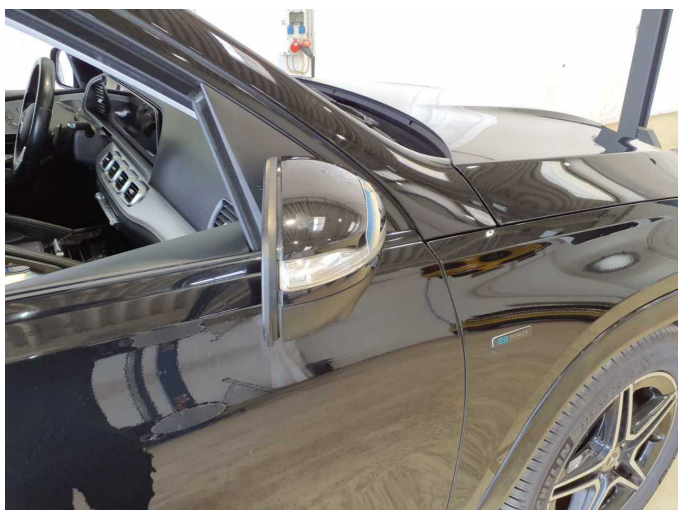
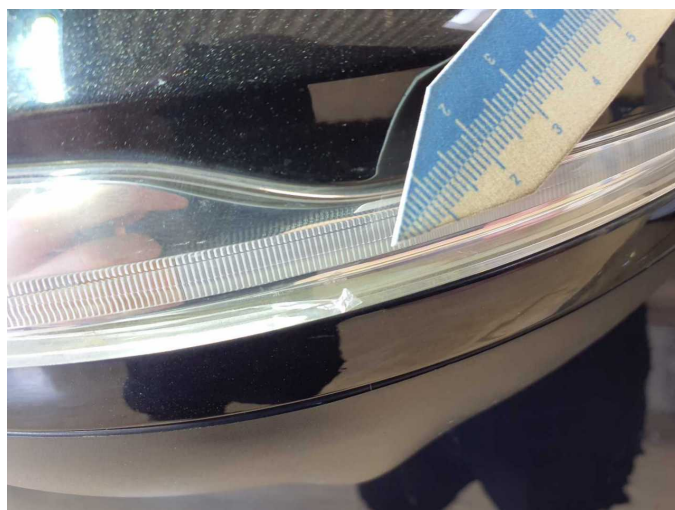
| No. | Component group | Description |
|---|---|---|
| 8 | Indicator - front | Mirror - right side - Broken / torn - Replace |

**Damage 8:** Indicator - front: Mirror - right side - Broken / torn - Replace

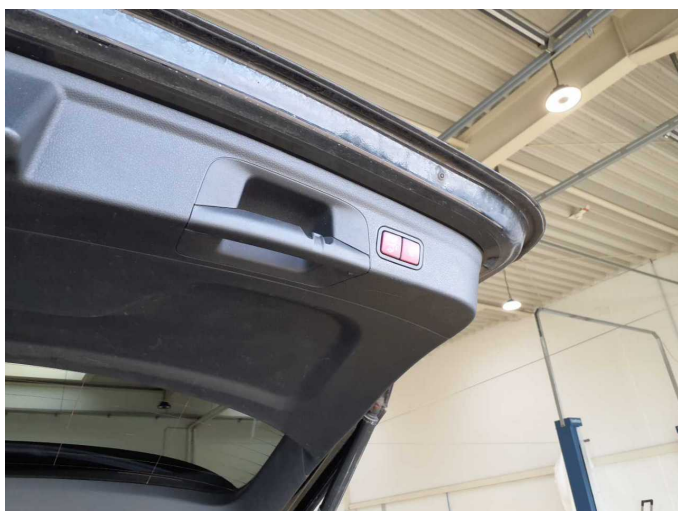
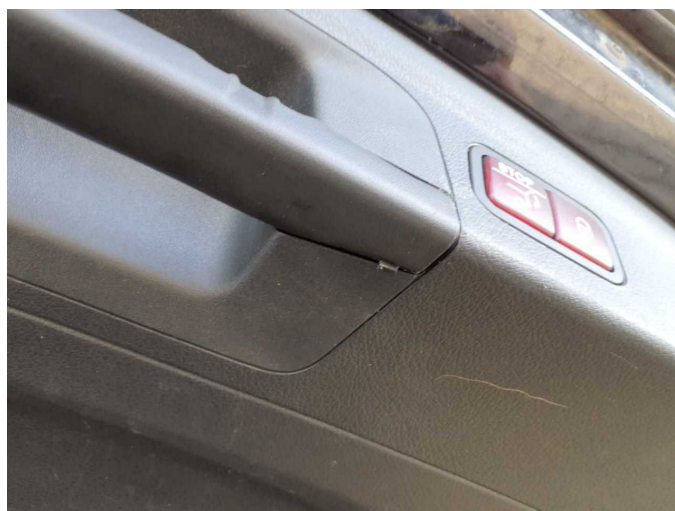
| No. | Component group | Description |
|---|---|---|
| 9 | Trim / covers | Boot lid - interior trim (unten) - Broken / torn - Replace |

**Damage 9:** Trim / covers: Boot lid - interior trim (unten) - Broken / torn - Replace

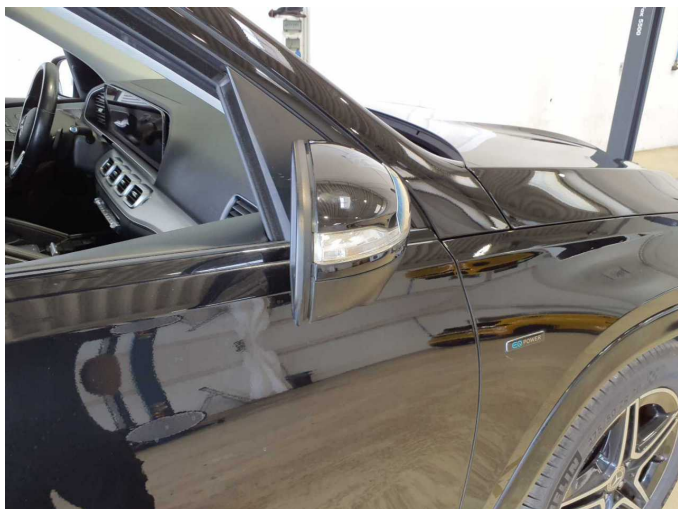
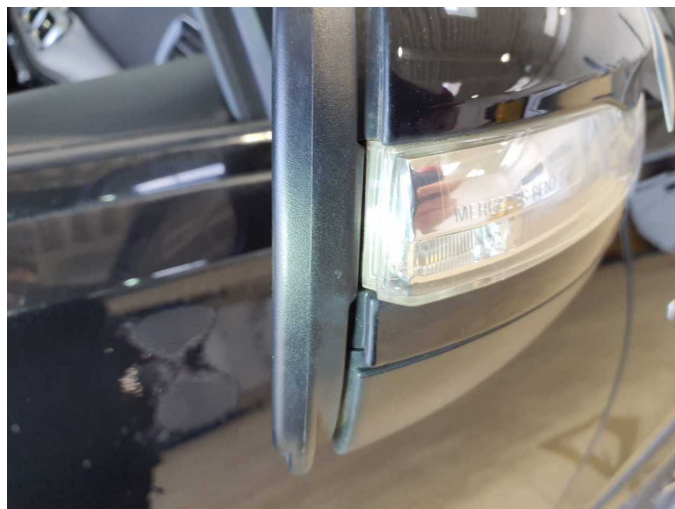
| No. | Component group | Description |
|---|---|---|
| 10 | Wing mirror - right side | Cap - Broken / torn - Replace |

**Damage 10:** Wing mirror - right side: Cap - Broken / torn - Replace

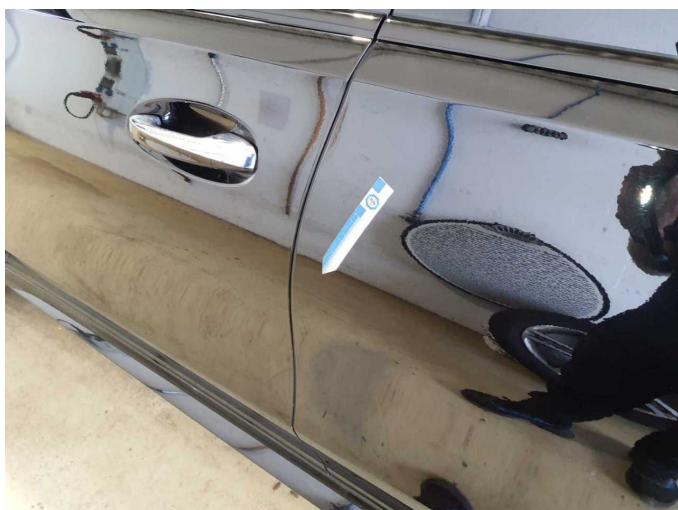
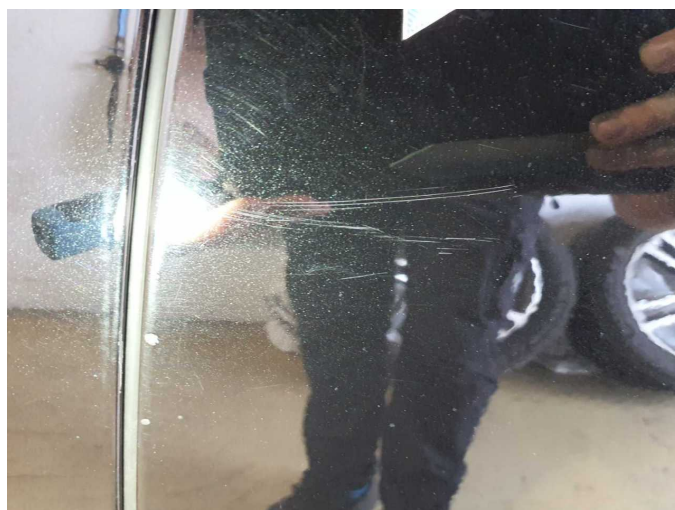
| No. | Component group | Description |
|---|---|---|
| 11 | Door - rear left side | Door - Scratch(es) - Paint |

**Damage 11:** Door - rear left side: Door - Scratch(es) - Paint

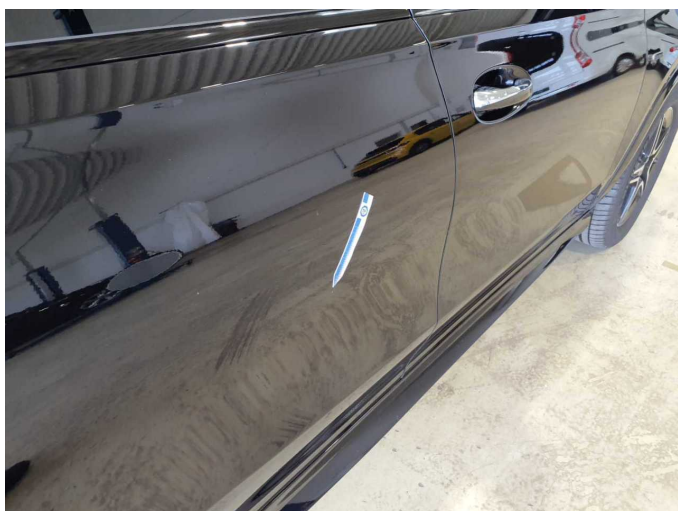
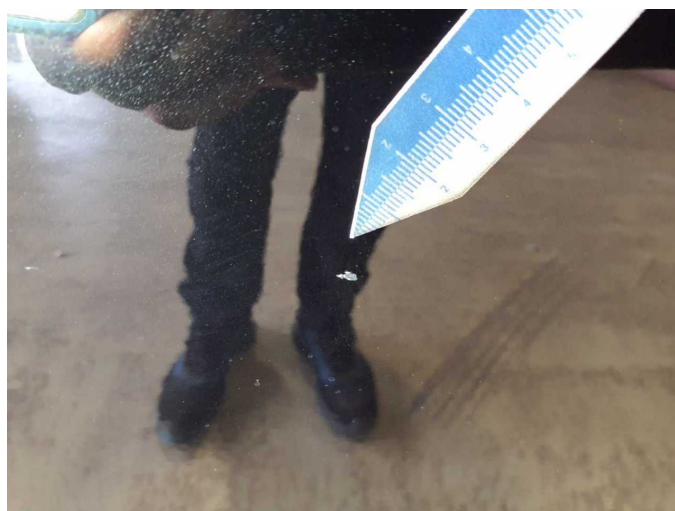
| No. | Component group | Description |
|---|---|---|
| 12 | Door - rear right side | Door - Scratch(es) - Paint |

**Damage 12:** Door - rear right side: Door - Scratch(es) - Paint

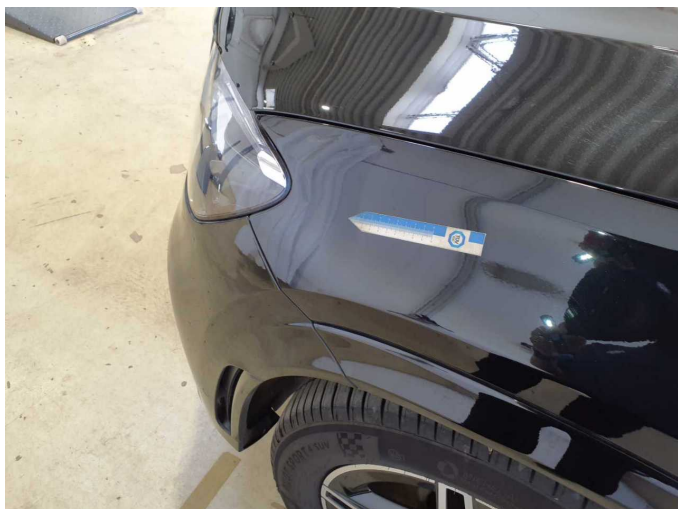
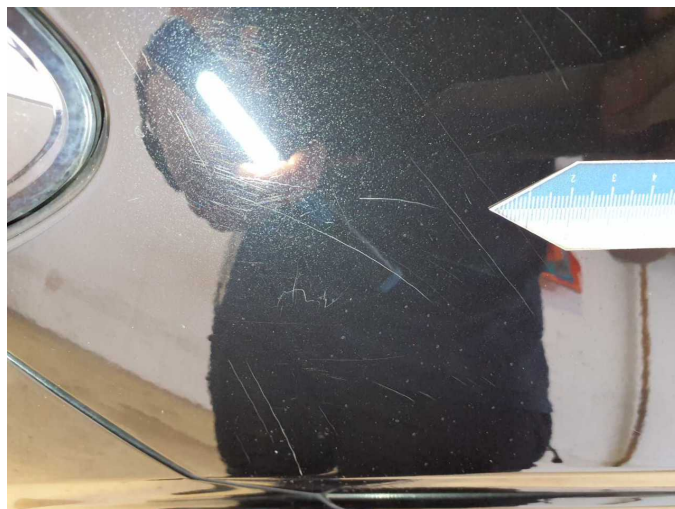
| No. | Component group | Description |
|---|---|---|
| 13 | Mudguard - left side | Mudguard - left side - Scratch(es) - Paint |

**Damage 13:** Mudguard - left side: Mudguard - left side - Scratch(es) - Paint

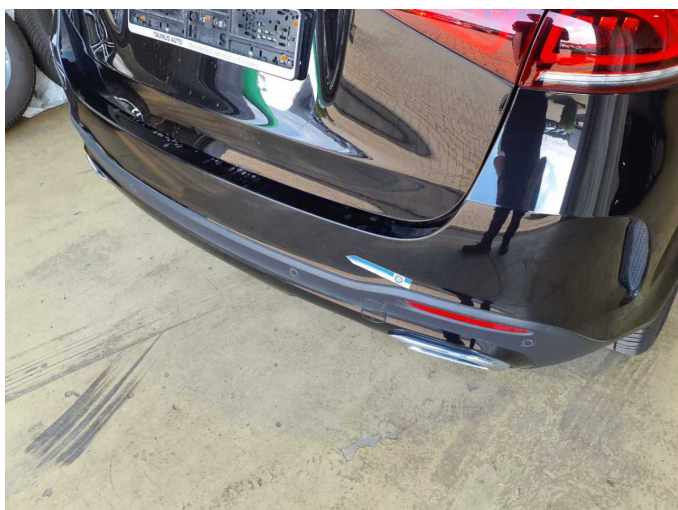
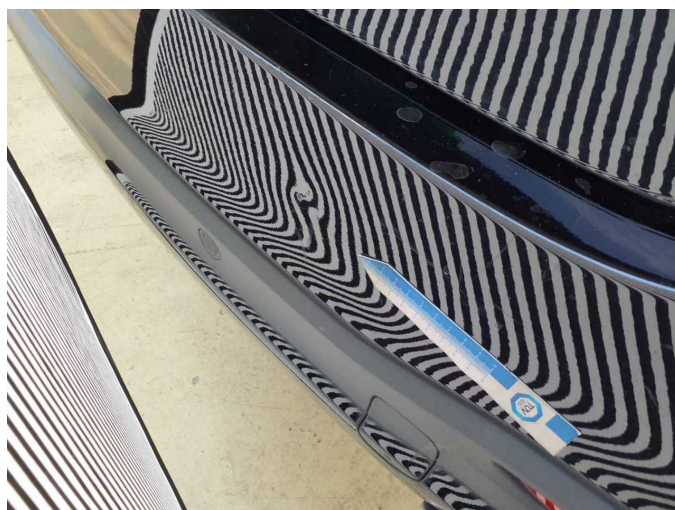
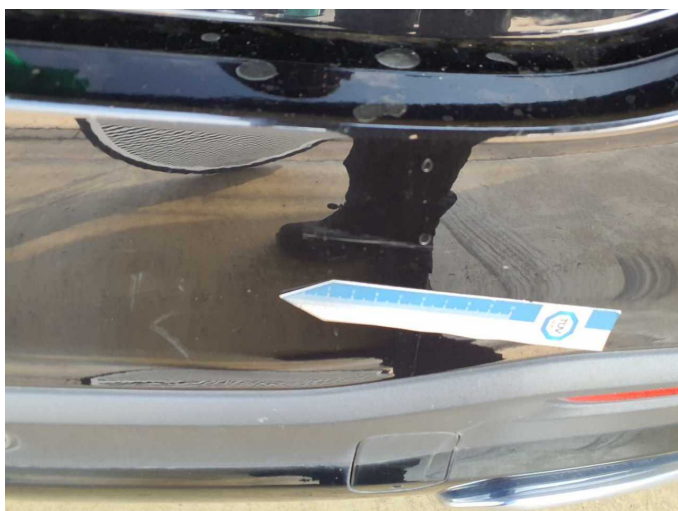
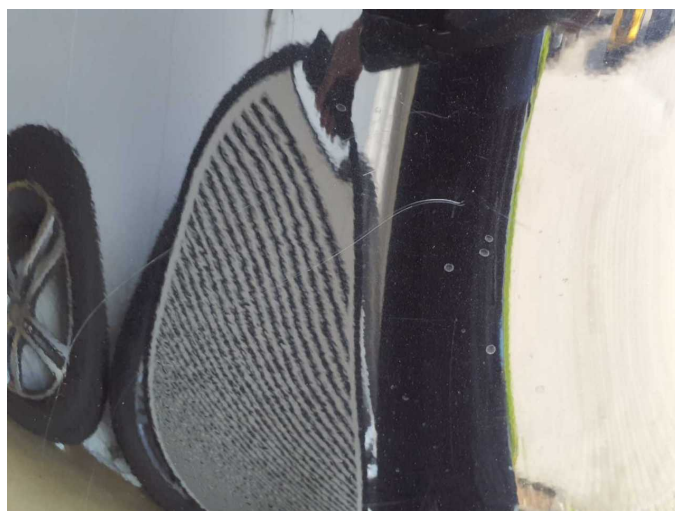
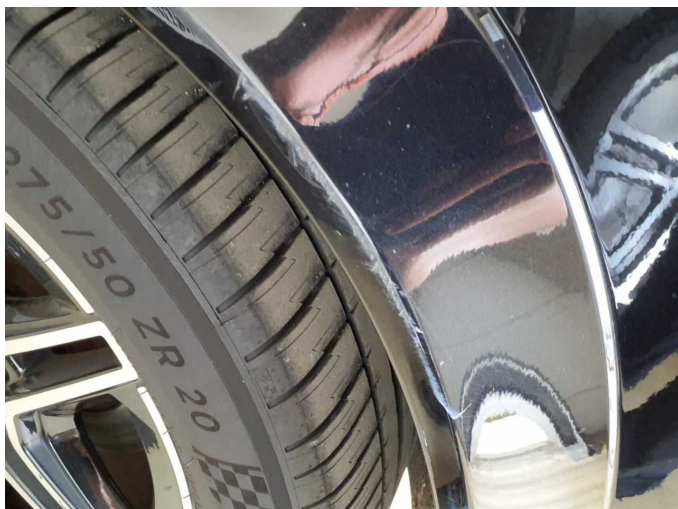
| No. | Component group | Description |
|---|---|---|
| 14 | Rear bumper | Rear bumper - Dent / paintcoat damage - Repair and paint |

**Damage 14:** Rear bumper: Rear bumper - Dent / paintcoat damage - Repair and paint

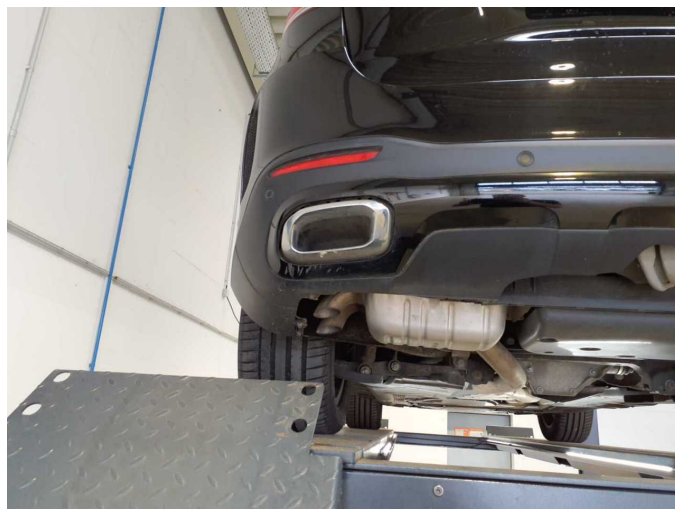
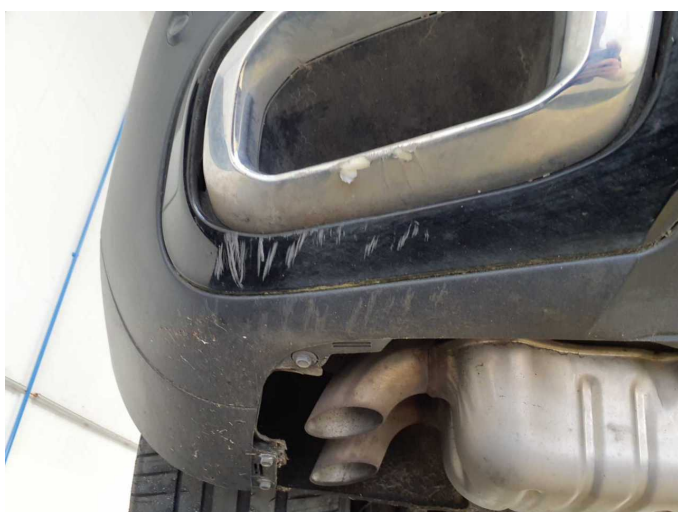
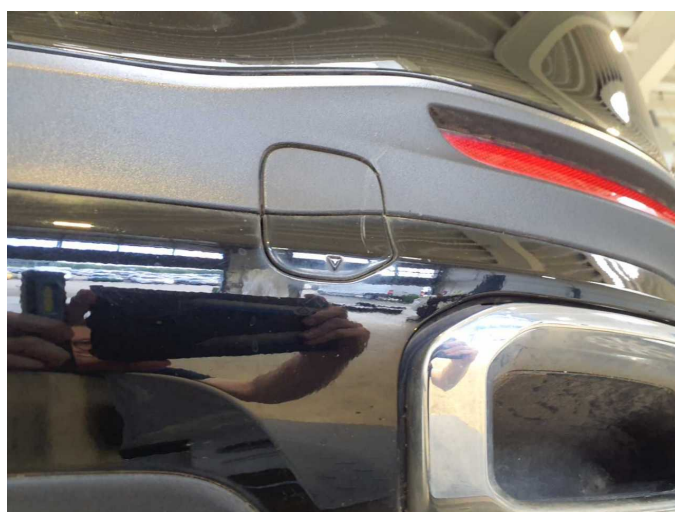
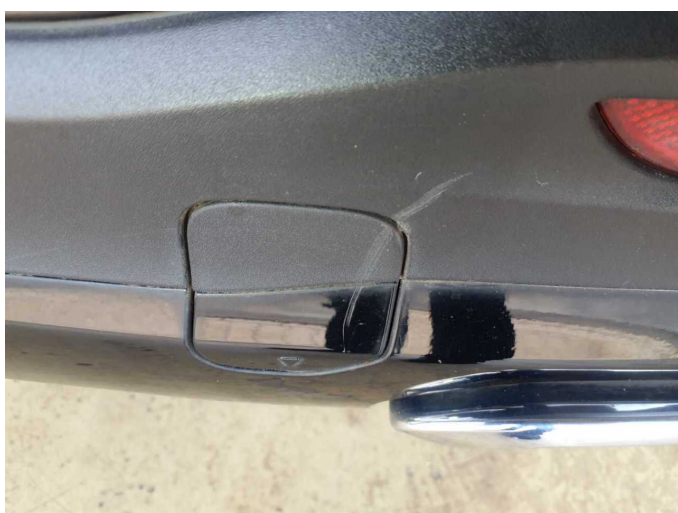
| No. | Component group | Description |
|---|---|---|
| 15 | Rear bumper | Spoiler (+Blende) - Scratch(es) - Replace |

**Damage 15:** Rear bumper: Spoiler (+Blende) - Scratch(es) - Replace

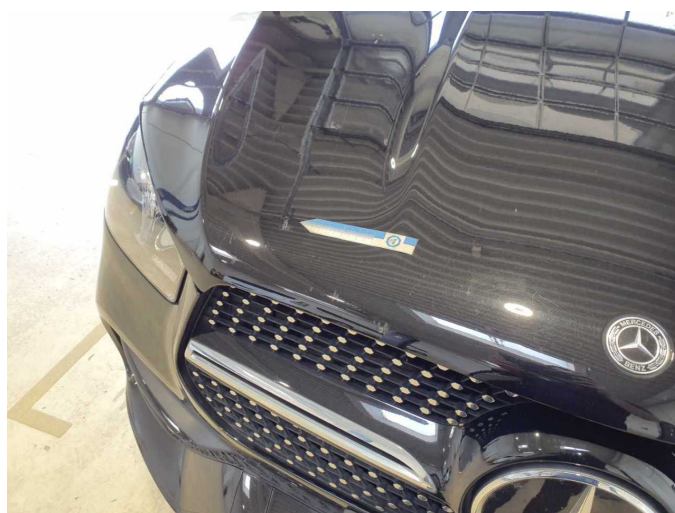
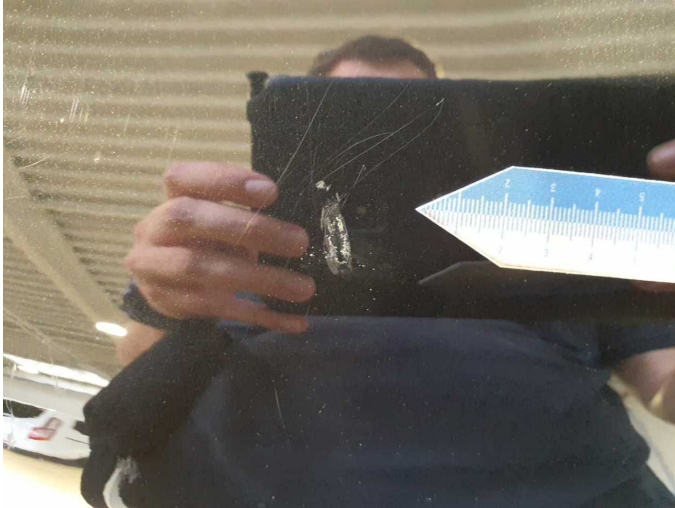
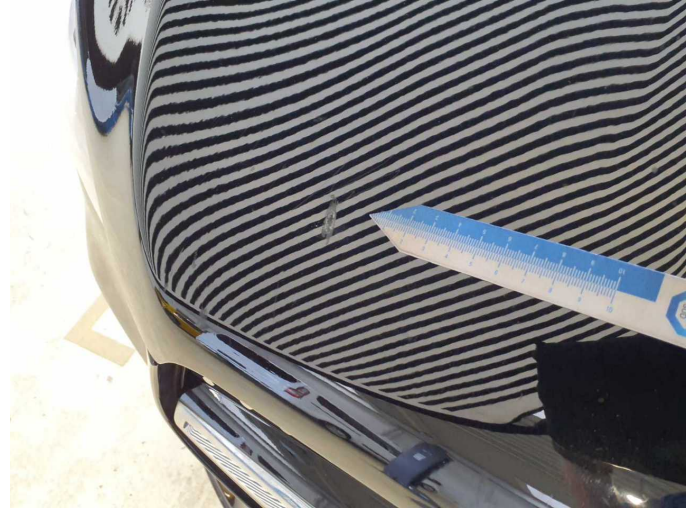
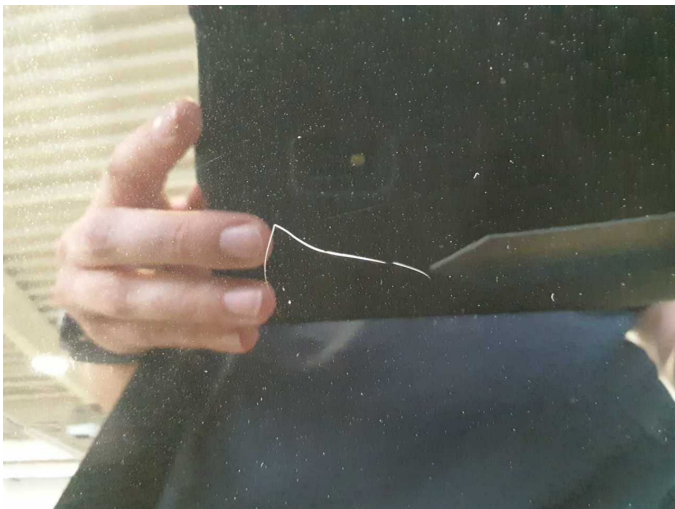
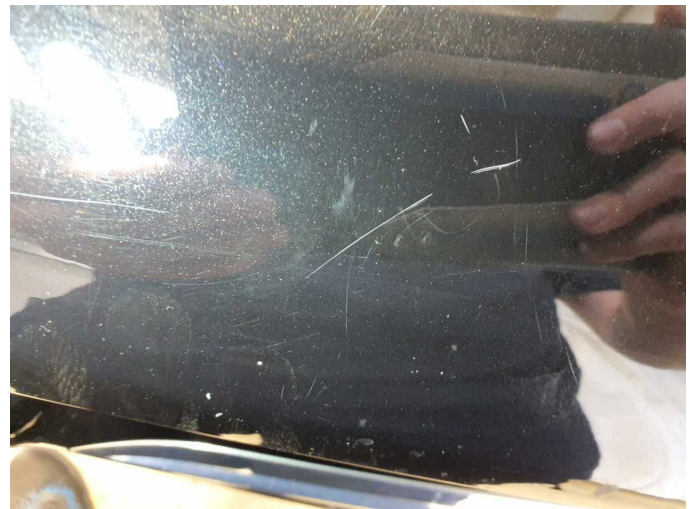
| No. | Component group | Description |
|---|---|---|
| 16 | Bonnet | Bonnet (Anätzung) - Paint defect - Repair and paint |

**Damage 16:** Bonnet: Bonnet (Anätzung) - Paint defect - Repair and paint

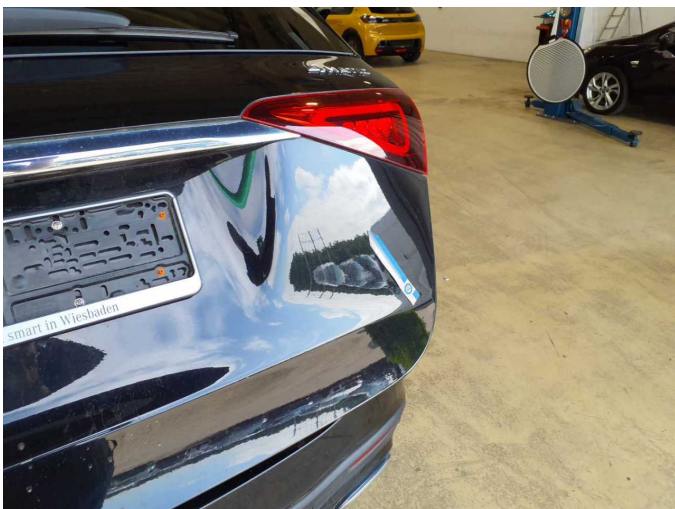
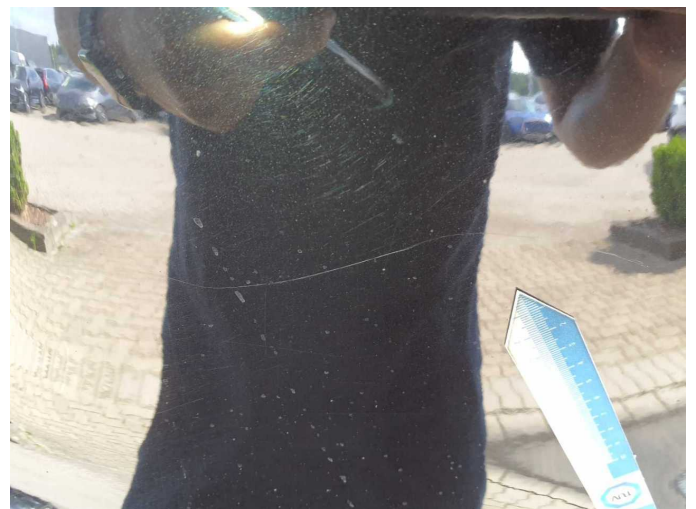
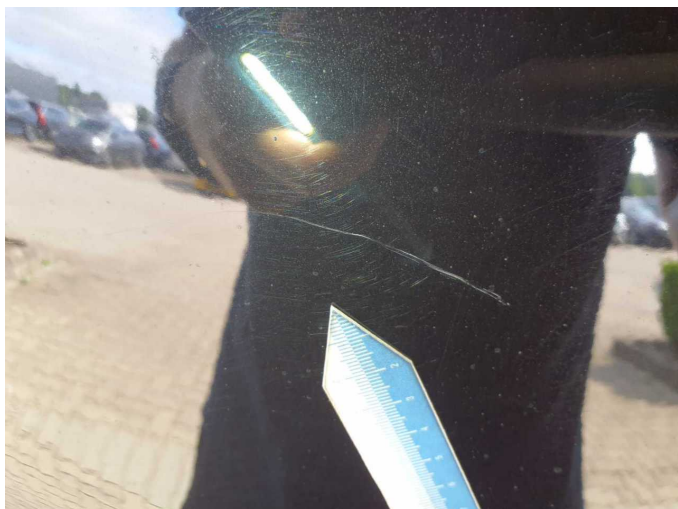
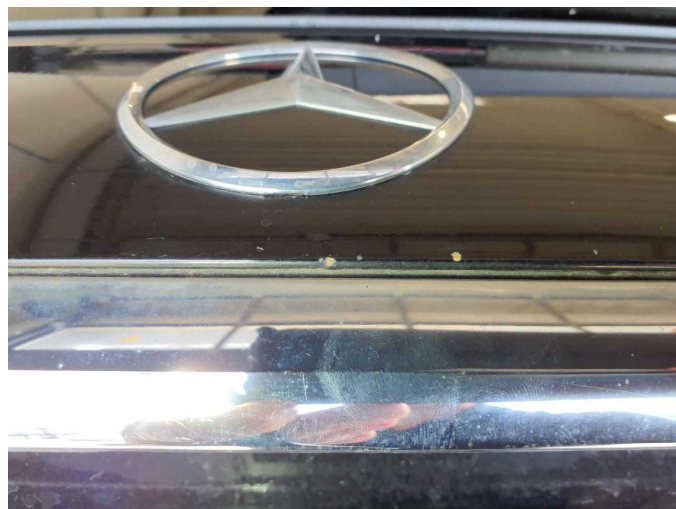
| No. | Component group | Description |
|---|---|---|
| 17 | Boot lid / rear door | Boot lid - Corrosion - Repair and paint |

**Damage 17:** Boot lid / rear door: Boot lid - Corrosion - Repair and paint

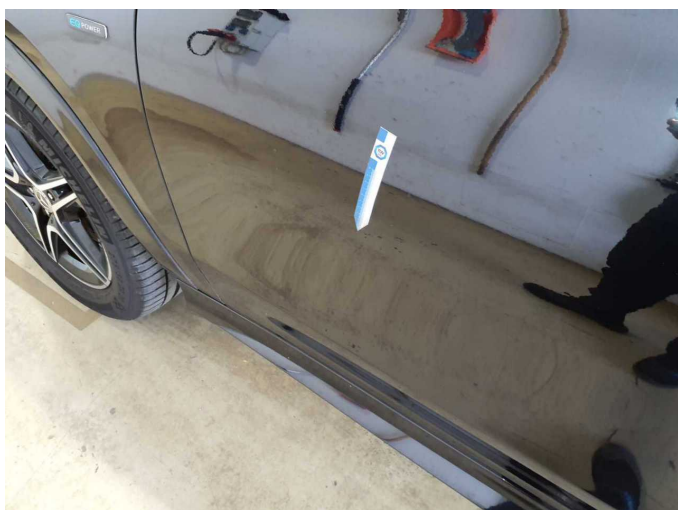
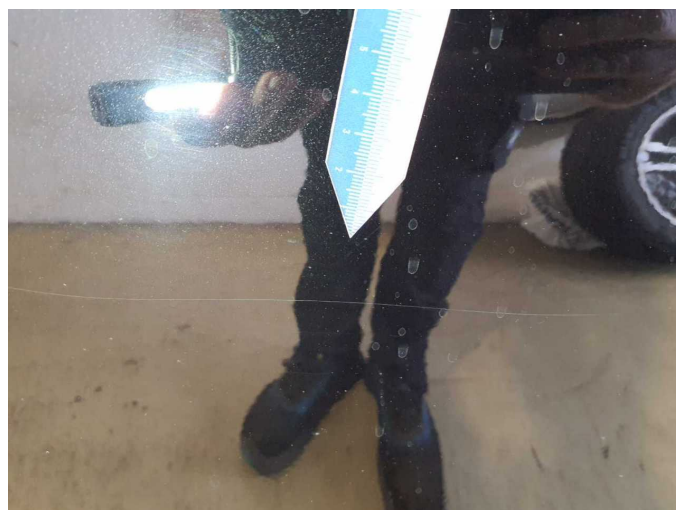
| No. | Component group | Description |
|---|---|---|
| 18 | Door - front left side | Door - Scratch(es) - Paint |

**Damage 18:** Door - front left side: Door - Scratch(es) - Paint

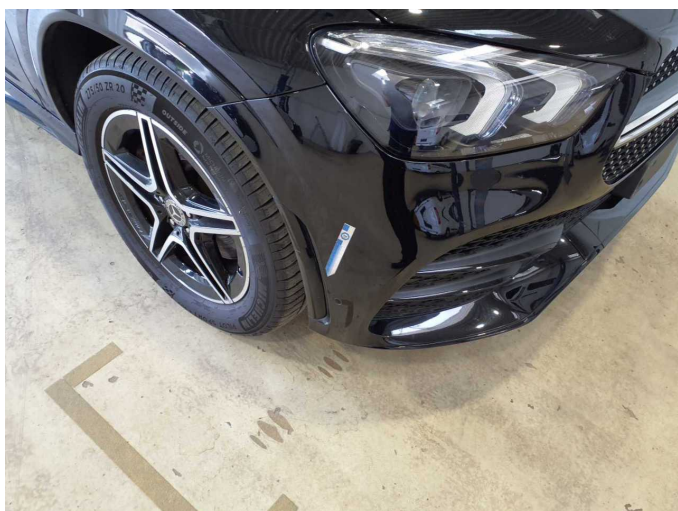
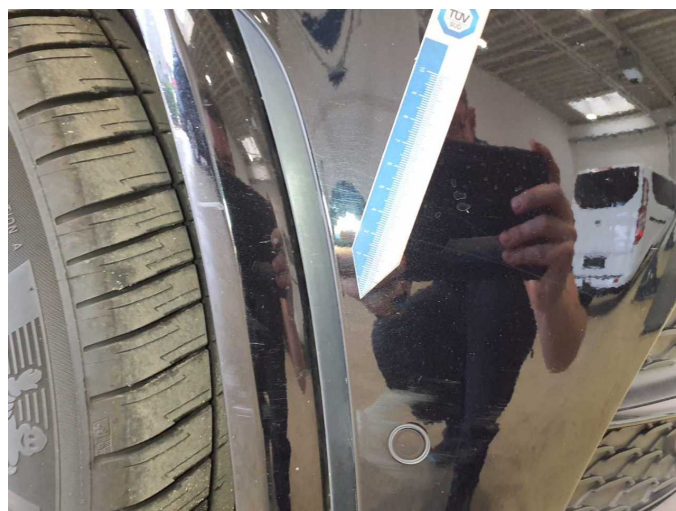
| No. | Component group | Description |
|---|---|---|
| 19 | Front bumper | Front bumper - Scratch(es) - Paint |

**Damage 19:** Front bumper: Front bumper - Scratch(es) - Paint

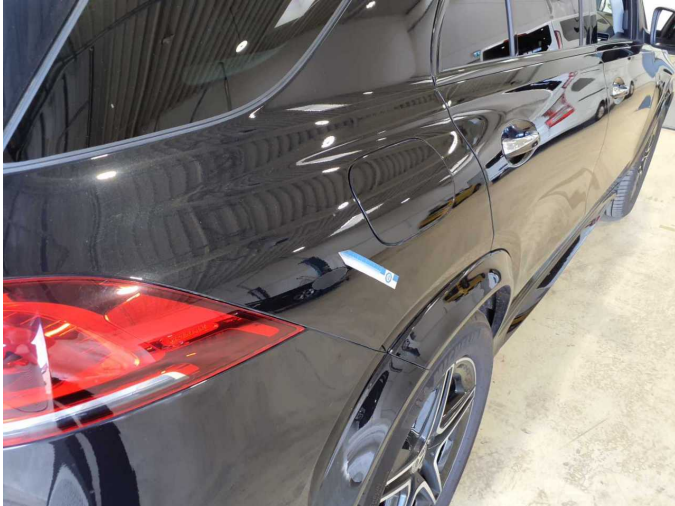
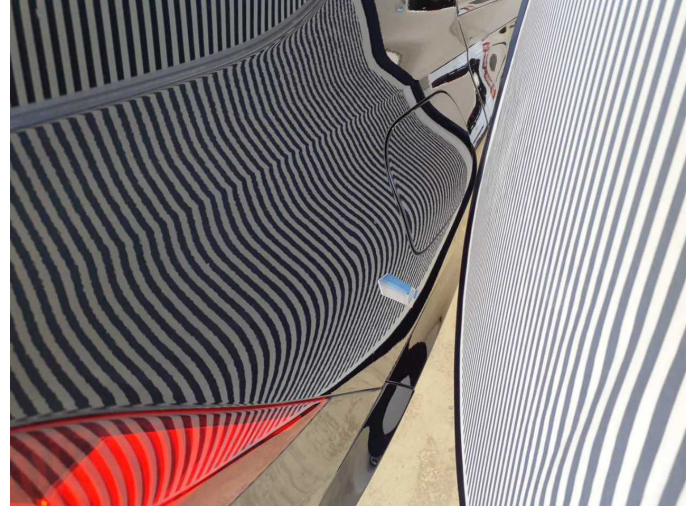
| No. | Component group | Description |
|---|---|---|
| 5 | Side panel - rear right side | Side panel - dent(s) - Smooth repair work |

**Wear and tear 5:** Side panel - rear right side: Side panel - dent(s) - Smooth repair work

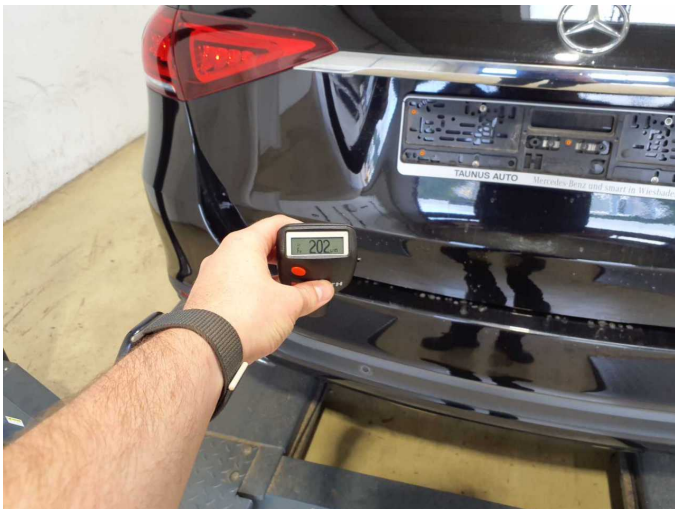
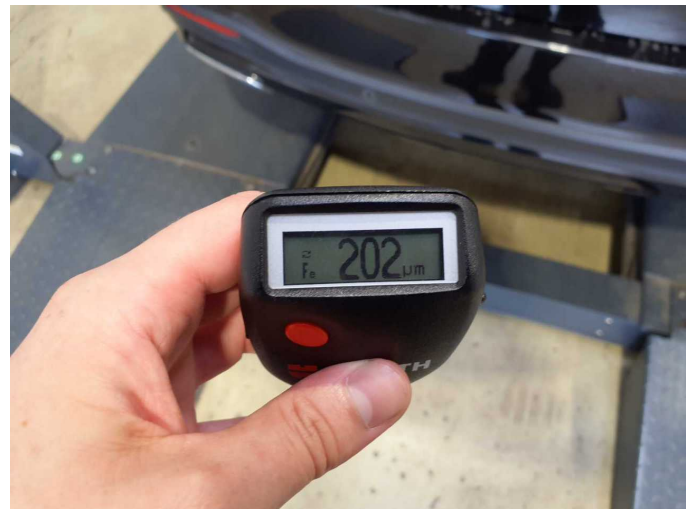
| No. | Repainting |
|---|---|
| 1 | Boot lid / rear door, Professionally carried out, Invoice of repair done Non-existent |

| Boot lid / rear door | 202 µm |

**Repainting 1:** Boot lid / rear door
