Expertise

Protocol number: 46850056  
Order No. / Reference: 26720002  
Inspection date: 3 Aug 2026

Manufacturer: Polestar

Model: 2 Single Motor 78kWh

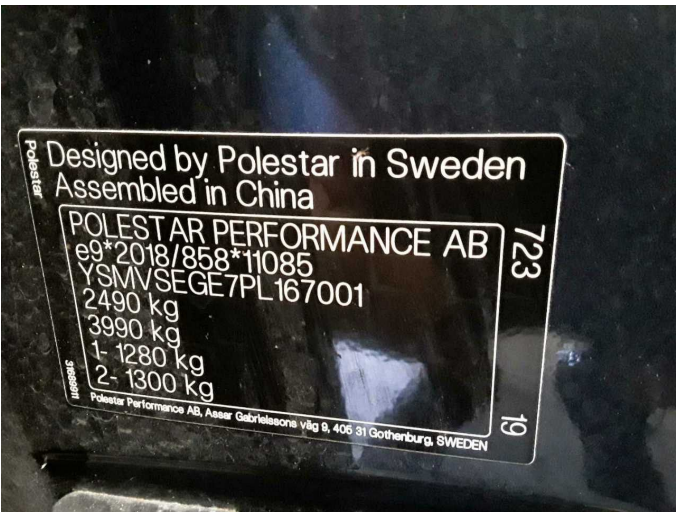
Figure 11: VIN

| VIN comparison | The vehicle identification number (VIN) was read from the vehicle and its conformity with the submitted documents was confirmed by the undersigned during the inspection. |

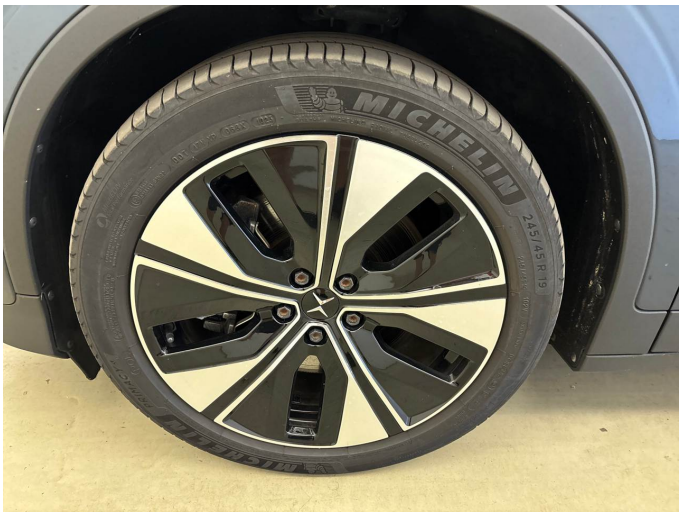
Figure 12: Mounted tyres

| # | Tyre size | Type of tyre | Manufacturer | Tread depth |
|---|---|---|---|---|
| 1) | 245/45 R19 102V | Summer tyres on Light alloy | Michelin | 5mm / 5mm |
| 2) | 245/45 R19 102V | Summer tyres on Light alloy | Michelin | 6mm / 6mm |

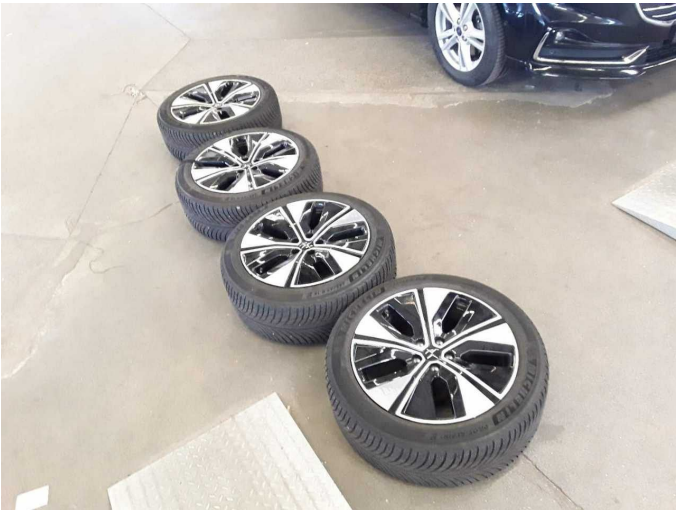
Figure 17: Additional tyres

| # | Tyre size | Type of tyre | Manufacturer | Tread depth |
|---|---|---|---|---|
| 1) | 245/45 R19 103V | Winter tyres on Light alloy | Michelin | 5mm / 5mm |
| 2) | 245/45 R19 103V | Winter tyres on Light alloy | Michelin | 6mm / 6mm |

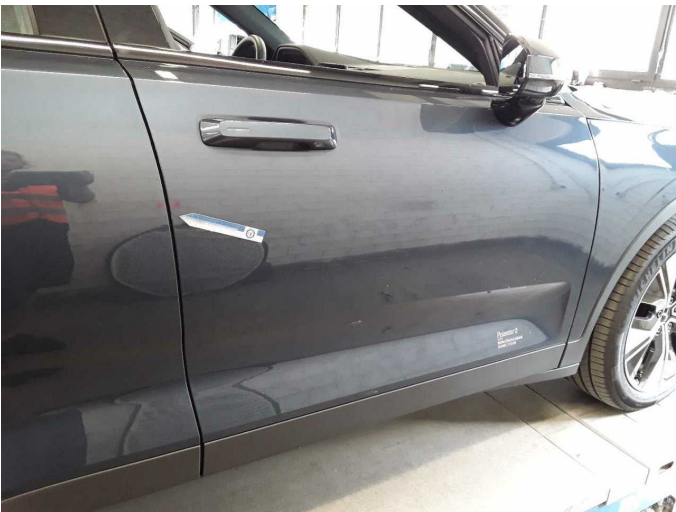
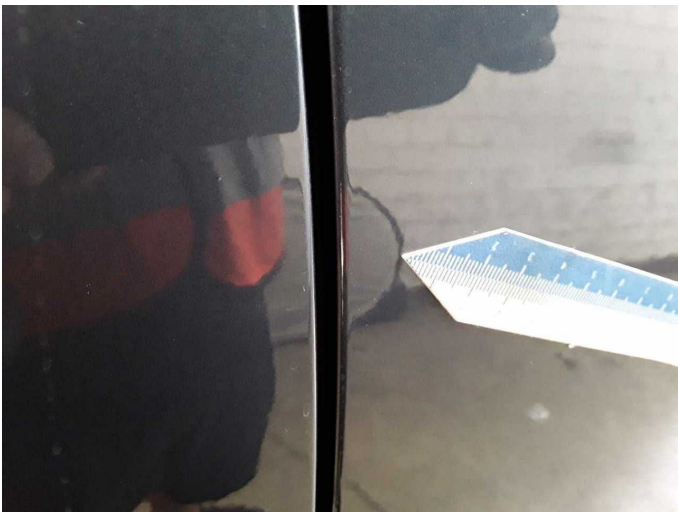
Damage 1: Door - front right side: Door edge - Scratched - Smart repair

| No. | Component group | Description |
|---|---|---|
| 1 | Door - front right side | Door edge - Scratched - Smart repair |

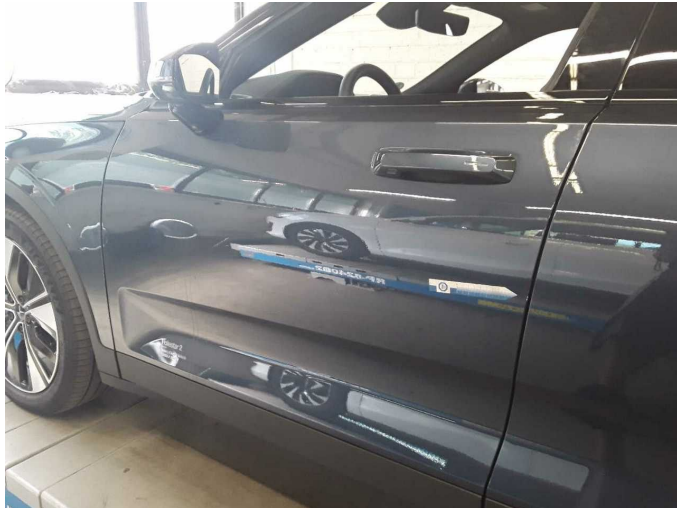
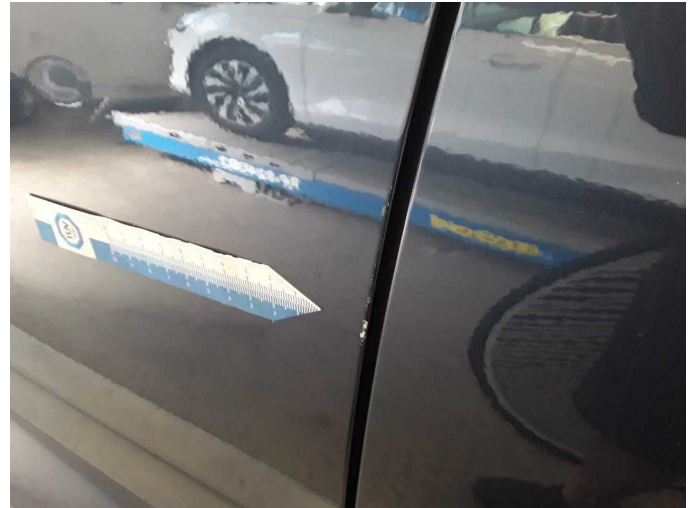
**Damage 2:** Door - front left side: Door edge - Scratched - Smart repair

| No. | Component group | Description |
|---|---|---|
| 2 | Door - front left side | Door edge - Scratched - Smart repair |

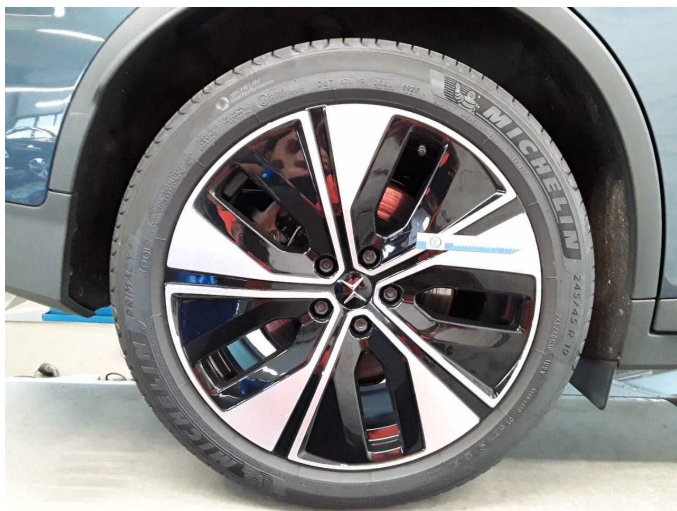
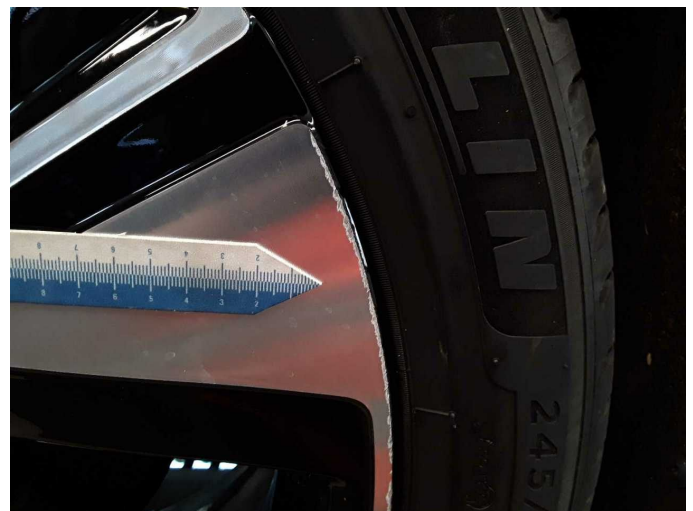
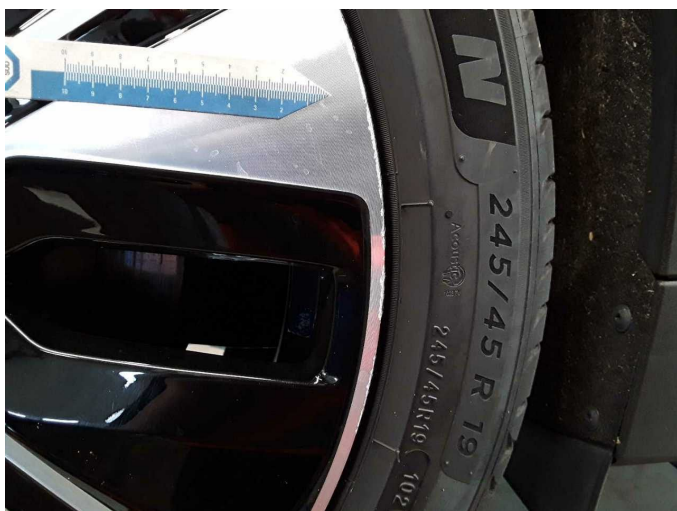
**Damage 3:** Wheel / tyres: Alloy rim - rear right side - Scratched - Loss in value

| No. | Component group | Description |
|---|---|---|
| 3 | Wheel / tyres | Alloy rim - rear right side - Scratched - Loss in value |

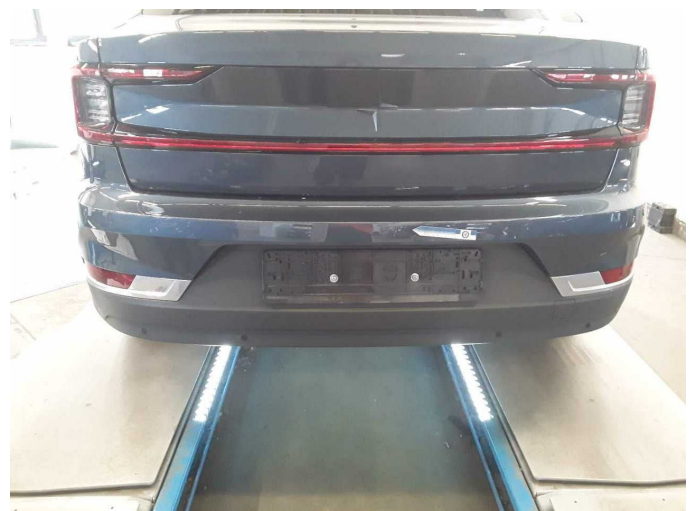
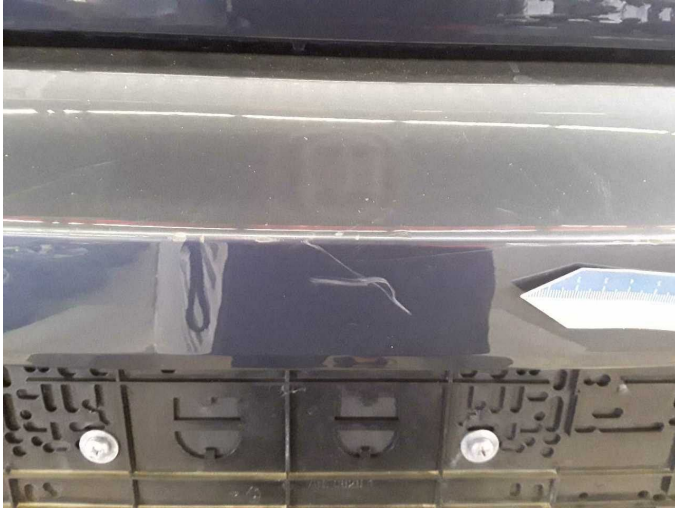
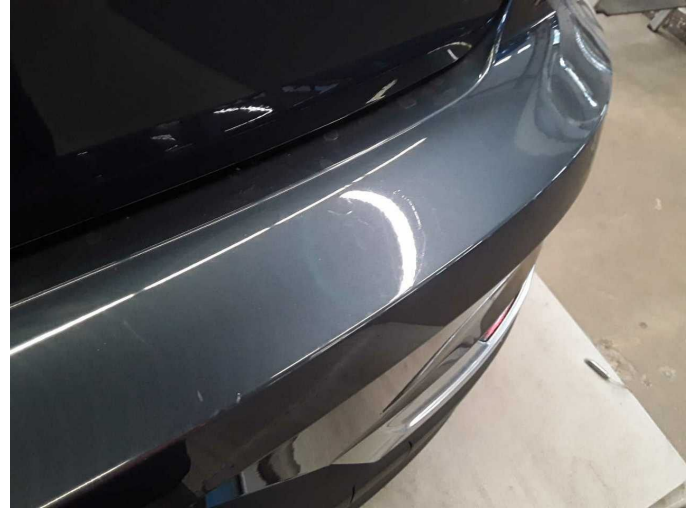
**Damage 4:** Rear bumper: Rear bumper - Scratched - Paint

| No. | Component group | Description |
|---|---|---|
| 4 | Rear bumper | Rear bumper - Scratched - Paint |
