Expertise

Manufacturer: Volkswagen

Model: Passat Variant 2.0 TDI SCR DSG Business

VIN: WVGZZ3C1RE002329

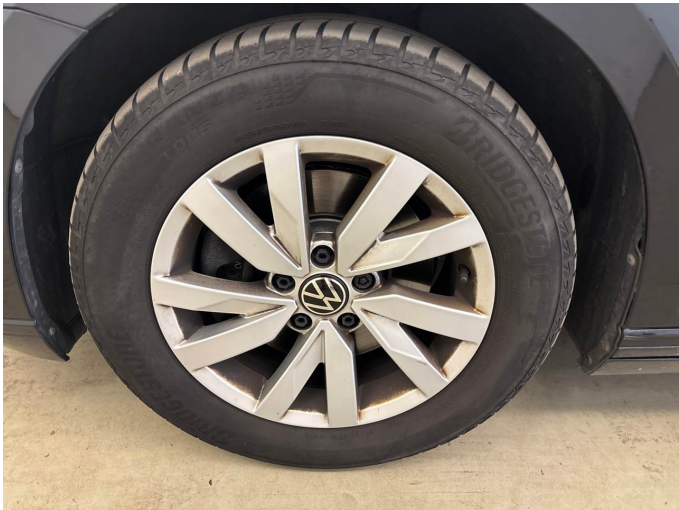
Figure 12: Mounted tyres

| Tyres | | | | |
|---|---|---|---|---|
| 1) | 215/60 R16 95V | Summer tyres on Light alloy | Bridgestone | 3mm / 3mm |
| 2) | 215/60 R16 95V | Summer tyres on Light alloy | Bridgestone | 4mm / 4mm |

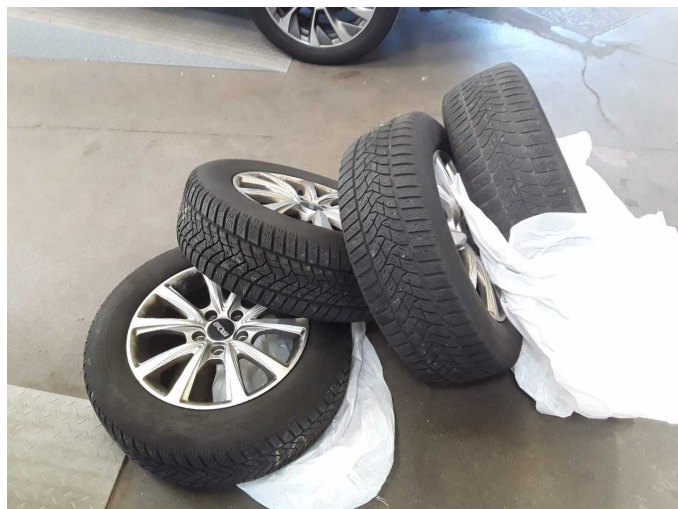
Figure 14: Additional tyres

| Tyres | | | | |
|---|---|---|---|---|
| 1) | 215/60 R16 95H | Winter tyres on Light alloy | Dunlop | 4mm / 4mm |
| 2) | 215/60 R16 95H | Winter tyres on Light alloy | Dunlop | 5mm / 5mm |

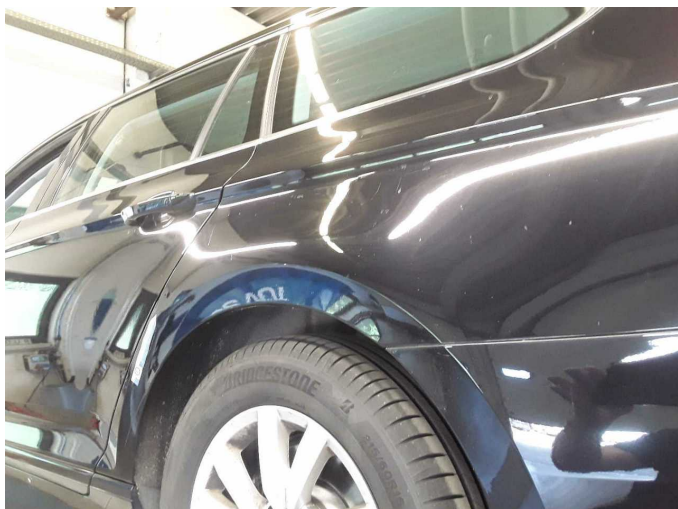
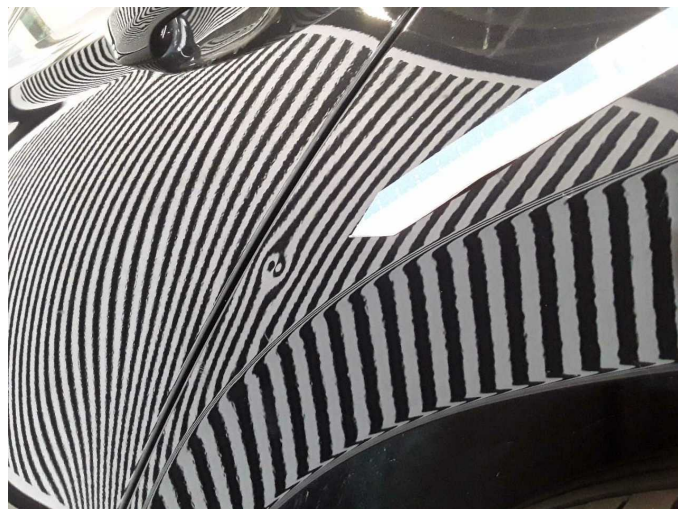
| No. | Component group | Description |
|---|---|---|
| 1 | Side panel - rear left side | Side panel - dent(s) - Smooth repair work |

**Damage 1:** Side panel - rear left side: Side panel - dent(s) - Smooth repair work

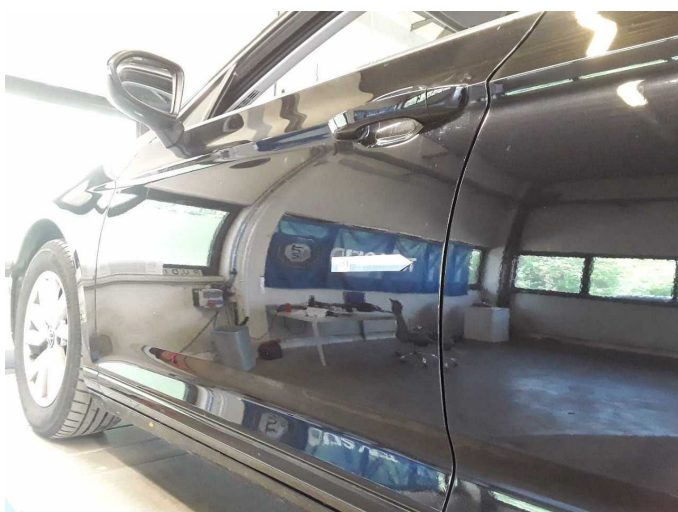
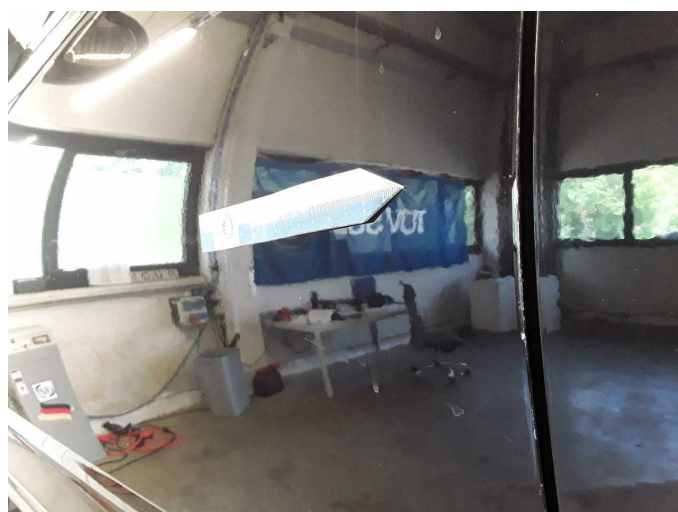
| No. | Component group | Description |
|---|---|---|
| 2 | Door - front left side | Door - Scratch(es) - Smart repair |

**Damage 2:** Door - front left side: Door - Scratch(es) - Smart repair

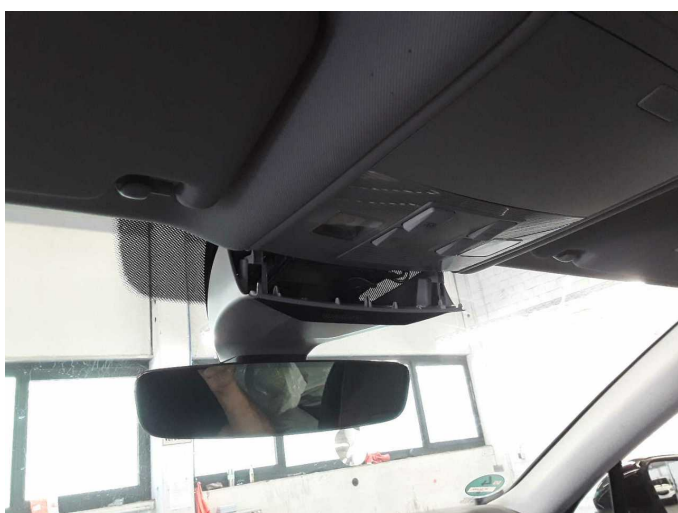
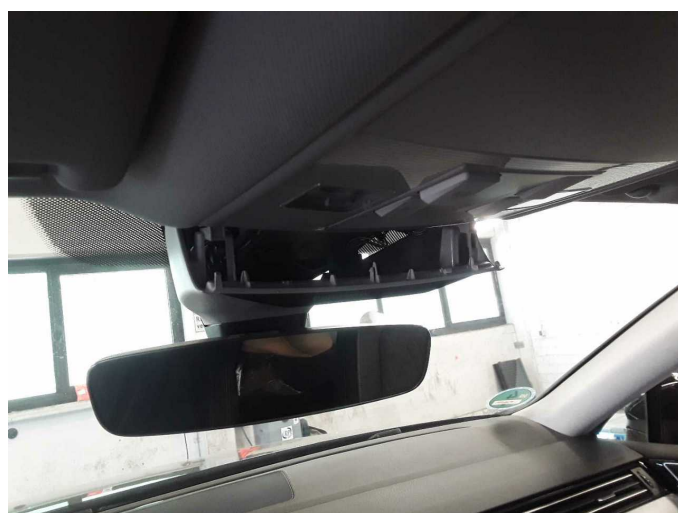
| No. | Component group | Description |
|---|---|---|
| 3 | Instrument panel | Interior mirror - Damaged - Replace |

**Damage 3:** Instrument panel: Interior mirror - Damaged - Replace

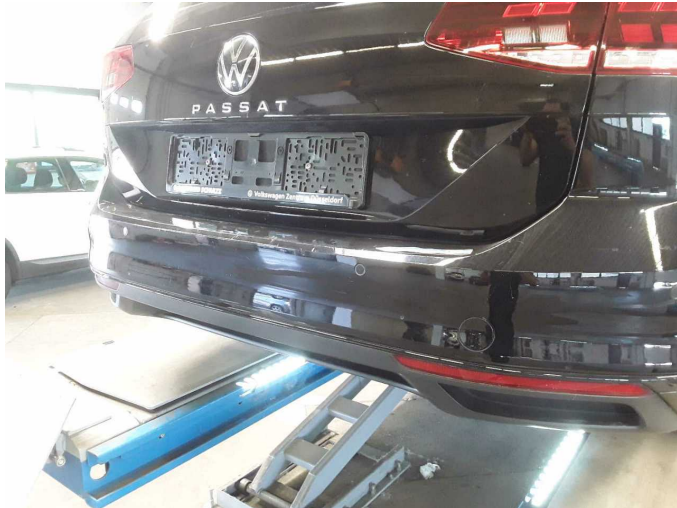
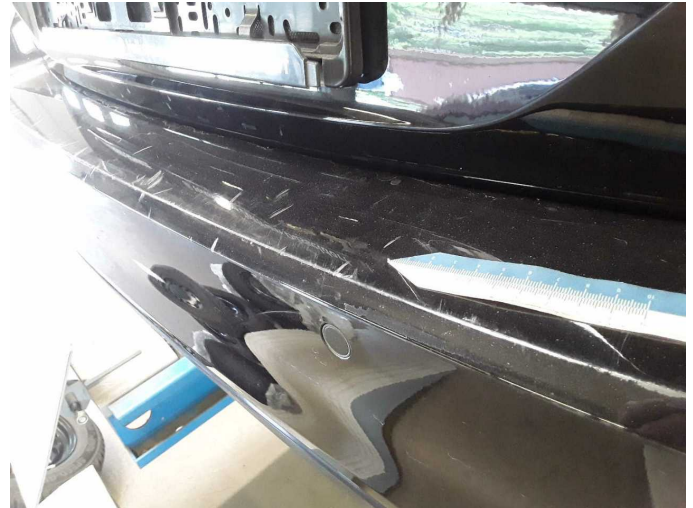
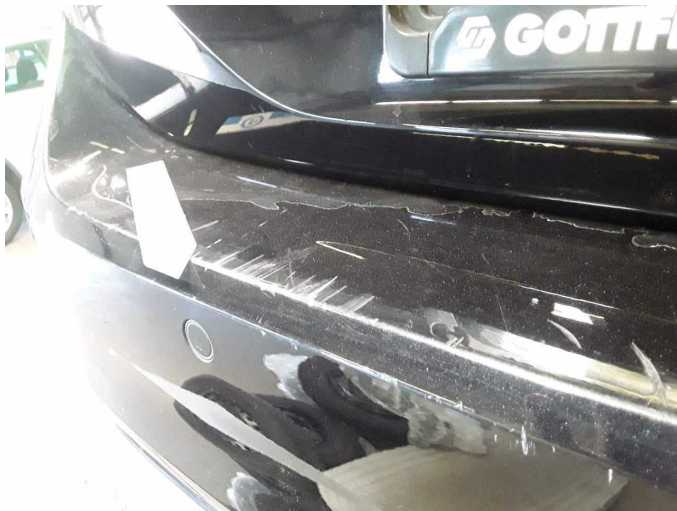
| No. | Component group | Description |
|---|---|---|
| 4 | Rear bumper | Rear bumper - Scratch(es) - Paint |

**Damage 4:** Rear bumper: Rear bumper - Scratch(es) - Paint

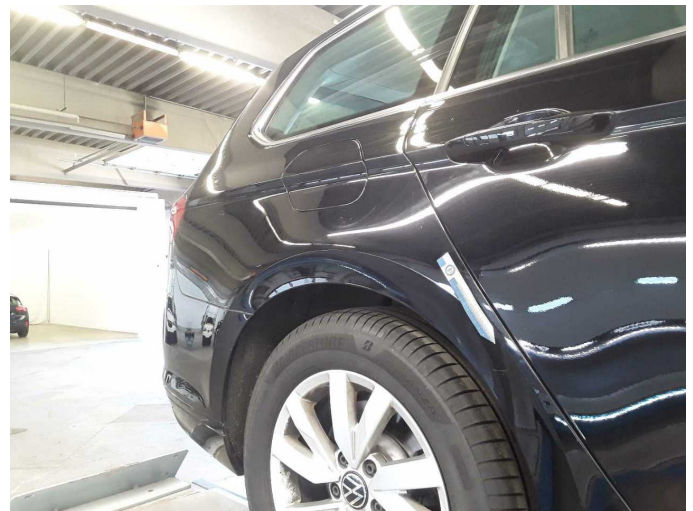
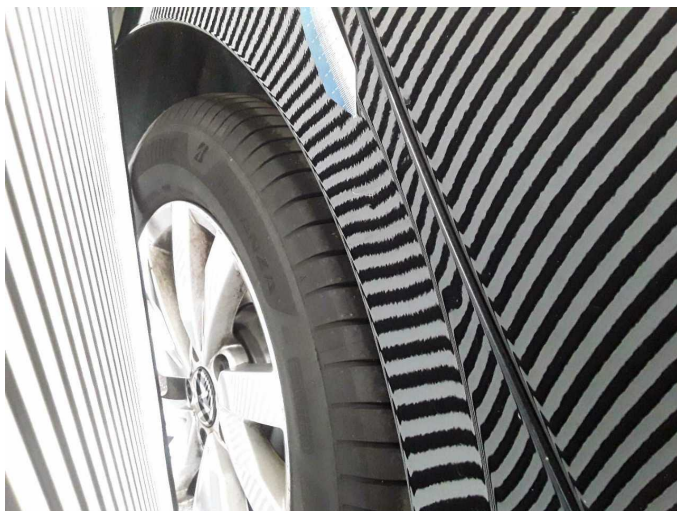
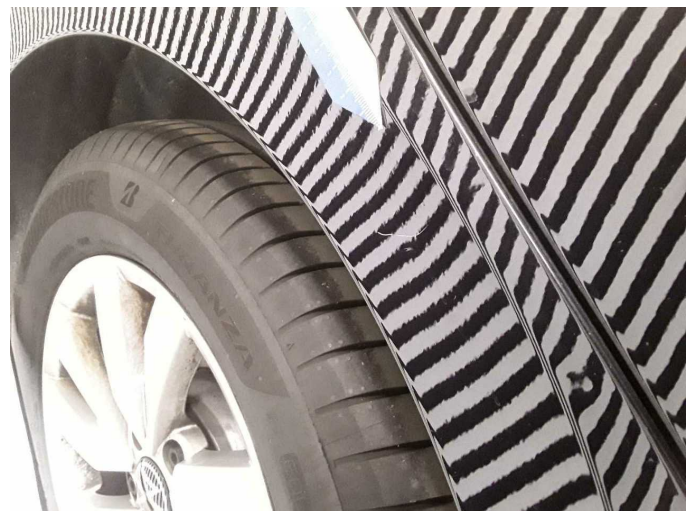
| No. | Component group | Description |
|---|---|---|
| 5 | Side panel - rear right side | Side panel - Dent / paintcoat damage - Repair and paint |

**Damage 5:** Side panel - rear right side: Side panel - Dent / paintcoat damage - Repair and paint

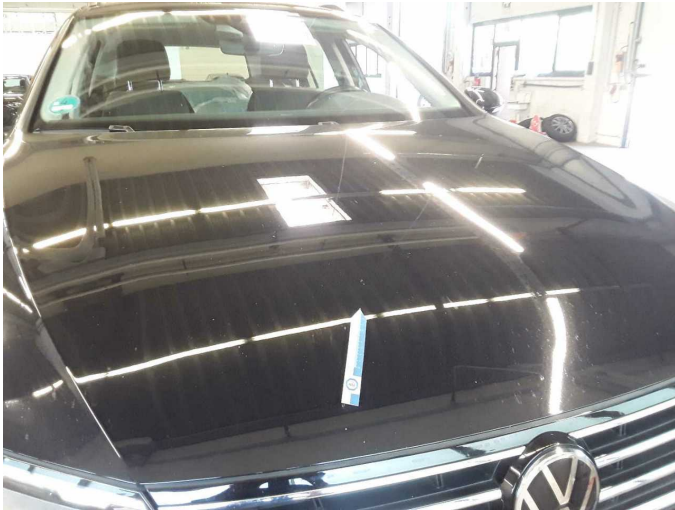
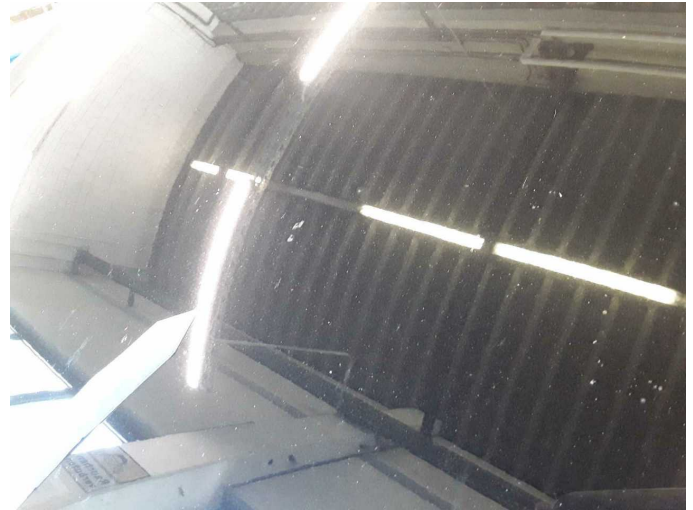
| No. | Component group | Description |
|---|---|---|
| 1 | Bonnet | Bonnet - Stone chips - No deduction |

**Wear and tear 1:** Bonnet: Bonnet - Stone chips - No deduction

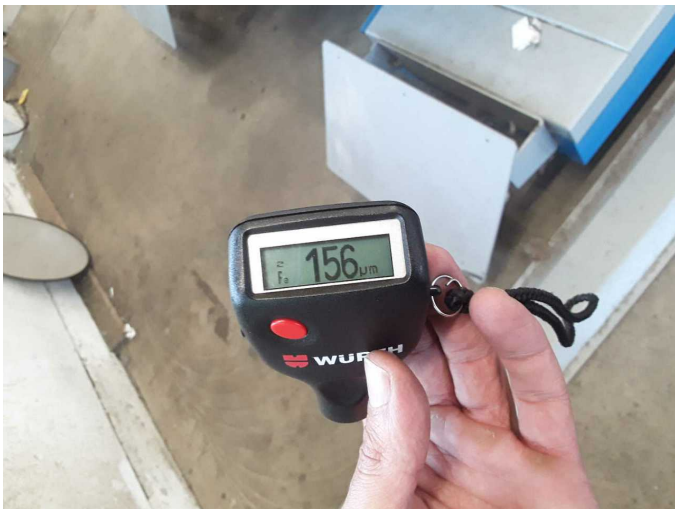
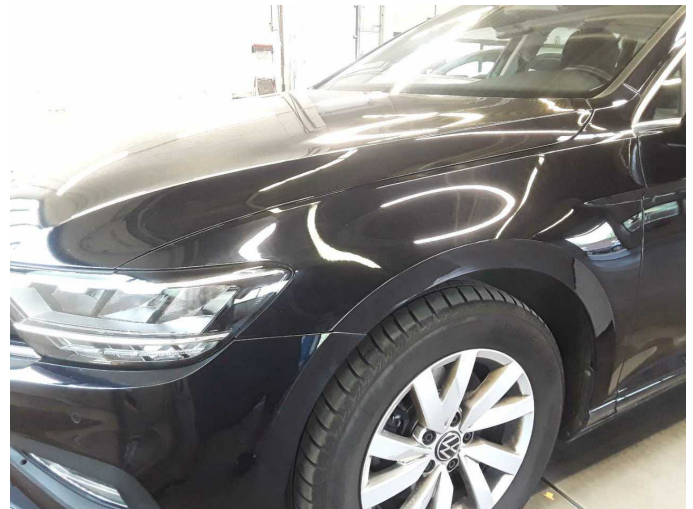
1 Mudguard - left side, Professionally carried out, Invoice of repair done Non-existent

**Repainting 1:** Mudguard - left side
