Expertise

Protocol number: 46838592  
Order No. / Reference: 26580685  
Inspection date: 31 Jul 2026

Manufacturer: Opel

Model: Insignia Sports Tourer 2.0 Diesel 4x4 Aut. Business

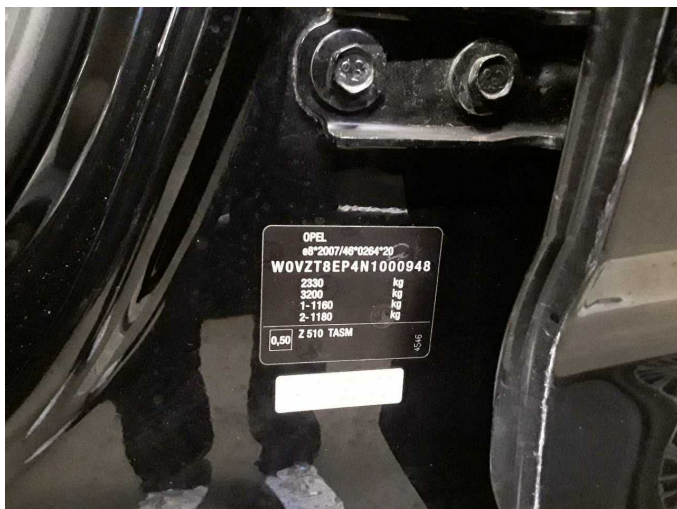
Figure 11: VIN

| VIN comparison | The vehicle identification number (VIN) was read from the vehicle and its conformity with the submitted documents was confirmed by the undersigned during the inspection. |

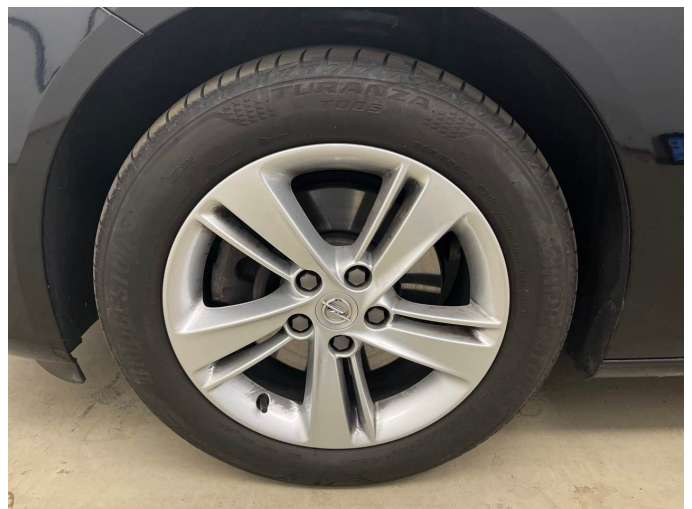
Figure 12: Mounted tyres

| # | Tyre size | Type of tyre | Manufacturer | Tread depth |
|---|---|---|---|---|
| 1) | 225/55 R17 97W | Summer tyres on Light alloy | Bridgestone | 3mm / 3mm |
| 2) | 225/55 R17 97W | Summer tyres on Light alloy | Bridgestone | 3mm / 3mm |

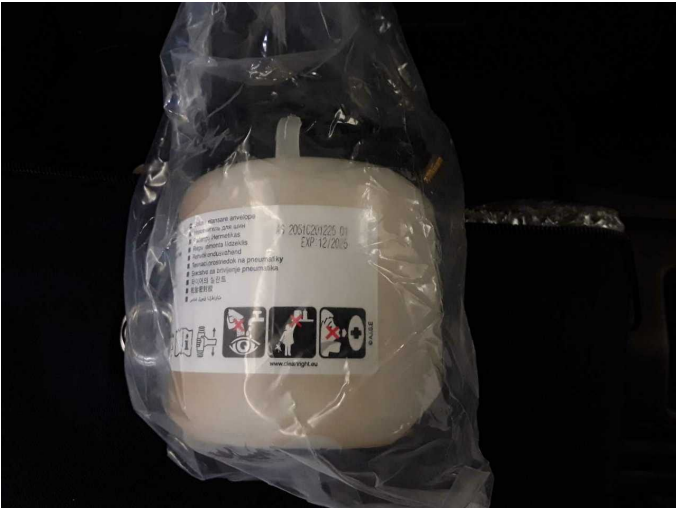
Damage 1: Equipment: Tirefit filler - Expired - Replace

| No. | Component group | Description |
|---|---|---|
| 1 | Equipment | Tirefit filler - Expired - Replace |

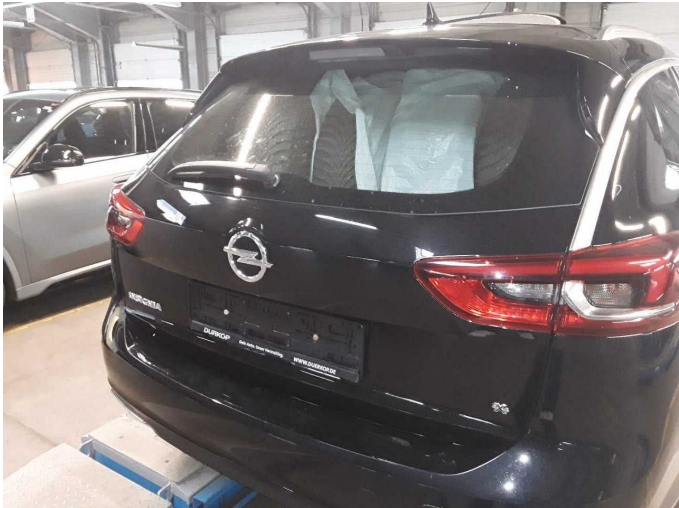
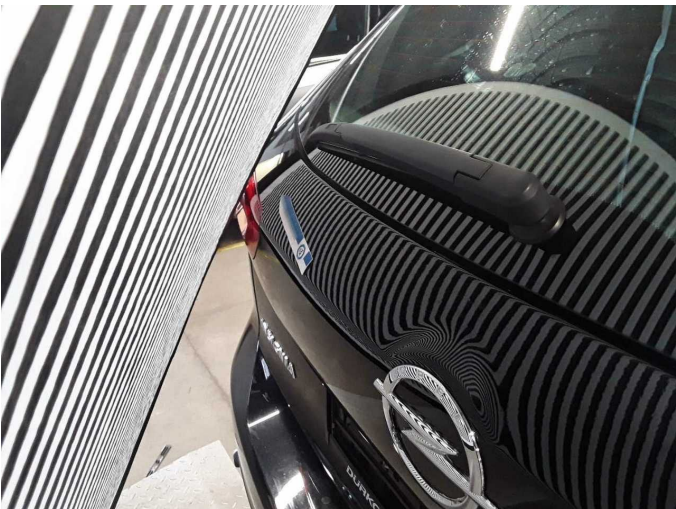
Damage 2: Boot lid / rear door: Boot lid - dent(s) - Smooth repair work

| No. | Component group | Description |
|---|---|---|
| 2 | Boot lid / rear door | Boot lid - dent(s) - Smooth repair work |

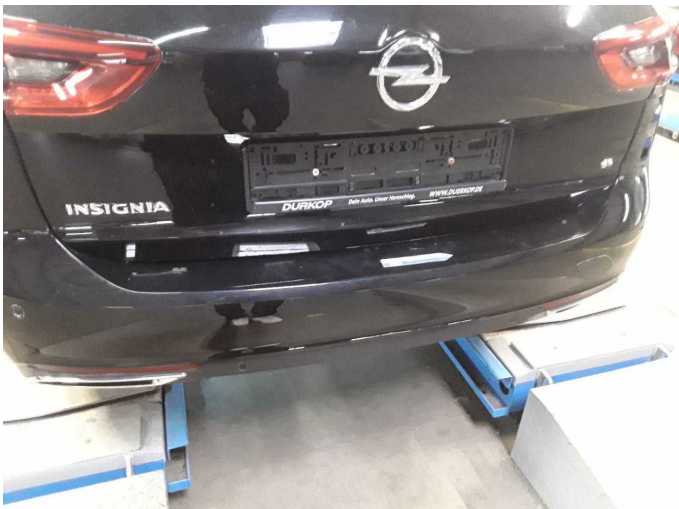
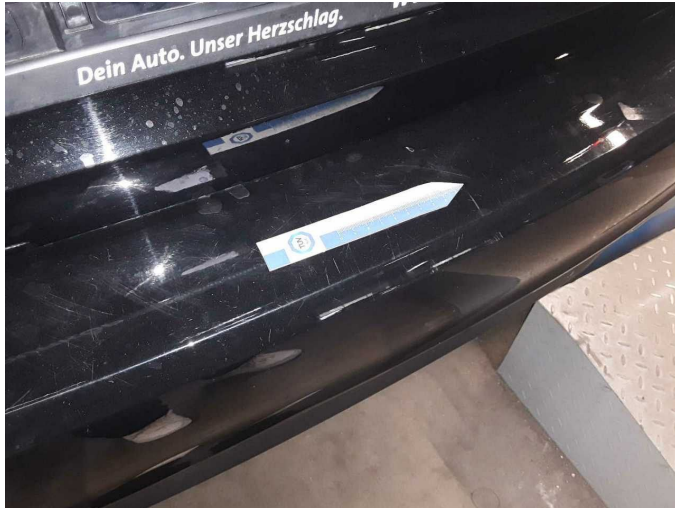
Damage 4: Rear bumper: Rear bumper - Scratch(es) - Paint

**Damage 4:** Rear bumper: Rear bumper - Scratch(es) - Paint

| No. | Component group | Description |
|---|---|---|
| 4 | Rear bumper | Rear bumper - Scratch(es) - Paint |

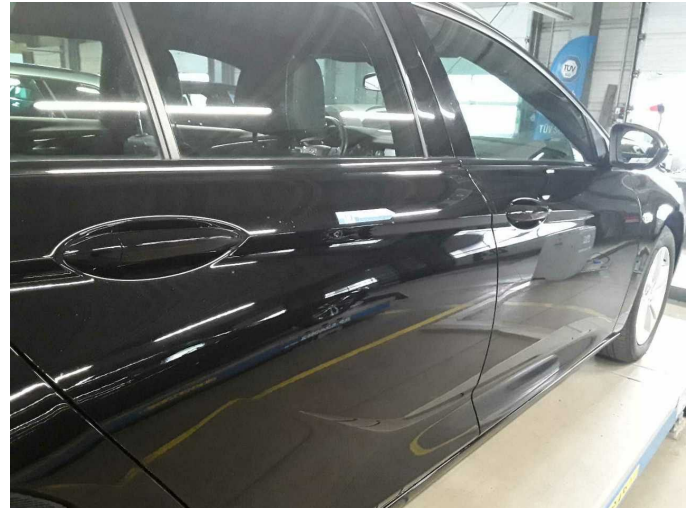
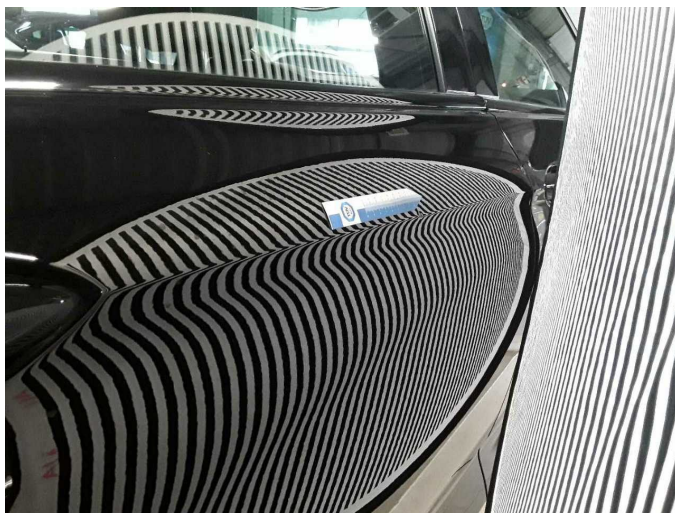
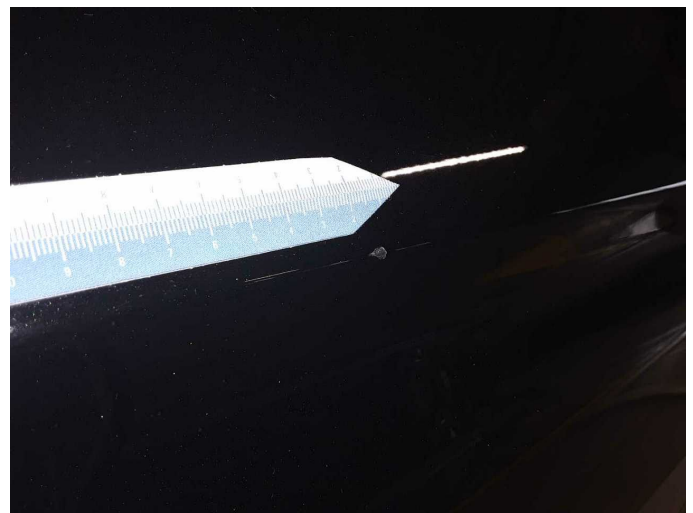
**Damage 5:** Door - rear right side: Door - Dent / paintcoat damage - Repair and paint

| No. | Component group | Description |
|---|---|---|
| 5 | Door - rear right side | Door - Dent / paintcoat damage - Repair and paint |

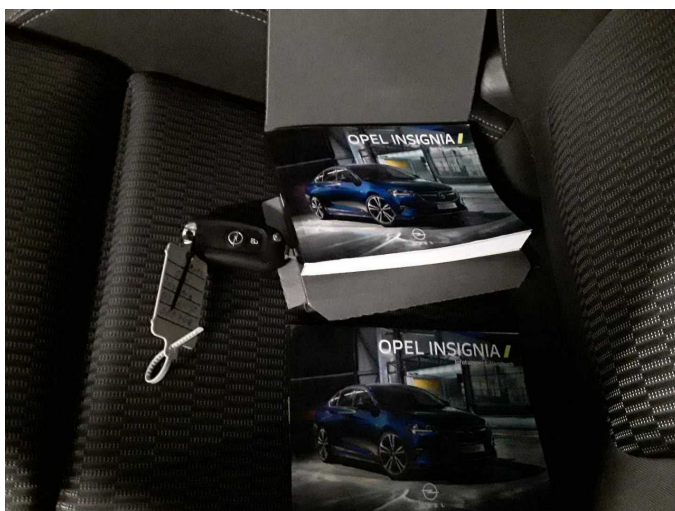
**Missing part 1:** Equipment: Vehicle key - Missing - Replace

Equipment - Vehicle key
