Expertise

Protocol number: 46294580  
Order No. / Reference: 26626938  
Inspection date: 2 Jul 2026

Model: Mondeo Turnier 2.0 EcoBlue Titanium

VIN: WF0FXXWPCFLT32769

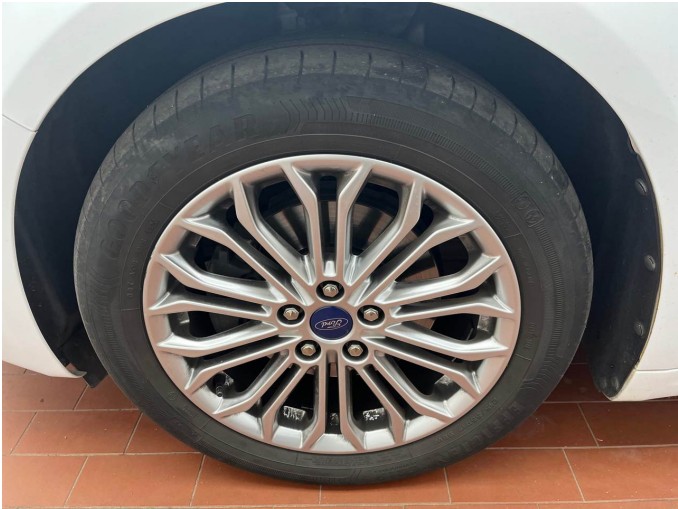
| # | Tyre size | Type of tyre | Manufacturer | Tread depth |
|---|---|---|---|---|
| 1) | 215/55 R17 98W | Summer tyres on Light alloy | Goodyear | 4mm / 4mm |
| 2) | 215/55 R17 98W | Summer tyres on Light alloy | Goodyear | 5mm / 5mm |

Figure 12: Mounted tyres

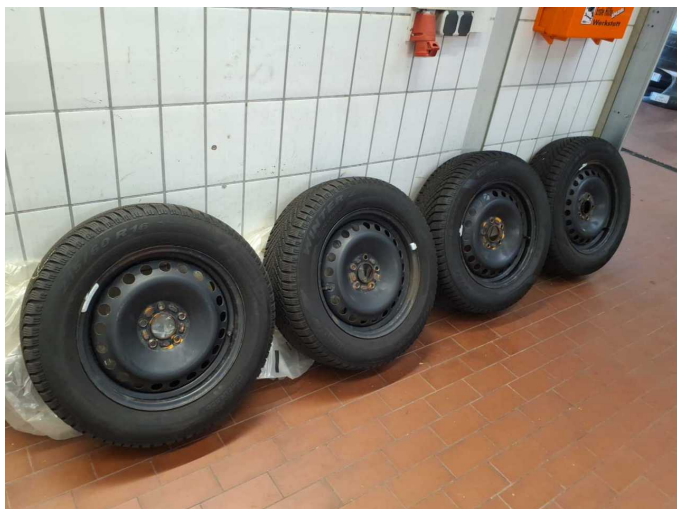
| # | Tyre size | Type of tyre | Manufacturer | Tread depth |
|---|---|---|---|---|
| 1) | 215/60 R16 99H | Winter tyres on Steel | Pirelli | 6mm / 6mm |
| 2) | 215/60 R16 99H | Winter tyres on Steel | Pirelli | 7mm / 7mm |

Figure 17: Additional tyres

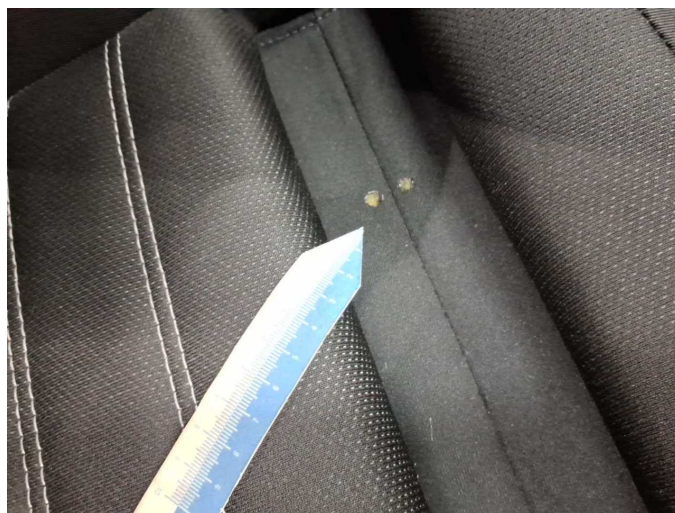
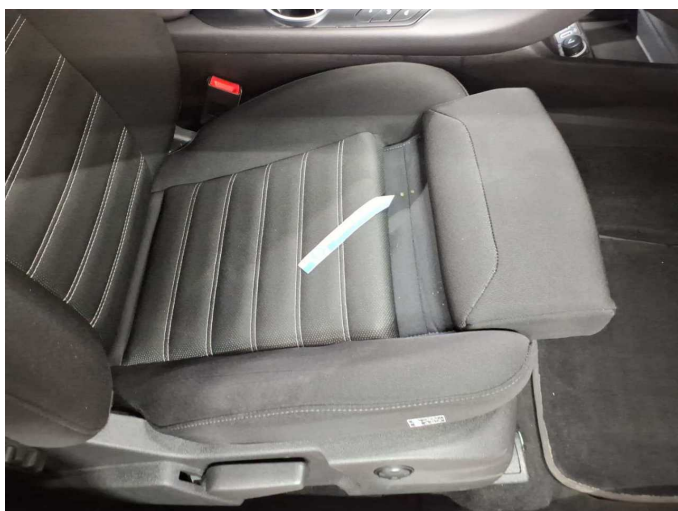
Damage 1: Seat - front: Seat cover - right side - Burn hole (cigarettes) - Smart repair

| No. | Component group | Description |
|---|---|---|
| 1 | Seat - front | Seat cover - right side - Burn hole (cigarettes) - Smart repair |

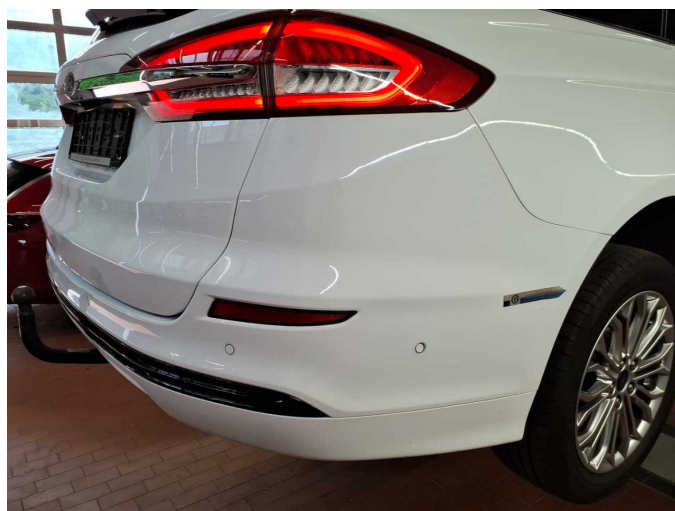
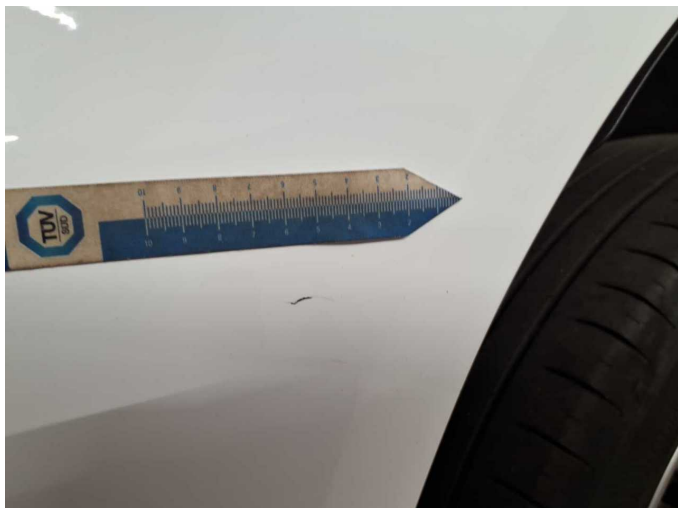
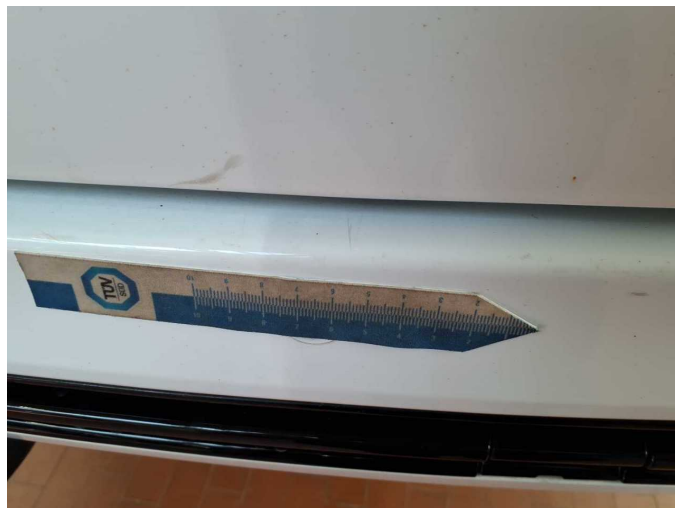
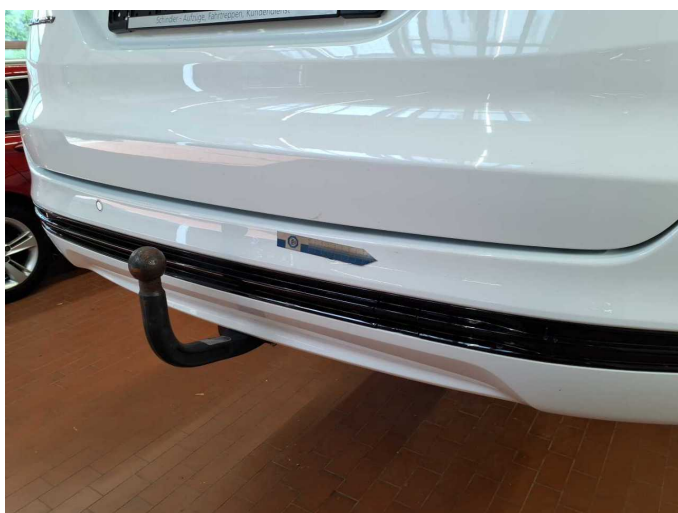
Damage 2: Rear bumper: Rear bumper - Scratch(es) - Smart repair

**Damage 2:** Rear bumper: Rear bumper - Scratch(es) - Smart repair

| No. | Component group | Description |
|---|---|---|
| 2 | Rear bumper | Rear bumper - Scratch(es) - Smart repair |

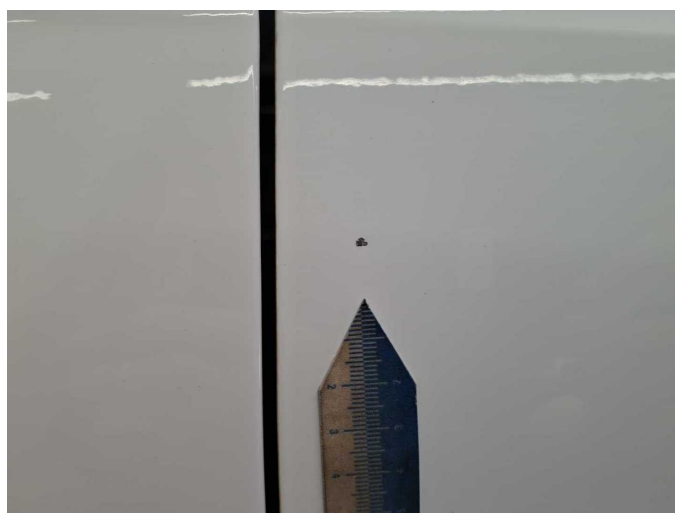
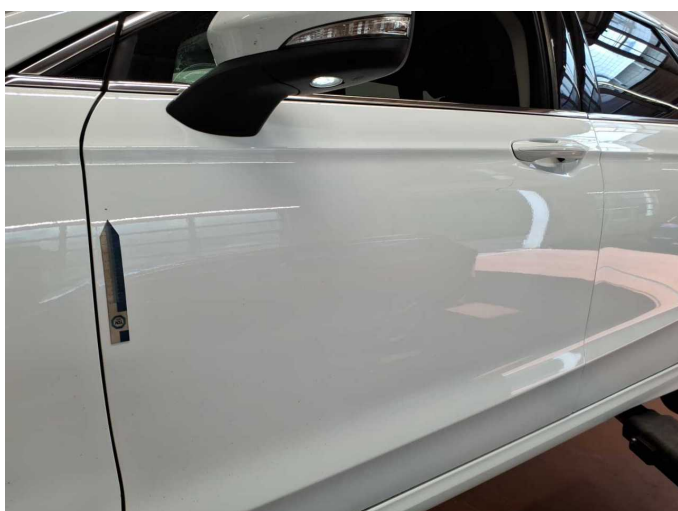
**Damage 3:** Door - front left side: Door - Scratch(es) - Smart repair

| No. | Component group | Description |
|---|---|---|
| 3 | Door - front left side | Door - Scratch(es) - Smart repair |

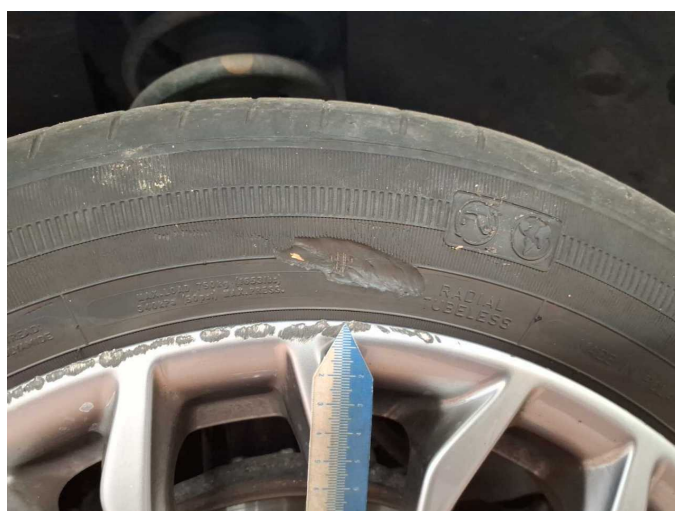
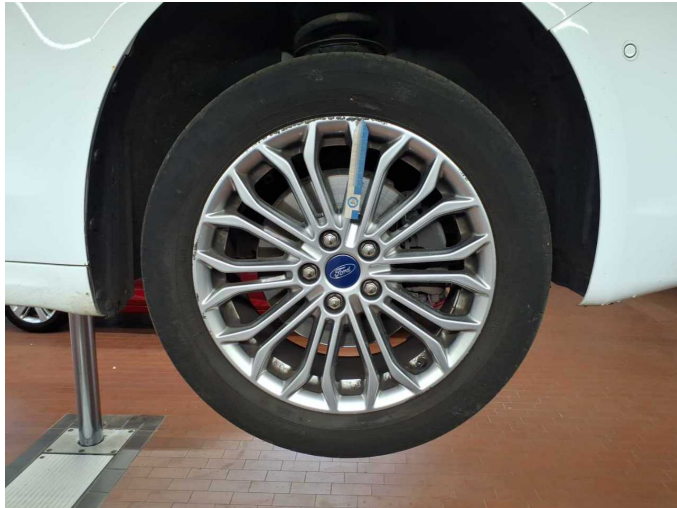
**Damage 4:** Wheel / tyres: Tyre - front right side - Broken / torn - Replace

| No. | Component group | Description |
|---|---|---|
| 4 | Wheel / tyres | Tyre - front right side - Broken / torn - Replace |

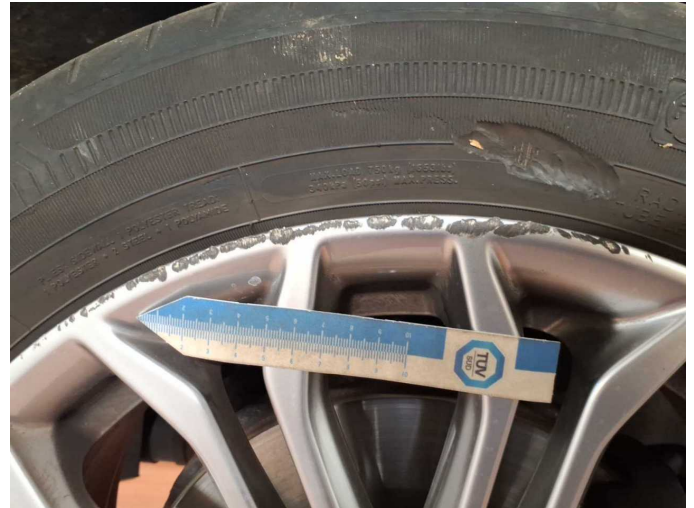
**Damage 5:** Wheel / tyres: Alloy rim - front right side - Scratched - Replace

| No. | Component group | Description |
|---|---|---|
| 5 | Wheel / tyres | Alloy rim - front right side - Scratched - Replace |

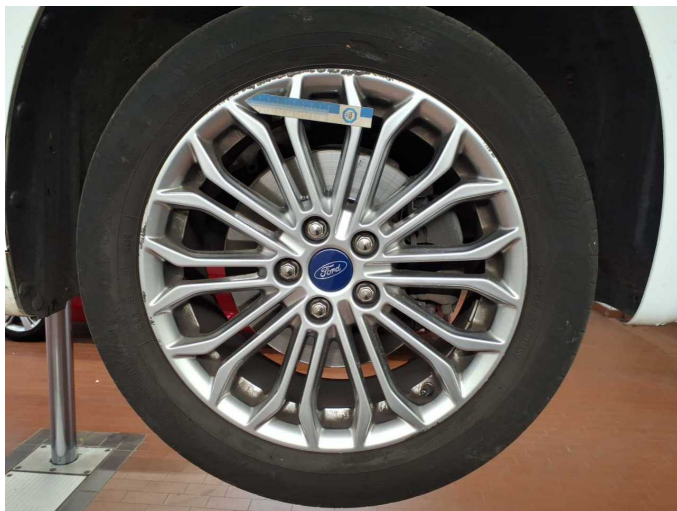
**Damage 5:** Wheel / tyres: Alloy rim - front left side - Scratched - Replace

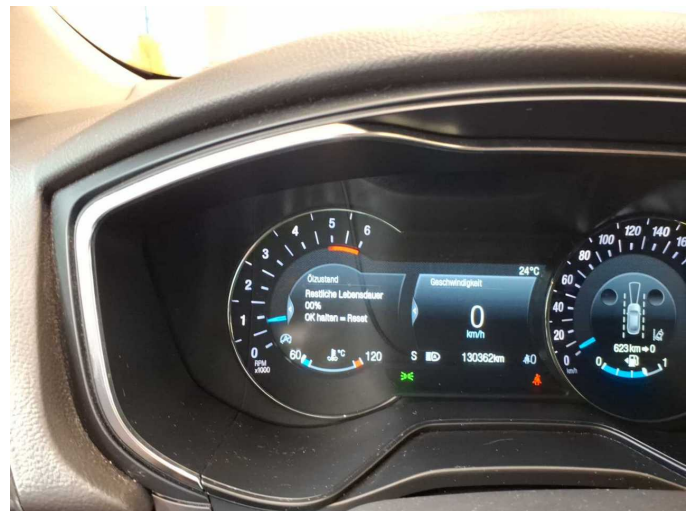
**Damage 6:** Misc.: Inspection / maintenance - Due - Perform

| No. | Component group | Description |
|---|---|---|
| 6 | Misc. | Inspection / maintenance - Due - Perform |

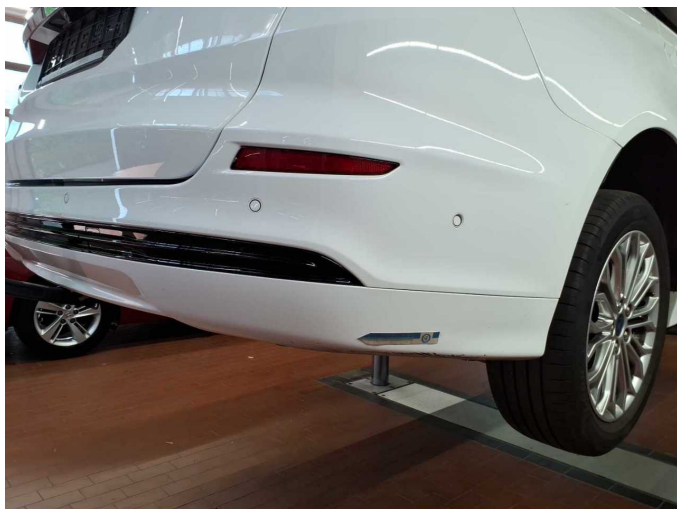
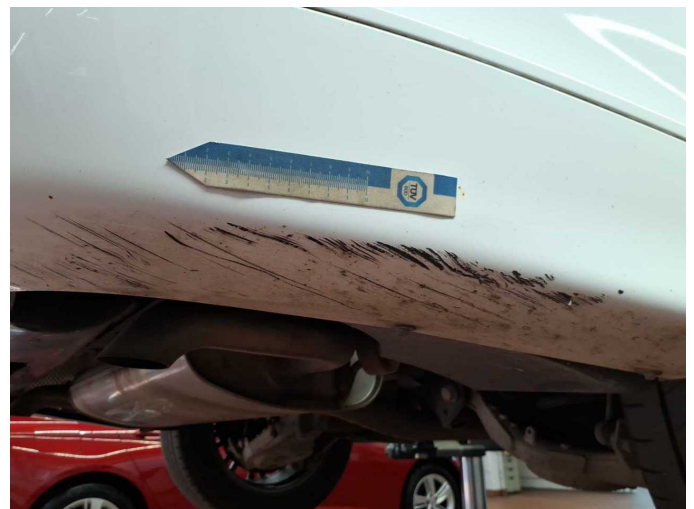
**Damage 7:** Rear bumper: Spoiler - Scratch(es) - Paint

| No. | Component group | Description |
|---|---|---|
| 7 | Rear bumper | Spoiler - Scratch(es) - Paint |

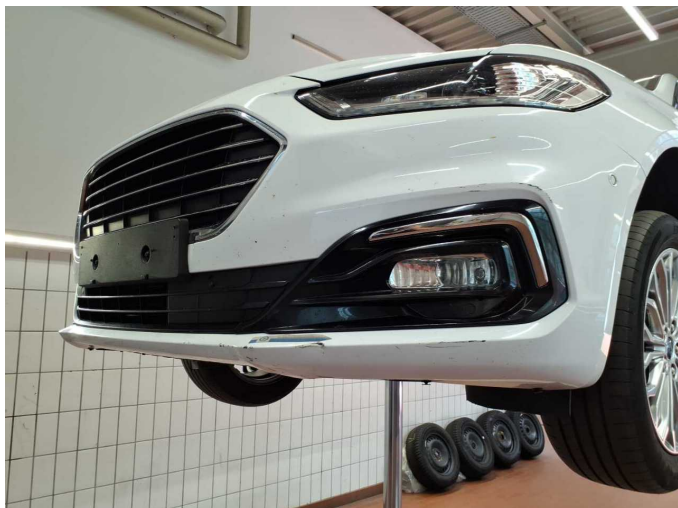
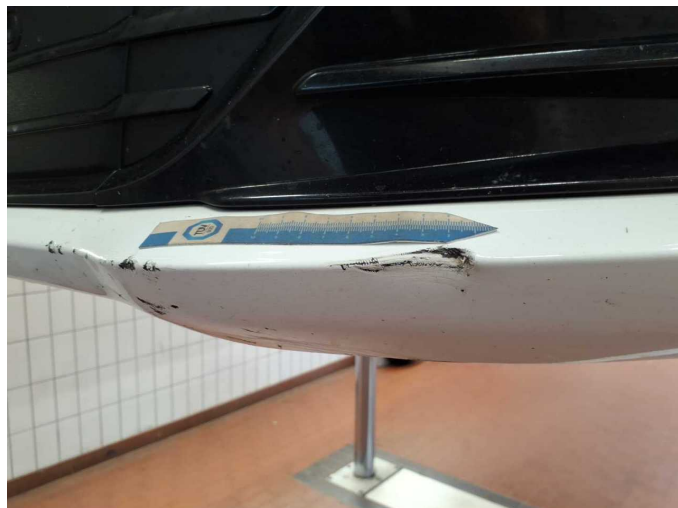
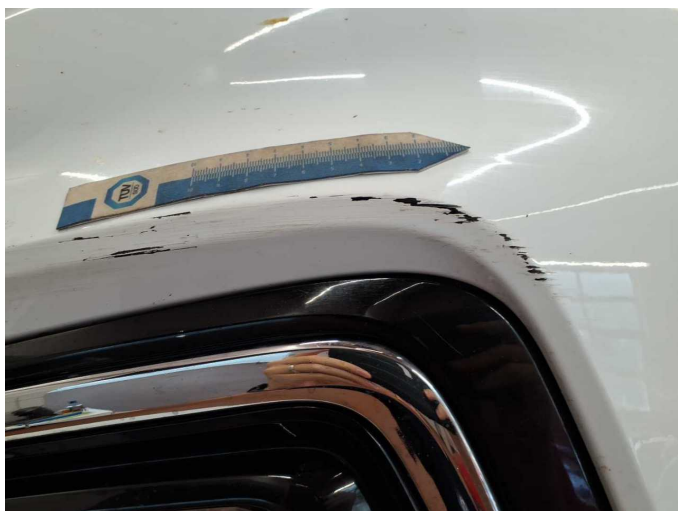
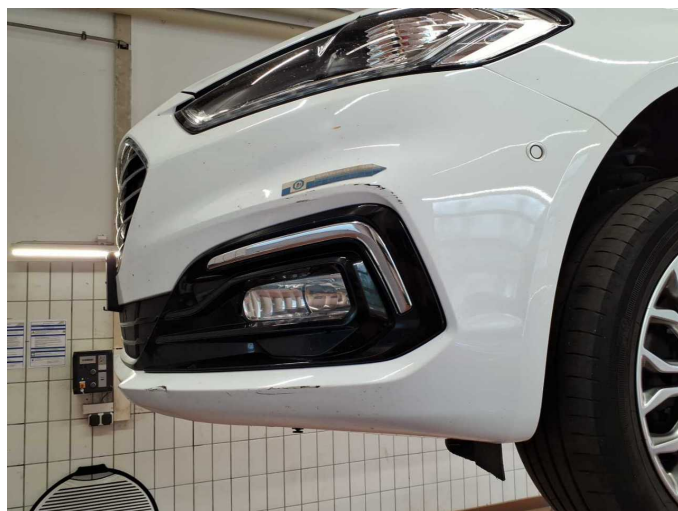
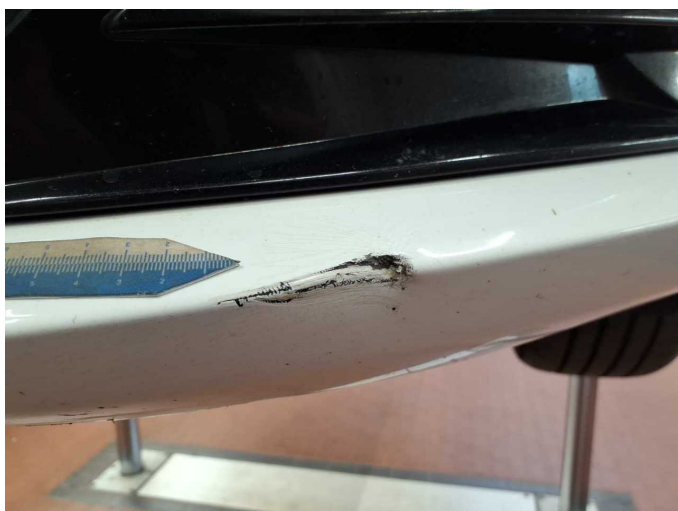
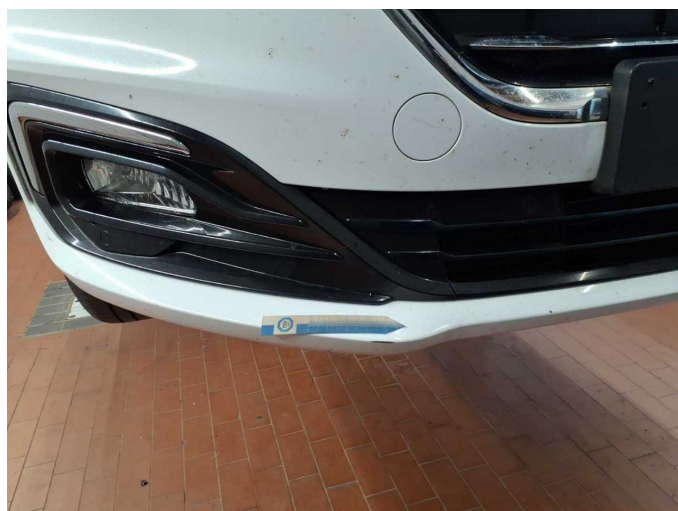
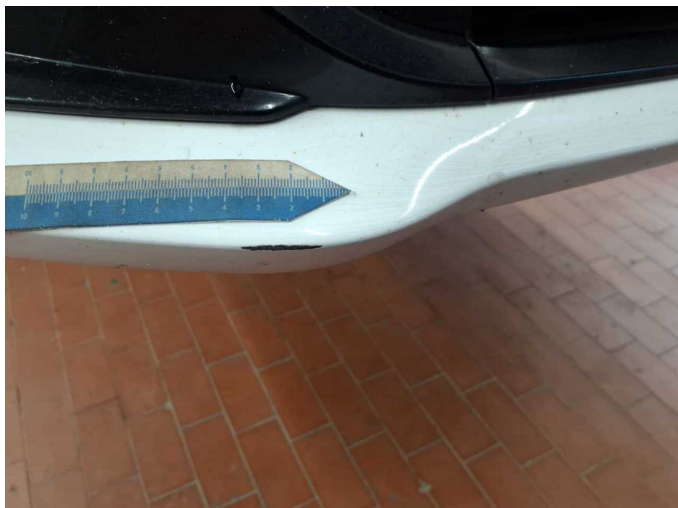
**Damage 8:** Front bumper: Front bumper - Deformed - Replace

| No. | Component group | Description |
|---|---|---|
| 8 | Front bumper | Front bumper - Deformed - Replace |

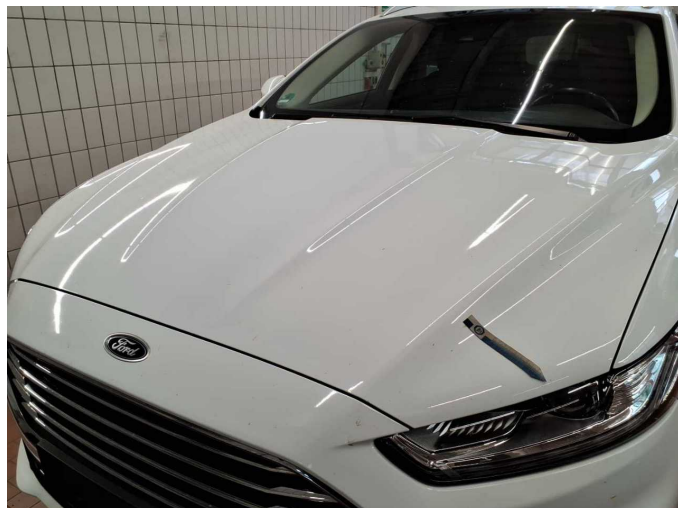
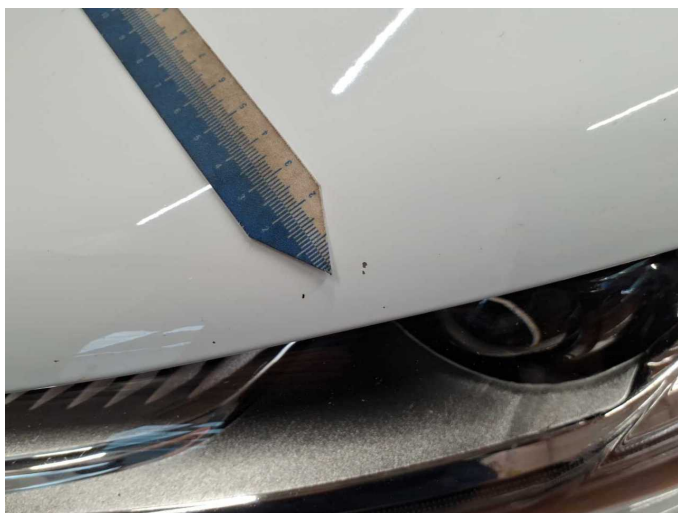
| No. | Component group | Description |
|---|---|---|
| 2 | Bonnet | Bonnet - Stone chips - No deduction |

**Wear and tear 2:** Bonnet: Bonnet - Stone chips - No deduction

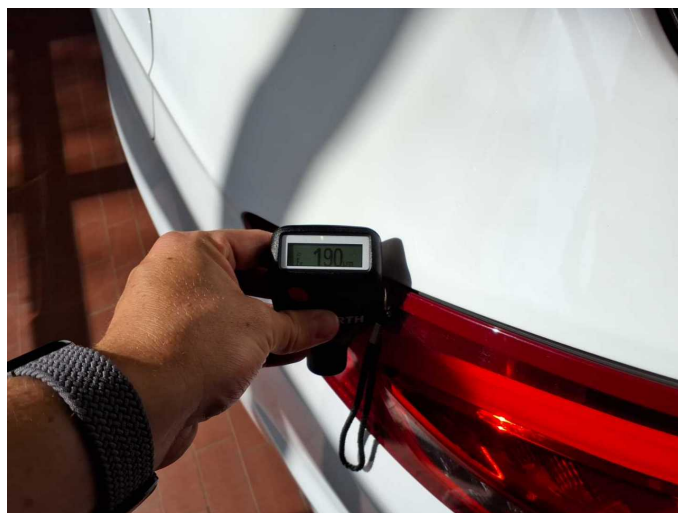
- 1 Side panel - rear left side, Professionally carried out, Invoice of repair done Non-existent
- 2 Side panel - rear right side, Professionally carried out, Invoice of repair done Non-existent
- 3 Door - rear right side, Professionally carried out, Invoice of repair done Non-existent

| Side panel - rear left side | 190 µm | Side panel - rear right side | 193 µm |

**Repainting 1:** Side panel - rear left side

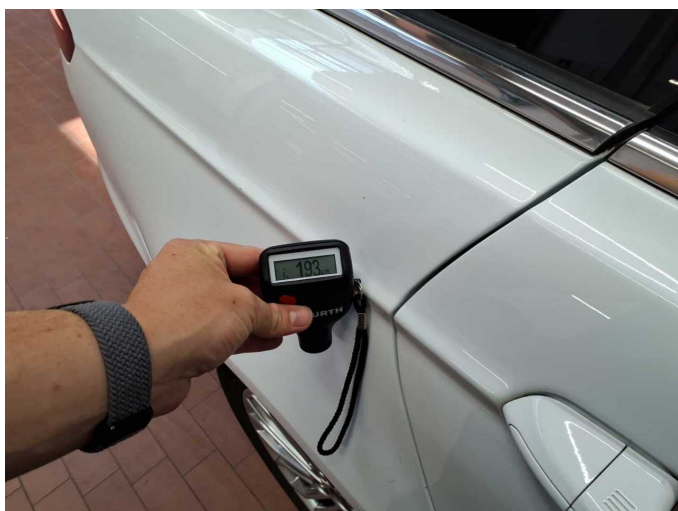
**Repainting 2:** Side panel - rear right side

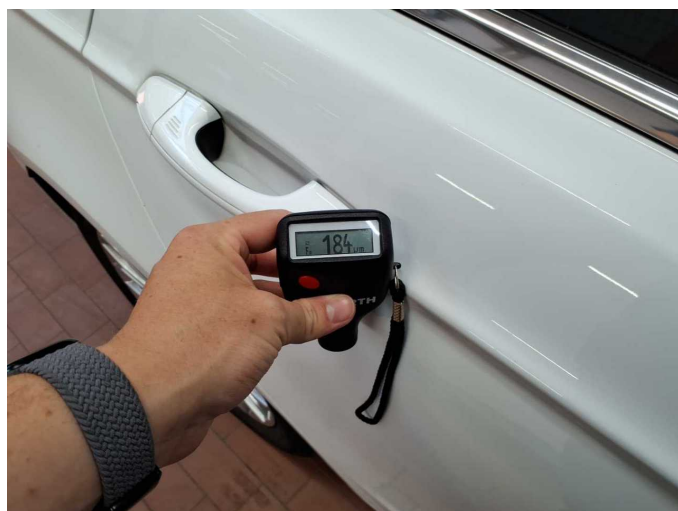
| Door - rear right side | 184 µm | | |

**Repainting 3:** Door - rear right side
