## Expertise

Protocol number: 46130872  
Order No. / Reference: 26430796  
Inspection date: 18 Jun 2026

Model: Insignia Sports Tourer 2.0 Diesel Aut. Business Edition

VIN: W0VZM8EP0M1026054

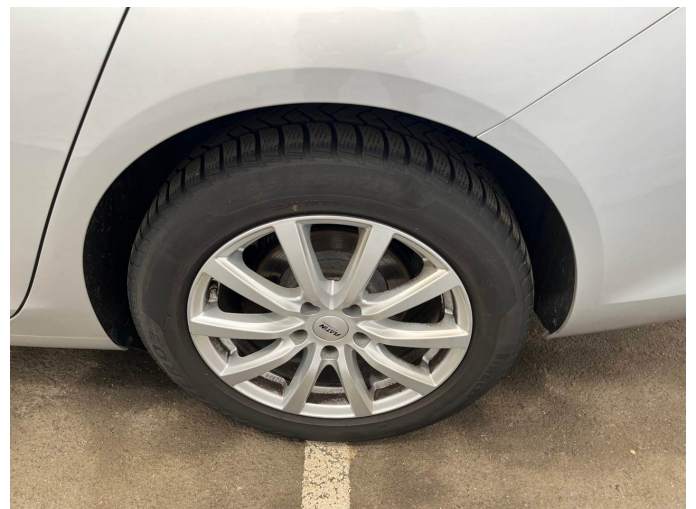
Figure 12: Mounted tyres

| # | Tyre size | Type of tyre | Manufacturer | Tread depth |
|---|---|---|---|---|
| 1) | 225/55 R17 101V | Winter tyres on Light alloy | Pirelli | 6mm / 6mm |
| 2) | 225/55 R17 101V | Winter tyres on Light alloy | Pirelli | 5mm / 5mm |

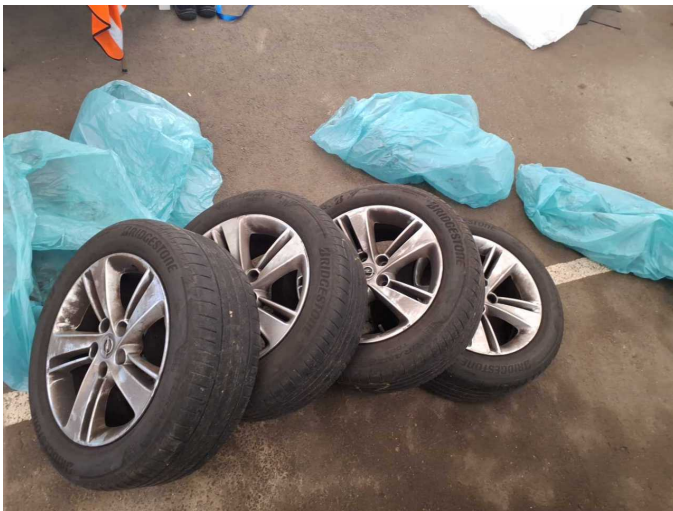
Figure 15: Additional tyres

| # | Tyre size | Type of tyre | Manufacturer | Tread depth |
|---|---|---|---|---|
| 1) | 225/55 R17 97W | Summer tyres on Light alloy | Bridgestone | 4mm / 4mm |
| 2) | 225/55 R17 97W | Summer tyres on Light alloy | Bridgestone | 5mm / 5mm |

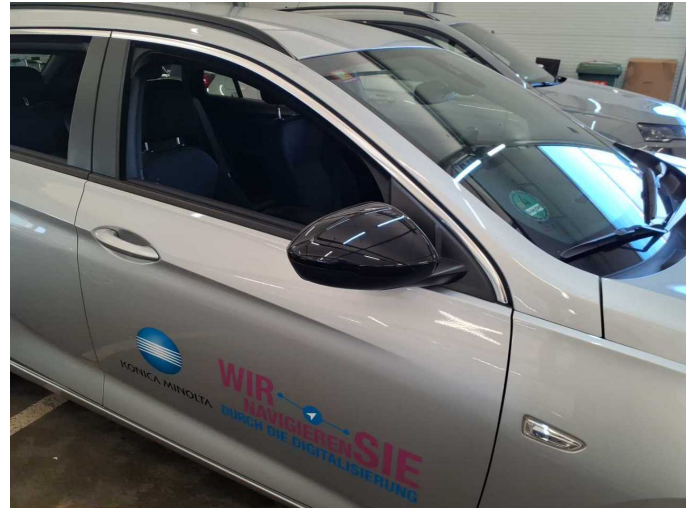
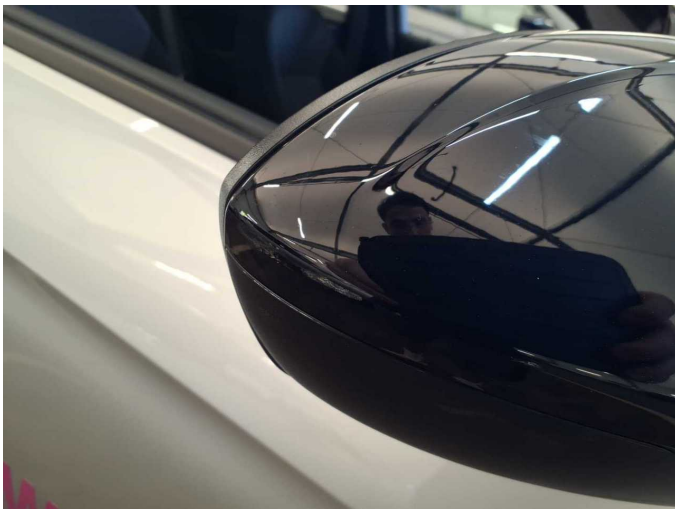
Damage 2: Wing mirror - right side: Cap - Scratch(es) - Smart repair

| No. | Component group | Description |
|---|---|--|
| 2 | Wing mirror - right side | Cap - Scratch(es) - Smart repair |

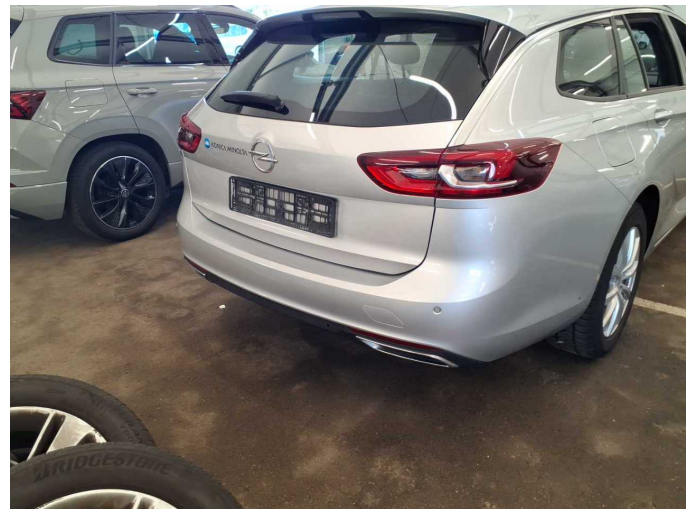
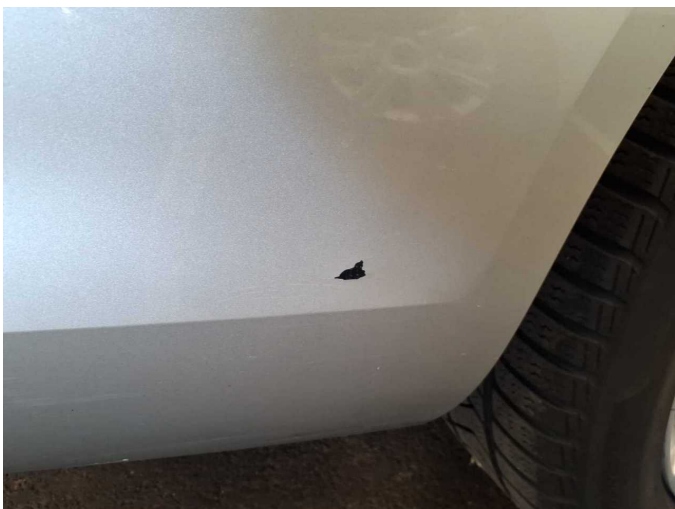
Damage 3: Rear bumper: Rear bumper - Scratched - Smart repair

| No. | Component group | Description |
|---|---|--|
| 3 | Rear bumper | Rear bumper - Scratched - Smart repair |

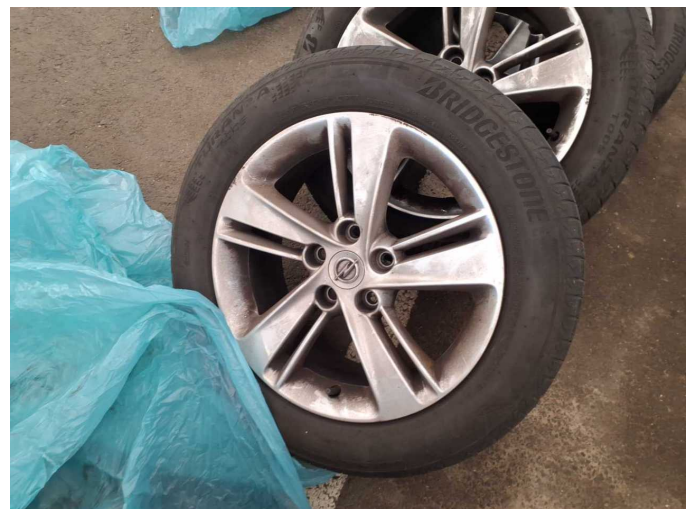
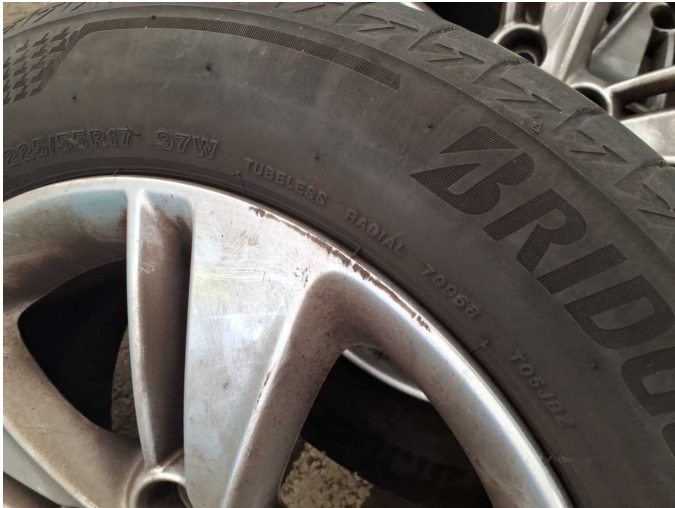
Damage 4: 2nd wheel set: 1 alloy rim - Scratch(es) - Loss in value

**Damage 4:** 2nd wheel set: 1 alloy rim - Scratch(es) - Loss in value

| No. | Component group | Description |
|---|---|--|
| 4 | 2nd wheel set | 1 alloy rim - Scratch(es) - Loss in value |

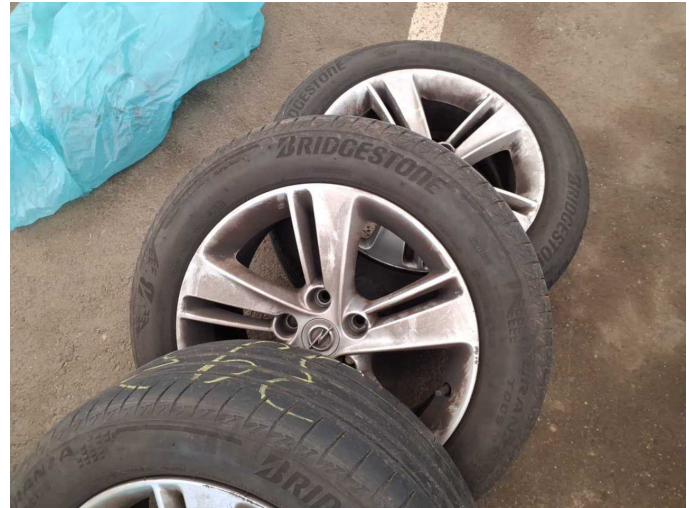
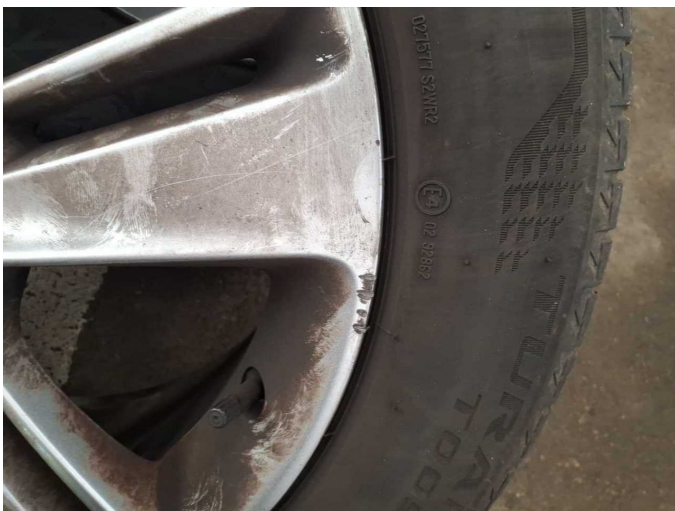
**Damage 5:** 2nd wheel set: 1 alloy rim - Scratch(es) - Loss in value

| No. | Component group | Description |
|---|---|--|
| 5 | 2nd wheel set | 1 alloy rim - Scratch(es) - Loss in value |

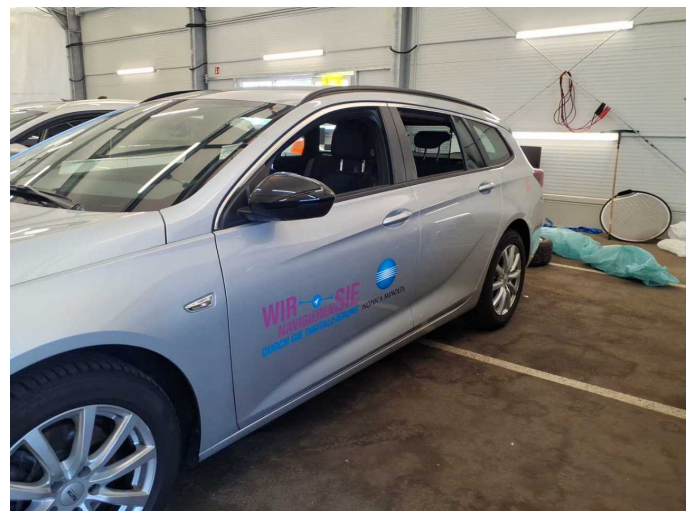
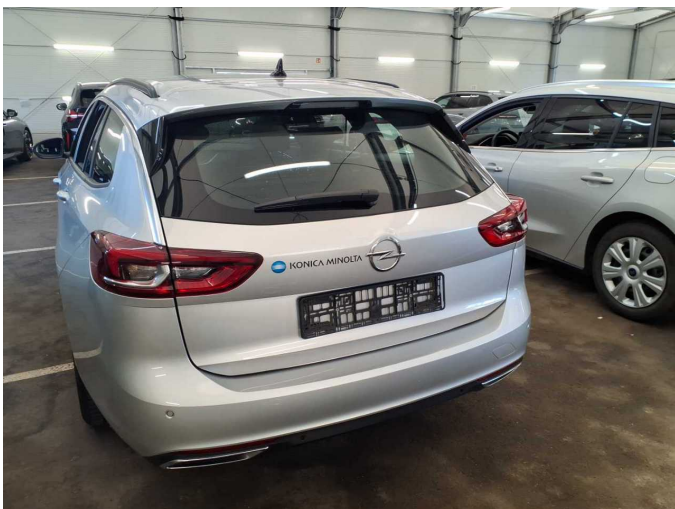
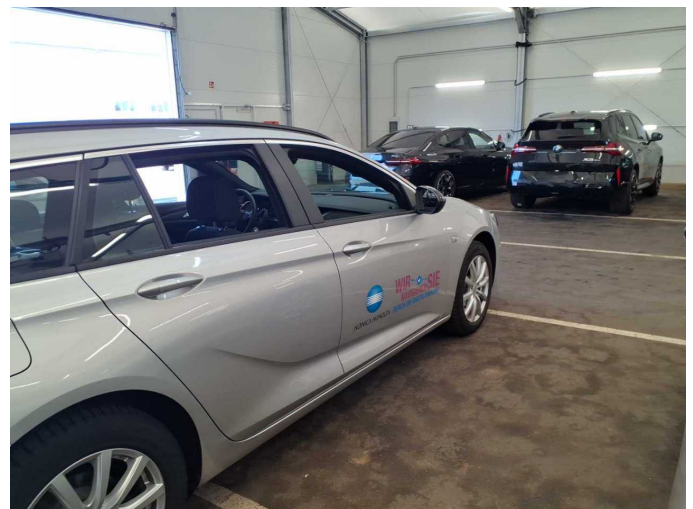
**Damage 6:** Body: Body - Glued / labelled - De-glug / neutralise

| No. | Component group | Description |
|---|---|--|
| 6 | Body | Body - Glued / labelled - De-glue / neutralise |
