## Expertise

Protocol number: 45506953  
Order No. / Reference: 26348573  
Inspection date: 19 May 2026

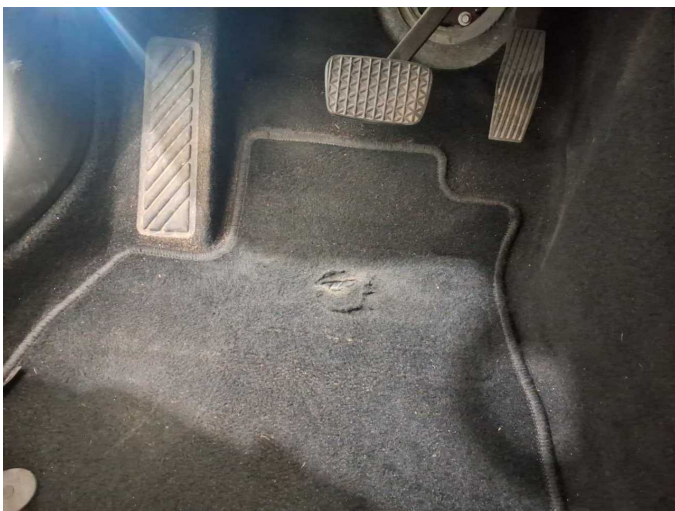
Damage 1: Trim / covers: Floor mats - Broken / torn - Replace

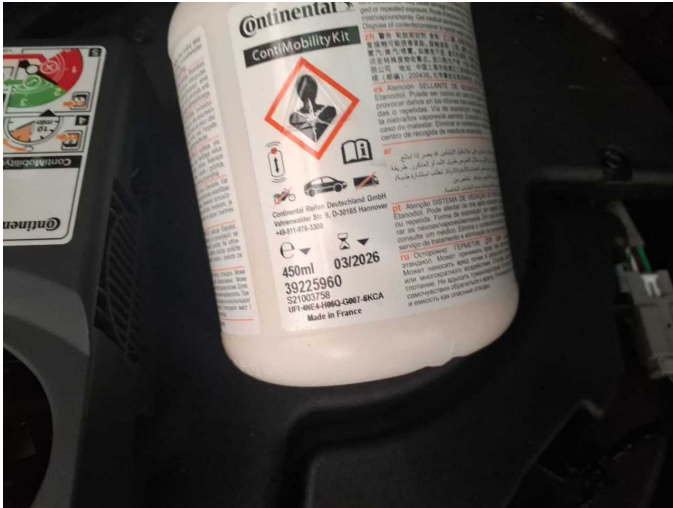
**Damage 2:** Equipment: Tirefit filler - Expired - Replace

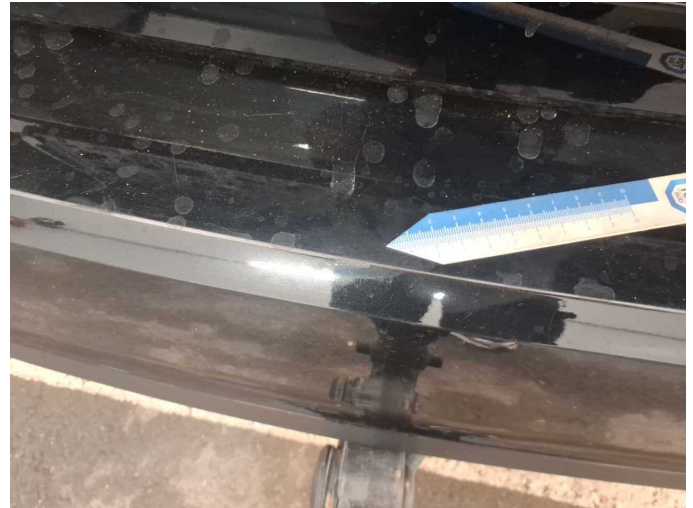
**Damage 3:** Rear bumper: Rear bumper - Scratch(es) - Smart repair

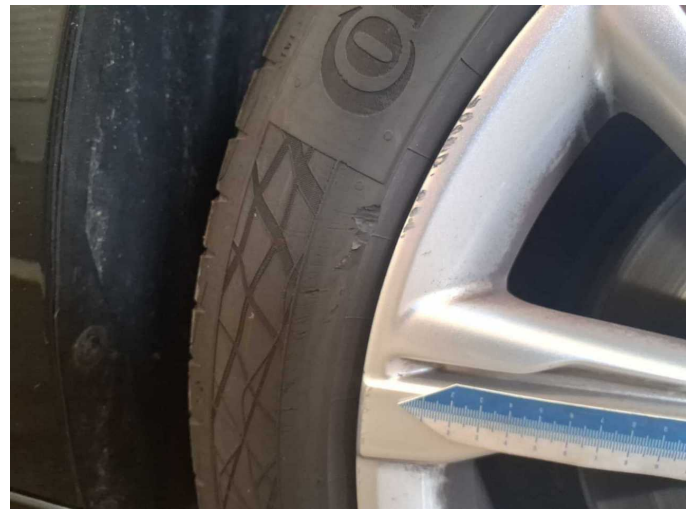
**Damage 4:** Wheel / tyres: Tyre - front right side - Broken / torn - Replace

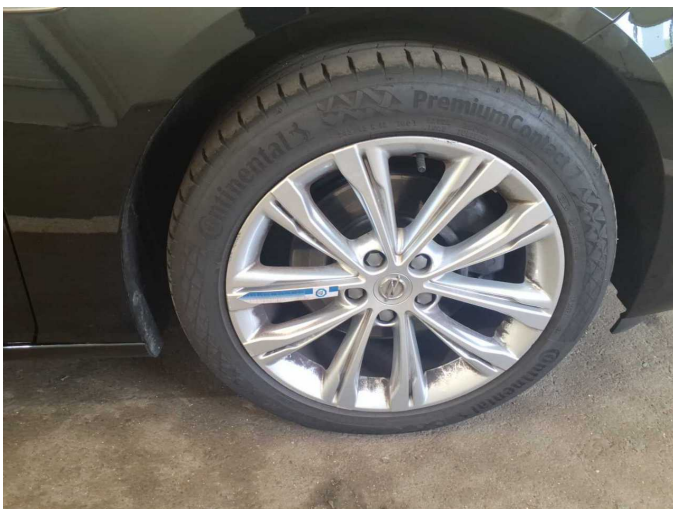
**Damage 4:** Wheel / tyres: Tyre - front right side - Broken / torn - Replace

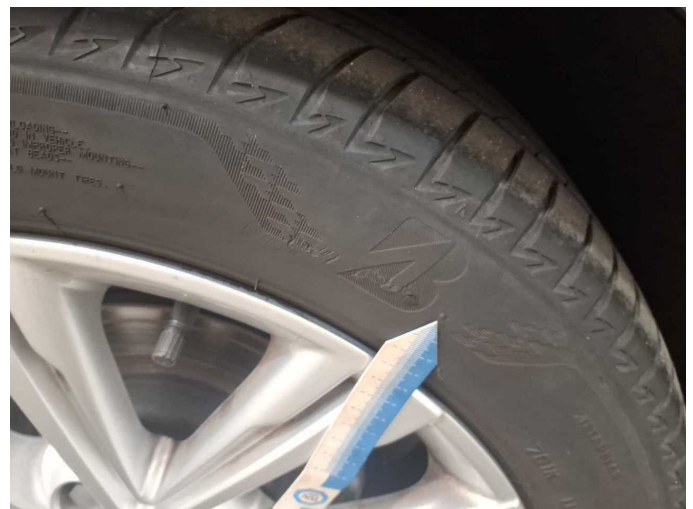
**Damage 5:** Wheel / tyres: Tyre - rear left side - Broken / torn - Replace

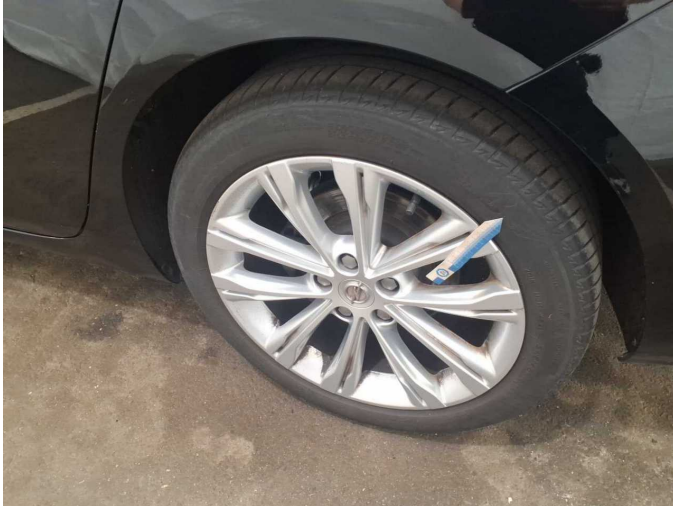
**Damage 5:** Wheel / tyres: Tyre - rear left side - Broken / torn - Replace

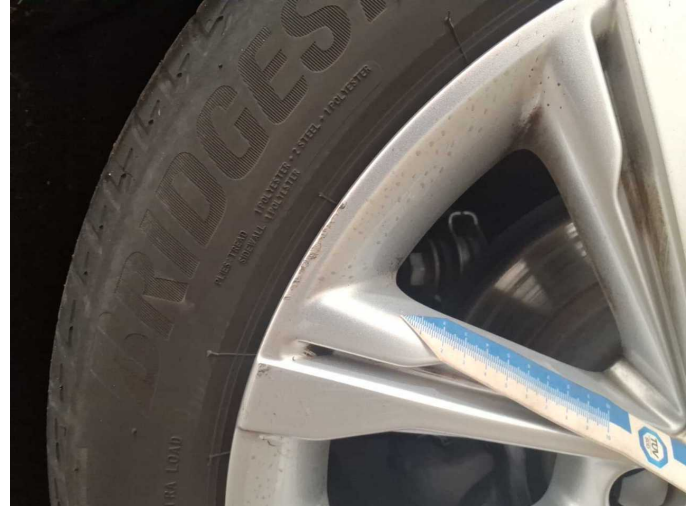
**Damage 6:** Wheel / tyres: Alloy rim - rear left side - Scratch(es) - Loss in value

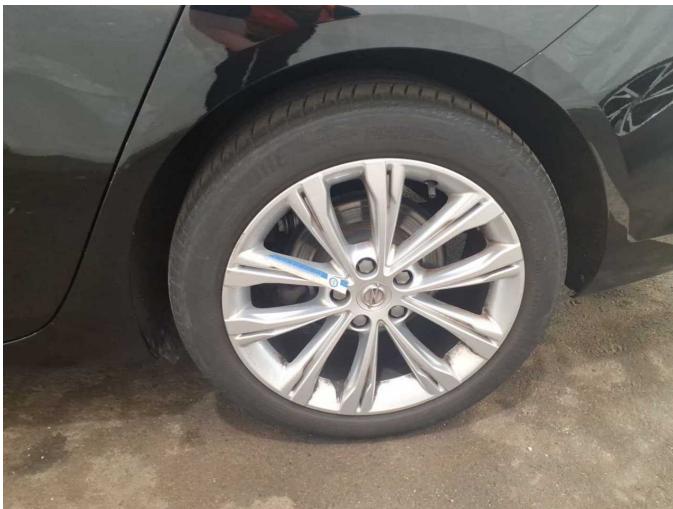
**Damage 6:** Wheel / tyres: Alloy rim - rear left side - Scratch(es) - Loss in value

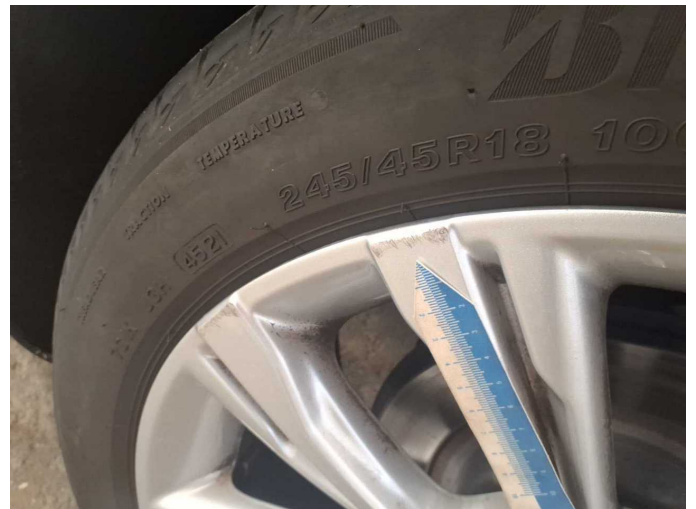
**Damage 7:** Wheel / tyres: Alloy rim - rear right side - Scratch(es) - Loss in value

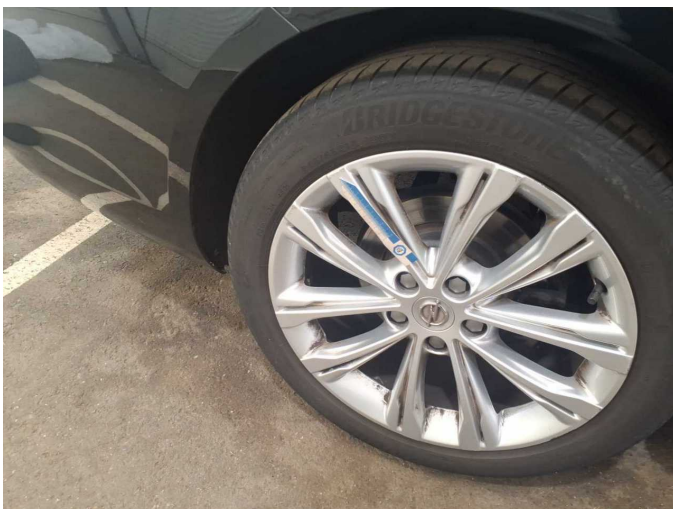
**Damage 7:** Wheel / tyres: Alloy rim - rear right side - Scratch(es) - Loss in value

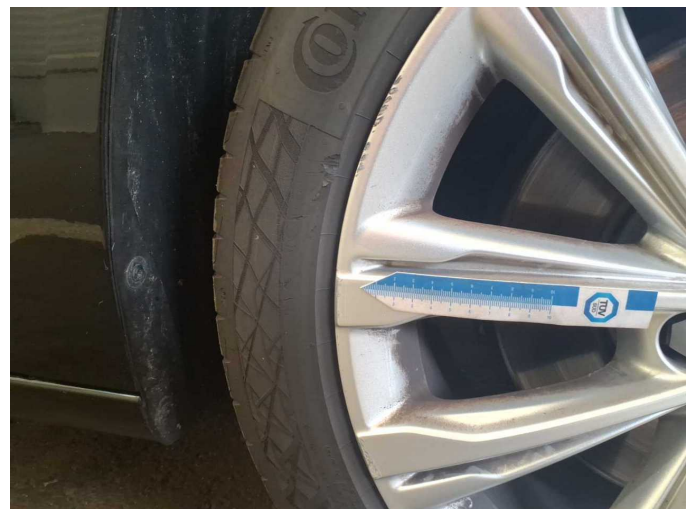
**Damage 8:** Wheel / tyres: Alloy rim - front right side - Scratch(es) - Loss in value

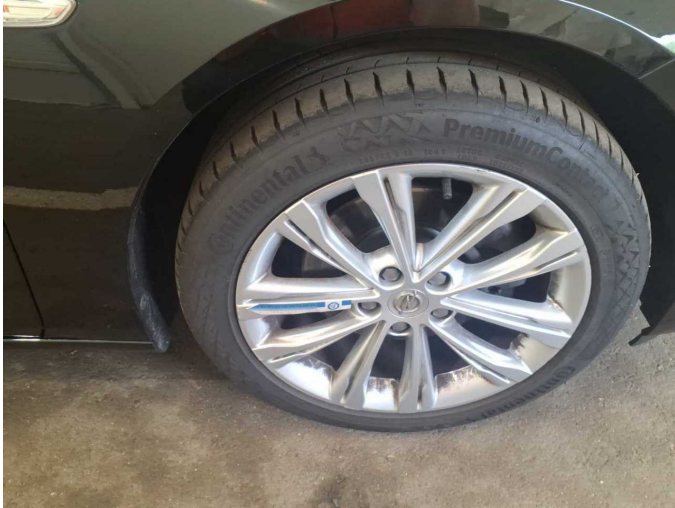
**Damage 8:** Wheel / tyres: Alloy rim - front right side - Scratch(es) - Loss in value

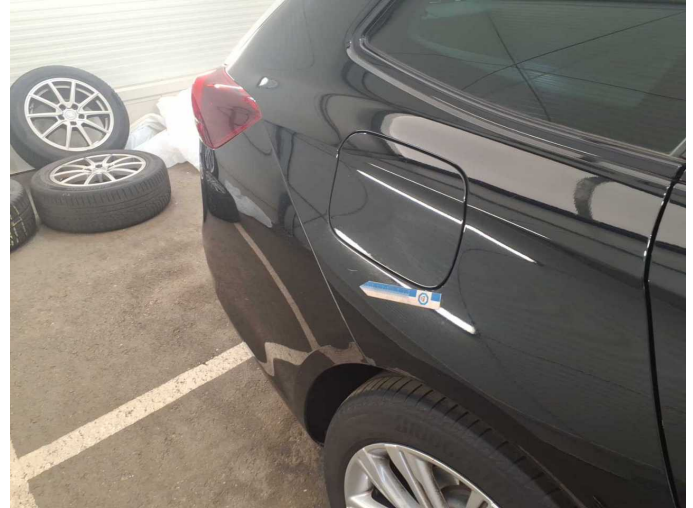
**Damage 9:** Side panel - rear right side: Side panel - Scratch(es) - Paint

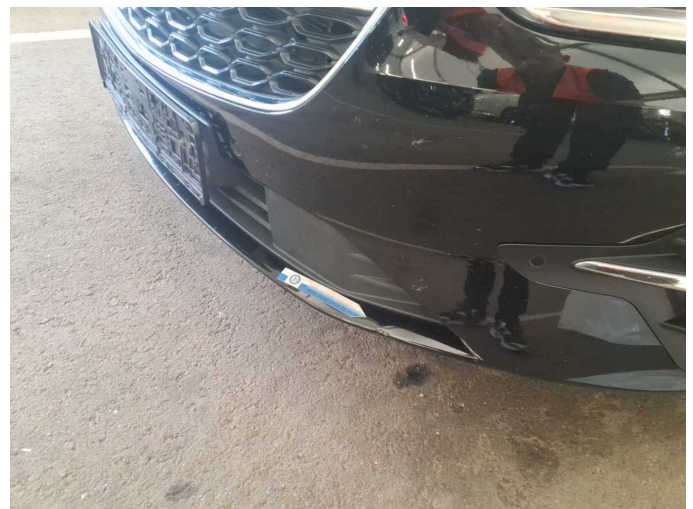
**Damage 10:** Front bumper: Front bumper - Scratched - Repair and paint

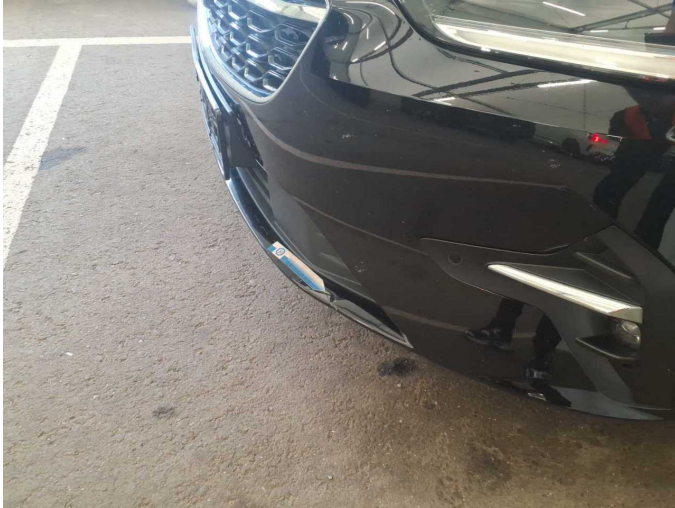
**Damage 10:** Front bumper: Front bumper - Scratched - Repair and paint

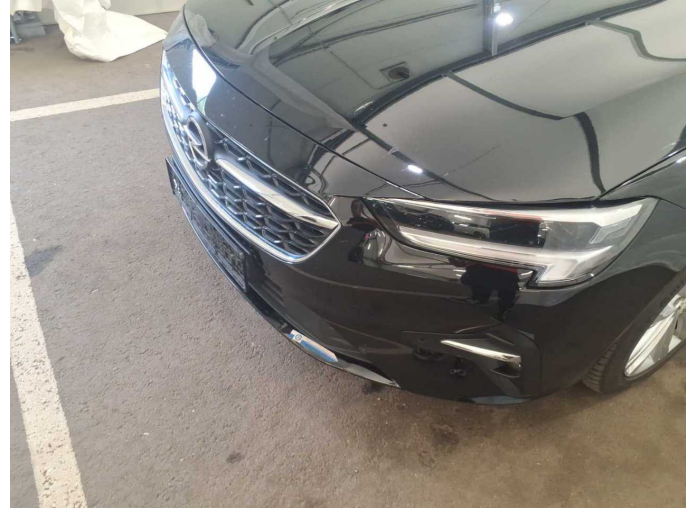
**Damage 10:** Front bumper: Front bumper - Scratched - Repair and paint
