Expertise

Protocol number: 46594365  
Order No. / Reference: 26746650  
Inspection date: 15 Jul 2026

Manufacturer: Volkswagen

Model: Passat Variant 2.0 TDI SCR Business

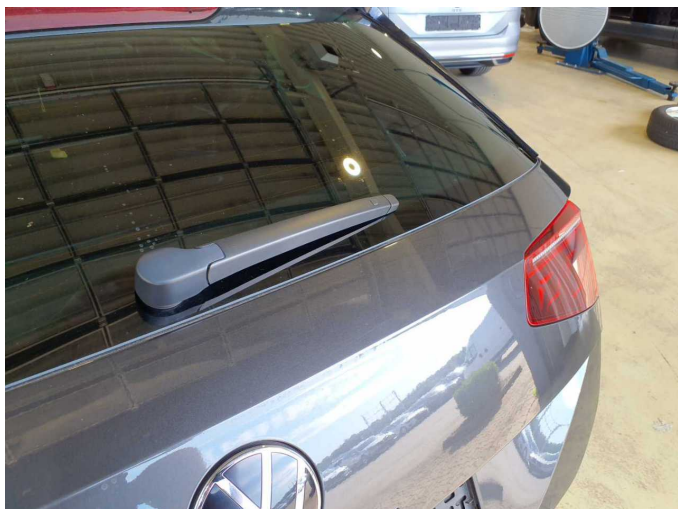
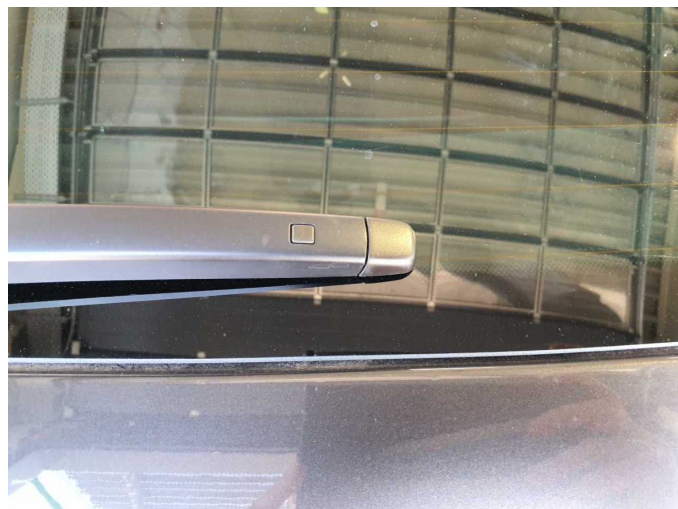
| No. | Component group | Description |
|---|---|---|
| 1 | Screen cleaning | Wiper blades - rear - Missing - Replace |

**Damage 1:** Screen cleaning: Wiper blades - rear - Missing - Replace

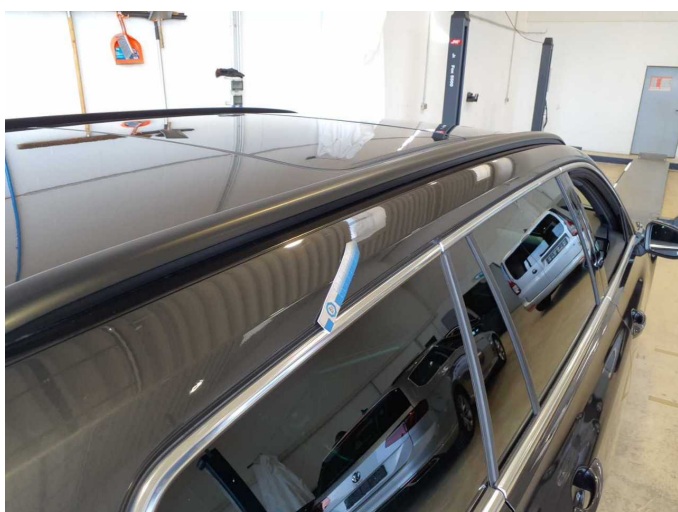
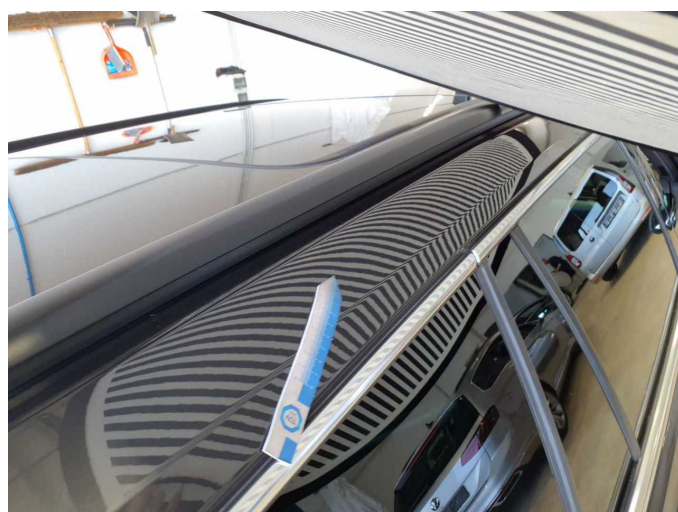
| No. | Component group | Description |
|---|---|---|
| 2 | Roof | Roof rail - right side - dent(s) - Smooth repair work |

**Damage 2:** Roof: Roof rail - right side - dent(s) - Smooth repair work

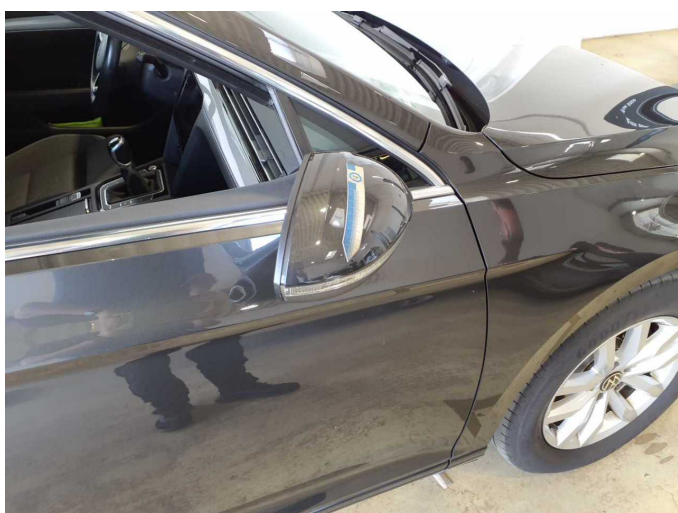
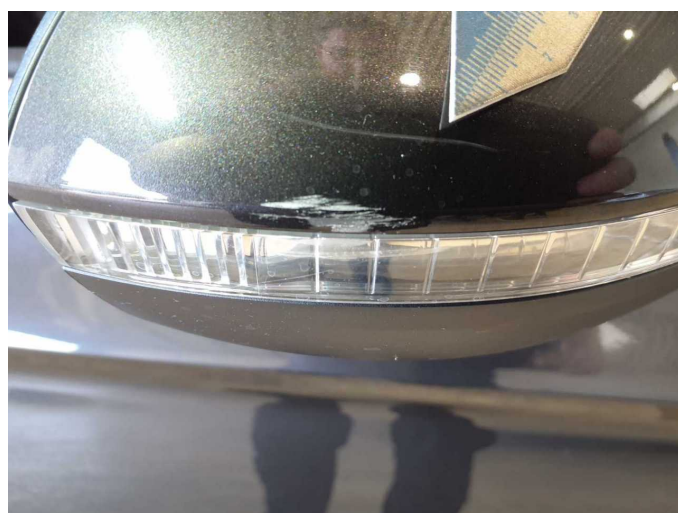
| No. | Component group | Description |
|---|---|---|
| 3 | Indicator - front | Mirror - right side - Scratch(es) - Replace |

**Damage 3:** Indicator - front: Mirror - right side - Scratch(es) - Replace

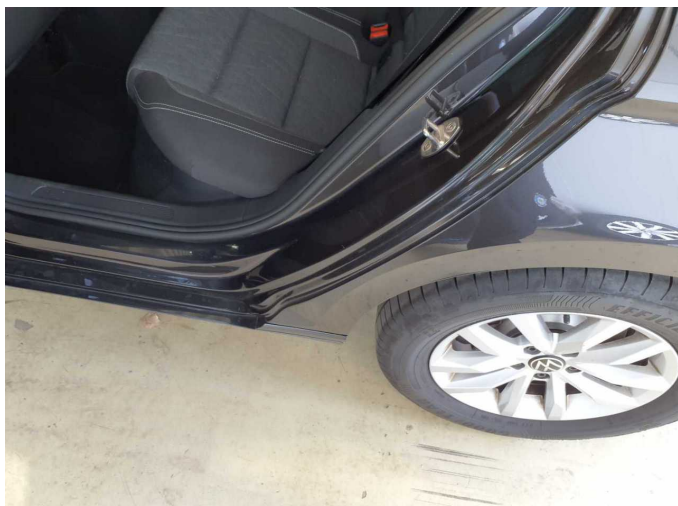
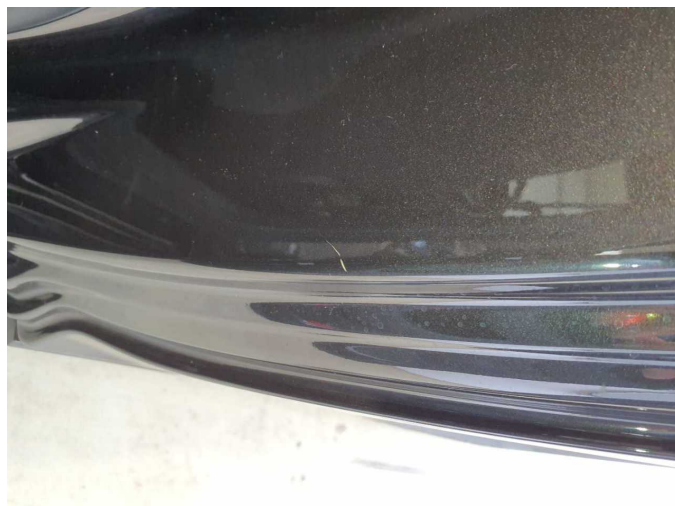
| No. | Component group | Description |
|---|---|---|
| 4 | Side panel - rear left side | Sill - Scratch(es) - Smart repair |

**Damage 4:** Side panel - rear left side: Sill - Scratch(es) - Smart repair

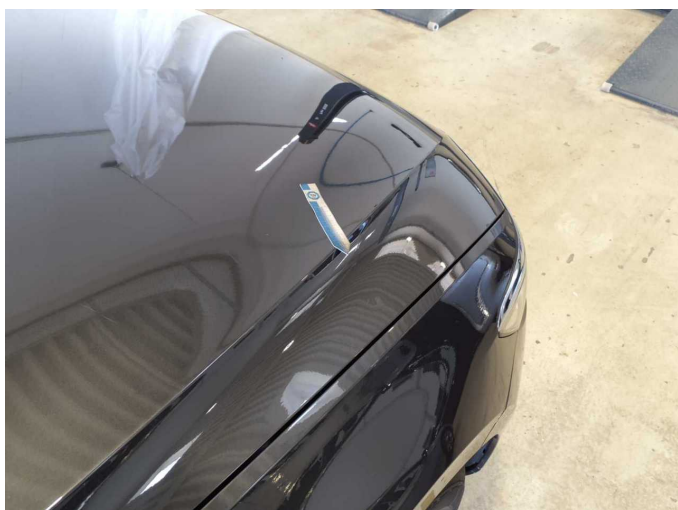
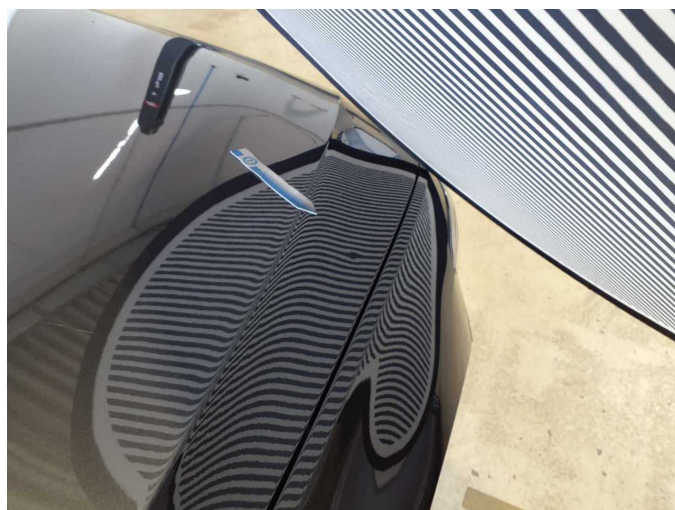
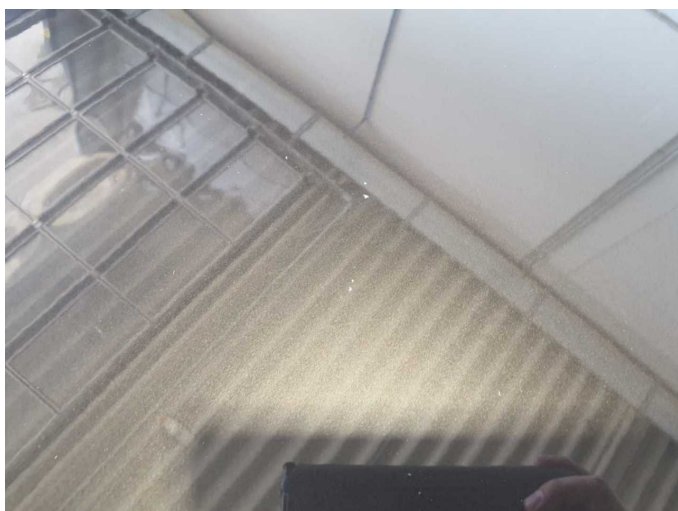
| No. | Component group | Description |
|---|---|---|
| 5 | Bonnet | Bonnet - Dent / paintcoat damage - Loss in value |

**Damage 5:** Bonnet: Bonnet - Dent / paintcoat damage - Loss in value

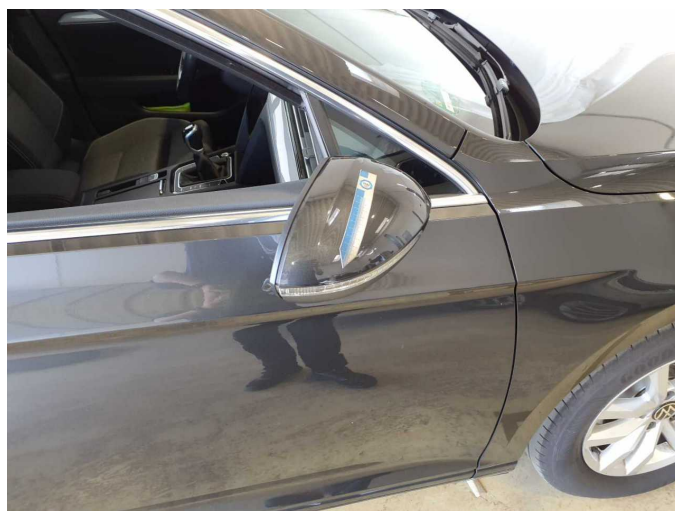
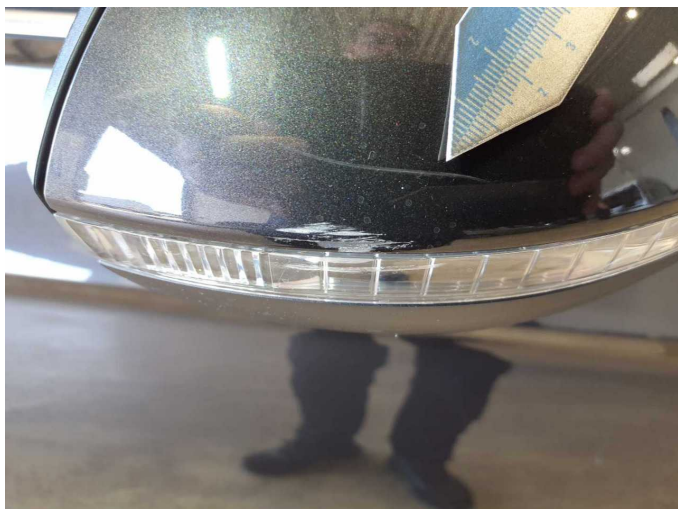
| No. | Component group | Description |
|---|---|---|
| 6 | Wing mirror - right side | Cap - Scratch(es) - Paint |

**Damage 6:** Wing mirror - right side: Cap - Scratch(es) - Paint

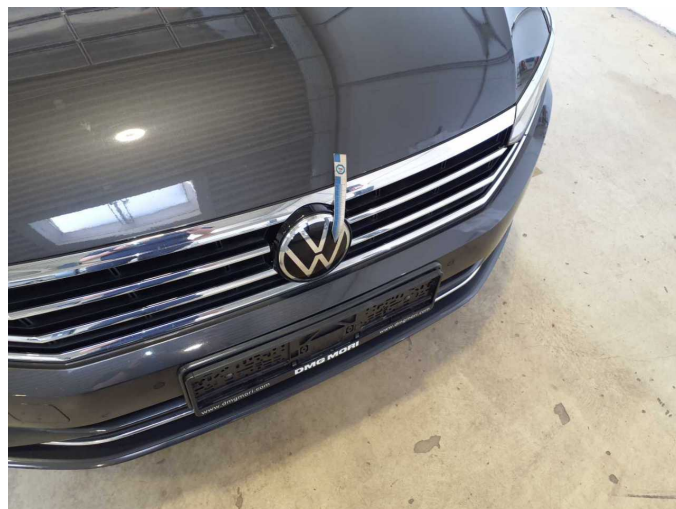
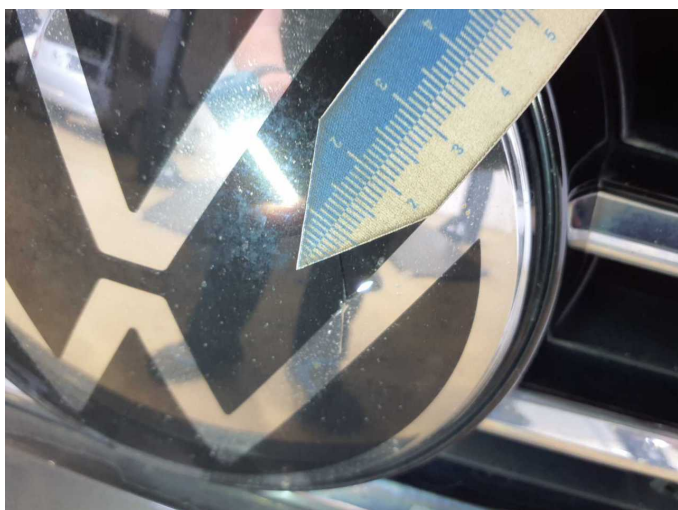
| No. | Component group | Description |
|---|---|---|
| 7 | Front structure | Emblem - Broken / torn - Replace |

**Damage 7:** Front structure: Emblem - Broken / torn - Replace

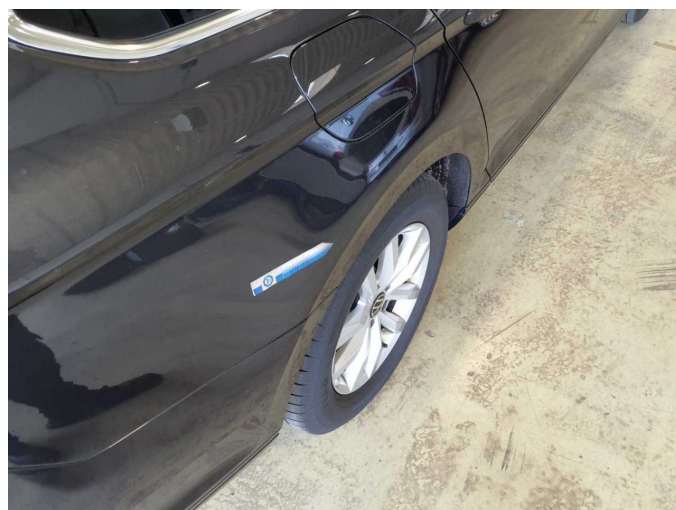
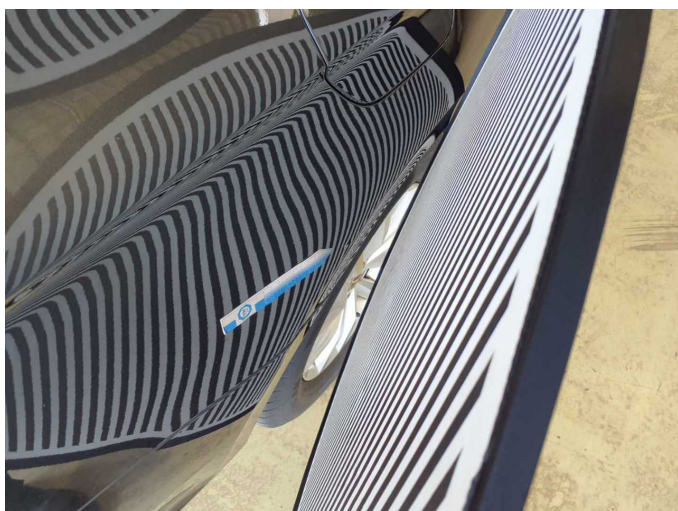
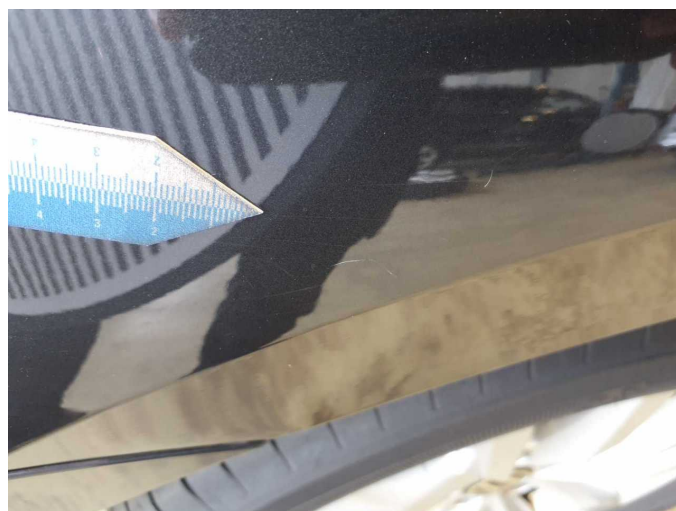
| No. | Component group | Description |
|---|---|---|
| 8 | Side panel - rear right side | Side panel - Dent / paintcoat damage - Repair and paint |

**Damage 8:** Side panel - rear right side: Side panel - Dent / paintcoat damage - Repair and paint

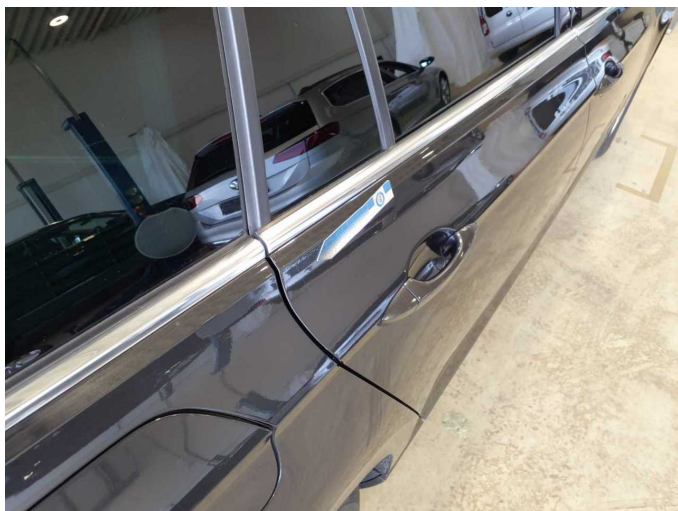
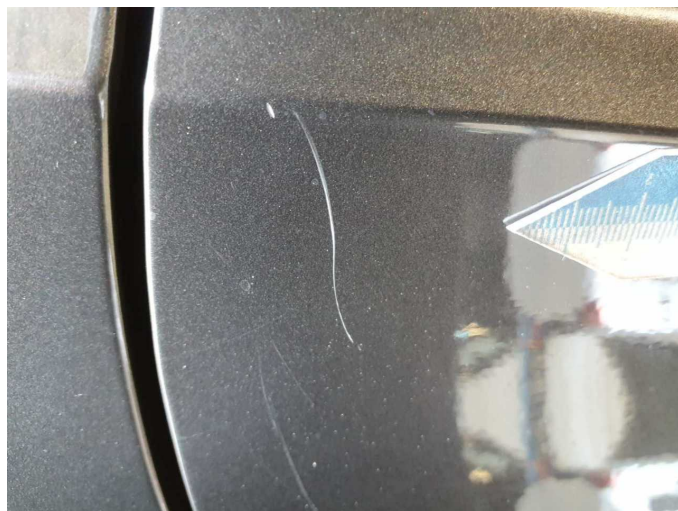
| No. | Component group | Description |
|---|---|---|
| 9 | Door - rear right side | Door - Scratch(es) - Paint |

**Damage 9:** Door - rear right side: Door - Scratch(es) - Paint

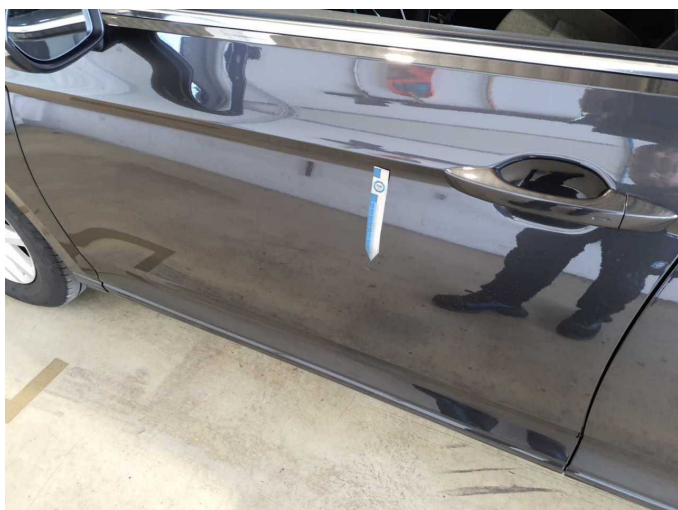
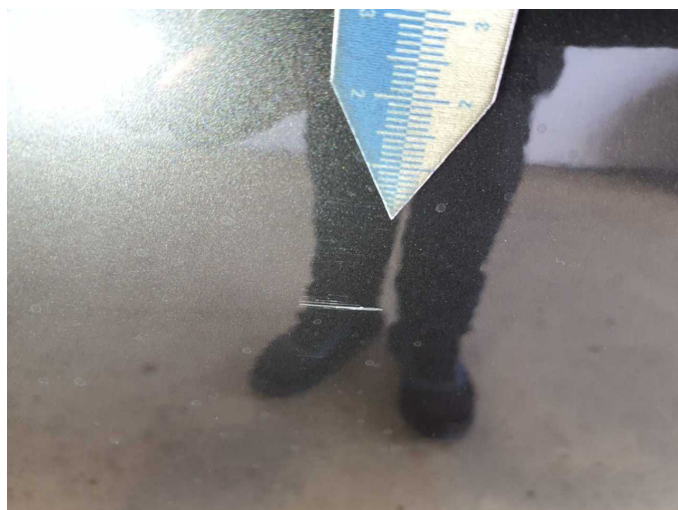
| No. | Component group | Description |
|---|---|---|
| 10 | Door - front left side | Door - Scratch(es) - Paint |

**Damage 10:** Door - front left side: Door - Scratch(es) - Paint

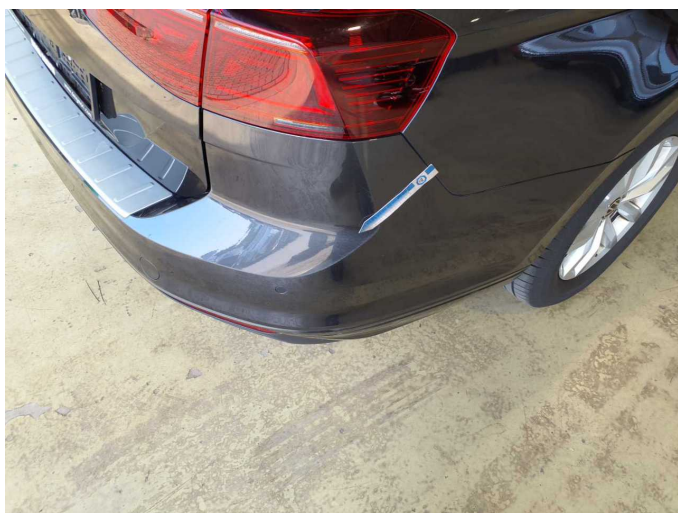
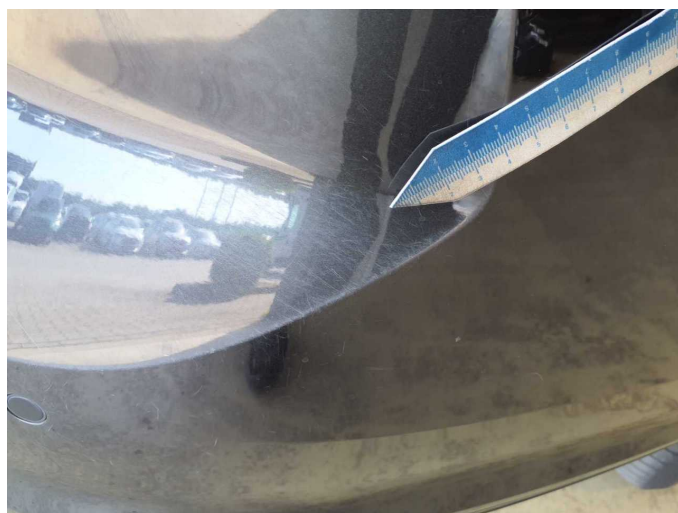
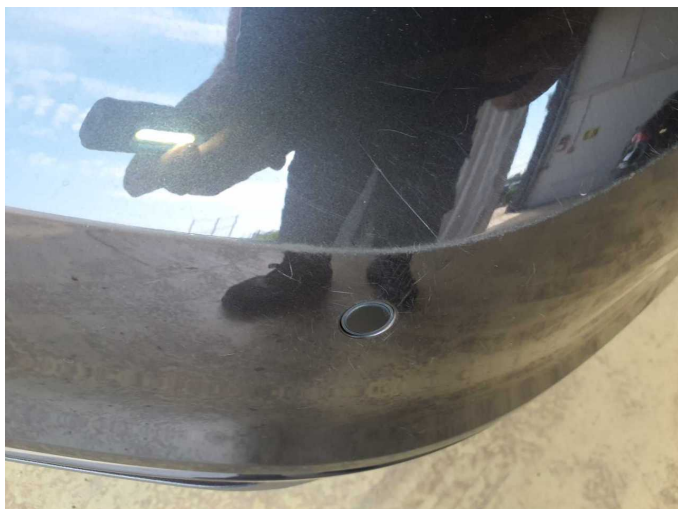
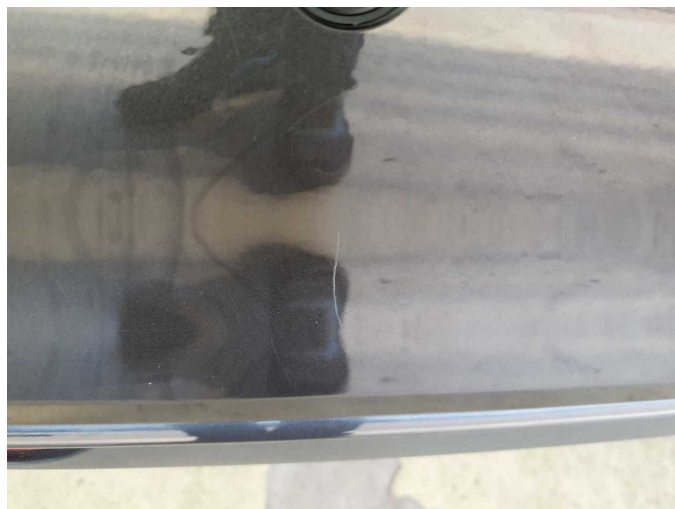
| No. | Component group | Description |
|---|---|---|
| 11 | Rear bumper | Rear bumper - Scratch(es) - Paint |

**Damage 11:** Rear bumper: Rear bumper - Scratch(es) - Paint

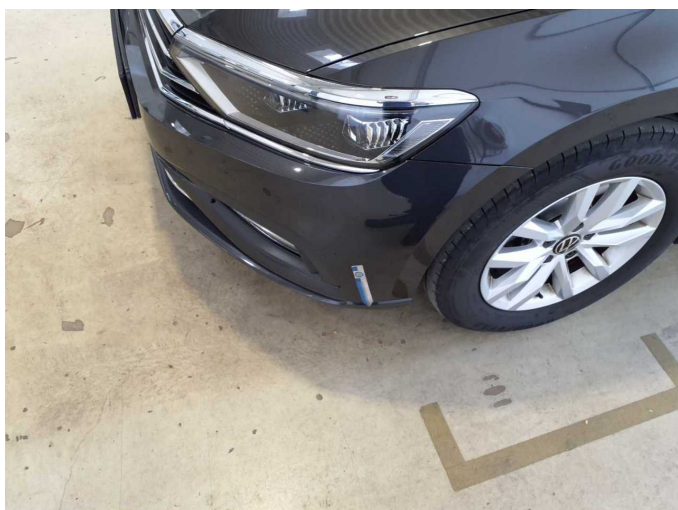
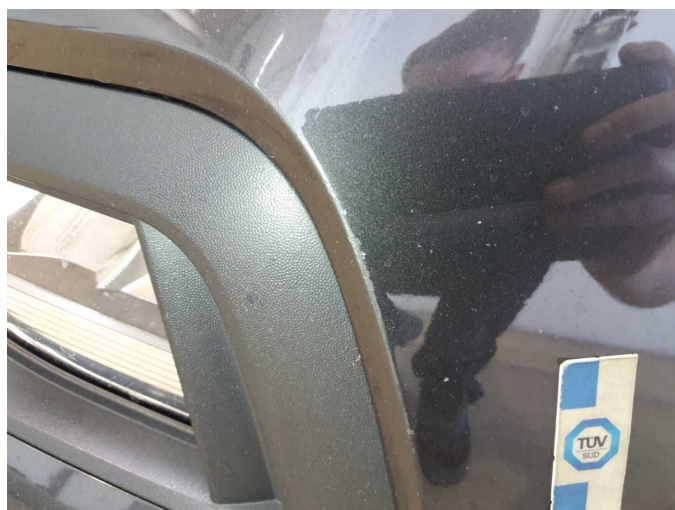
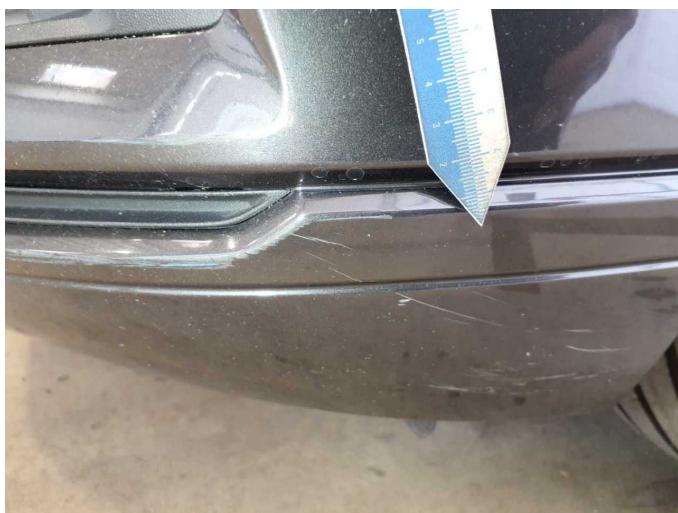
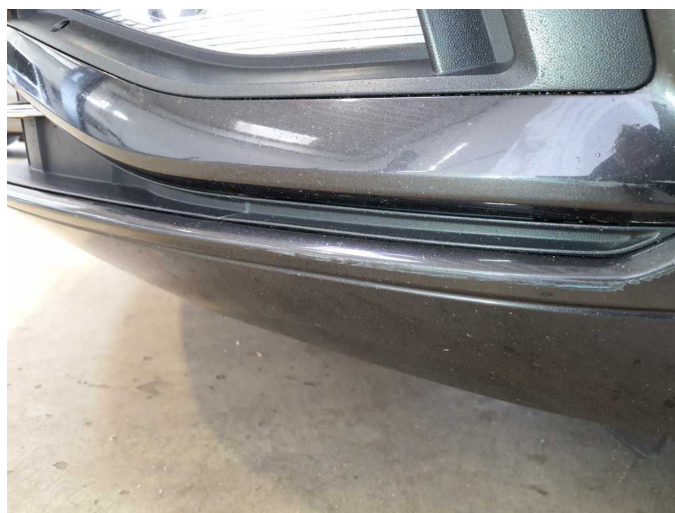
| No. | Component group | Description |
|---|---|---|
| 12 | Front bumper | Front bumper - Scratch(es) - Paint |

**Damage 12:** Front bumper: Front bumper - Scratch(es) - Paint

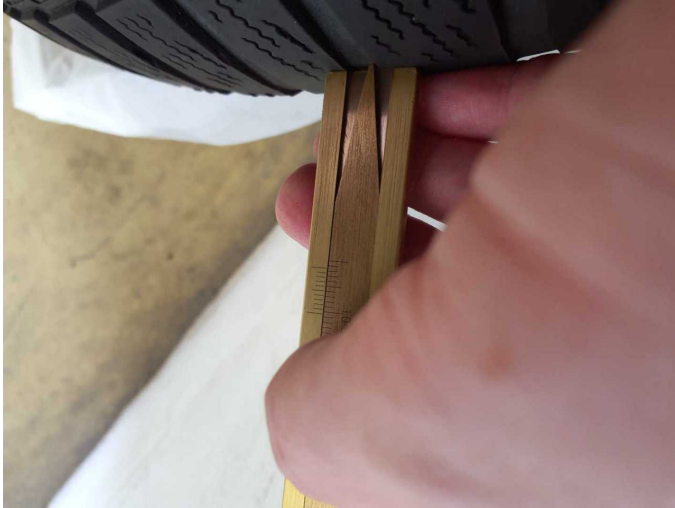
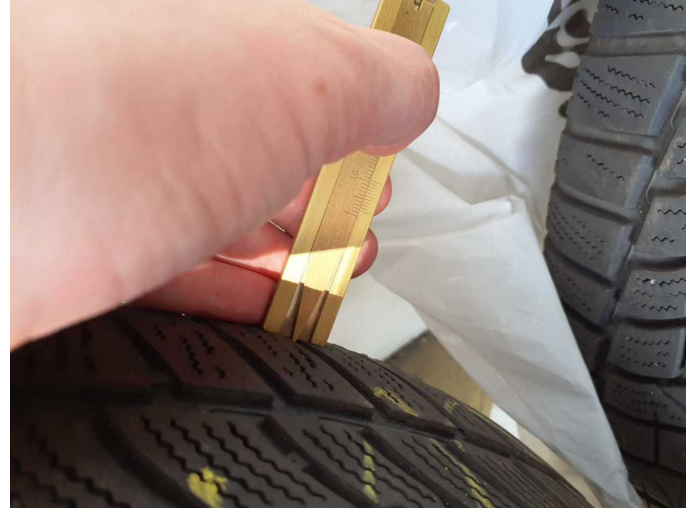
| No. | Component group | Description |
|---|---|---|
| 4 | 2nd wheel set | 2 tyres - does not meet manufacturer specifications - No deduction |

**Wear and tear 4:** 2nd wheel set: 2 tyres - does not meet manufacturer specifications - No deduction
