Expertise

Protocol number: 46122619  
Order No. / Reference: 26445233  
Inspection date: 24 Jun 2026

Manufacturer: Skoda  
VIN: TMBJJ7NS2P8029435

Model: Kodiahq 2.0 TDI DSG Ambition

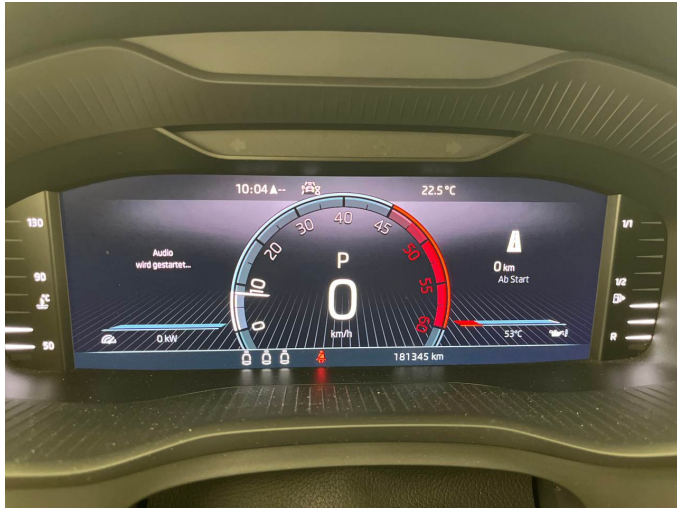
Figure 7: Instrument cluster

| Vehicle details | |
|---|---|
| Mileage (Read) | 181,345 km |

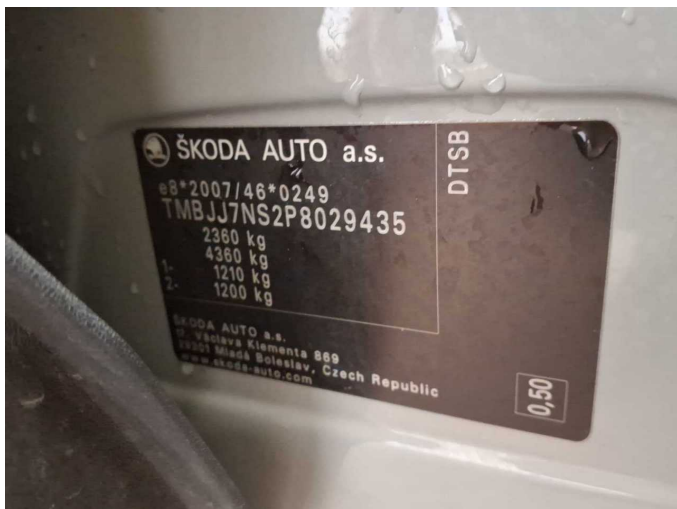
Figure 11: VIN

| VIN comparison | The vehicle identification number (VIN) was read from the vehicle and its conformity with the submitted documents was confirmed by the undersigned during the inspection. |

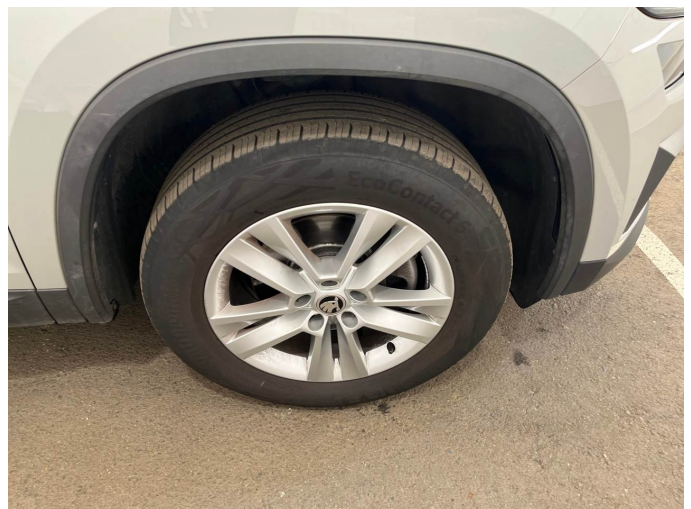
Figure 12: Mounted tyres

| Tyres | | | | |
|---|---|---|---|---|
| 1) | 215/65 R17 99V | Summer tyres on Light alloy | Hankook | 4mm / 4mm |
| 2) | 215/65 R17 99V | Summer tyres on Light alloy | Hankook | 4mm / 4mm |

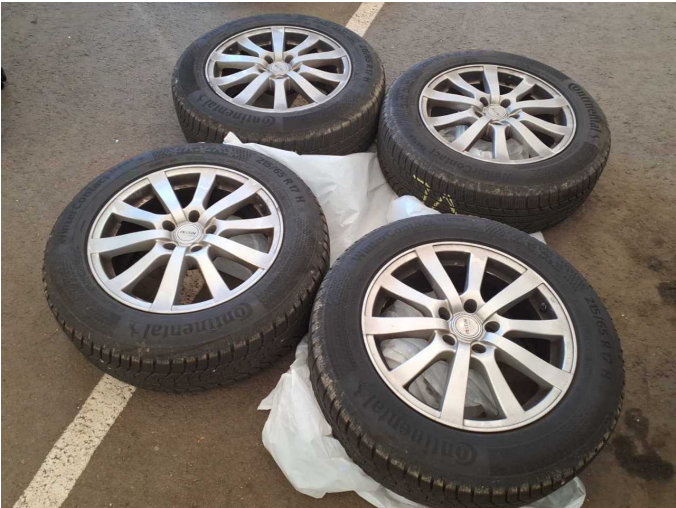
Figure 15: Additional tyres

| Tyres | | | | |
|---|---|---|---|---|
| 1) | 215/65 R17 99H | Winter tyres on Light alloy | Continental | 6mm / 6mm |
| 2) | 215/65 R17 99H | Winter tyres on Light alloy | Continental | 7mm / 7mm |

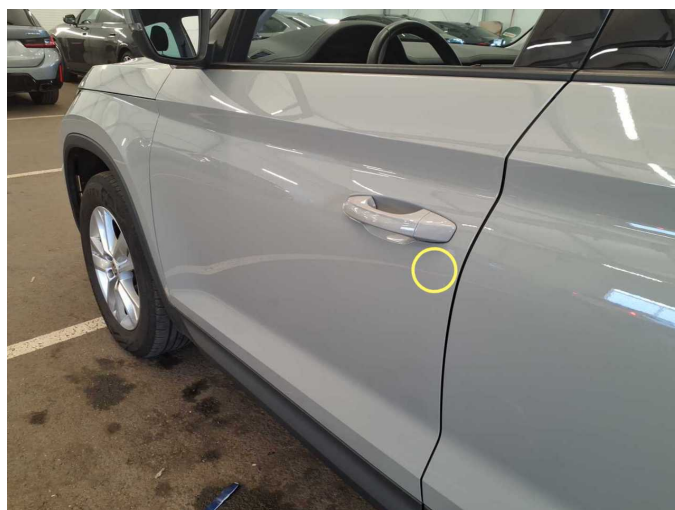
| No. | Component group | Description |
|---|---|---|
| 1 | Door - front left side | Door - Scratch(es) - Smart repair |

**Damage 1:** Door - front left side: Door - Scratch(es) - Smart repair

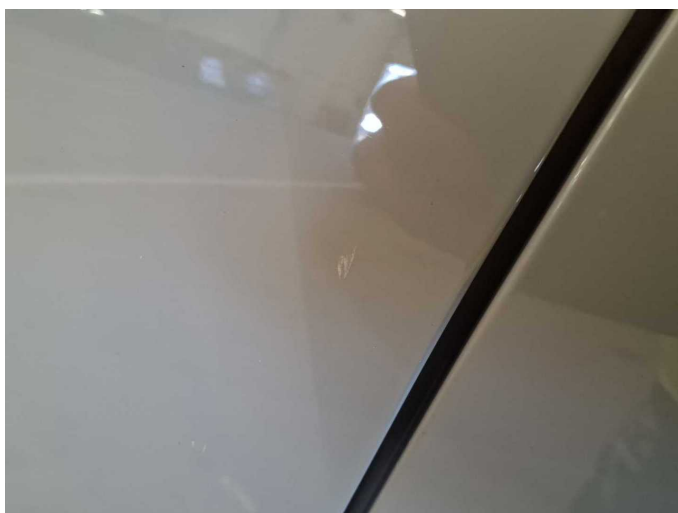
**Damage 1:** Door - front left side: Door - Scratch(es) - Smart repair

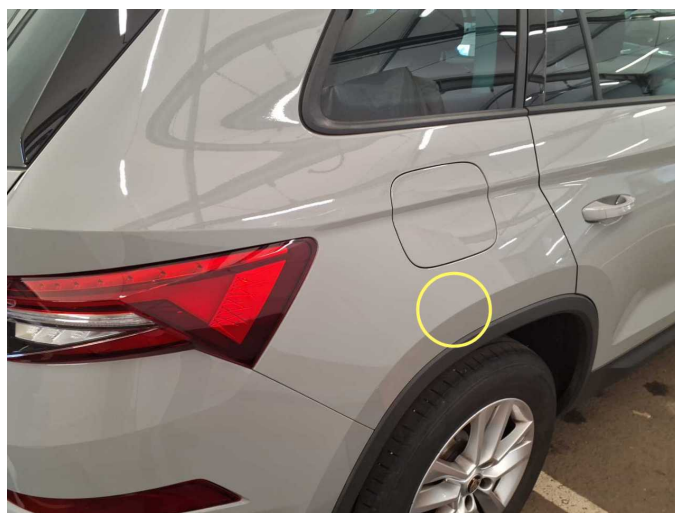
| No. | Component group | Description |
|---|---|---|
| 2 | Side panel - rear right side | Side panel - Dent / paintcoat damage - Repair and paint |

**Damage 2:** Side panel - rear right side: Side panel - Dent / paintcoat damage - Repair and paint

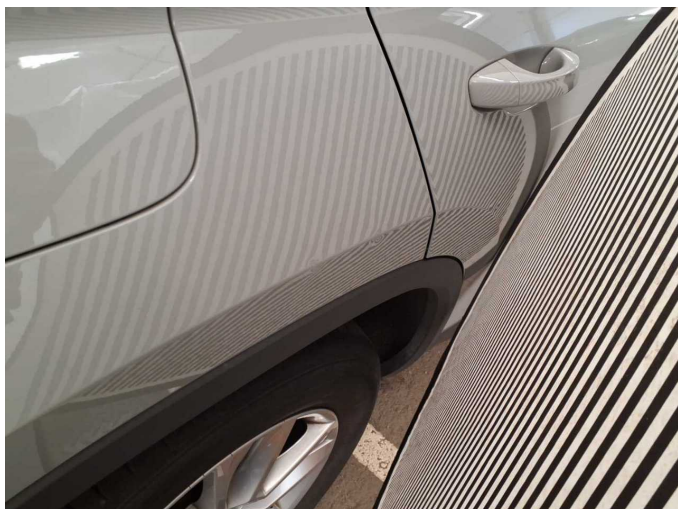
**Damage 2:** Side panel - rear right side: Side panel - Dent / paintcoat damage - Repair and paint

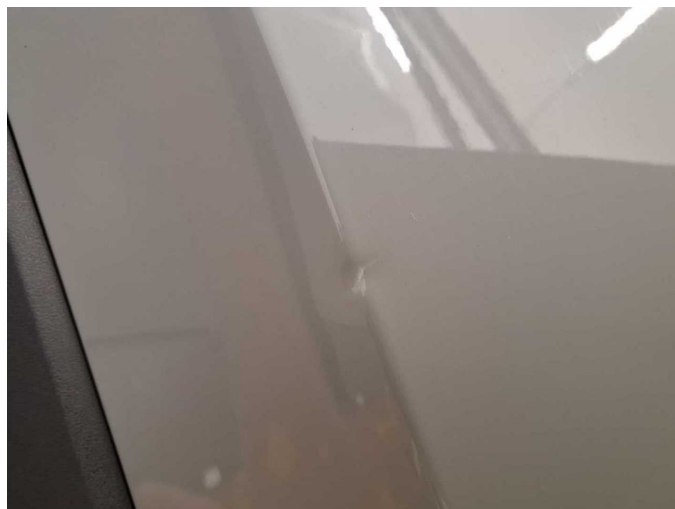
**Damage 2:** Side panel - rear right side: Side panel - Dent / paintcoat damage - Repair and paint
